## Inspection Report, New Elk Min, C1981012, Partial, December 13, 2023

### PERMIT INFORMATION

<b>Permit Number:</b> C-1981-012 <b>Mine Name:</b> New Elk Mine <b>Operator:</b> New Elk Coal Company, LLC <b>Operator Address:</b> Mr. Nick Mason 12250 Highway 12 Weston, CO 81091	<b>County:</b> Las Animas <b>Operation Type:</b> Underground <b>Permit Status:</b> Active <b>Ownership:</b> Private
	<b>Operator Representative Present:</b>  Nick Mason
<b>Operator Representative Signature: (Field Issuance Only)</b>

<b>Inspection Start Date:</b> December 13, 2023 <b>Inspection Start Time:</b> 09:10 <b>Inspection End Date:</b> December 13, 2023 <b>Inspection End Time:</b> 10:15		<b>Inspection Type:</b> Coal Partial Inspection <b>Inspection Reason:</b> Normal I&E Program <b>Weather:</b> Snowing	
<b>Joint Inspection Agency:</b>  None		<b>Joint Inspection Contacts:</b>	
<b>Post Inspection Agency:</b>  None		<b>Post Inspection Contacts:</b>	
<b>Inspector(s):</b>  Amber Gibson	<b>Inspector's Signature:</b>

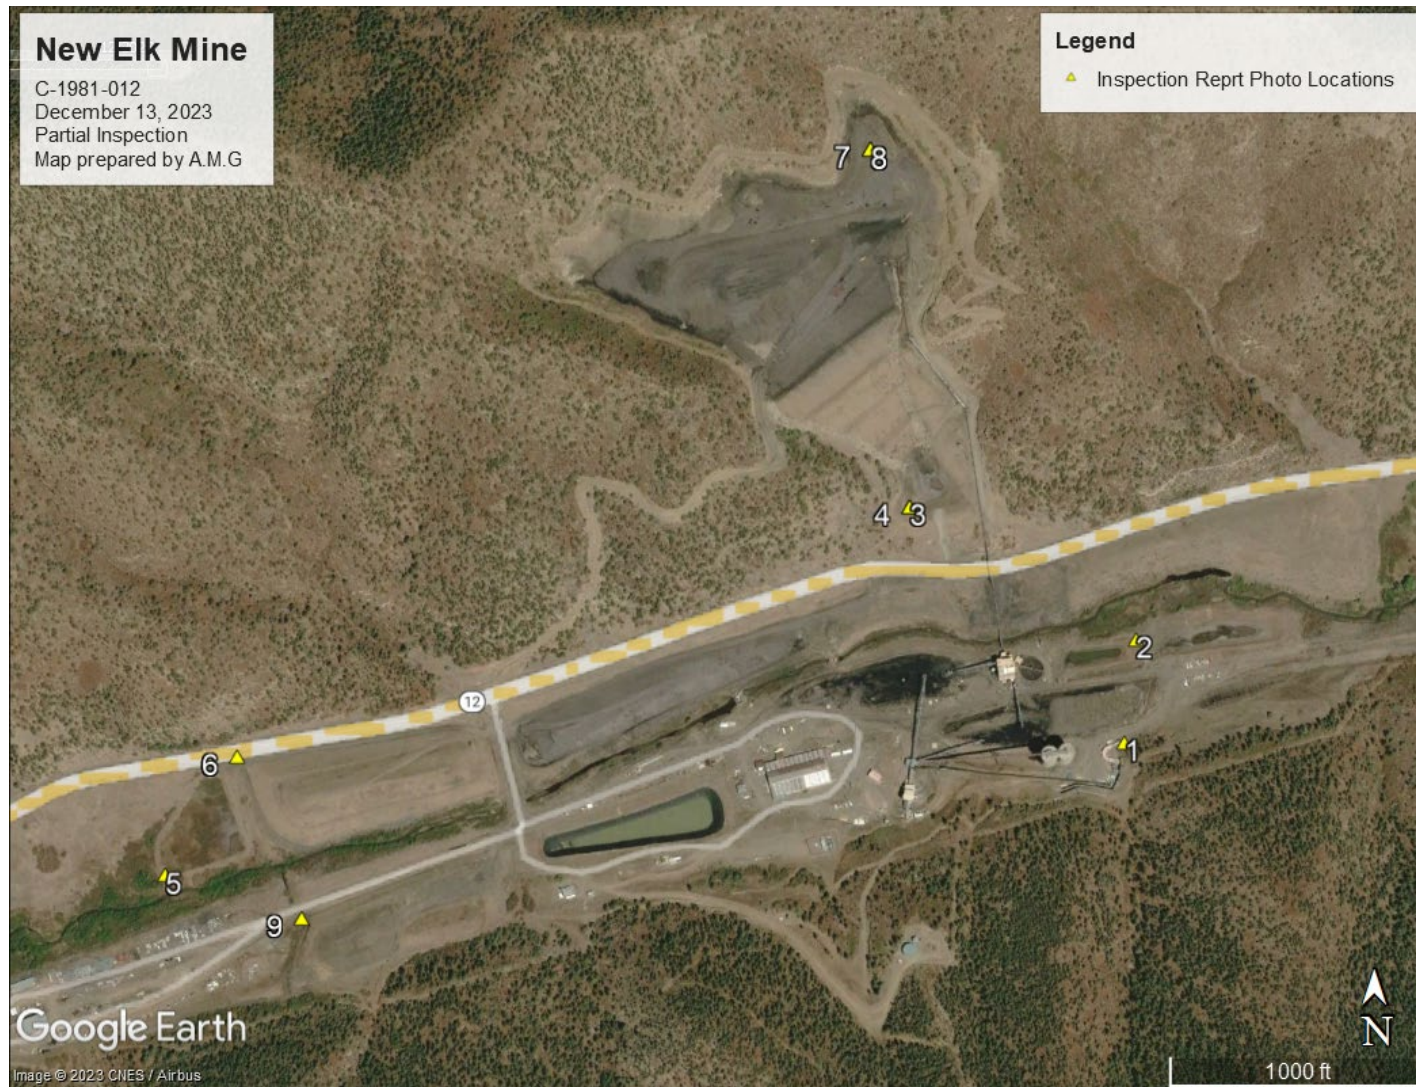
**Figure 1:** Map displaying the photo locations for the inspection photos referenced in this report. Google Earth Pro imagery dated June 2020.
