To: Jerald Schnabel  
Castle Aggregate Industries Inc.  
File: November 2023 Monitoring Summary

**Reference: November 2023 Geotechnical Monitoring Summary Pikeview Quarry**

Client/Project  
CASTLE AGGREGATE  
PIKEVIEW QUARRY SLOPE  
MONITORING  
Project No.  
2057288200

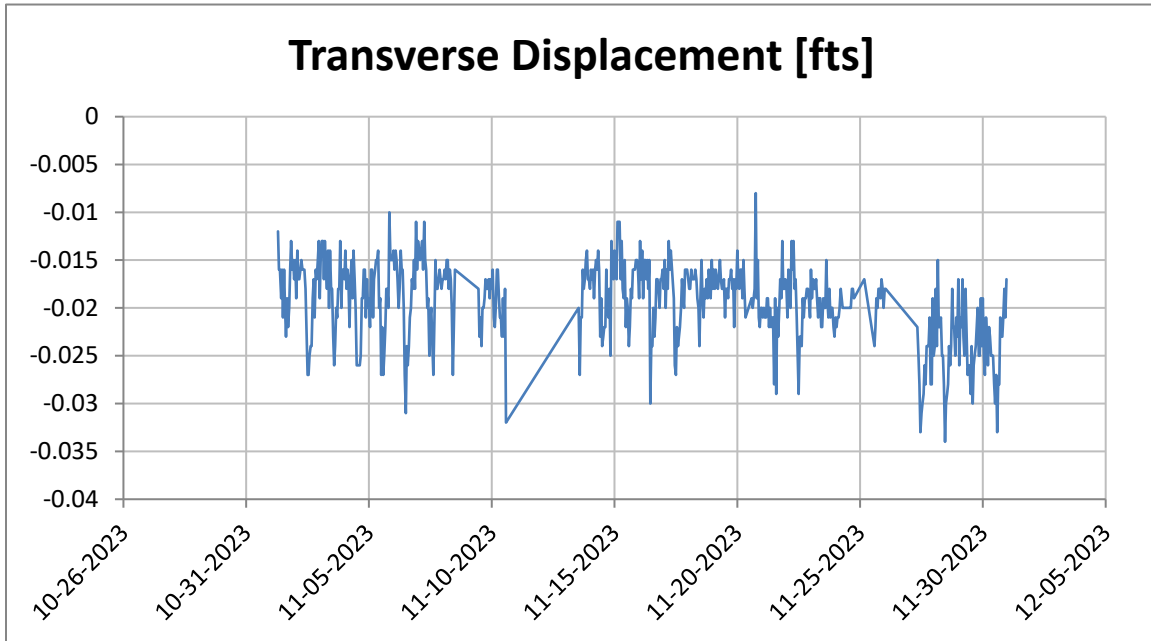
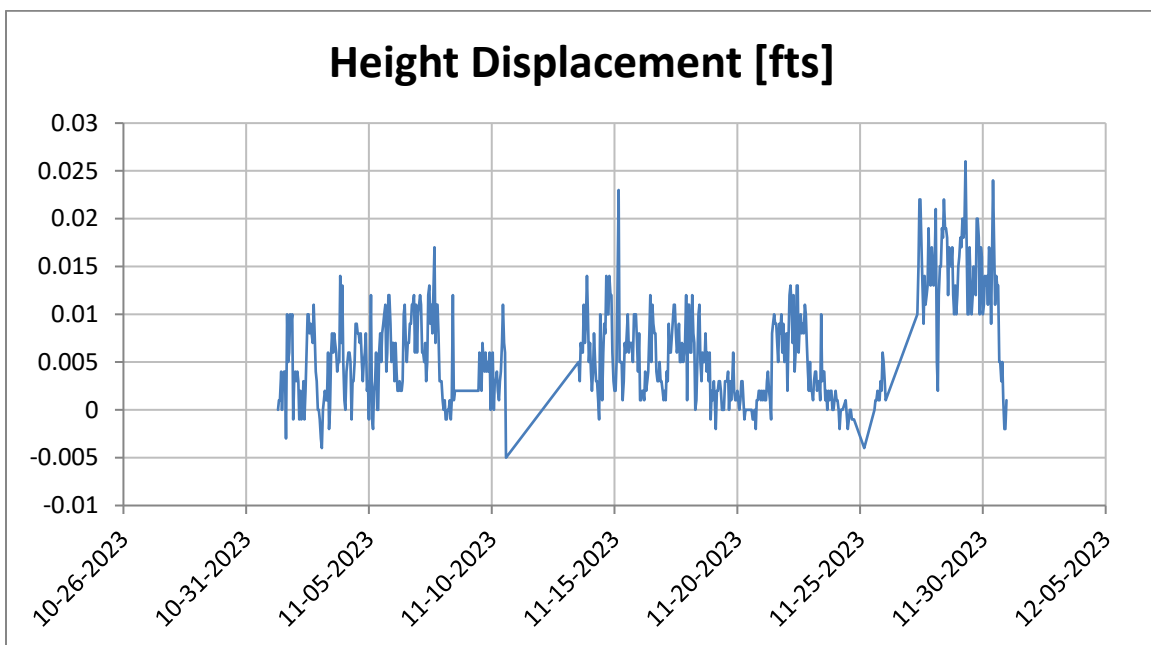
## Prism B7200-1

1. Survey accuracy is  $\pm 0.016$  feet.
2. Alert threshold is  $\pm 0.35$  feet.
3. Transverse displacement is in the horizontal direction. Positive direction means closer to the robotic station.
4. Height displacement is in the vertical direction. Positive direction means higher in elevation.
5. Similar displacements were recorded in the control point and other prisms; data shift is not an indication of slope movements.

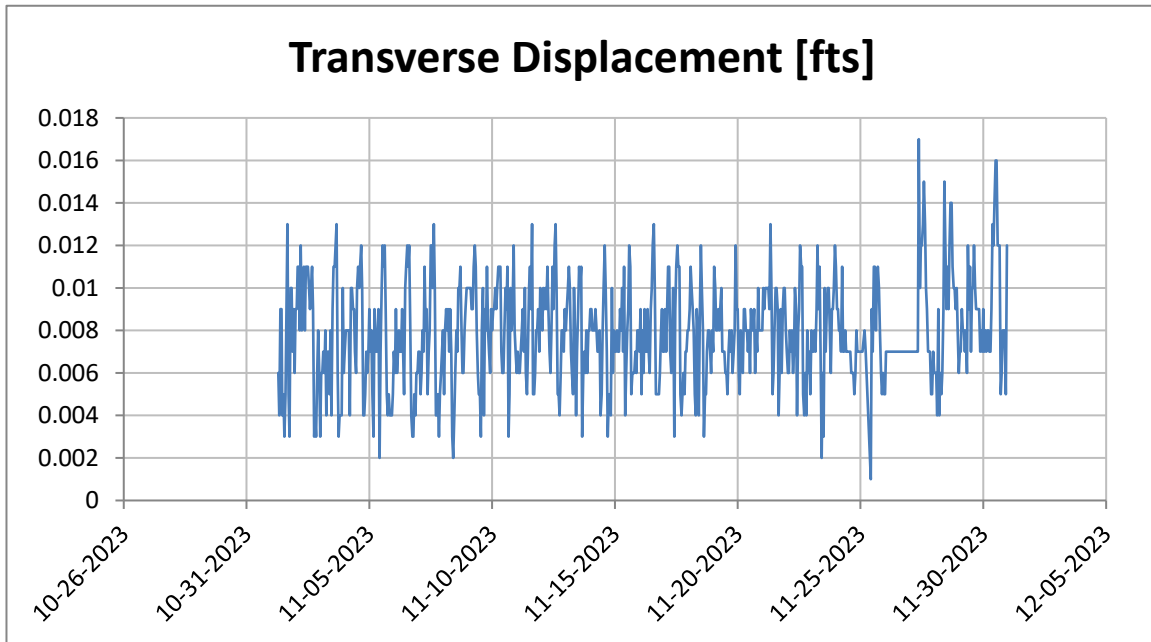
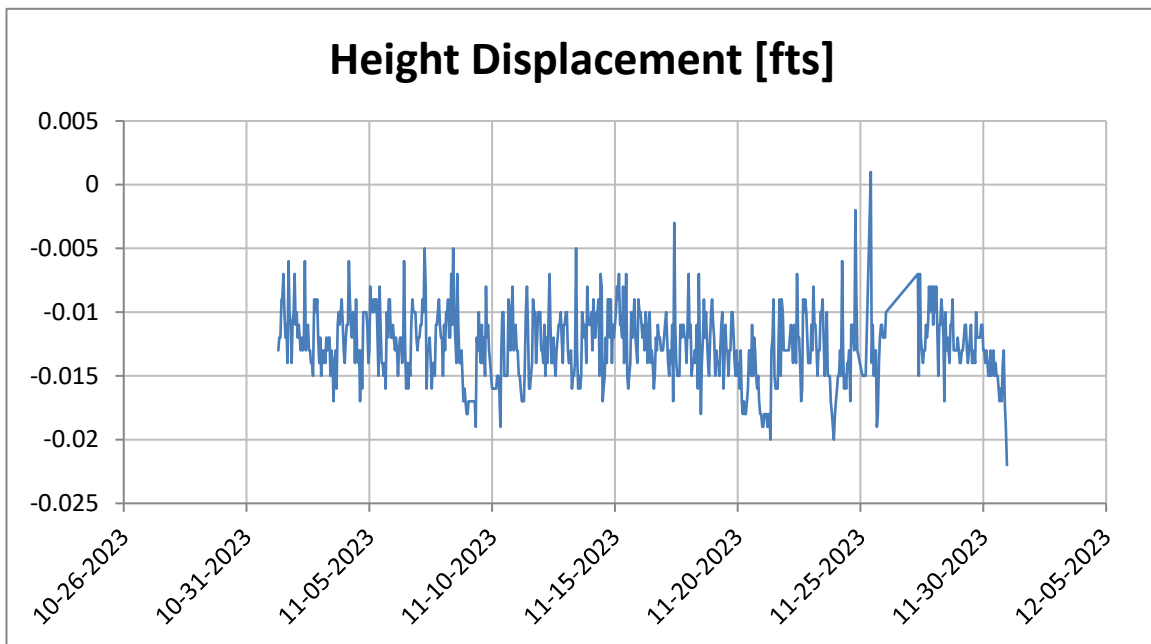
## Prism B7200-2

1. Survey accuracy is  $\pm 0.016$  feet.
2. Alert threshold is  $\pm 0.35$  feet.
3. Transverse displacement is in the horizontal direction. Positive direction means closer to the robotic station.
4. Height displacement is in the vertical direction. Positive direction means higher in elevation.
5. Similar displacements were recorded in the control point and other prisms; data shift is not an indication of slope movements.

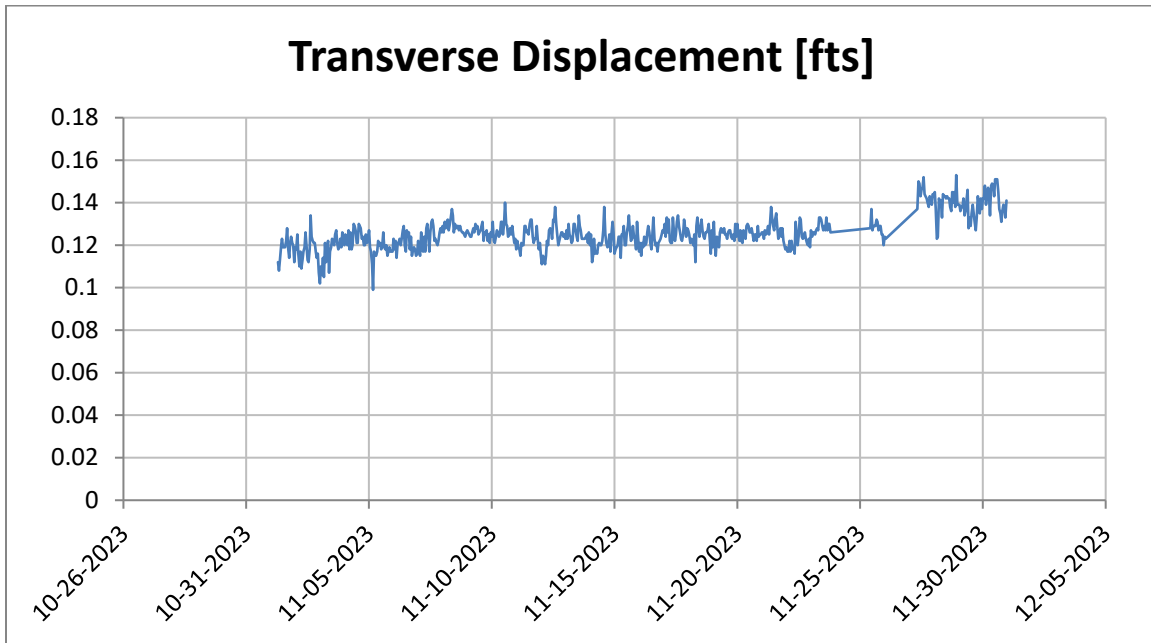
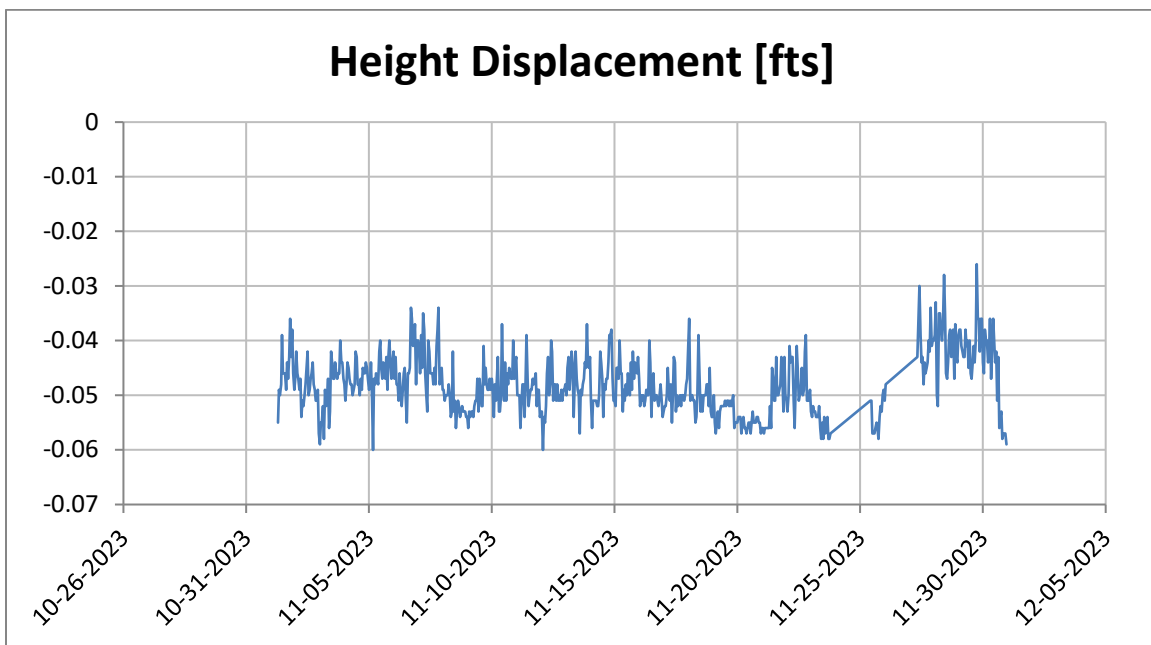
## Prism B7200-3

1. Survey accuracy is  $\pm 0.016$  feet.
2. Alert threshold is  $\pm 0.35$  feet.
3. Transverse displacement is in the horizontal direction. Positive direction means closer to the robotic station.
4. Height displacement is in the vertical direction. Positive direction means higher in elevation.
5. Similar displacements were recorded in the control point and other prisms; data shift is not an indication of slope movements.

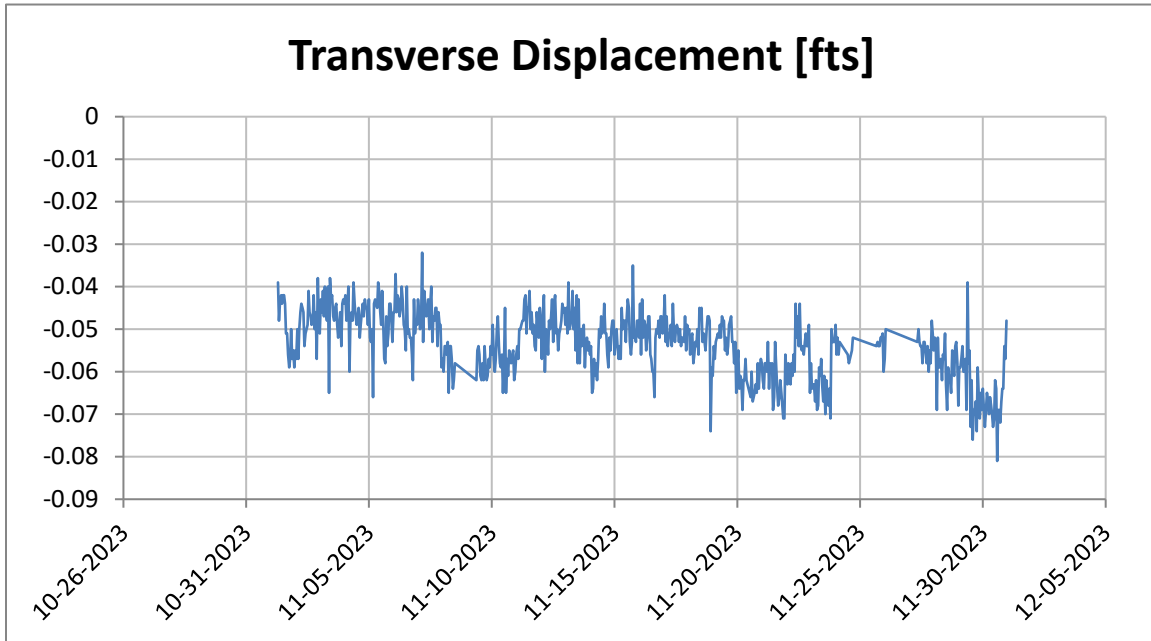
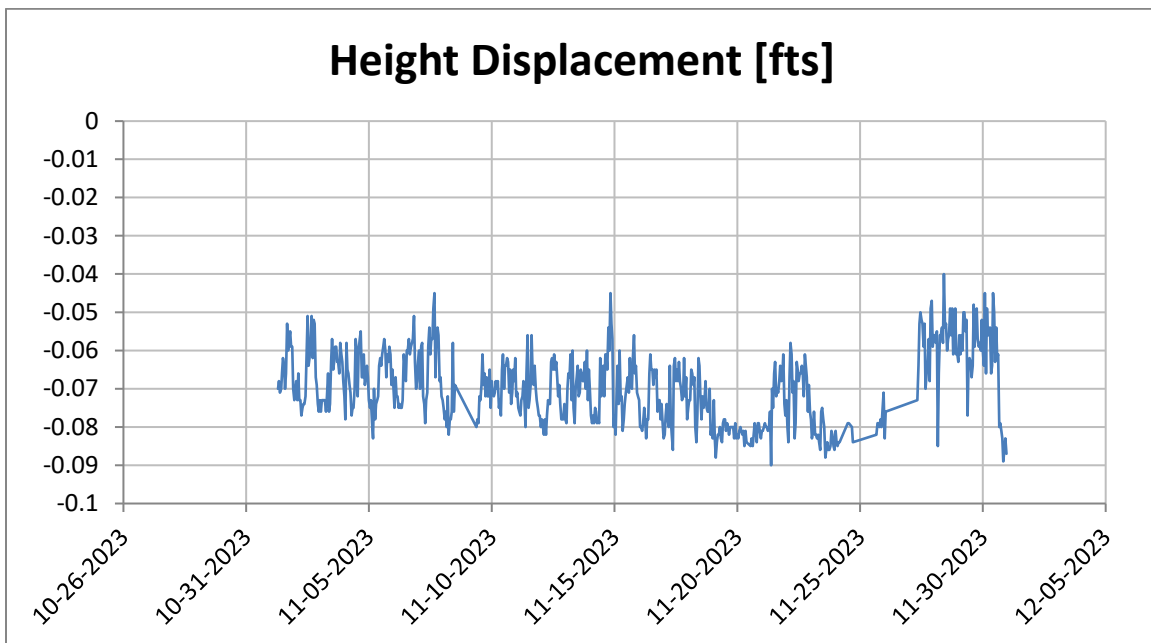
## Prism B7300-0

1. Survey accuracy is  $\pm 0.016$  feet.
2. Alert threshold is  $\pm 0.35$  feet.
3. Transverse displacement is in the horizontal direction. Positive direction means closer to the robotic station.
4. Height displacement is in the vertical direction. Positive direction means higher in elevation.
5. Similar displacements were recorded in the control point and other prisms; data shift is not an indication of slope movements.

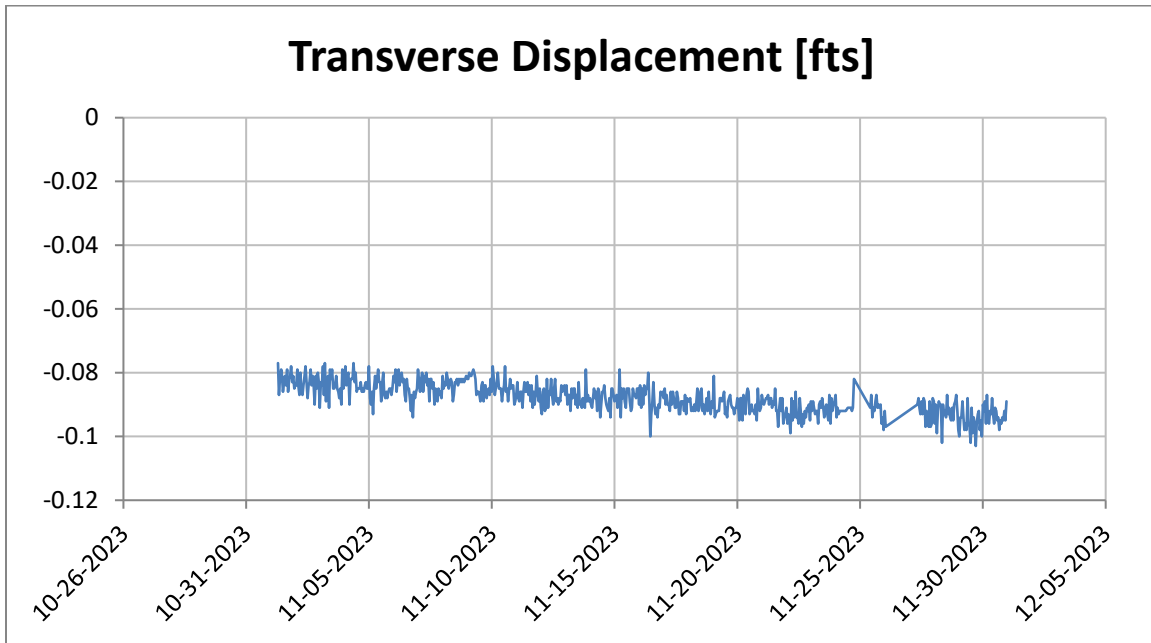
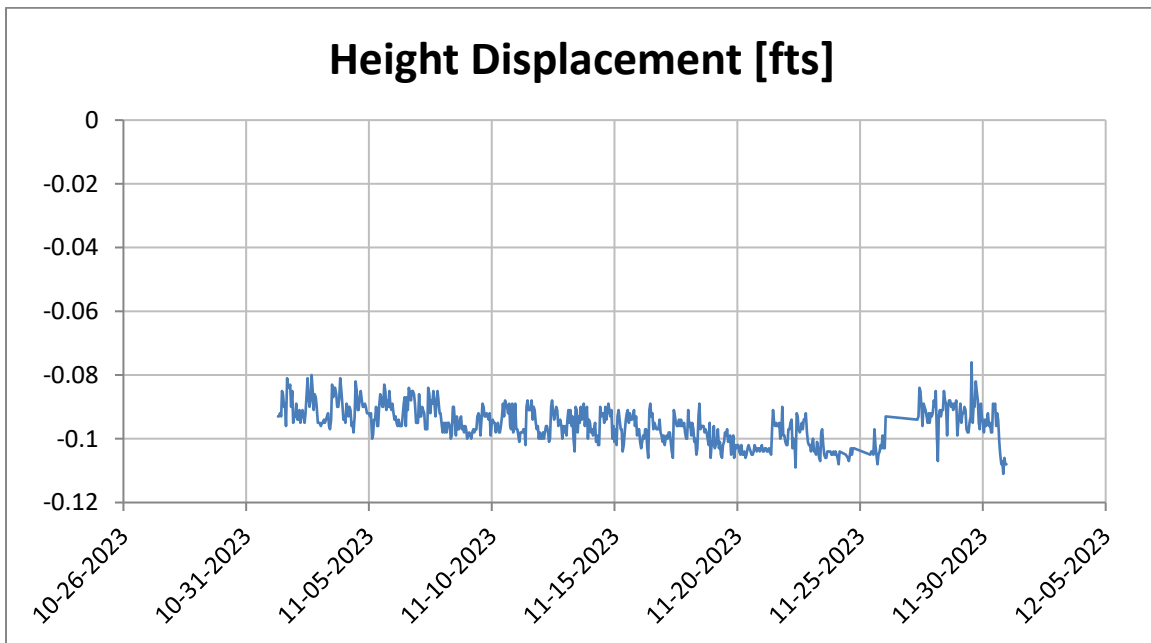
## Prism B7300-1

1. Survey accuracy is  $\pm 0.016$  feet.
2. Alert threshold is  $\pm 0.35$  feet.
3. Transverse displacement is in the horizontal direction. Positive direction means closer to the robotic station.
4. Height displacement is in the vertical direction. Positive direction means higher in elevation.
5. Similar displacements were recorded in the control point and other prisms; data shift is not an indication of slope movements.

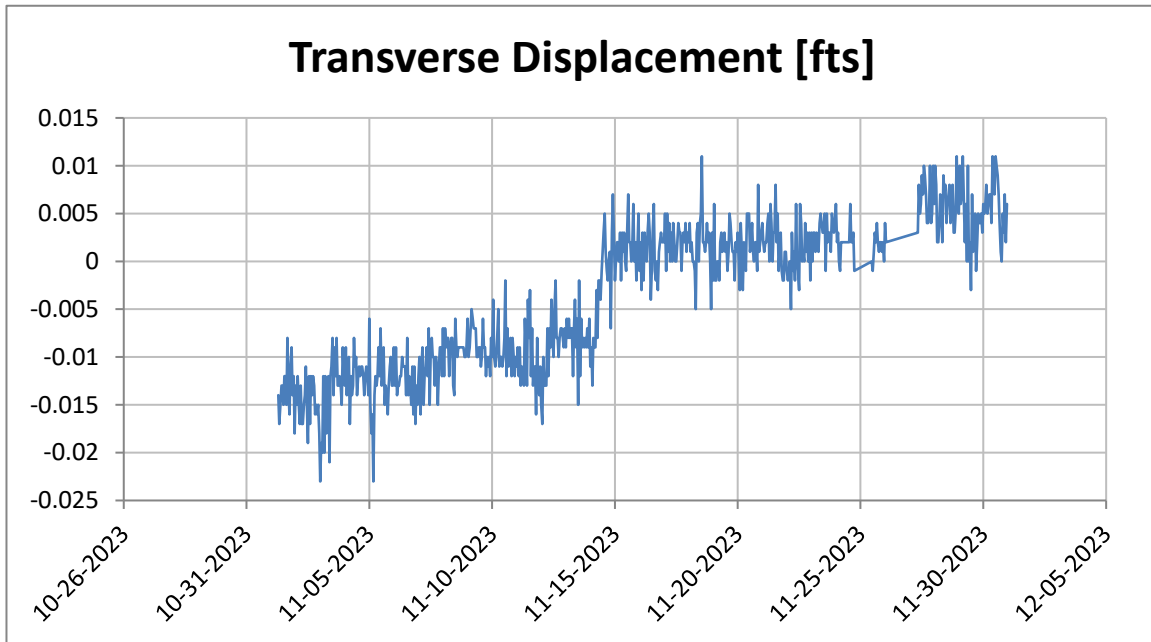
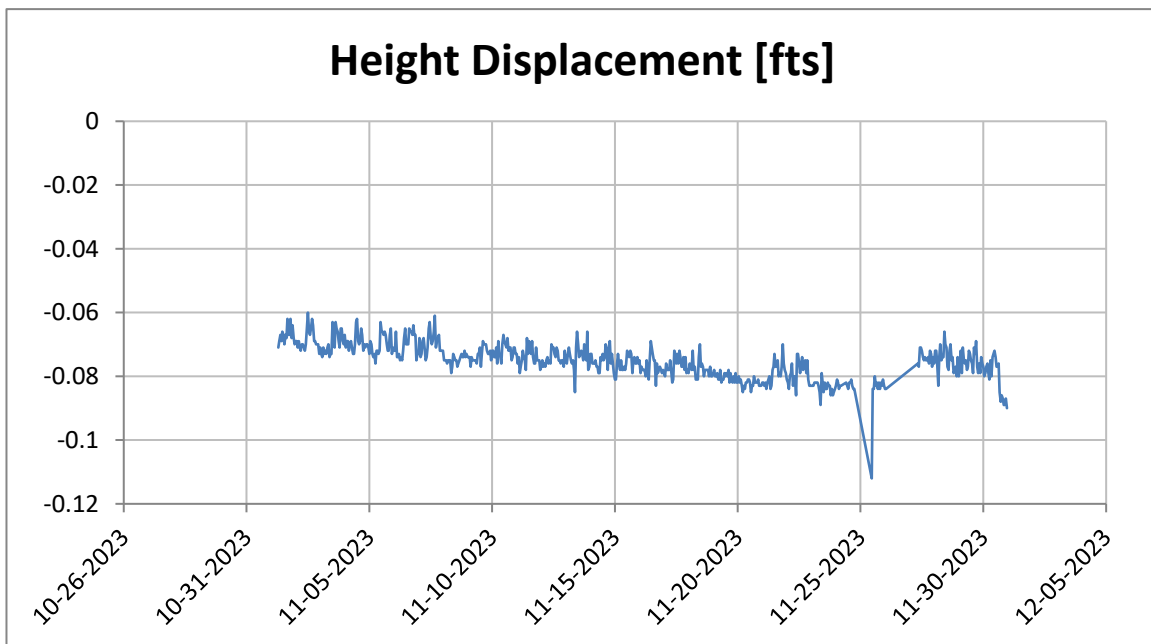
## Prism B7300-2

1. Survey accuracy is  $\pm 0.016$  feet.
2. Alert threshold is  $\pm 0.35$  feet.
3. Transverse displacement is in the horizontal direction. Positive direction means closer to the robotic station.
4. Height displacement is in the vertical direction. Positive direction means higher in elevation.
5. Similar displacements were recorded in the control point and other prisms; data shift is not an indication of slope movements.

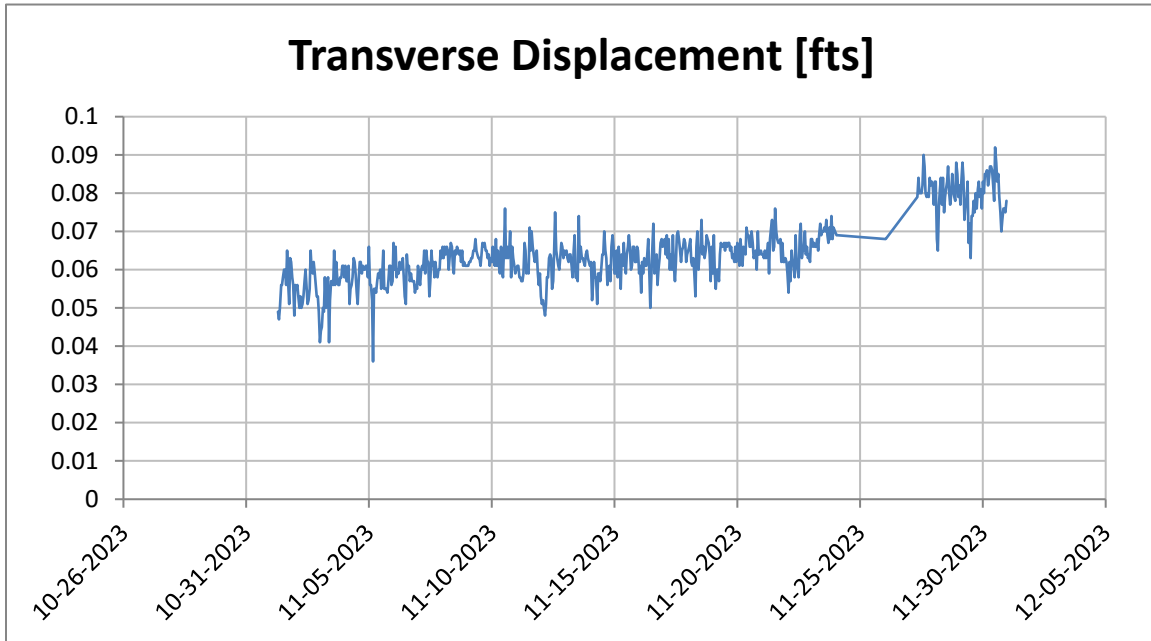
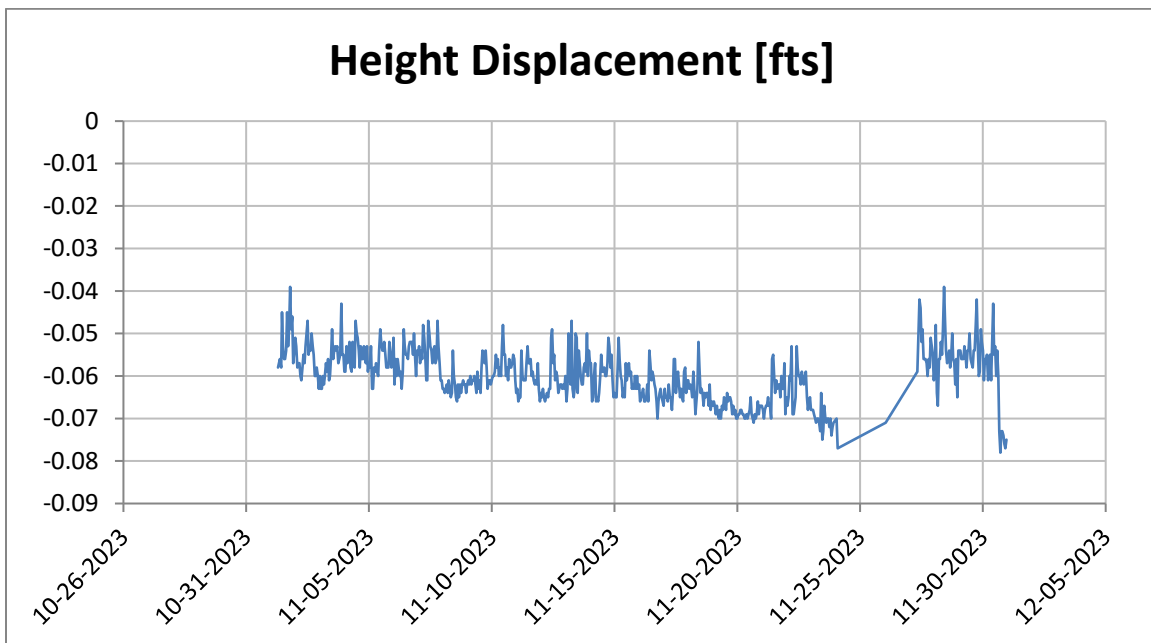
## Prism B7300-3

1. Survey accuracy is +/-0.016 feet.
2. Alert threshold is +/-0.35 feet.
3. Transverse displacement is in the horizontal direction. Positive direction means closer to the robotic station.
4. Height displacement is in the vertical direction. Positive direction means higher in elevation.
5. Similar displacements were recorded in the control point and other prisms; data shift is not an indication of slope movements.

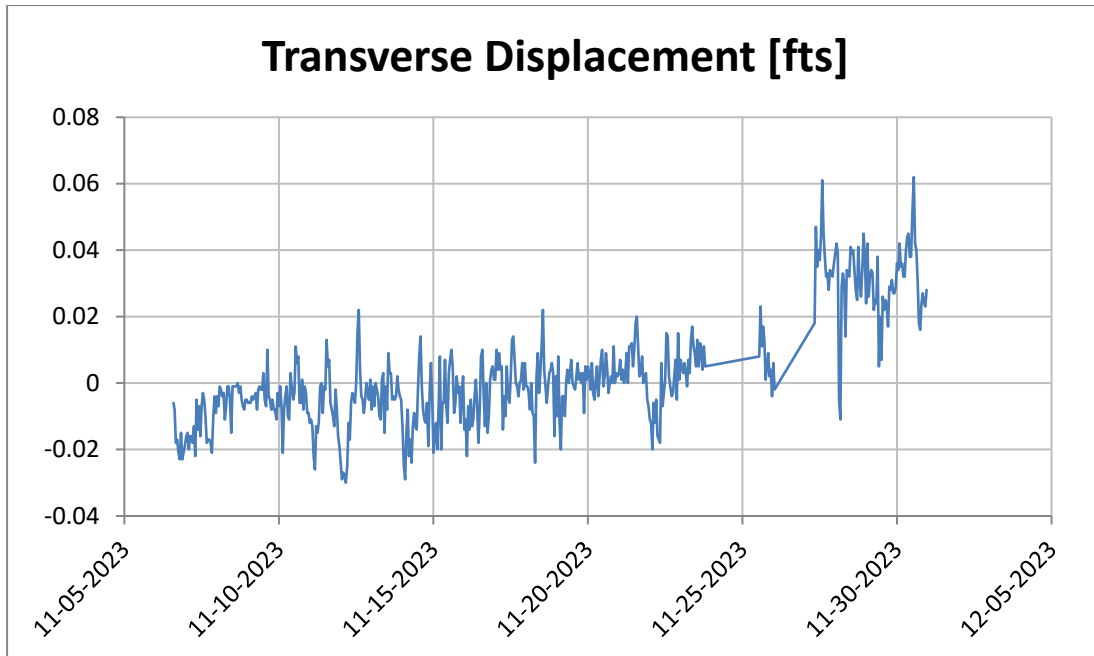
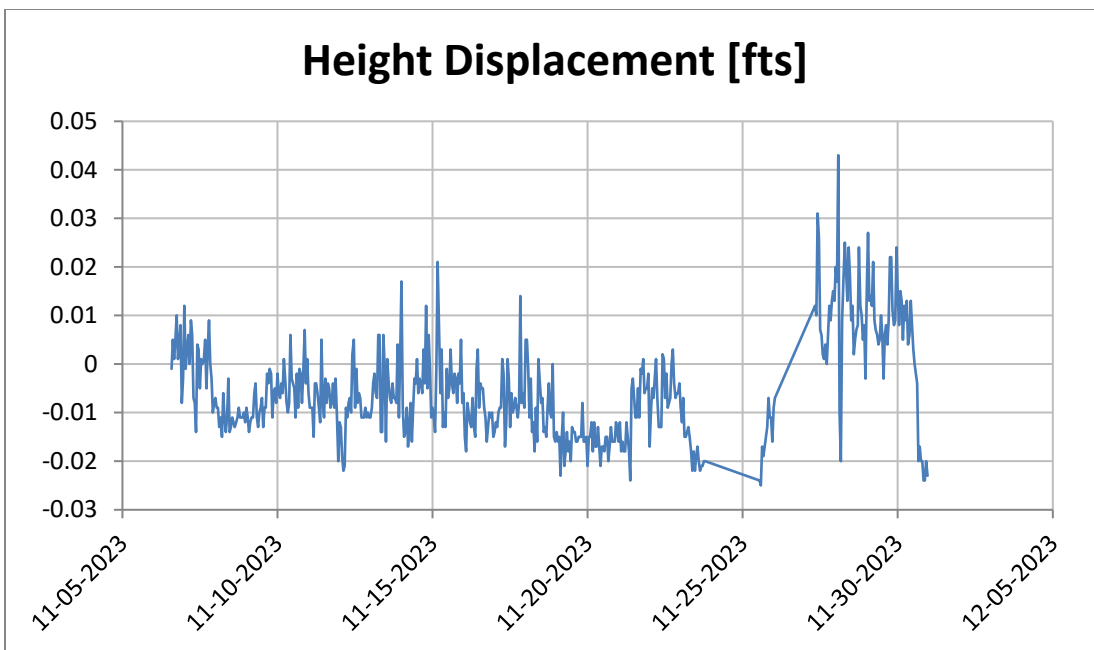
## Prism B7300-4

1. Survey accuracy is +/-0.016 feet.
2. Alert threshold is +/-0.35 feet.
3. Transverse displacement is in the horizontal direction. Positive direction means closer to the robotic station.
4. Height displacement is in the vertical direction. Positive direction means higher in elevation.
5. Similar displacements were recorded in the control point and other prisms; data shift is not an indication of slope movements.
