Geotechnical Addendum

2023 Annual Report

Holcim – US Deer Creek Quarry

Permit M1977-014
Jefferson County, Colorado

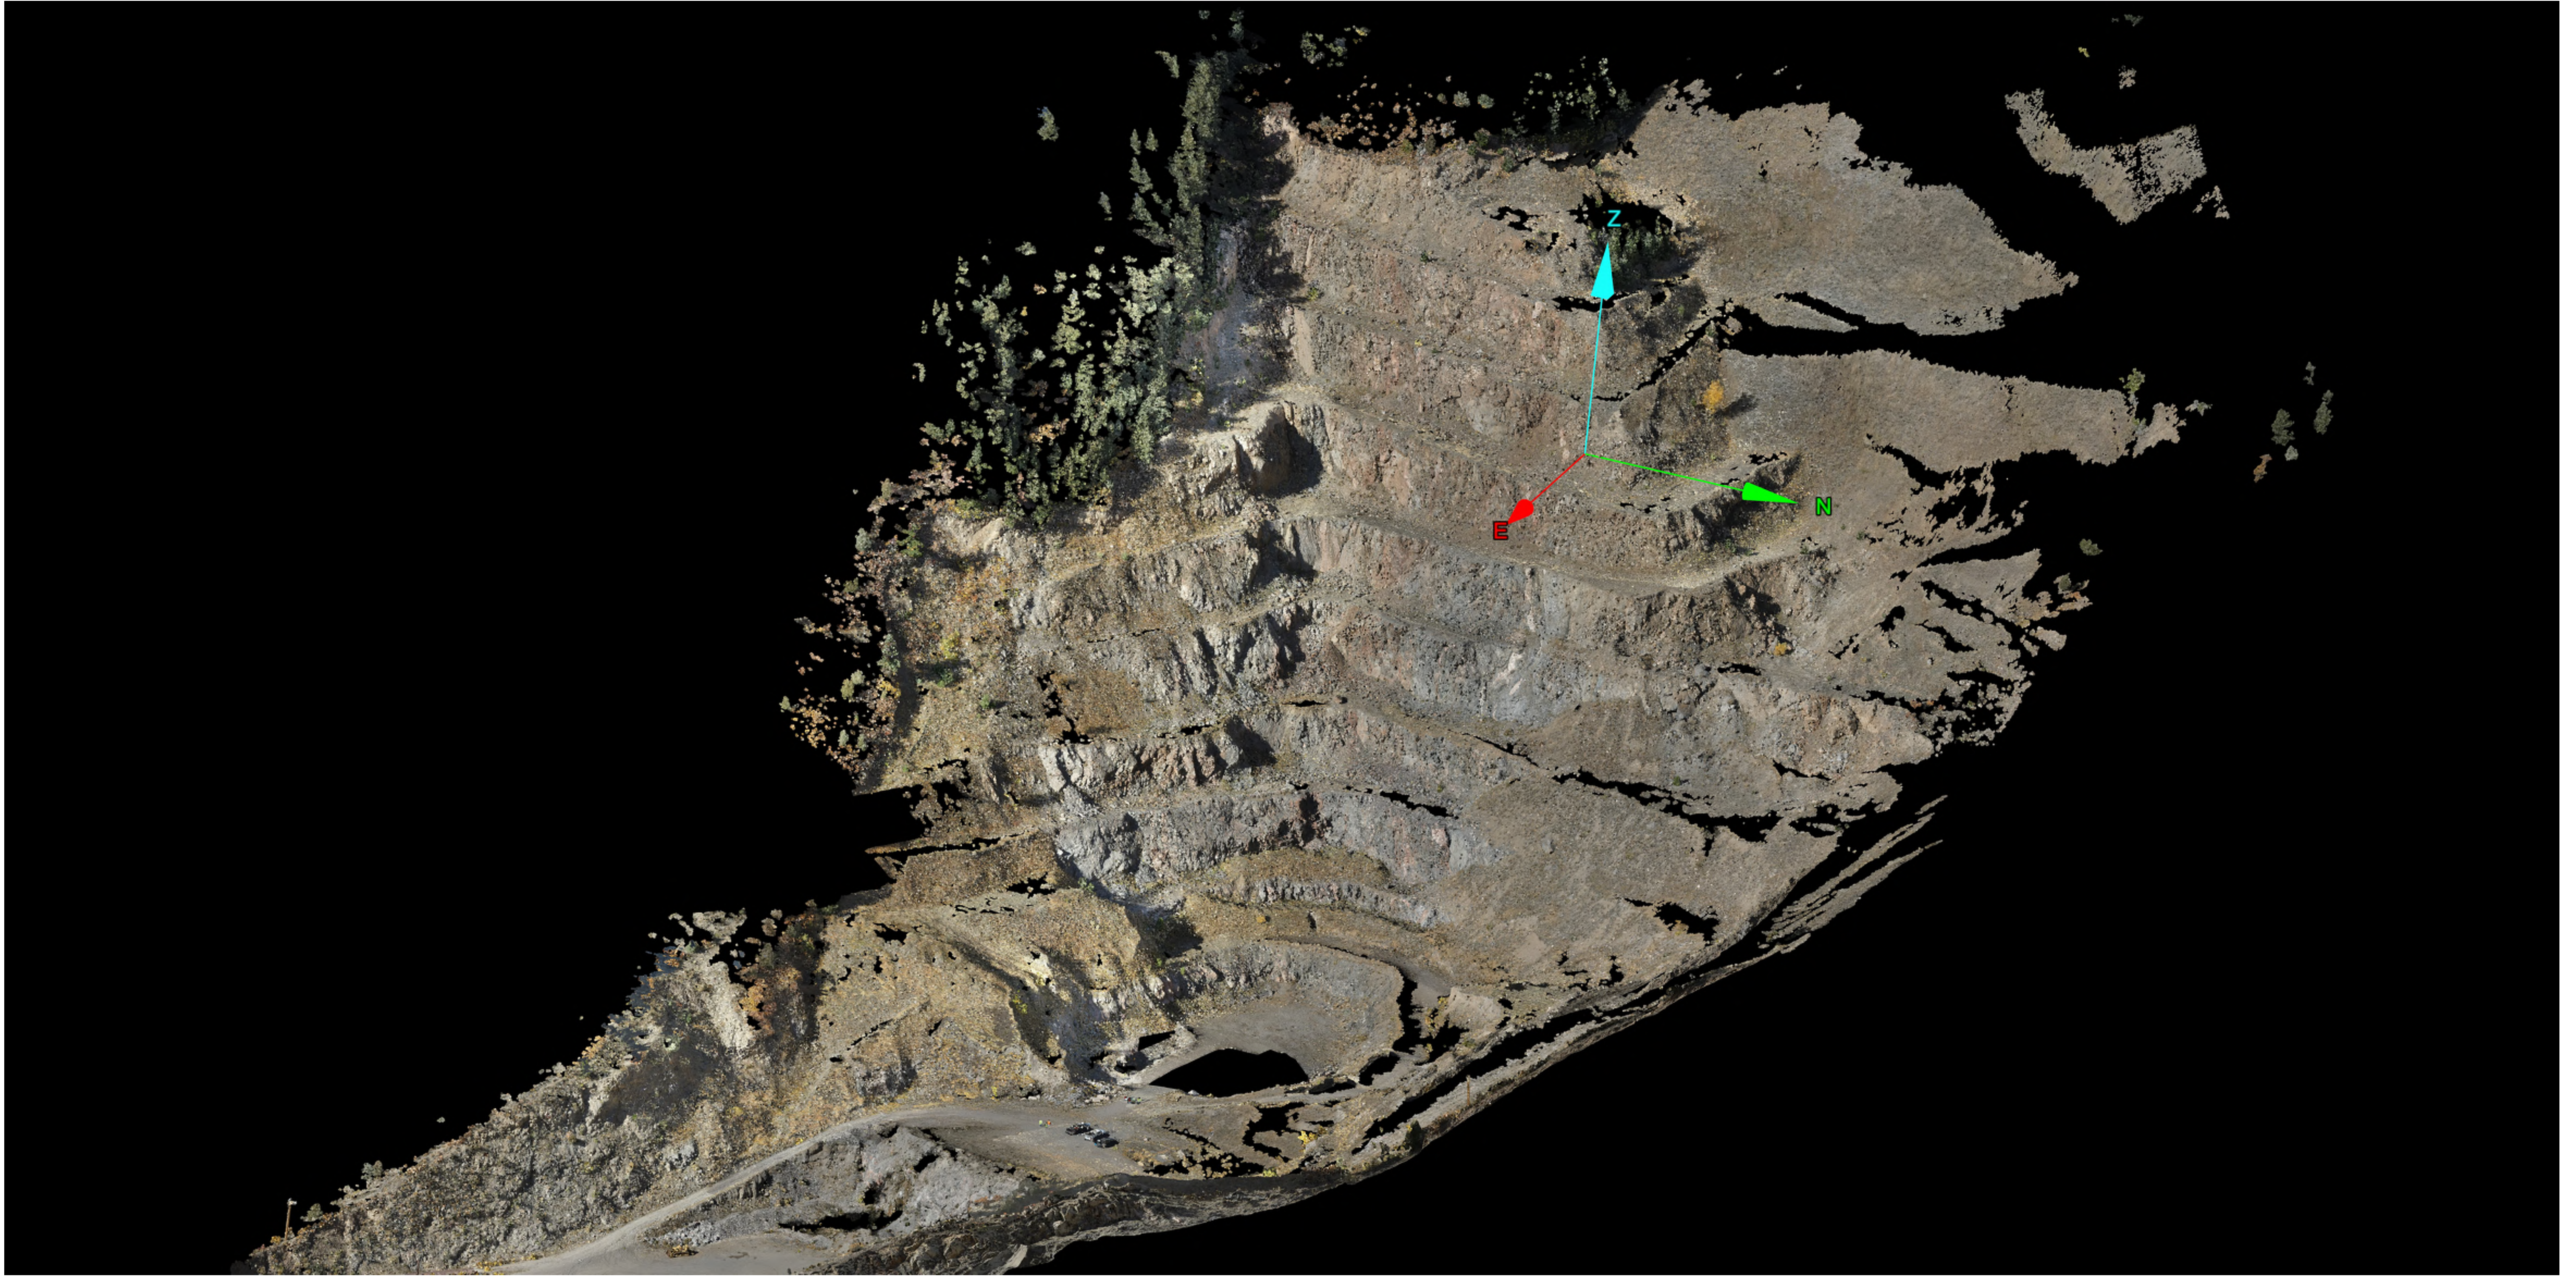
Figure 1 – Aerial view of noted site conditions

Based on HDR's observations, it appears a significant rain event occurred and impacted the existing flowpaths throughout the site. Existing overland flow does not appear to be controlled by the existing BMP's on site, and the current discharge location is not consistent with the approved discharge point. The following photos document the observed conditions.

Regarding the evidence of recent surface water runoff and access road degradation observed during our June 2023 site visit, HDR recommends a drainage survey be performed to identify positive drainage channels and methods to channelize future surface water runoff away from sensitive features such as access roads, highwalls slopes, and benches.
