MINERALS PROGRAM INSPECTION REPORT
PHONE: (303) 866-3567

| MINE NAME: Patton Clay Mine | MINE/PROSPECTING ID#: M-1998-067 | MINERAL: Clay (general) | COUNTY: Fremont |
| INSPECTION TYPE: Monitoring | WEATHER: Clear | INSP. DATE: February 23, 2023 | INSP. TIME: 12:40 |

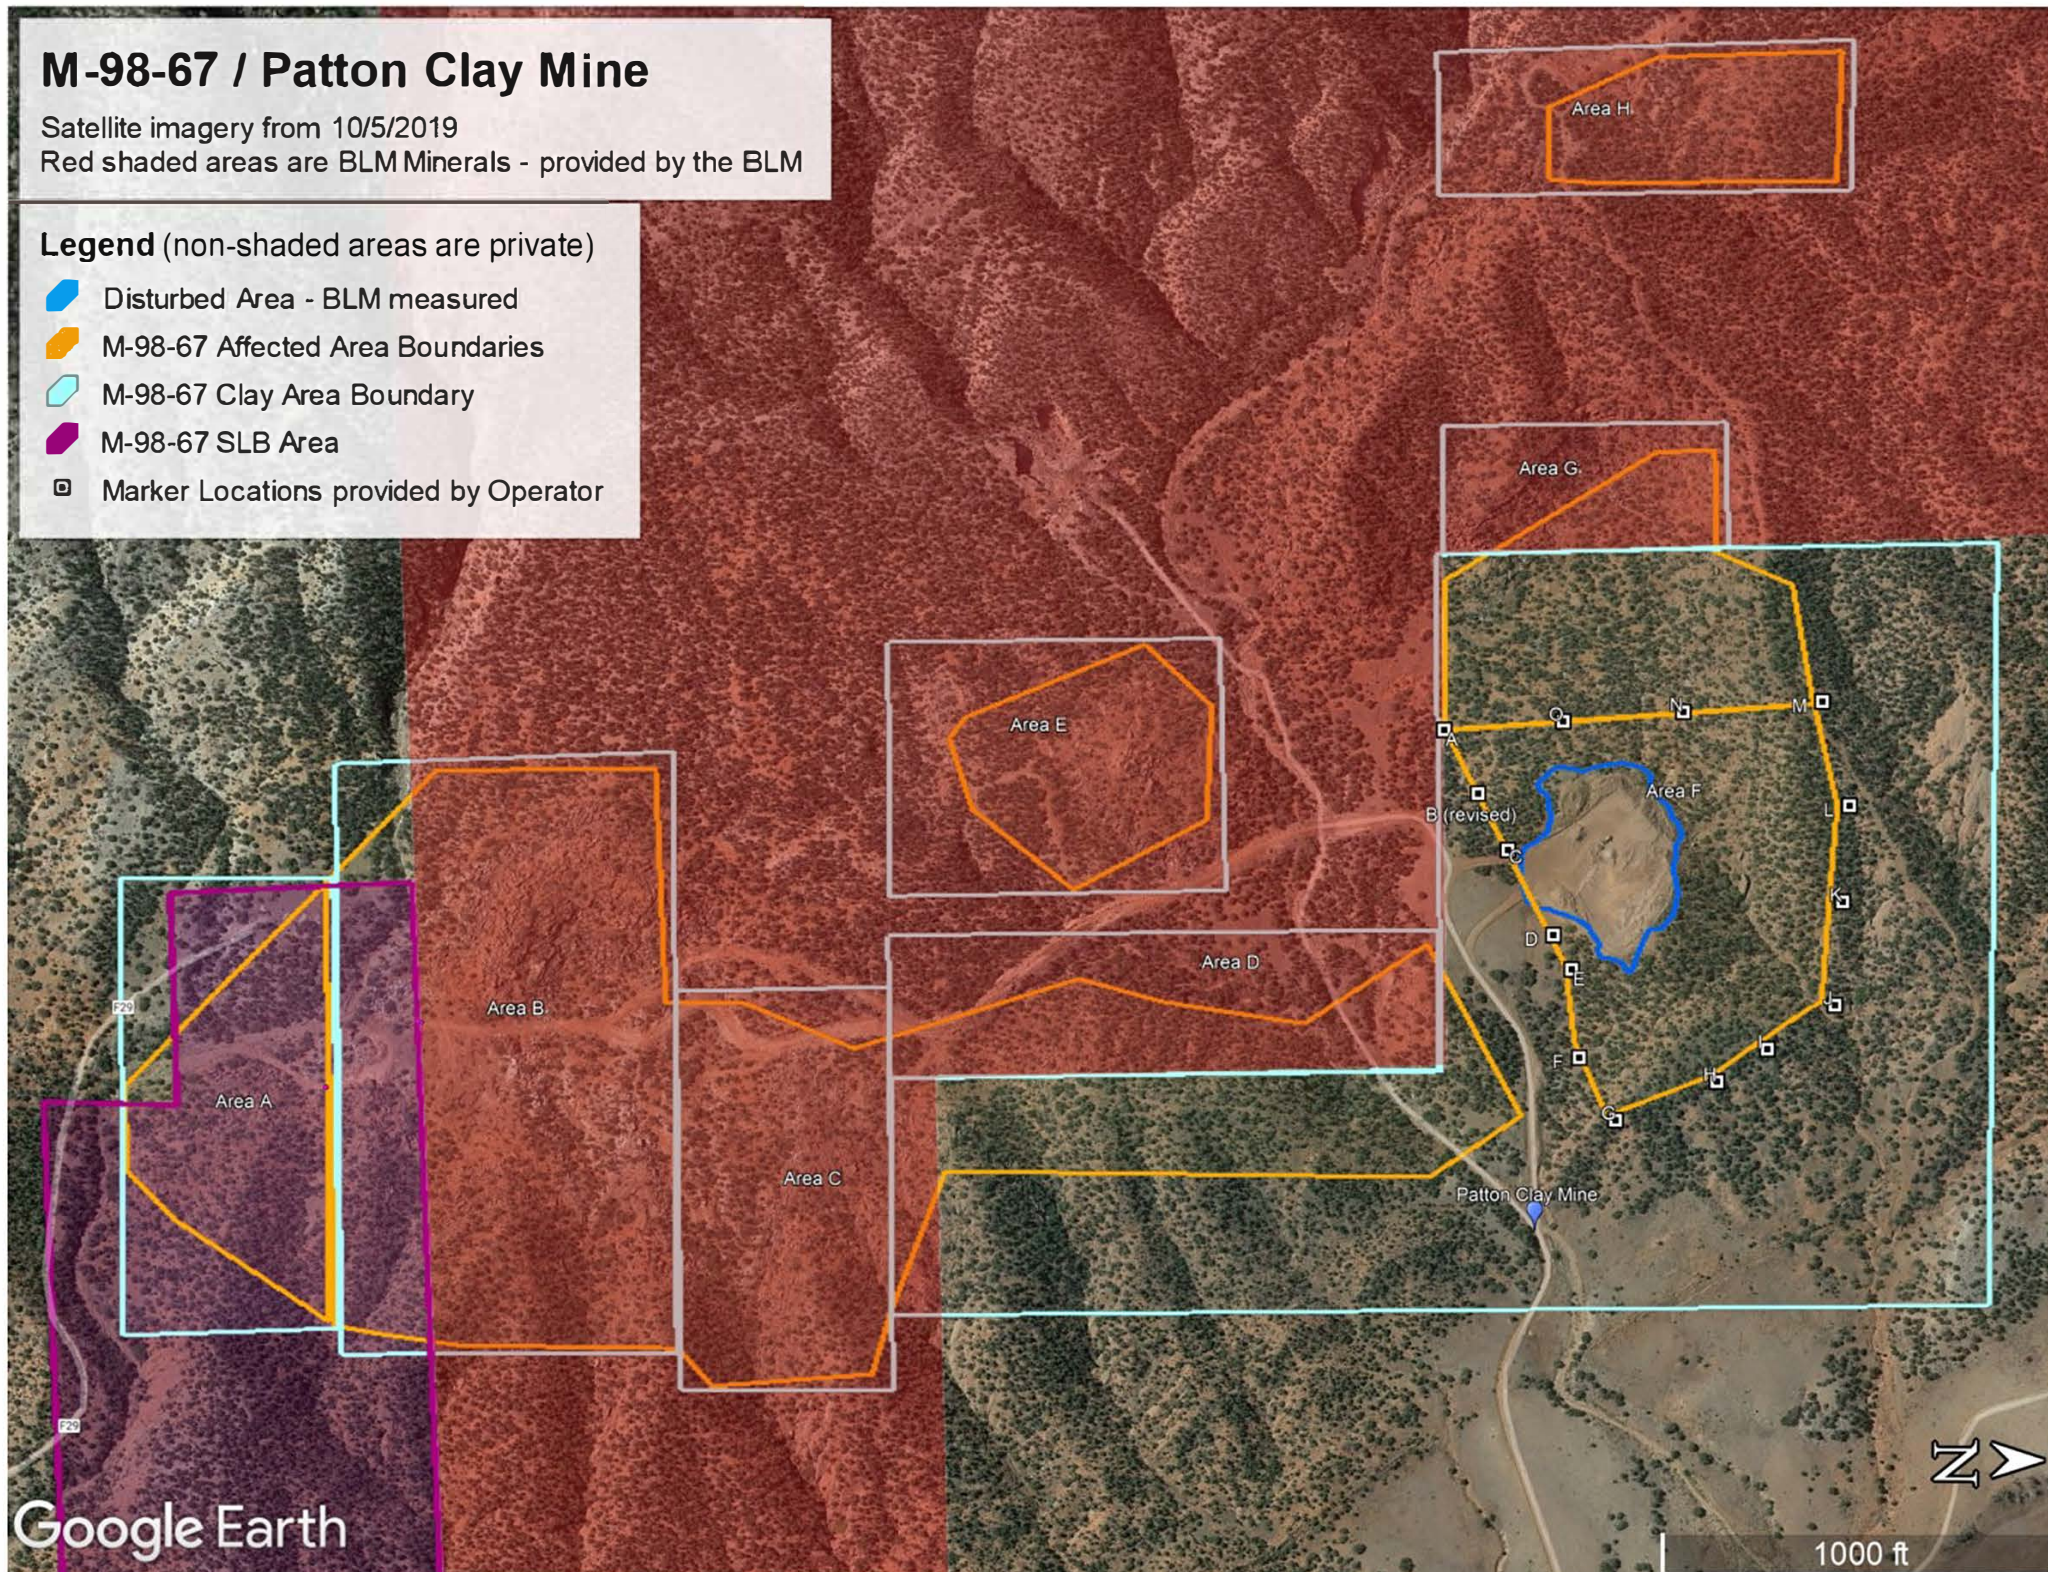
Marker Locations provided by Operator

Signs and Markers: Due to the access road change, the location where the permit sign has been posted during previous inspections could not be accessed to confirm it was still there. The DRMS recommends placing a new sign near Area F.
