C-1981-008 New Horizon January Partial Inspection Report

PERMIT INFORMATION

Permit Number: C-1981-008 Mine Name: New Horizon Mine Operator: Elk Ridge Mining and Reclamation, LLC Operator Address: Mr Tony Tennyson P.O. Box 628 27646 West 5th Avenue Nucla, CO 81424	County: Montrose Operation Type: Surface Permit Status: Active Ownership: Private
	Operator Representative Present: Mindy Sickles
Operator Representative Signature: (Field Issuance Only)

Inspection Start Date: January 23, 2024 Inspection Start Time: 11:30 Inspection End Date: January 23, 2024 Inspection End Time: 11:55	Inspection Type: Coal Partial Inspection Inspection Reason: Normal I&E Program Weather: Clear
Joint Inspection Agency: None	Joint Inspection Contacts:
Post Inspection Agency: None	Post Inspection Contacts:
Inspector(s): Lucas West	Inspector's Signature:

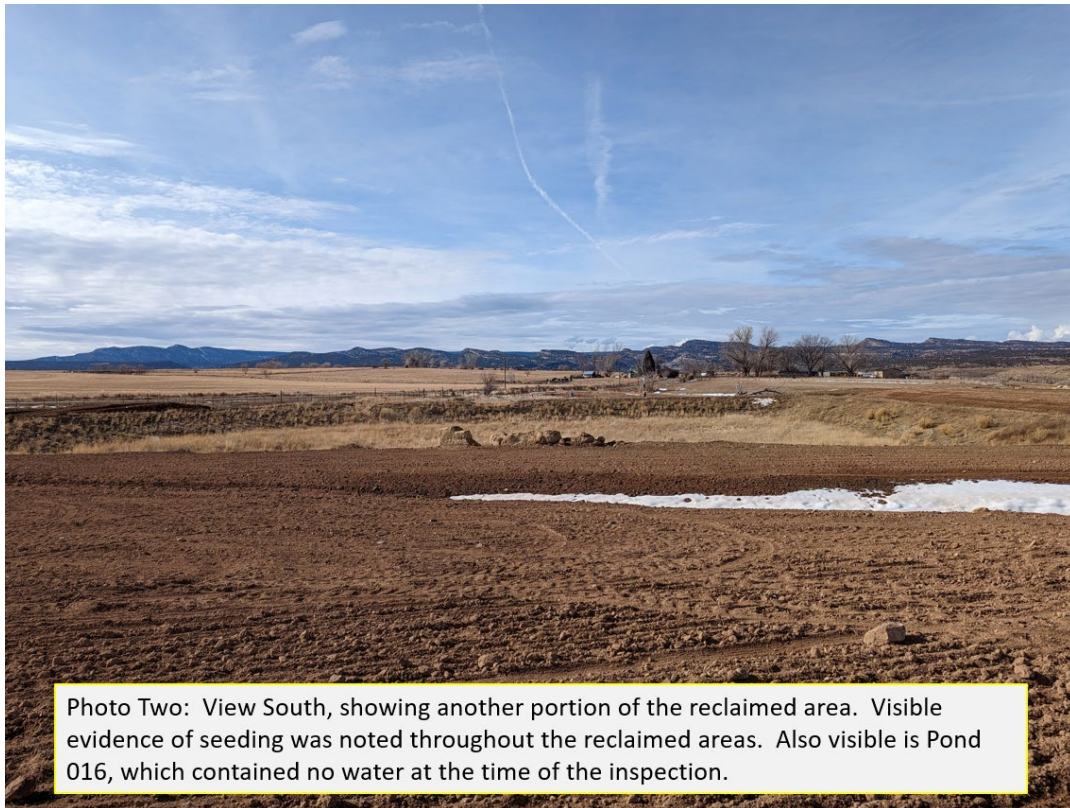
The main focus of this inspection was to observe the condition of the backfilling, topsoil replacement and seeding efforts that were recently concluded in the Section 36 area. At the time of the inspection all reclamation work in this area had been completed and no equipment was present on site. Of all the areas observed from the vantage point of the Pond 13 access road due to muddy conditions, there were no signs of settling, slumping or erosion. The reclaimed areas are in excellent condition and were seeded in the fall of 2023 prior to snowfall. Evidence of seeding was visible and undisturbed. Examples of the reclaimed area can be seen in Photos One through Three. The reclaimed topography consists of gently sloping hills with storm water control structures installed.

Photo One: View East, showing an example of the reclaimed area in Section 36. all the areas show no signs of settling, slumping or erosion and are in excellent condition.

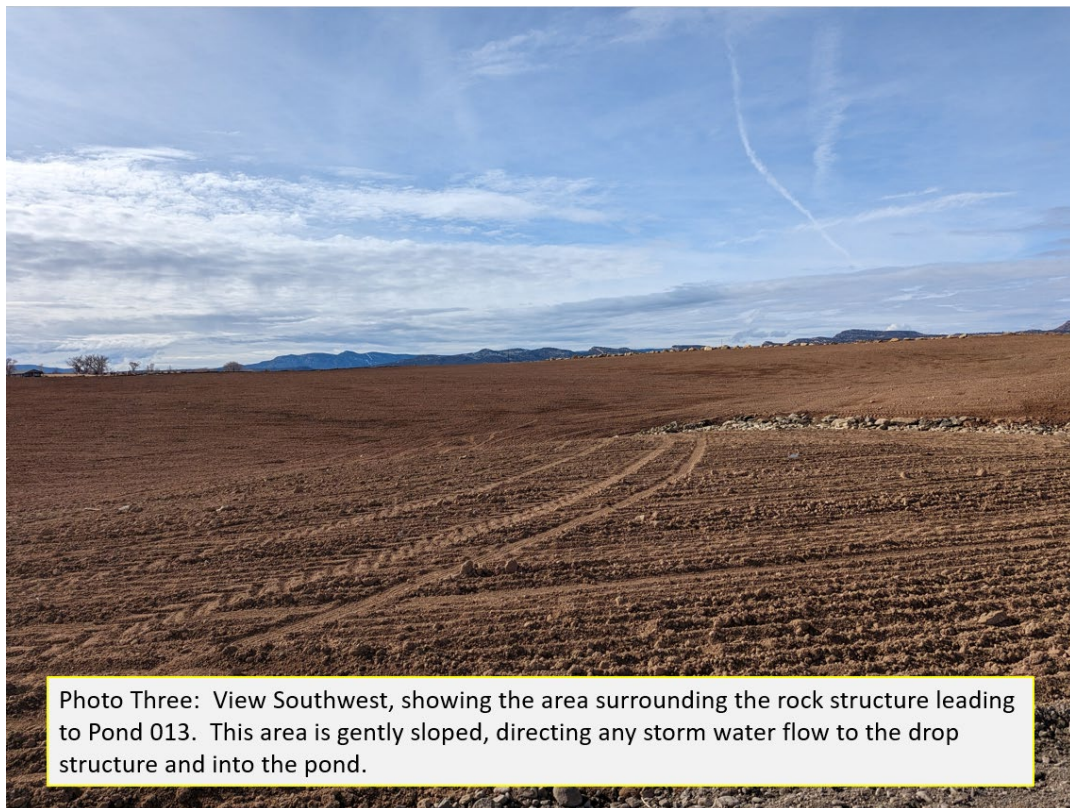
In the reclaimed area, a few stormwater control structures have been installed, including a small drainage ditch with a culvert as it passes under the access road. The small drainage ditch as well as the culvert are in excellent condition and shows no evidence of recent flow.
