To: Jerald Schnabel  
Castle Aggregate

File: December 2023 Monitoring Summary      Date: January 31, 2024

**Reference:      December 2023 Geotechnical Monitoring Summary Pikeview Quarry**

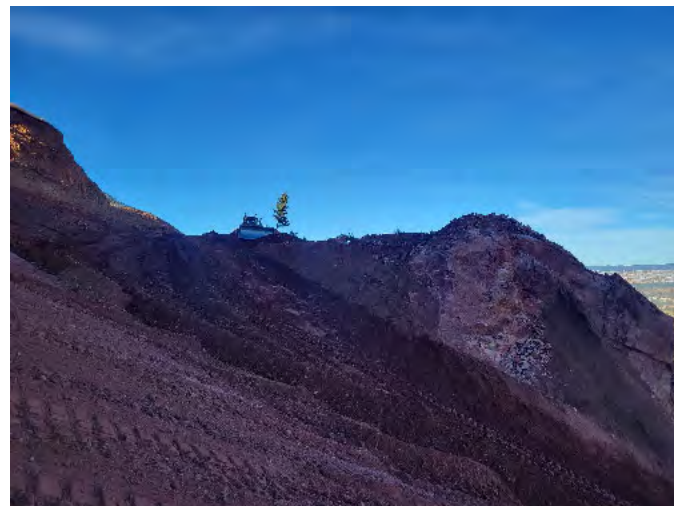
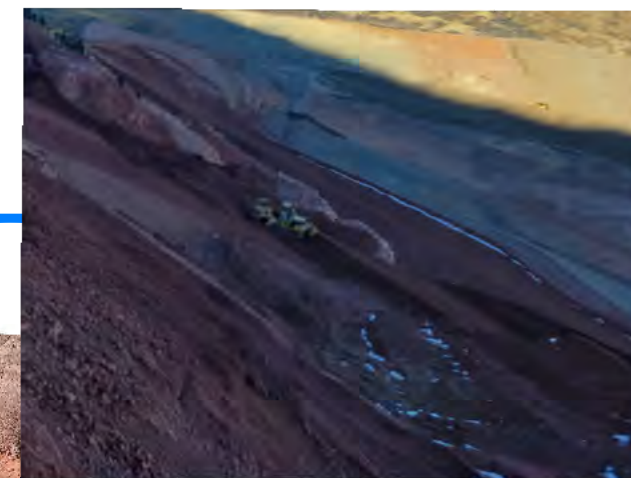
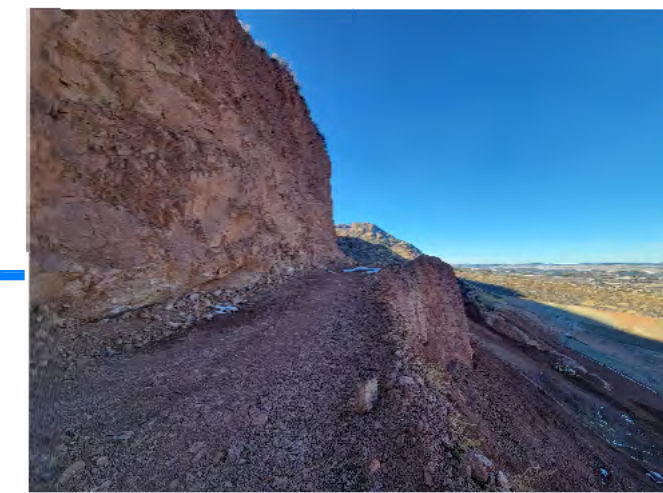
5. Dozers working near top of haul road.

NOTE 1:  
NO CRACKS

4. Dozers placing material in the "Bathtub".

3. Highwalls being planned for blasting.
