File: January 2024 Monitoring Summary

Date: February 29, 2024

Reference: January 2024 Geotechnical Monitoring Summary Pikeview Quarry

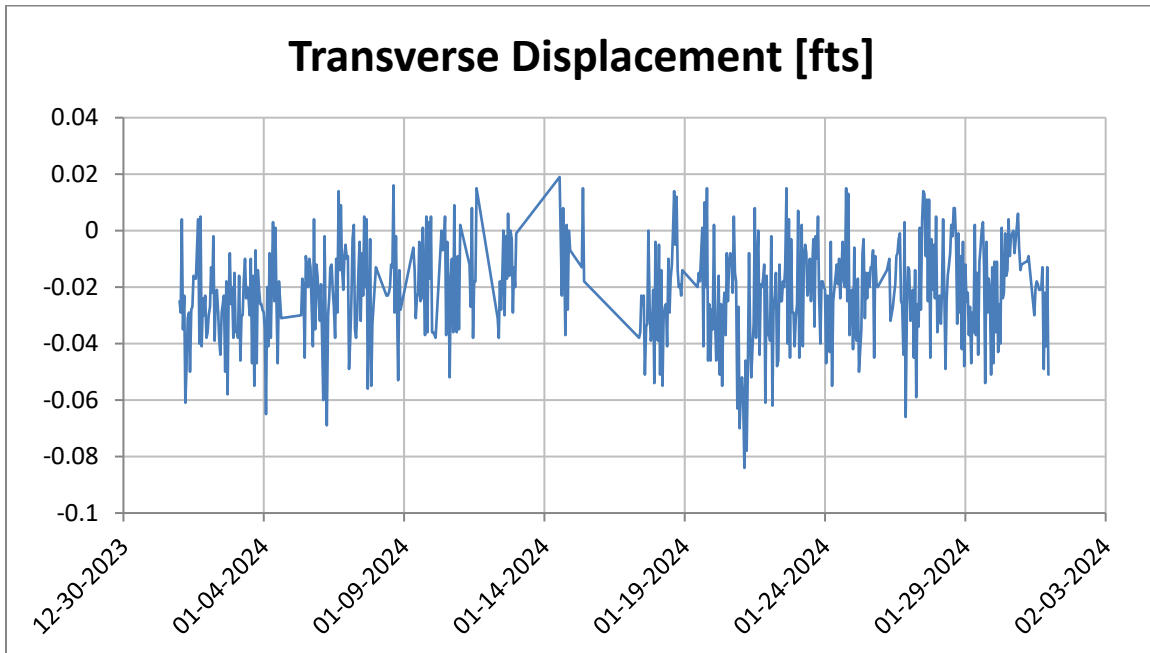
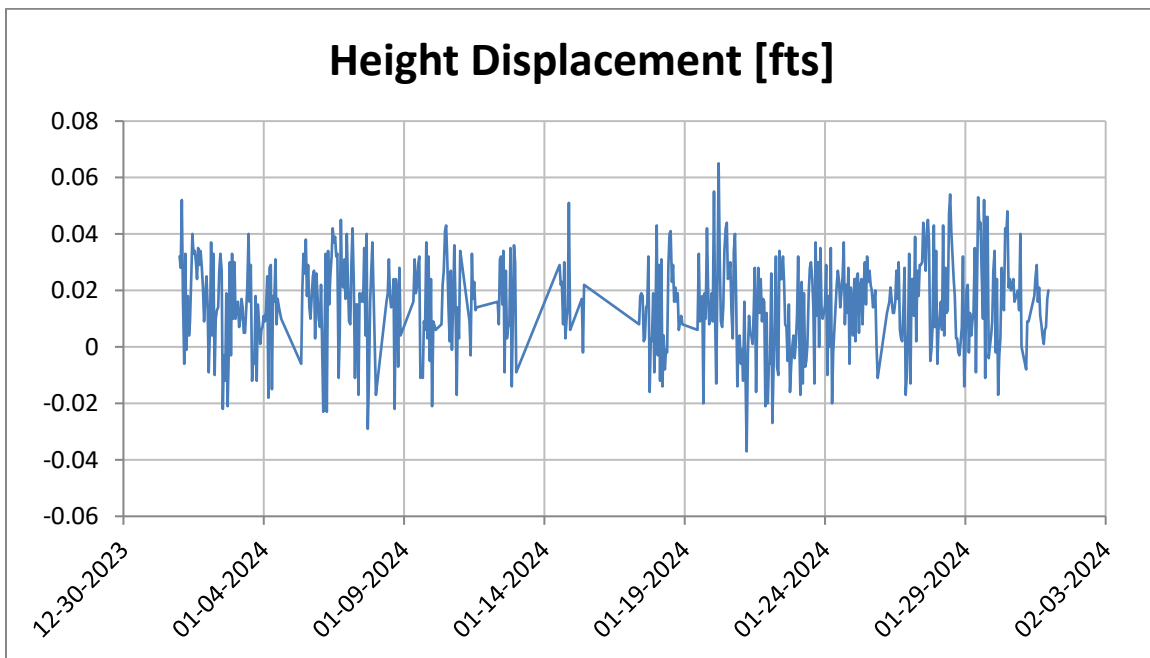
Prism P32R

Prism	Date	Action	Comment
P32	1-Aug-23	Prism Removed	P32 was damaged by a falling rock. P32R was installed in the same location.
P32R	1-Aug-23	Prism Added	
P69A	28-Sep-23	Prism Removed	Reclamation grading to affect prism in near future
NP3	30-Sep-23	Prism Removed	Reclamation grading to affect prism in near future
BR2	20-Oct-23	Prism Removed	Reclamation grading in Upper Borrow Area affected prim
B7300-4	6-Nov-23	Prism Added	New Prism Added
NP4	6-Nov-23	Prism Added	New Prism Added
BR3	6-Nov-23	Prism Added	New Prism Added
NP66	15-Nov-23	Prism Removed	Reclamation grading to affect prism in near future
B7400-1	Jan-24	Prism Added	New Prism Added
B7400-2	Jan-24	Prism Added	New Prism Added
B7400-3	Jan-24	Prism Added	New Prism Added
B7400-4	Jan-24	Prism Added	New Prism Added
B7400-5	Jan-24	Prism Added	New Prism Added

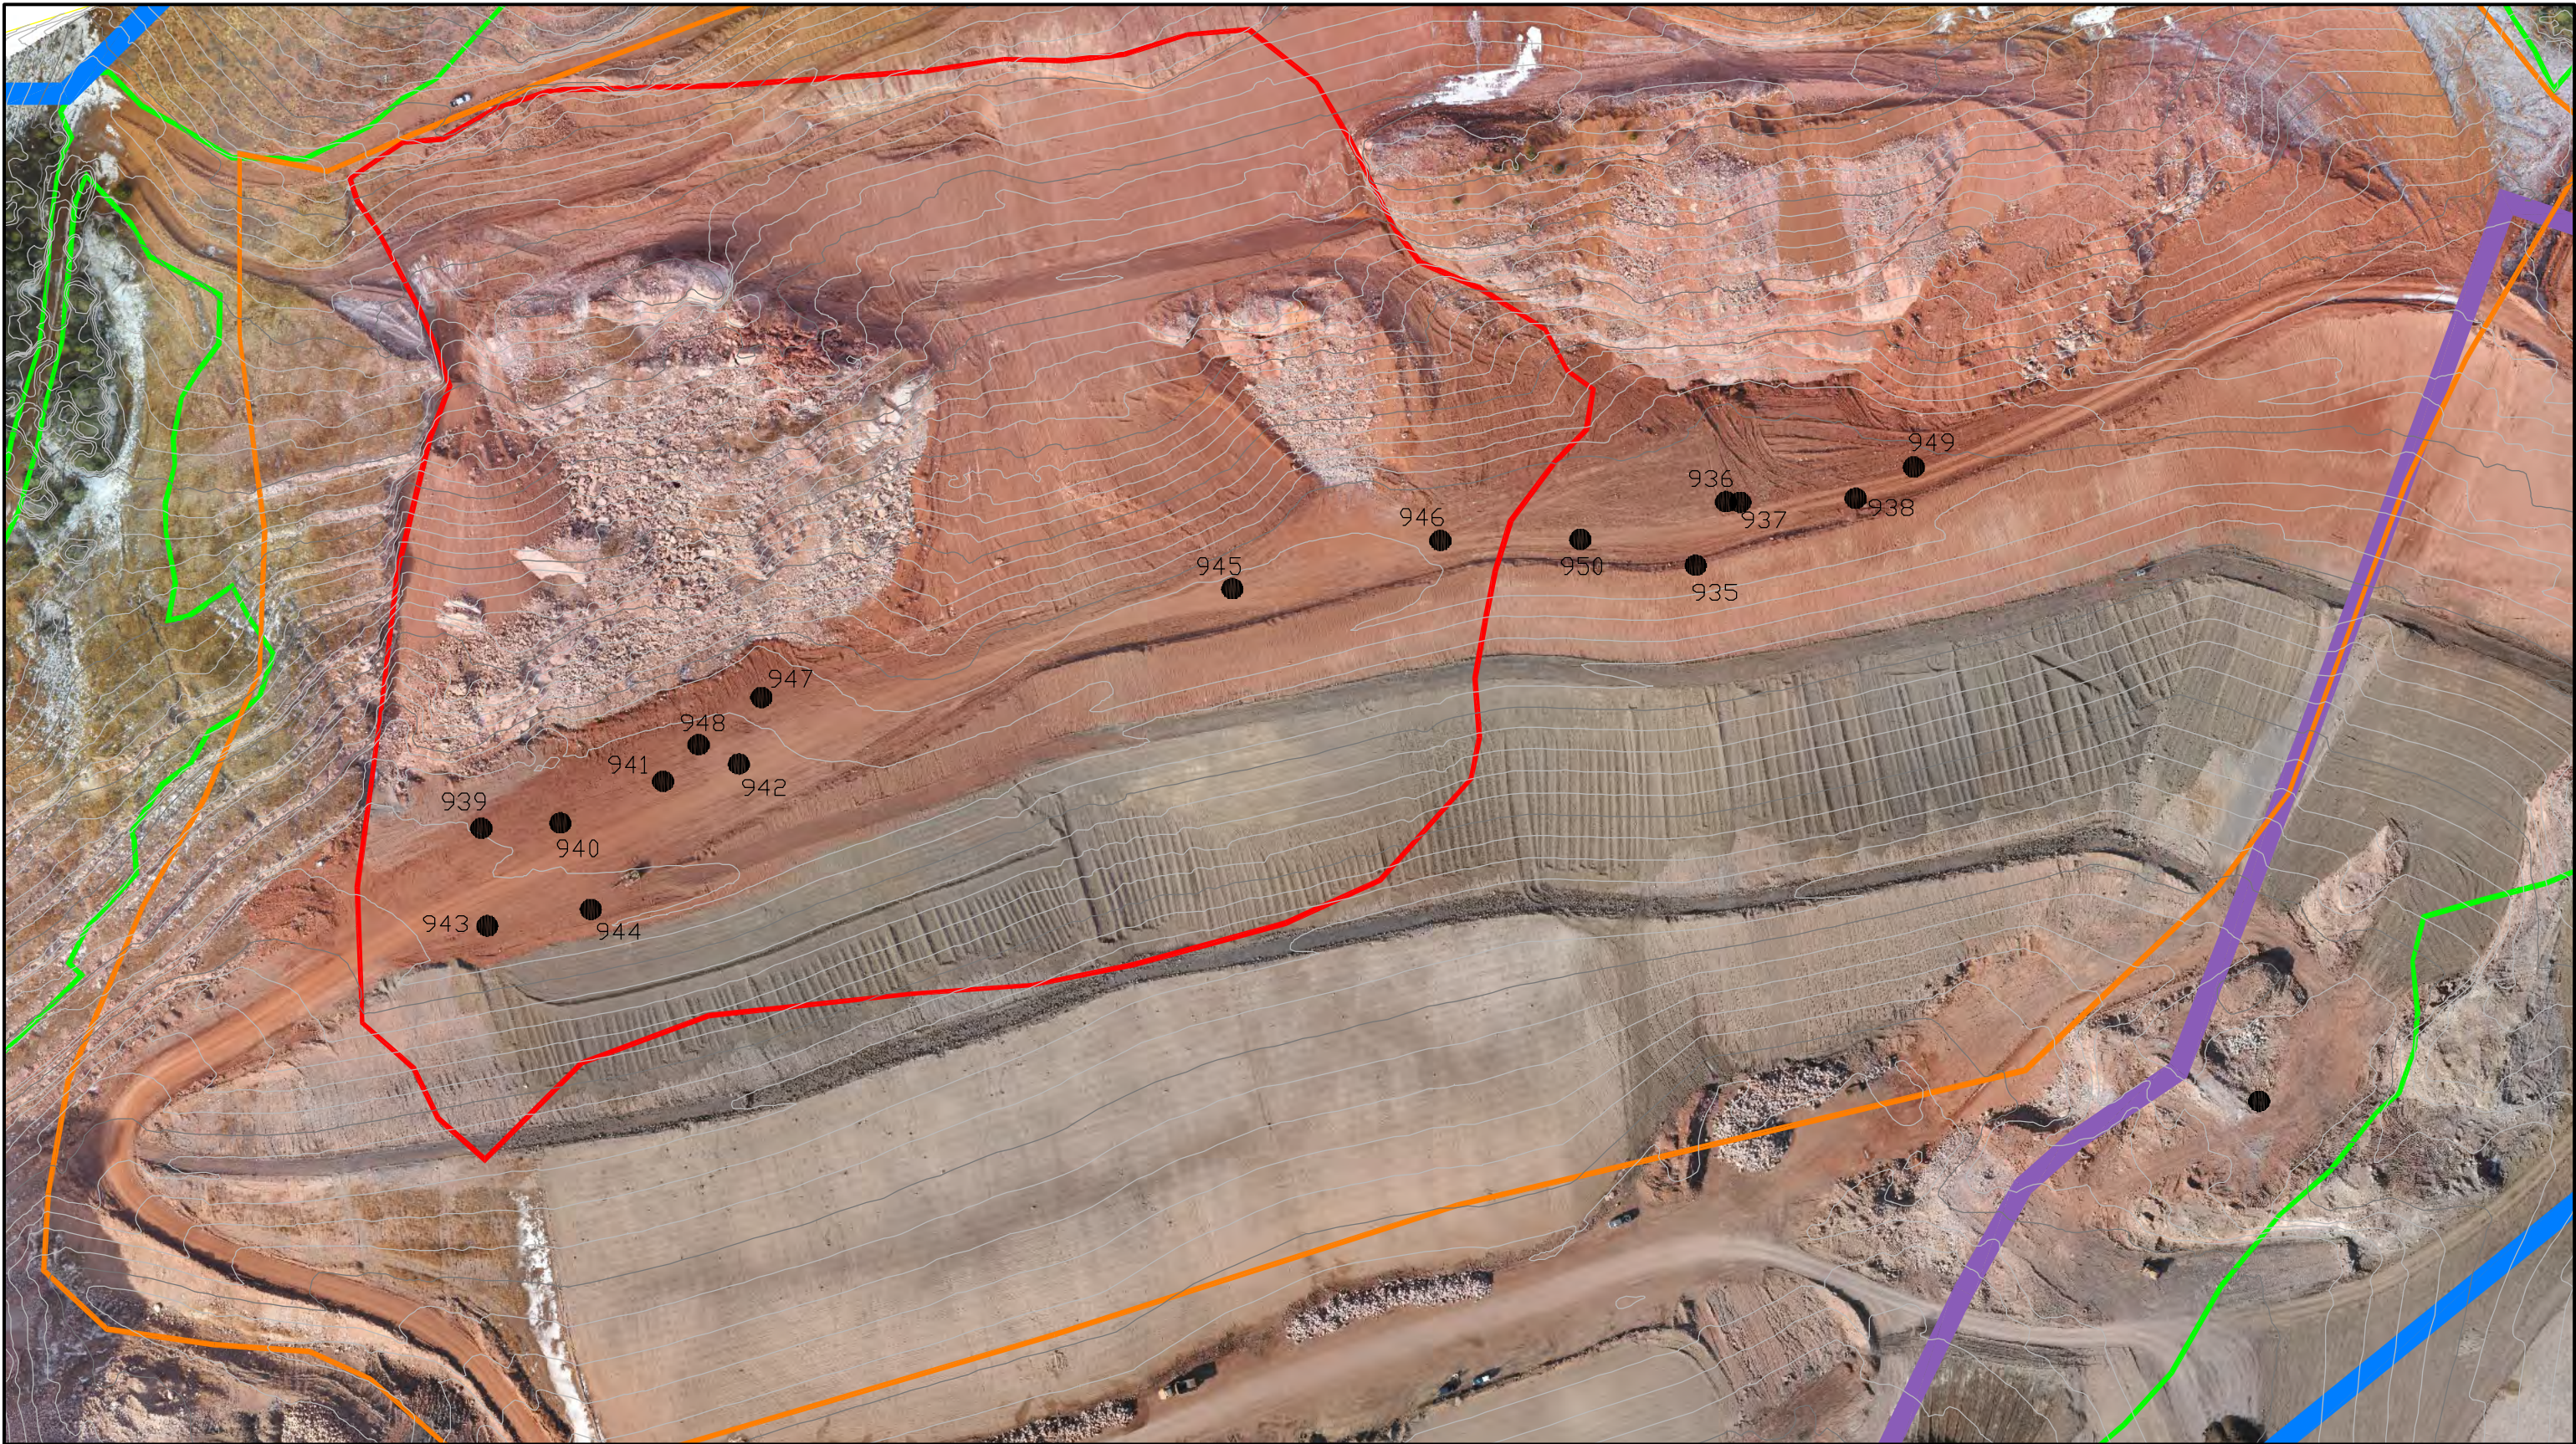
Fill placement occurred from February 2022 through June 2023 and from September 2023 to present. In the month of January 2024, the contractor placed and compacted 55,000 yd³ of material on the buttress floor. All of this material was from the Upper Borrow Area and was either pushed down by dozers or hauled by scrapers. All fill is moisture conditioned as necessary and then compacted. Compaction testing occurs at the rate of at least one test per 5,000 yd³ placed. This volume placed in the buttress zone required at least 11 compaction tests. There were 15 compaction tests taken in January. As of January 24, 2024, when the site was surveyed, a total of approximately 2,909,000 yd³ had been placed and compacted. This required at least 582 compaction tests, and 1,156 tests have been taken. All tests in January met the minimum compaction requirement of 90%.

1. TEST LOCATIONS 949 AND 950 ARE APPROXIMATE LOCATIONS.
