Inspection Report, February 15 2024 Cresson Project M-1980-244

MINERALS PROGRAM INSPECTION REPORT
PHONE: (303) 866-3567

MINE NAME: Cresson Project	MINE/PROSPECTING ID#: M-1980-244	MINERAL: Gold and silver	COUNTY: Teller
INSPECTION TYPE: Monitoring	WEATHER: Clear	INSP. DATE: February 15, 2024	INSP. TIME: 10:00
OPERATOR: Cripple Creek & Victor Gold Mining Company	OPERATOR REPRESENTATIVE: Katie Blake	TYPE OF OPERATION: 112d-3 - Designated Mining Operation	
REASON FOR INSPECTION: Priority – reported ore stacking issue In VLF 2 Phase III.	BOND CALCULATION TYPE: None	BOND AMOUNT: \$291,100,000.00	
DATE OF COMPLAINT: NA	POST INSP. CONTACTS: None	JOINT INSP. AGENCY: None	
INSPECTOR(S): Nikie Gagnon	INSPECTOR'S SIGNATURE:

On February 15, 2024, Nikie Gagnon with the Division of Reclamation, Mining and Safety (Division) conducted a priority inspection of Cells 5 & 6 in the VLF2 Phase 3A area. Katie Blake, Kathy Steele, and Brian Crawford representing the Operator, and Jay Janney-Moore representing Newfields, accompanied the Division for this inspection.

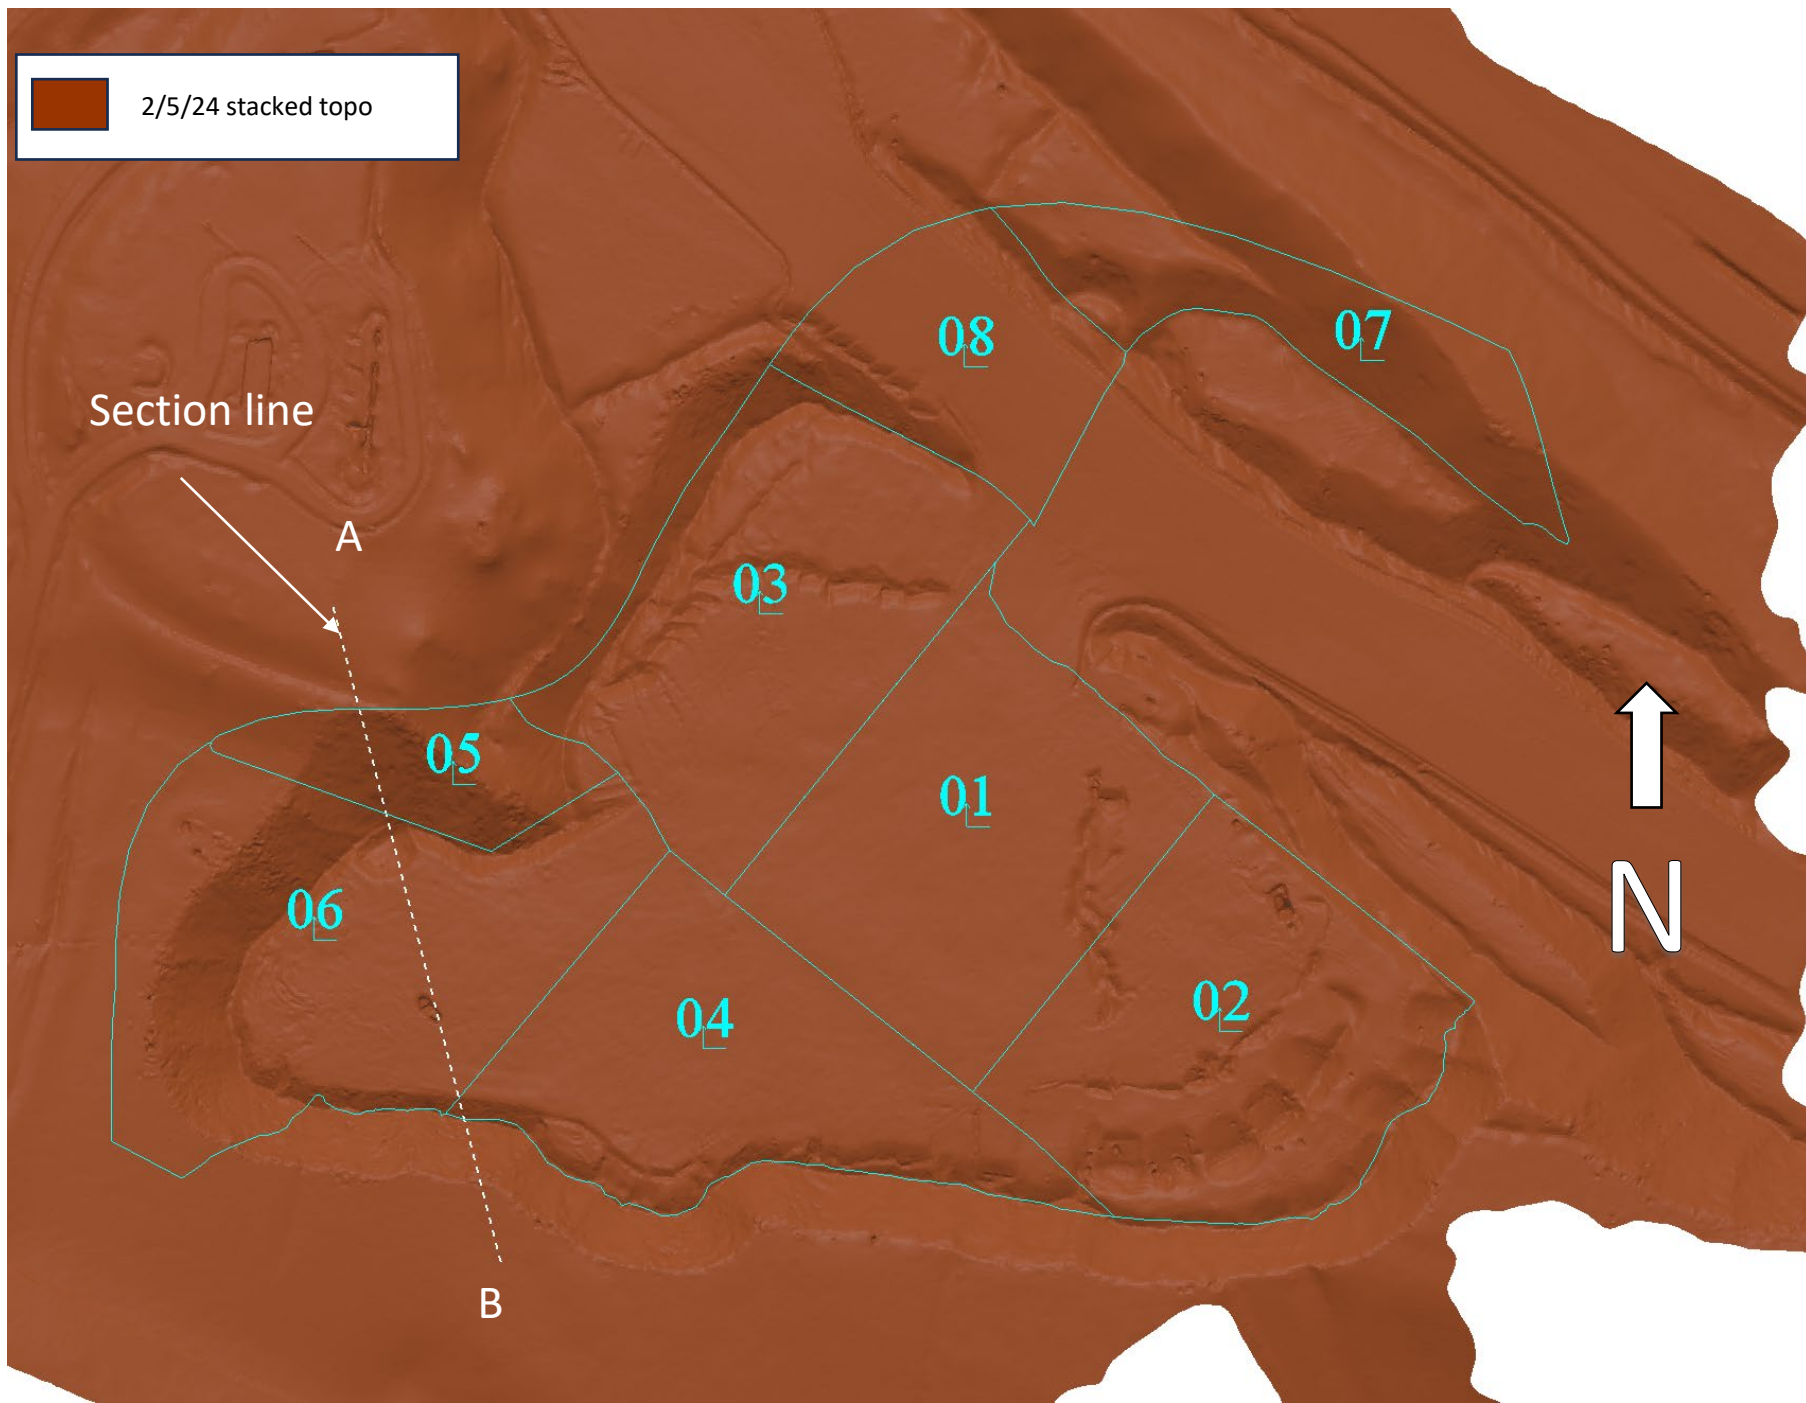
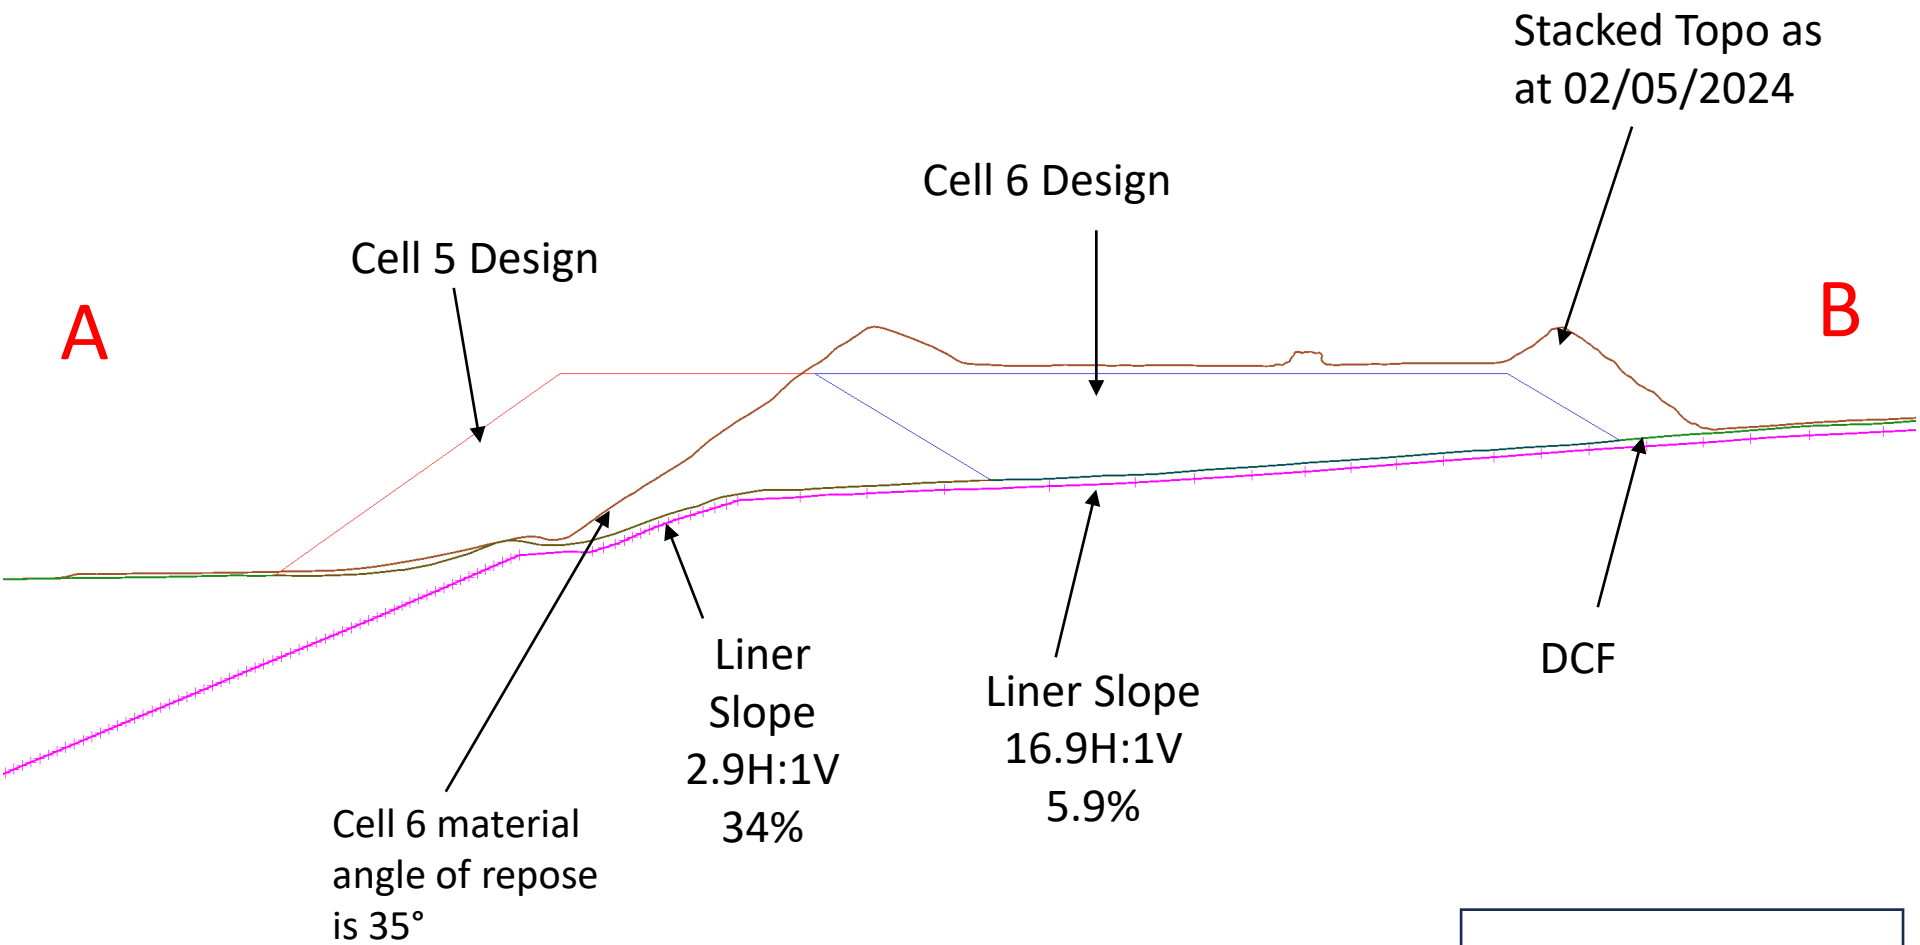
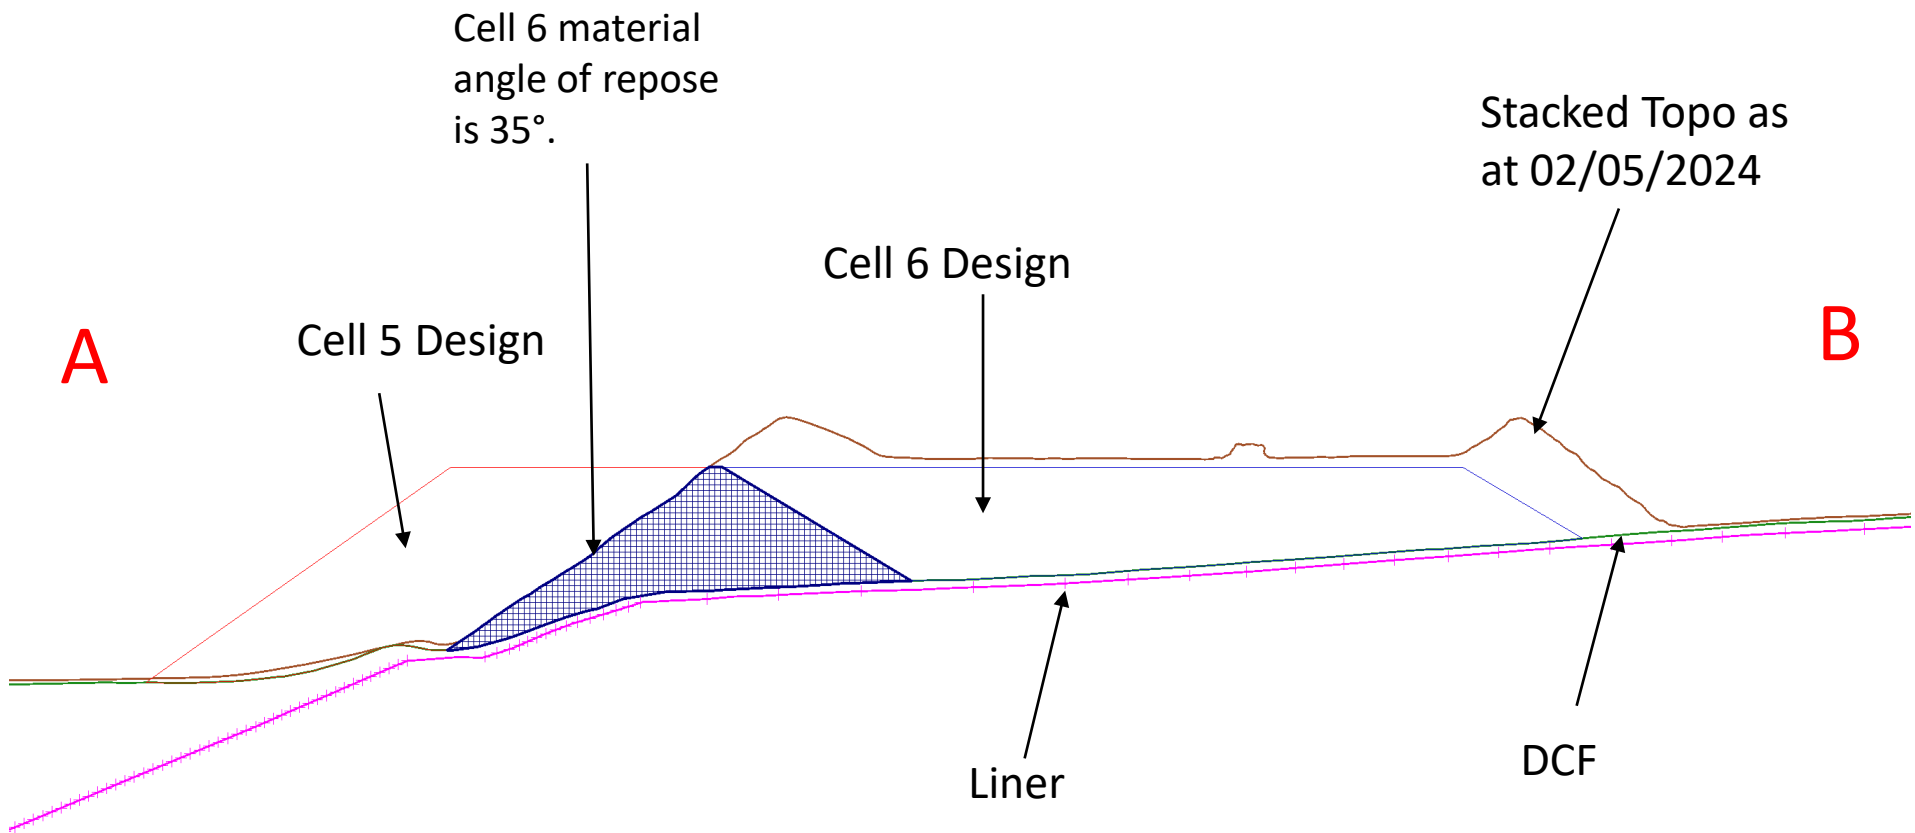
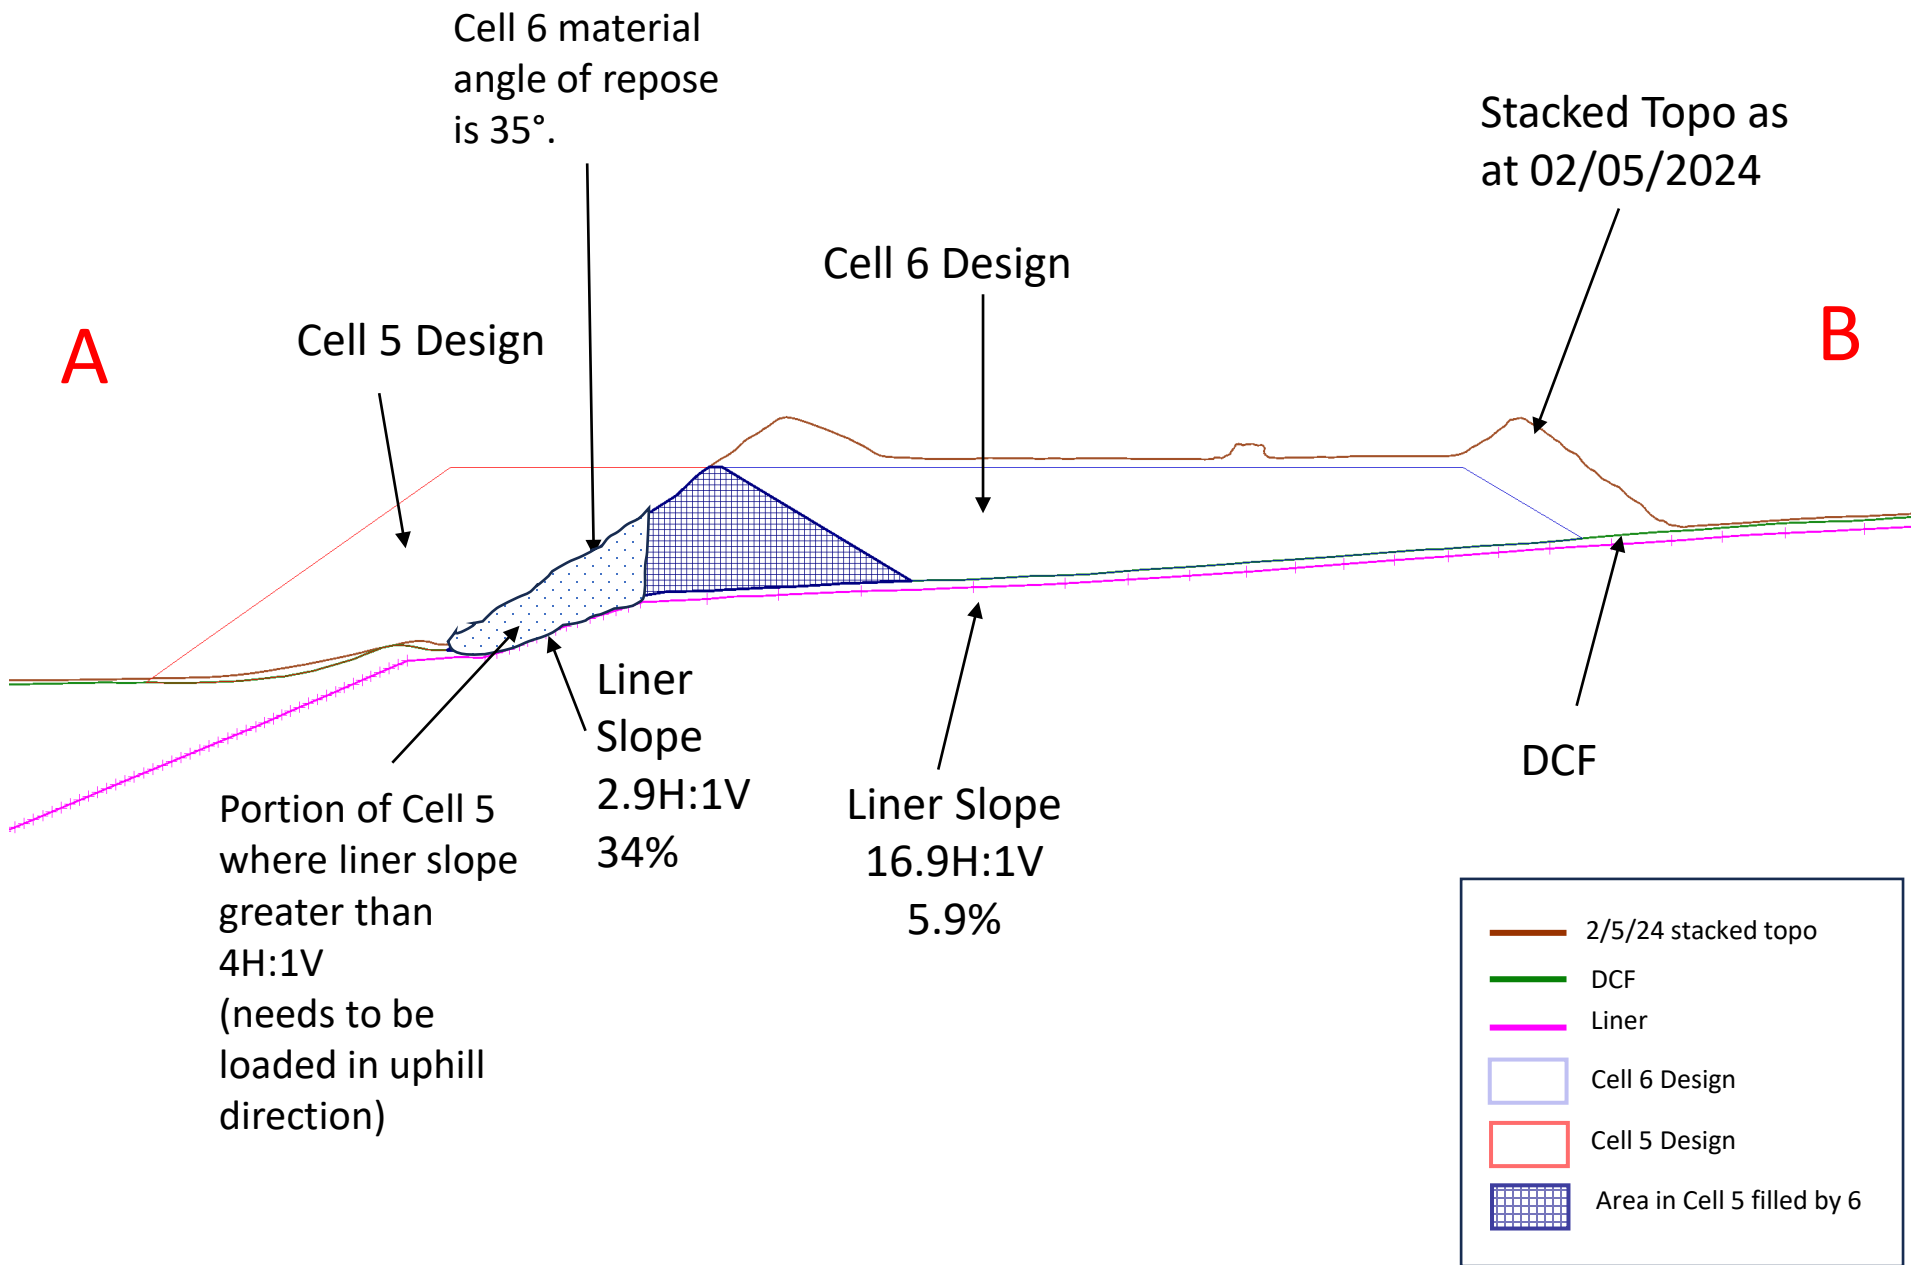
Cell 5 Overdump Tonnage: 5,232 tons

Cell 5 Overdump Surface Area: 5,144 ft²

Portion of Cell 5 dumped incorrectly on liner steeper than 25%

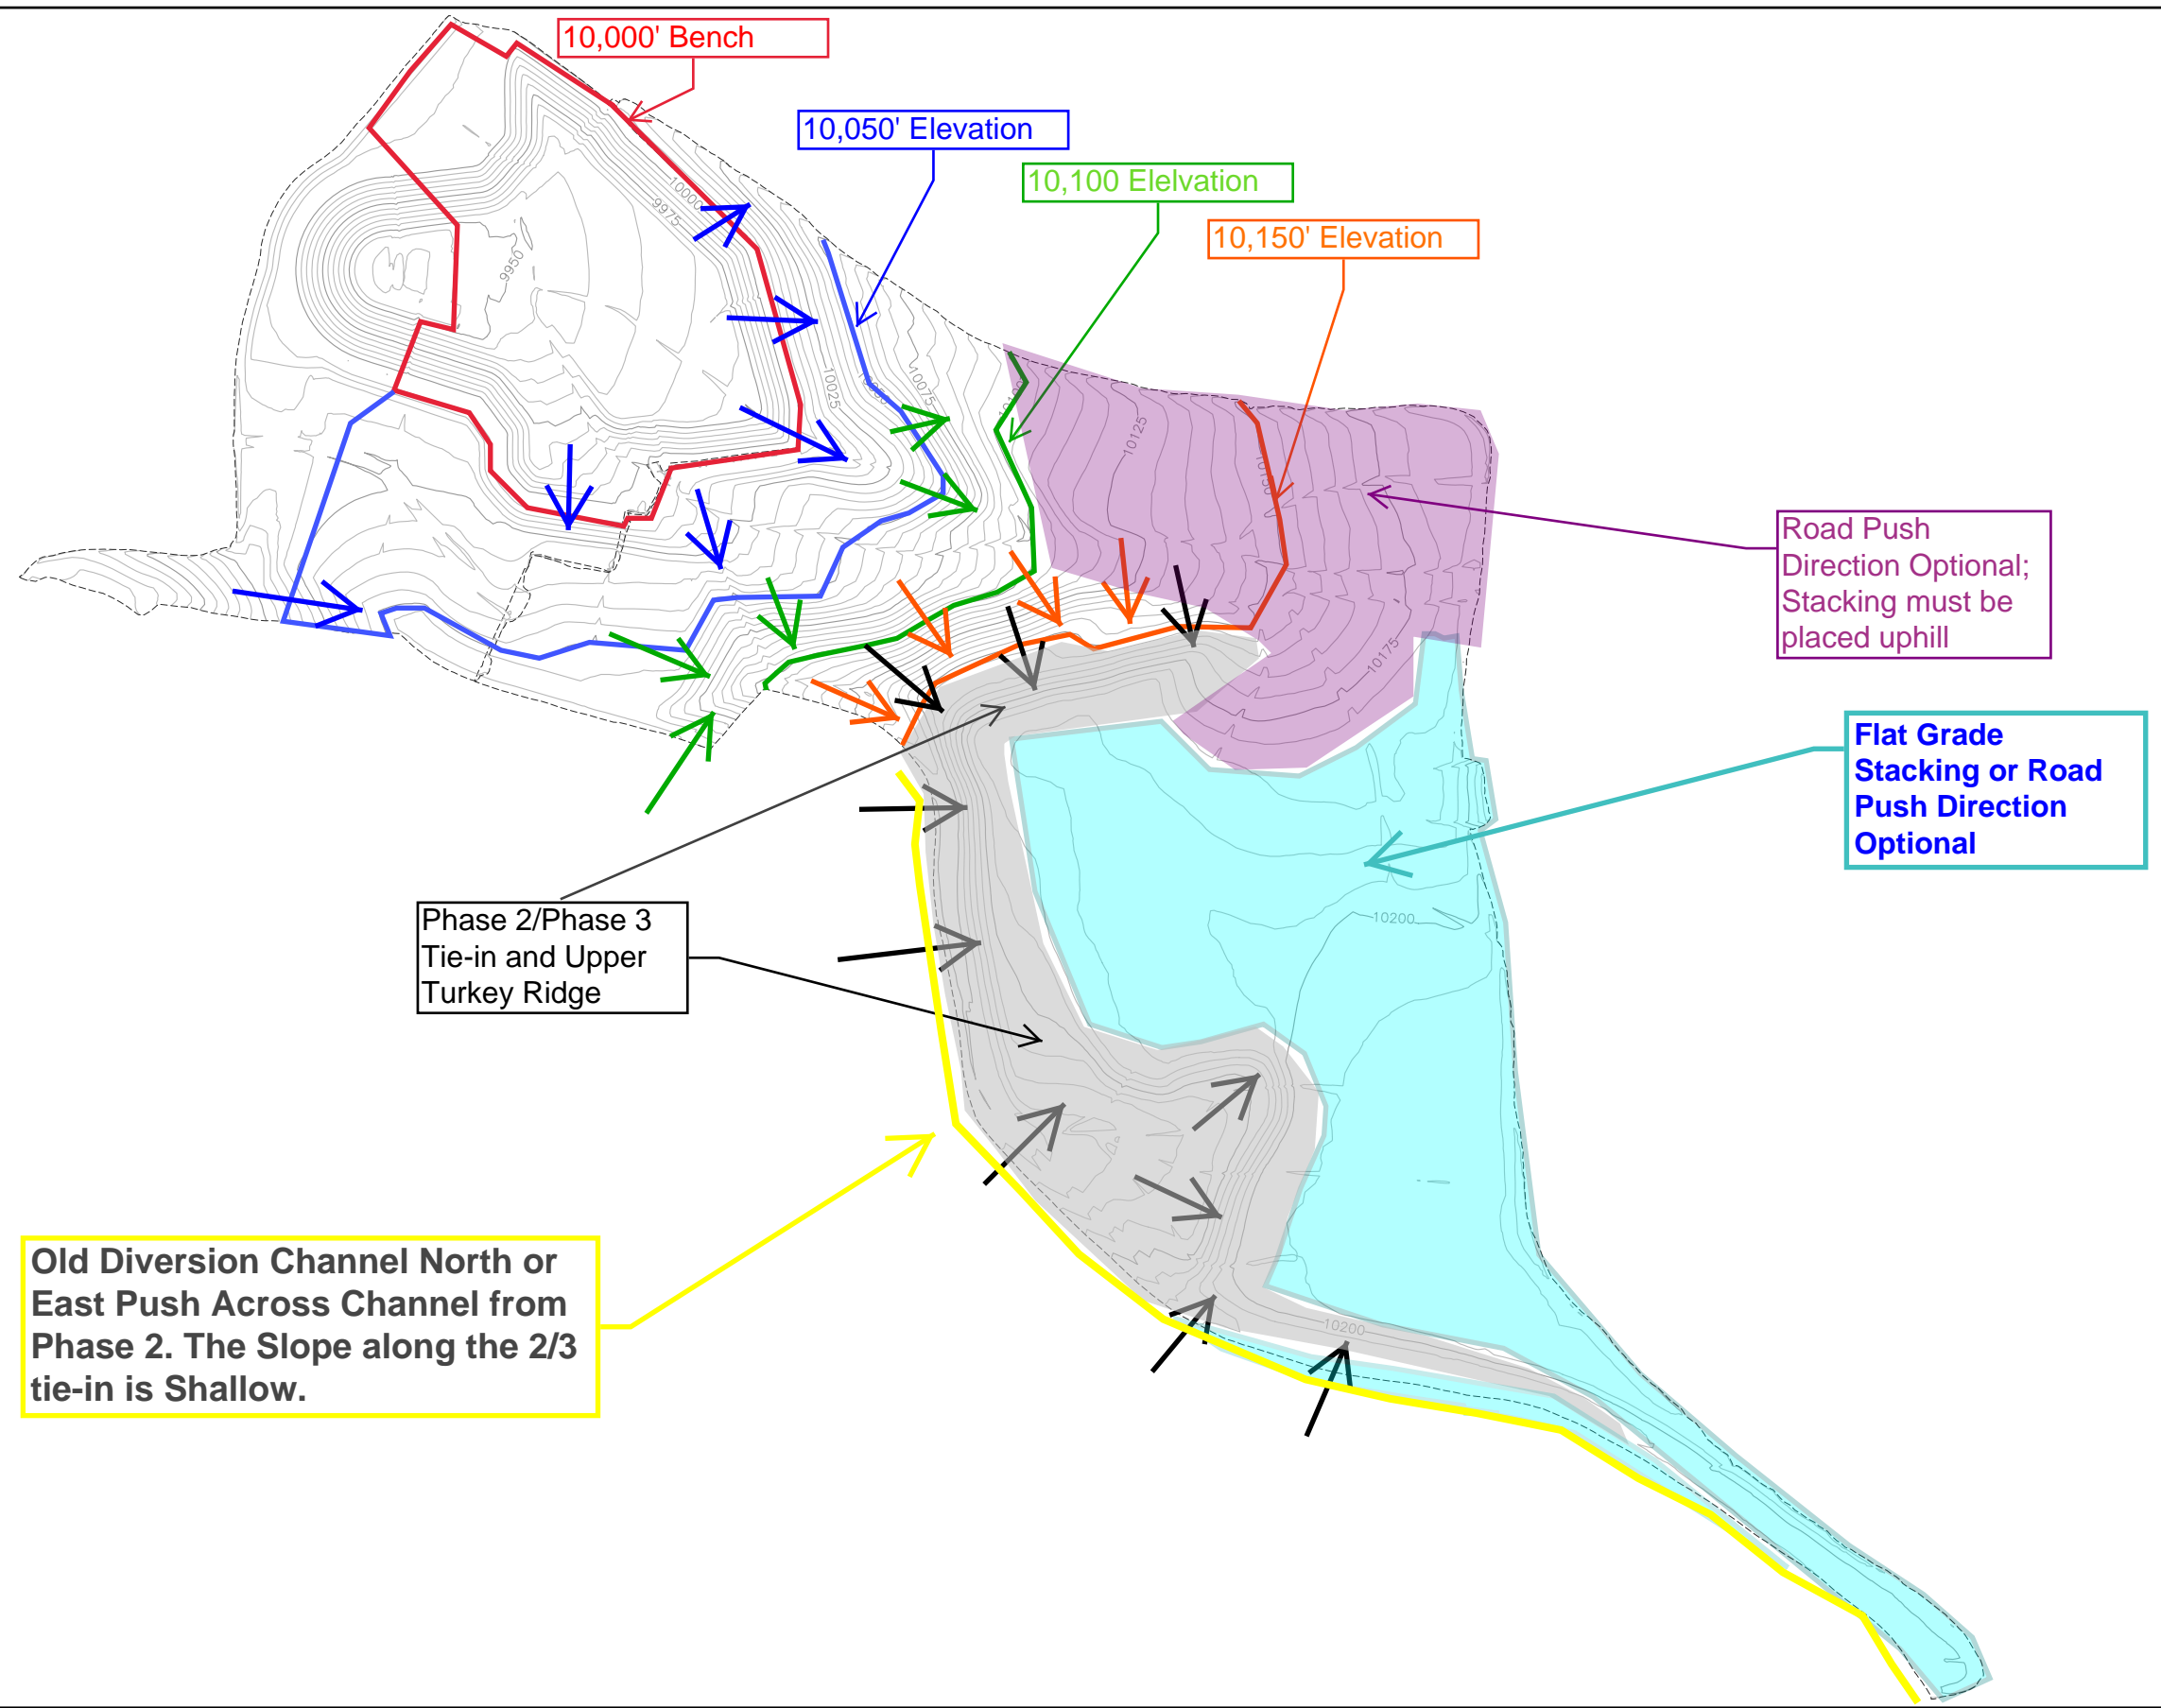
“Areas considered relatively flat, highlighted blue on the figure, are open to have access roads placed in any direction. These slopes are 9H:1V (11.5%) or less. The project specifications for the placement of DCF, including road construction, specify that material cannot be placed in a downhill direction on slopes steeper than a 25% slope (4:1).” – Email December 13, 2023, from Tyler Wendlandt, New Fields. VLF2 P3 Stage A Ore Material Placement Recommendations/Guidelines.

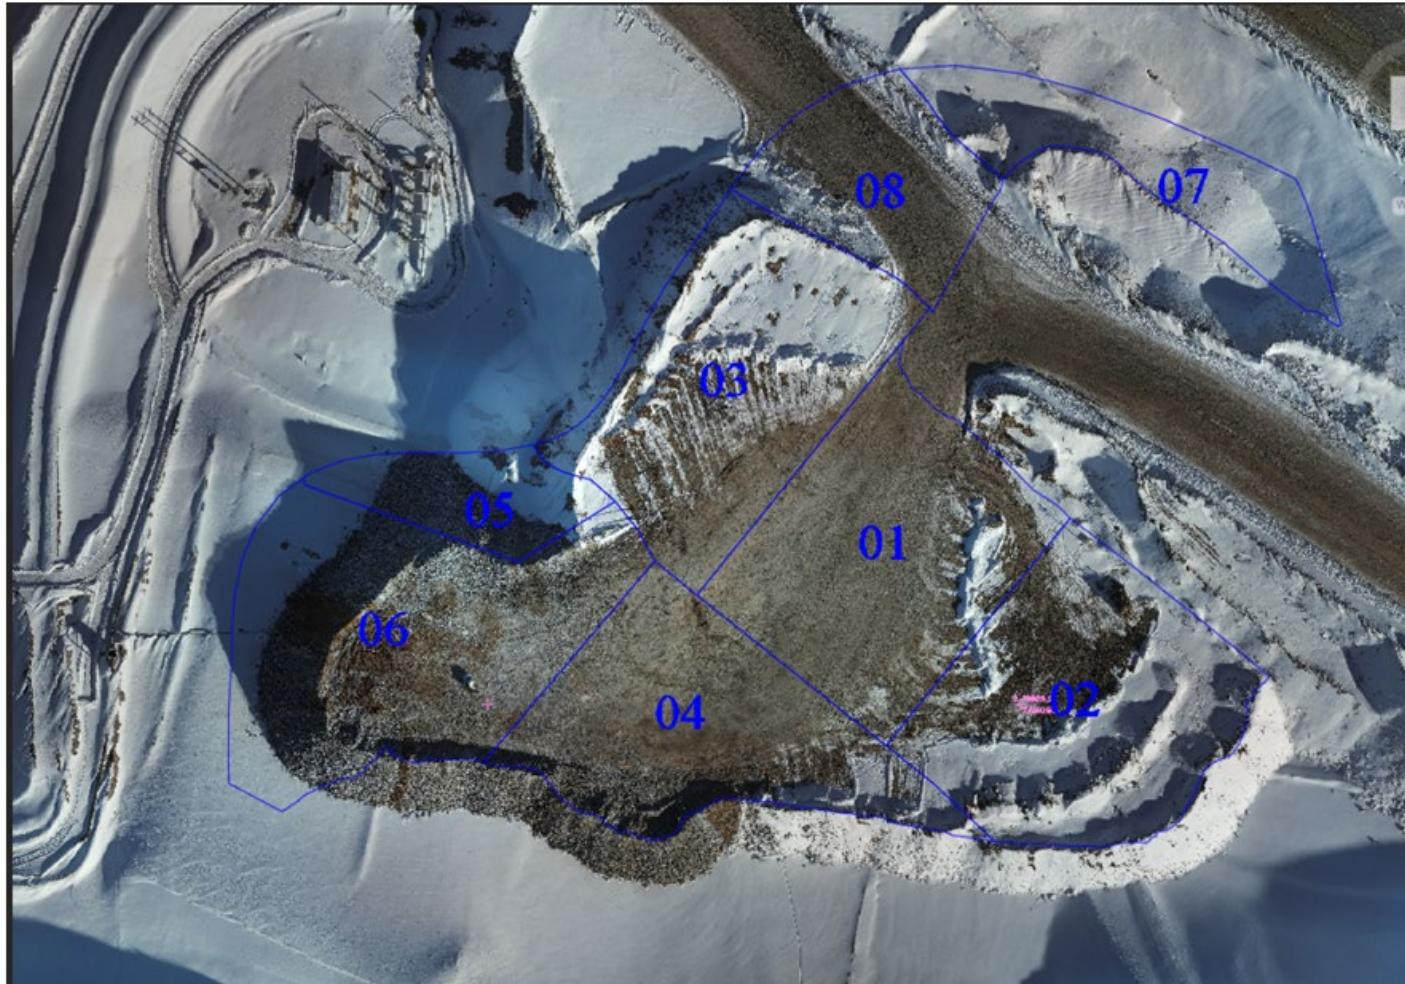
Drone photo
and scan of
10050 lift,
Cell 5 and
Cell 6

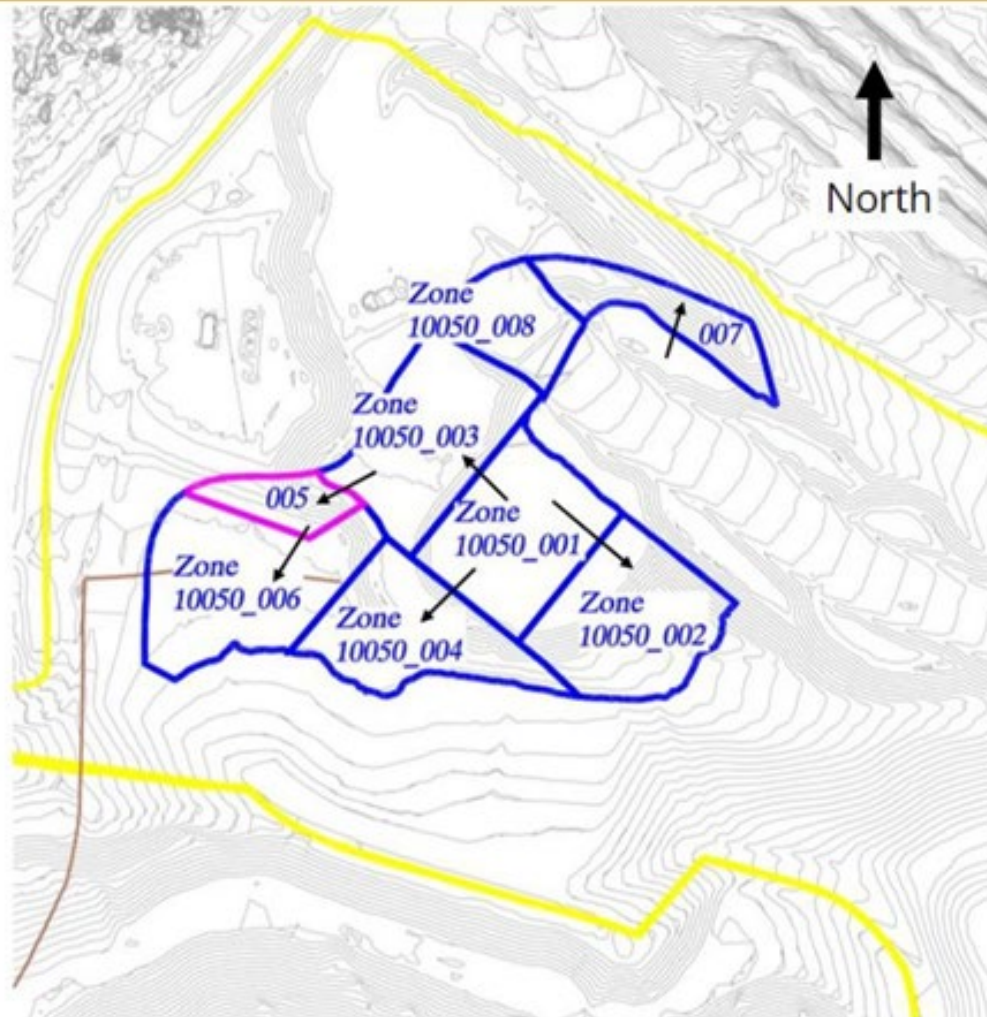
Old Controls: Stacking Order Guidance 10050 Lift

Blue boundary is an all material types zone.

Magenta is crushed only

Arrows show stacking direction.
