Newmont Mining Corporation
 Cripple Creek & Victor Gold Mine
 Liner Repair CQA
 NewFields Job No. 475.0106.068
 Week Ending Friday, March 15, 2024

FIELD WEEKLY PROGRESS REPORT

PROJECT: VLF2 PHASE 3 STAGE A.1 LINER REPAIR
SITE: CRIPPLE CREEK & VICTOR GOLD MINE (COLORADO)
CONTRACTOR: NEWMONT CC&V MINING OPERATIONS
 JHL CONSTRUCTORS
WEEK ENDING: FRIDAY, MARCH 15, 2024

REPORTING PERIOD: 03.09.2024 THROUGH 03.15.2024

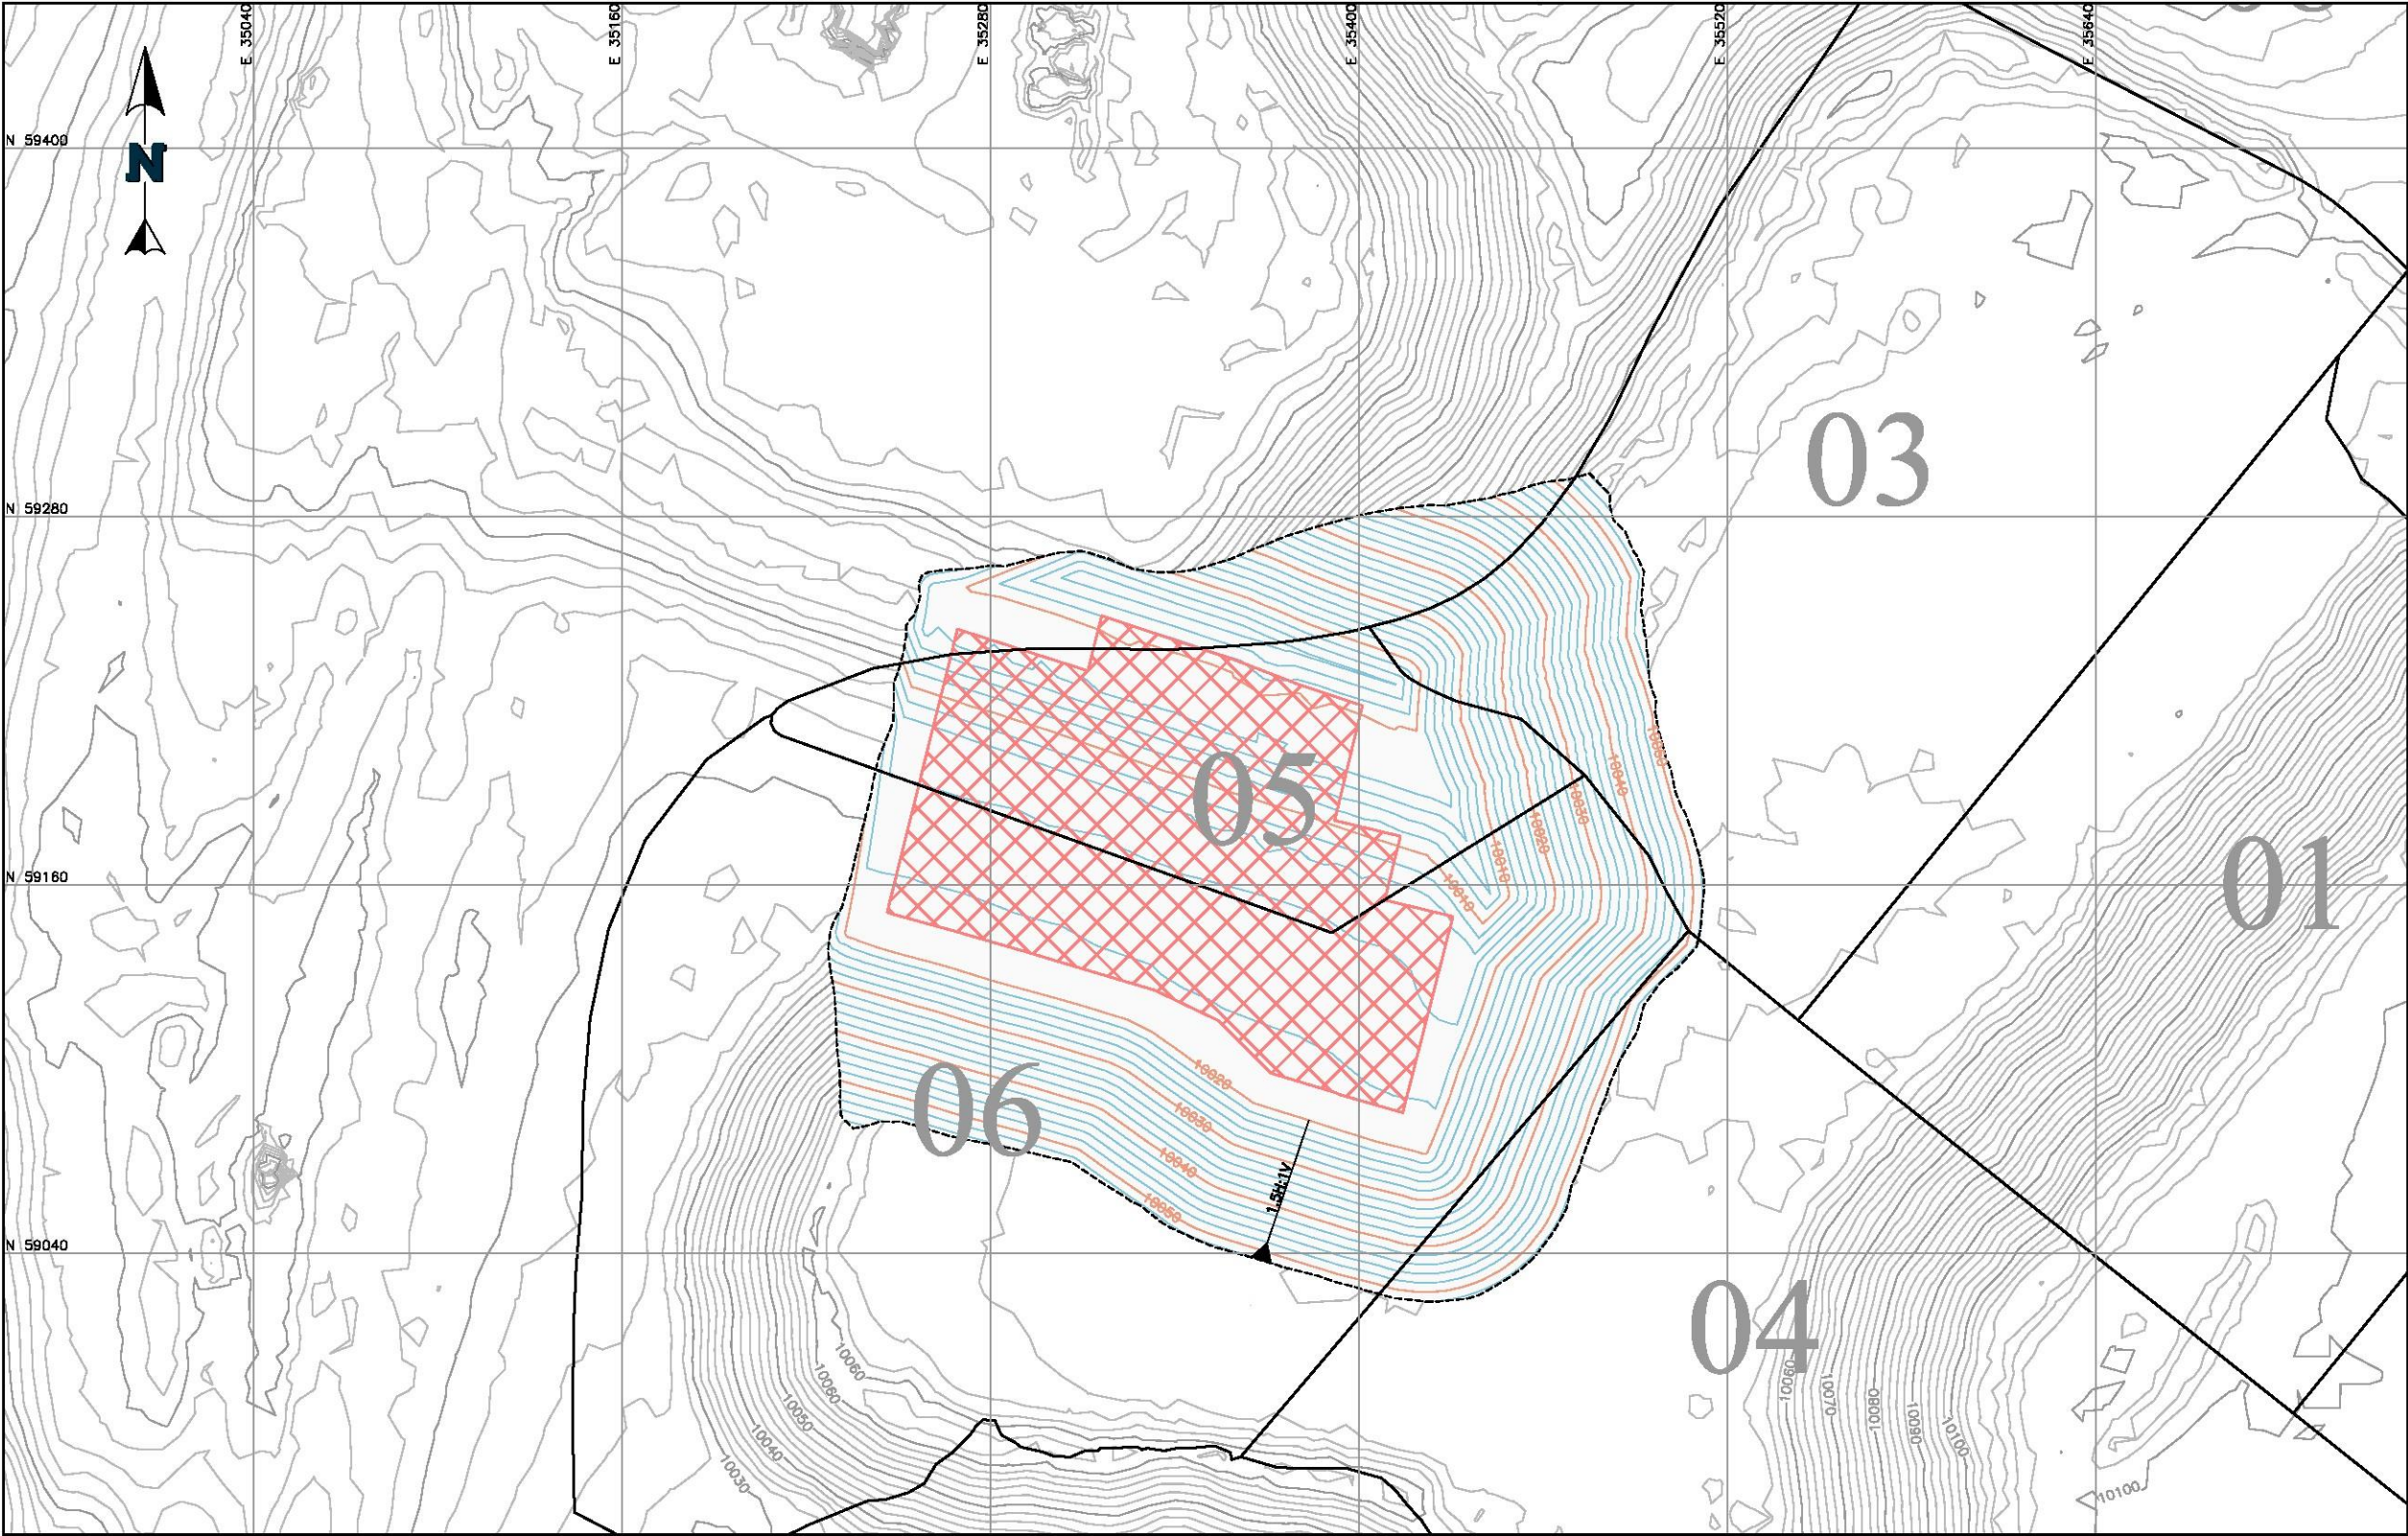
Figure 1 – VLF2 Phase 3A.1 Repair Limits of Excavation with Cell Boundaries

Newmont Operations continued to excavate Run of Mine (ROM) and Crushed Ore material from the repair project limits. A 6015B shovel/excavator excavated material from Cell 5. A 993 loader assisted the 6015B with stockpile management. The equipment worked on a platform approximately 20' to 25' above the geomembrane surface. The 6015B excavated material to approximately 5' above the geomembrane surface.
