Roadside Mine, C-1981-041, March Complete Inspection Report

PERMIT INFORMATION

Permit Number: C-1981-041 Mine Name: Roadside Portals Operator: Snowcap Coal Company, Inc. Operator Address: MS Tonya Hammond 743 Horizon Court, Suite 334 Grand Junction, CO 81506	County: Mesa Operation Type: Underground Permit Status: Active Ownership: Private
	Operator Representative Present: Tonya Hammond
Operator Representative Signature: (Field Issuance Only)

MINERALS PROGRAM INSPECTION REPORT
PHONE: (303) 866-3567

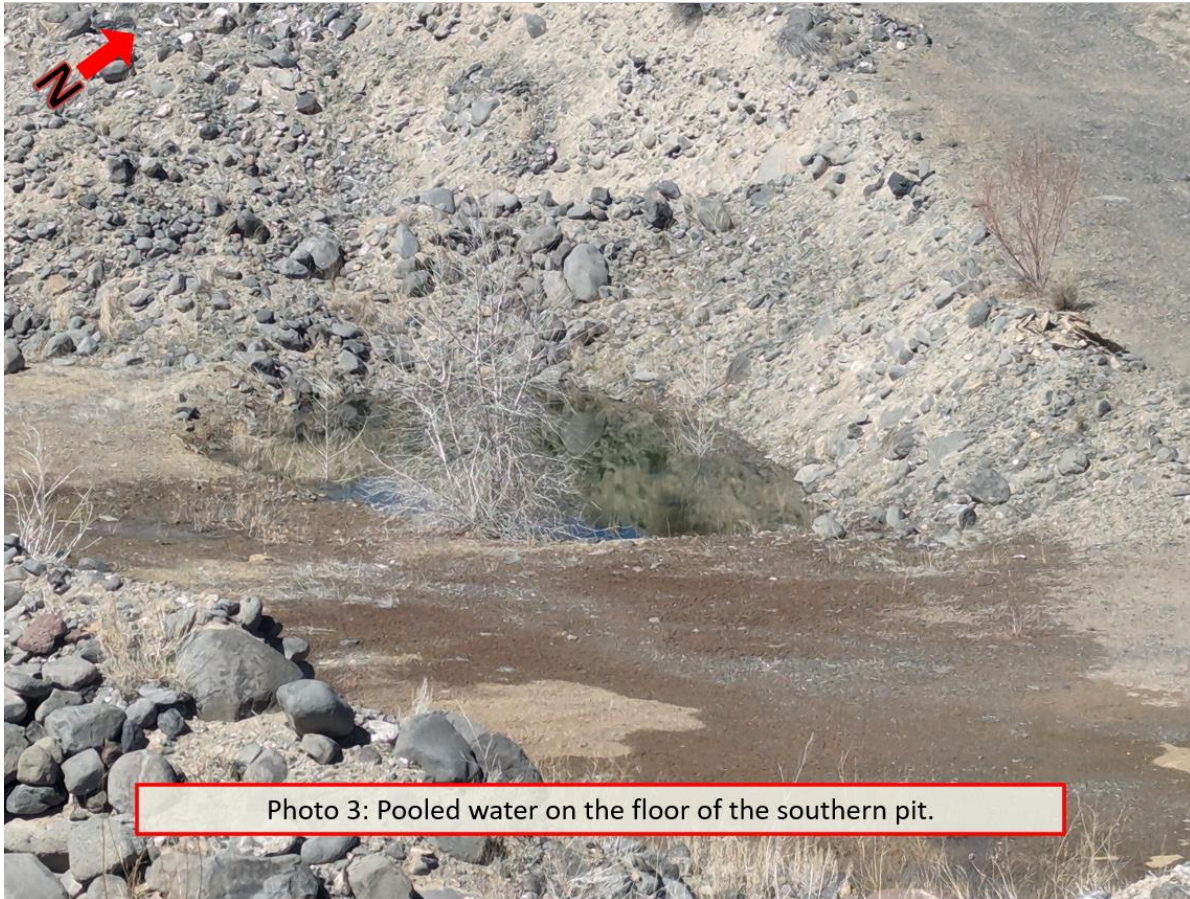
Water was observed discharging from a buried pipe* then being conveyed via an earthen ditch into the permit boundary ** (Photo 1). Water was estimated to be flowing at less than 30 gallons per minute. The discharging water resulted in ponding of water in two places within the southern pit area (Photos 2 and 3). Water infiltrated from the upper pool through the highwall and into the southern pit. The depth of the impounded water was not measured. Saturated soils on the southern pit floor were visually evident as the result of water flowing into the pit (Photo 4). The source of the water was believed to be from Rapid Creek above the Martin Crawford Ditch.

Photo 3: Pooled water on the floor of the southern pit.

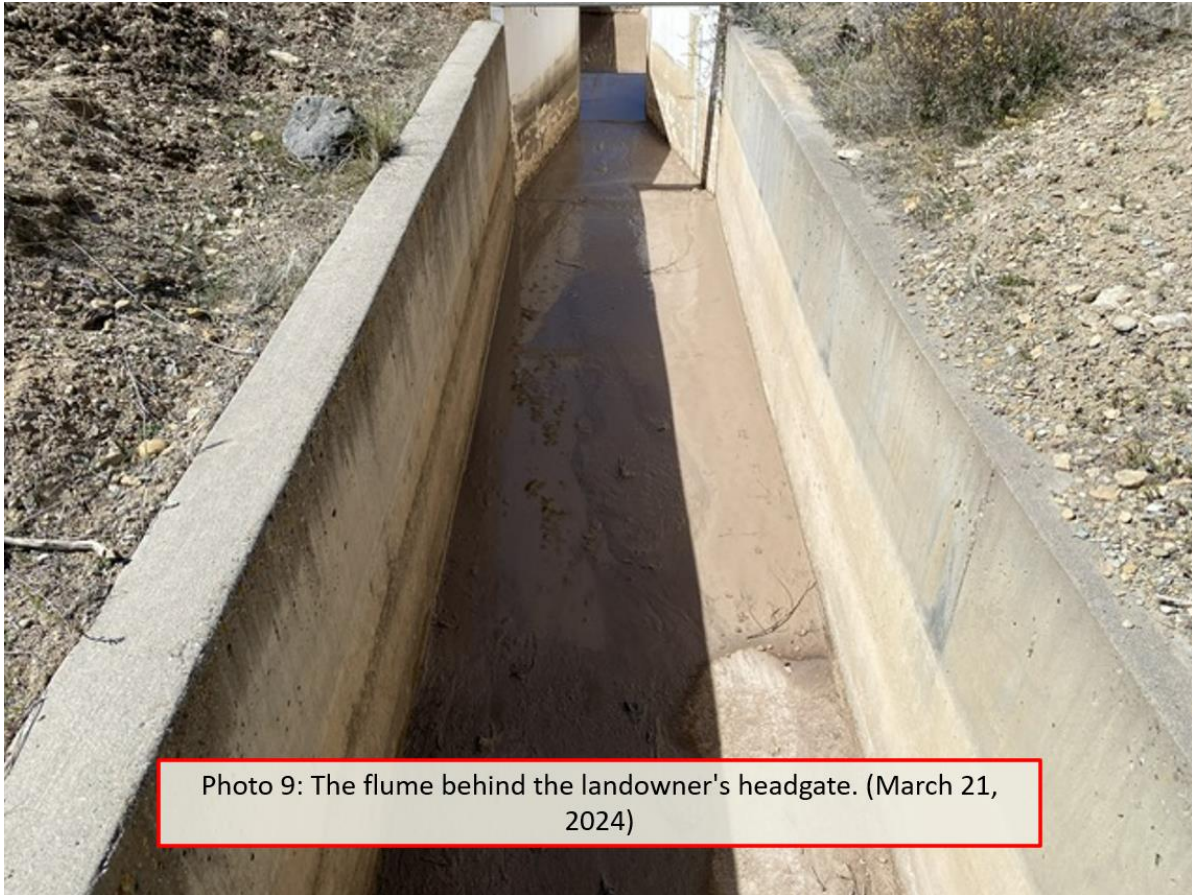
Photo 9: The flume behind the landowner's headgate. (March 21, 2024)
