### REQUEST FOR TECHNICAL REVISION (TR) COVER SHEET

File No.: M- 1980-110 Site Name: Henderson Development

Technical Revision  
M-1980-110  
Henderson Development (Sandy Acres)  
March 2024

To: Derek Slack  
From: Tim Crawford and Austin Malotte  
Subject: E-470 – Sandy Acres Pit – Gravel Pit History, Shallow Alluvial Ground Water and Standing Water Condition Summary  
Job: 9607.00  
Date: March 28, 2024

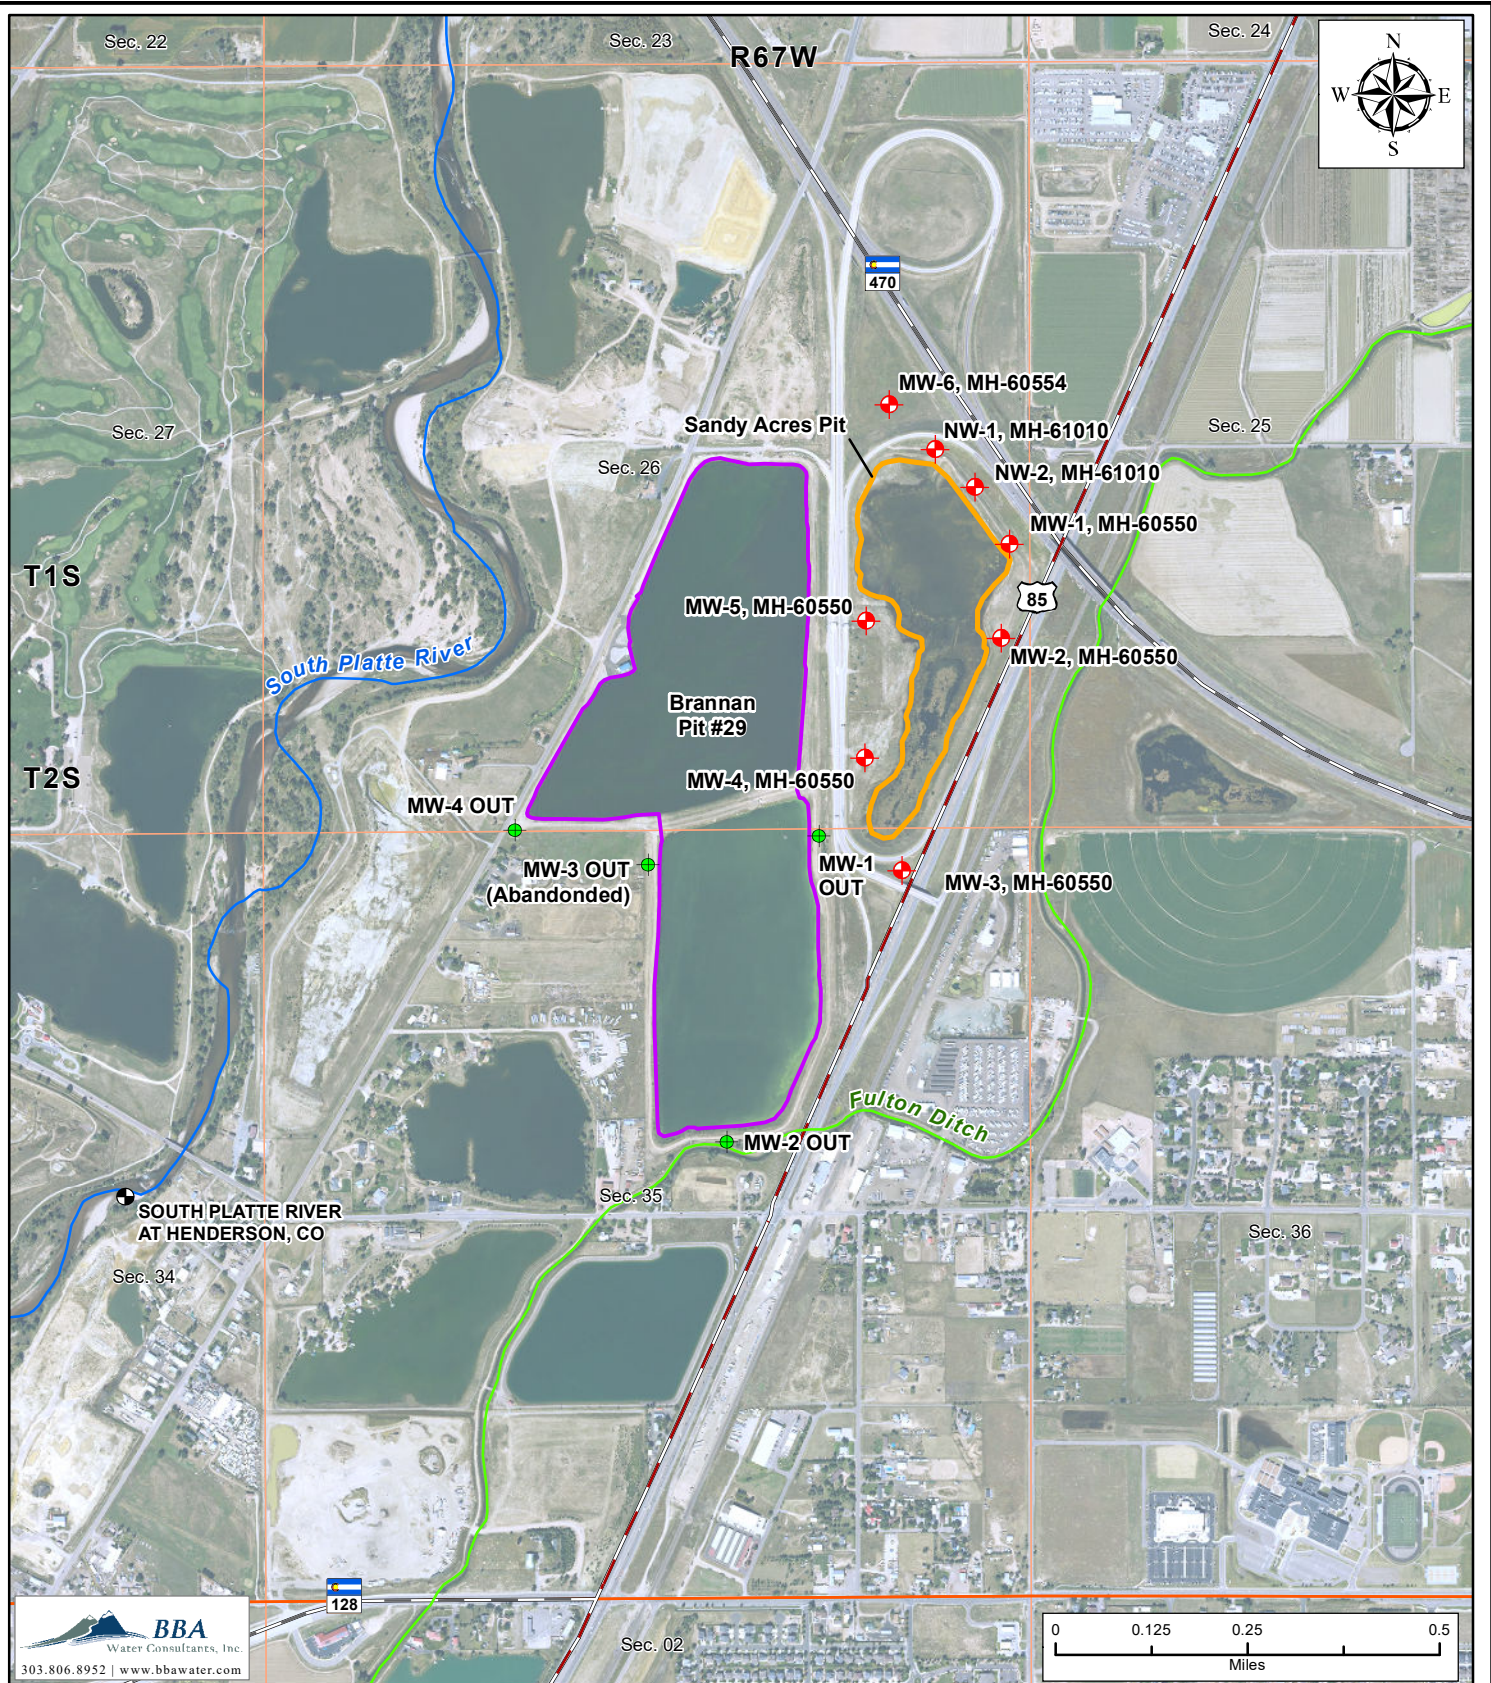
**Figure 1**  
**E-470 Sandy Acres Pit**  
**Monitoring Well Locations**

In March of 2020, E-470 installed six monitoring wells around the Sandy Acres Pit to monitor ground water level elevations in the South Platte River alluvial aquifer to better understand the standing water in the pit. In July of 2020, two additional monitoring wells were constructed. The locations of the wells are presented in Figure 1 and details regarding the wells are summarized below. Water level data collected from the wells is presented in the attached Table 1.

A gravel pit complex (Brannan Pit #29 – DRMS Permit No. M-1980-183) is located directly to the west and southwest of the Sandy Acres Pit, as presented in Figure 1. This gravel pit complex is the closest gravel pit to the Sandy Acres Pit and, as we know based on information in the permit file for the pit, has affected local ground water elevations and locally increased ground water elevations to the point that corrective action was required, as discussed below.

- Water level data should continue to be collected from the 8 monitoring wells installed by E-470 around the Sandy Acres Pit. Measurements should be collected on a monthly basis, weather permitting, and the measurements should be used to maintain the water level hydrograph of water levels around the pit. The water level data and hydrograph will allow for ongoing monitoring of the elevation of ground water around the pit and the impact of efforts to mitigate the standing water conditions in the Sandy Acres Pit.

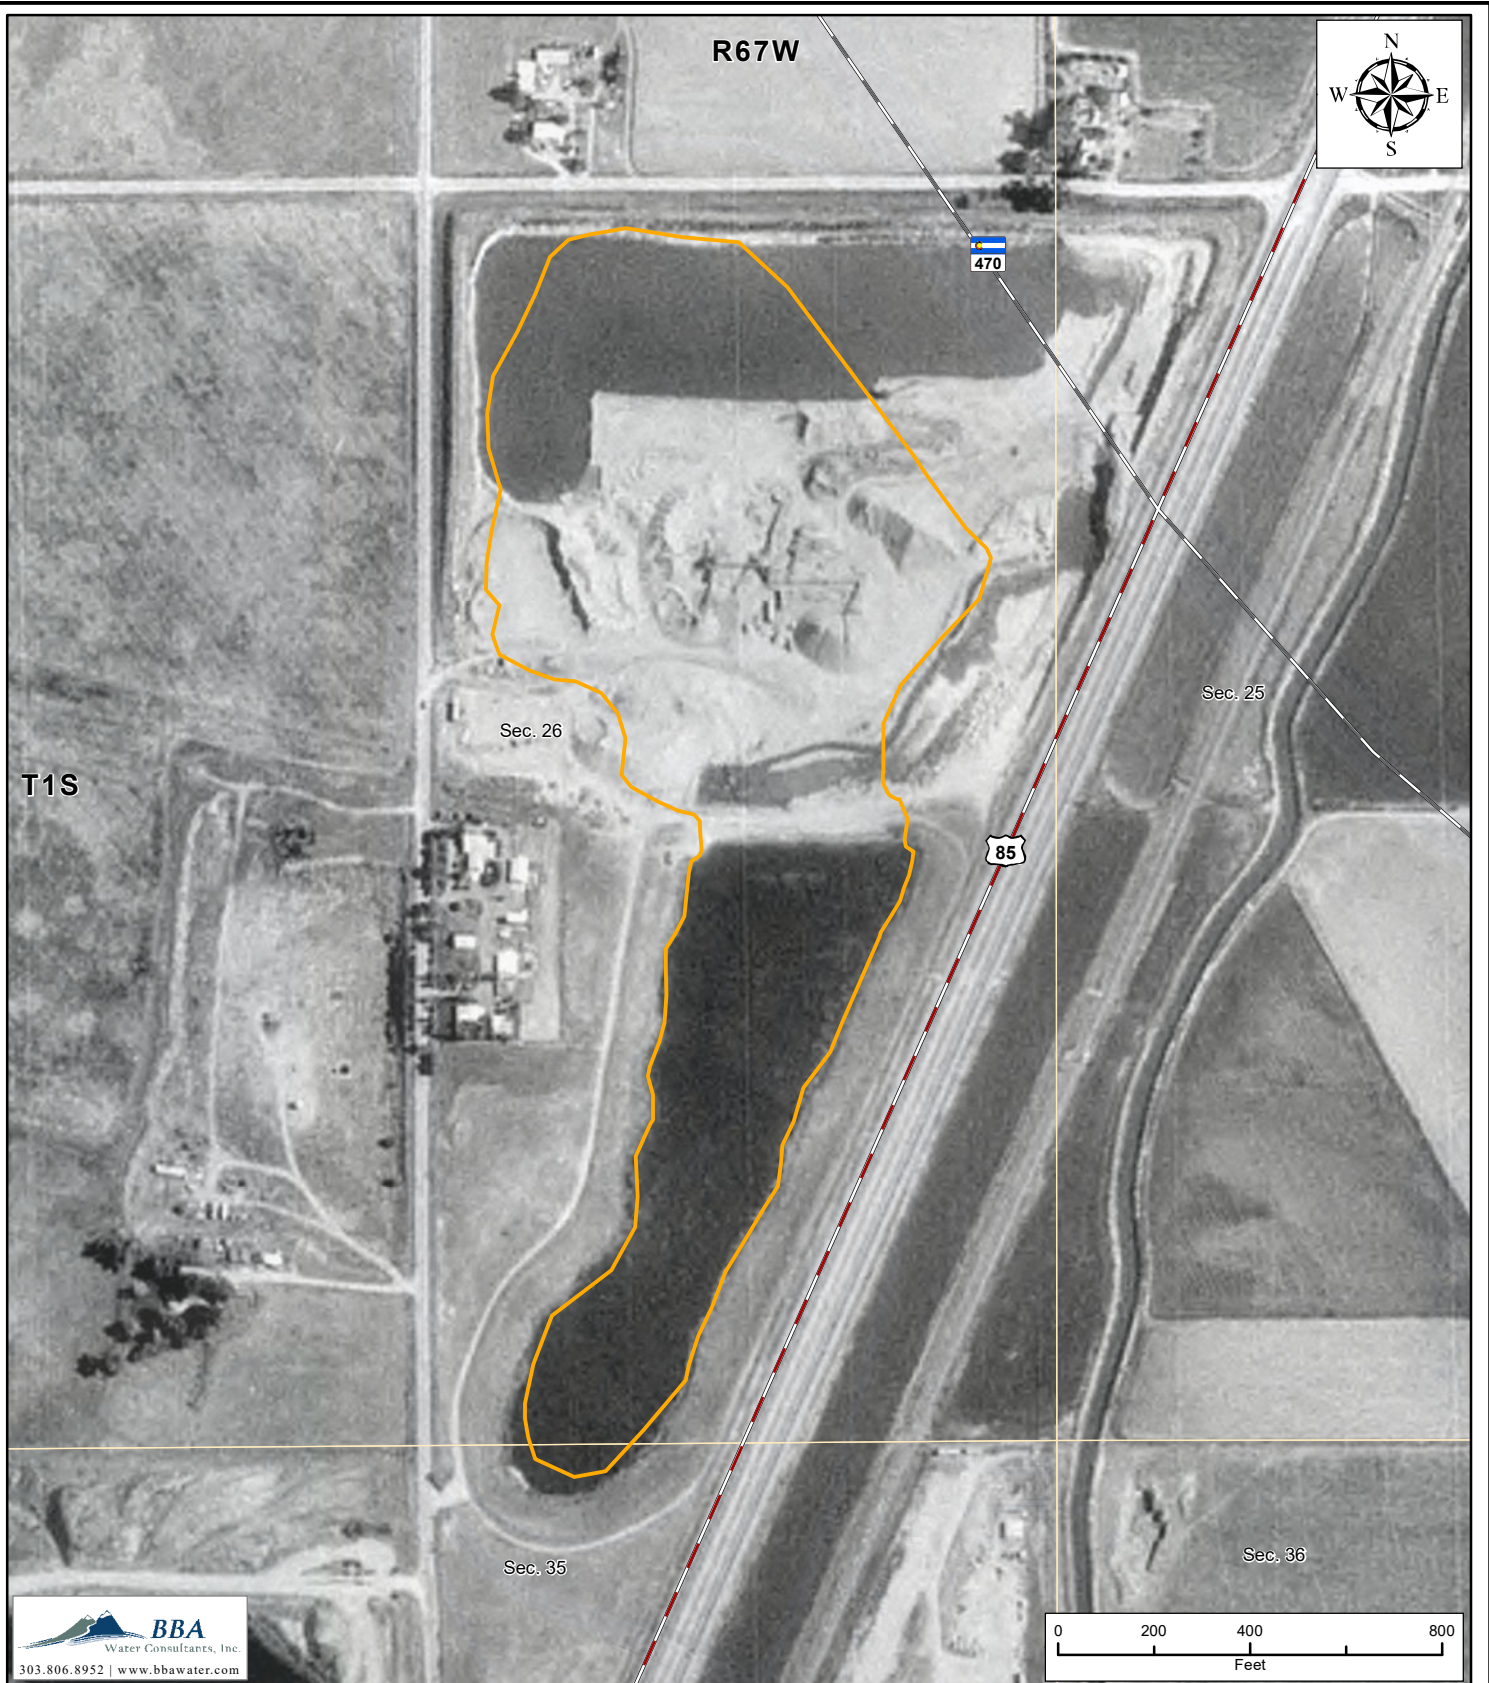
**Figure 2**  
**E-470 Sandy Acres Pit**  
**Aerial Photography 1993**

Aerial photography of the Sandy Acres Pit site generally confirms the history of the pit presented in the permit file. The photography confirms that by 1993, a southern gravel pit cell had been constructed and the mining of a second northern gravel pit cell had begun (Figure 2). Aerial photography confirms that the mining of the Sandy Acres Pit was completed by approximately 2001 (Figure 3). Standing water was observed in the pit in the available photography through this time and continued consistently until 2015 when E-470 began the backfilling project, discussed above (Figure 4). The aerial photography depicts the backfilling of the pond and confirms that no standing water was observed on top of the backfilled material in the pit during 2018 (Figure 5). By the end of the summer of 2019, however, aerial photography indicates standing water was again present in the bottom of the Sandy Acres Pit on top of the backfill material (Figure 6). Aerial photography from April of 2023, after the installation of the trenching and sump collection system, indicates a decrease in the amount of standing water in the pond (Figure 7).
