Division of Reclamation,
Mining and Safety

Permit Number: C-1981-012 Mine Name: New Elk Mine Operator: New Elk Coal Company, LLC Operator Address: Mr. John Terry 12250 Highway 12 Weston, CO 81091	County: Las Animas Operation Type: Underground Permit Status: Active Ownership: Private
	Operator Representative Present: John Terry
Operator Representative Signature: (Field Issuance Only)

Inspection Start Date: March 26, 2024 Inspection Start Time: 14:31 Inspection End Date: March 28, 2024 Inspection End Time: 12:55	Inspection Type: Coal Complete Inspection Inspection Reason: Surety Related Weather: Clear
Joint Inspection Agency: None	Joint Inspection Contacts:
Post Inspection Agency: None	Post Inspection Contacts:
Inspector(s): Amber M. Gibson	Inspector's Signature:

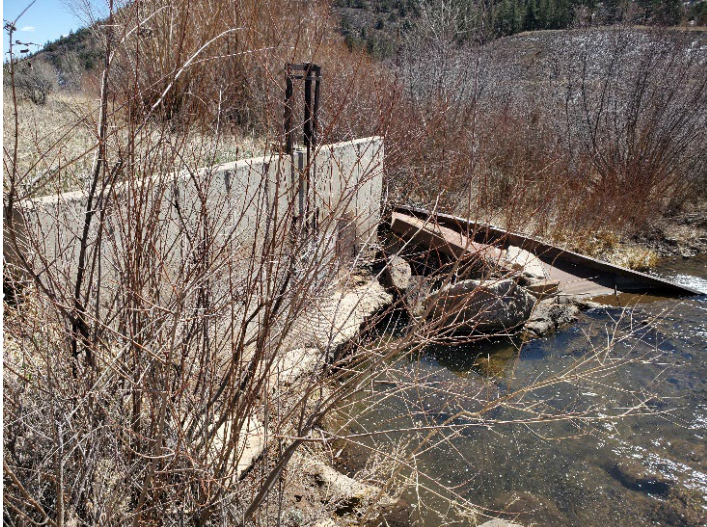
<p>-Listed as a retaining wall on Map 11-3. However, the Operator stated that this dam is used by a farmer east of the site that directs water through a culvert to his farm -This structure also merits further investigation</p>

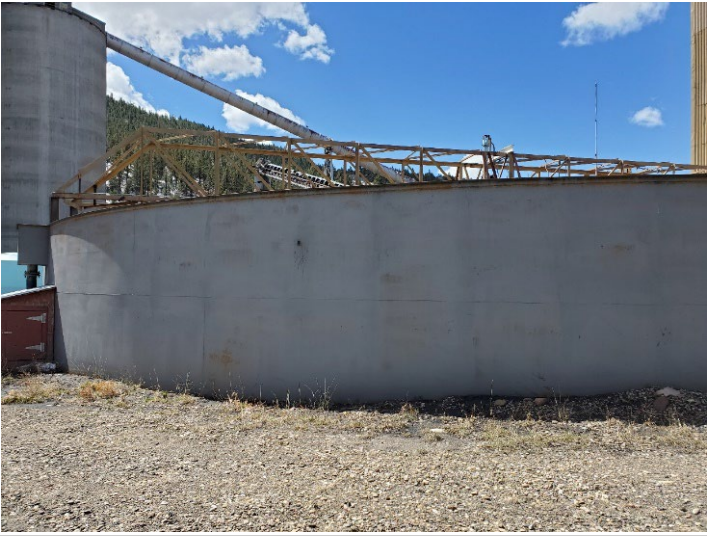
8	Thickener Tank

<p>-No visible pad. Operator believes that tank was possibly placed on level ground. -Tank is approx. 10' tall -Metal</p>
9	<p>Thickener Substation *Control Room for the Thickener Tank</p>

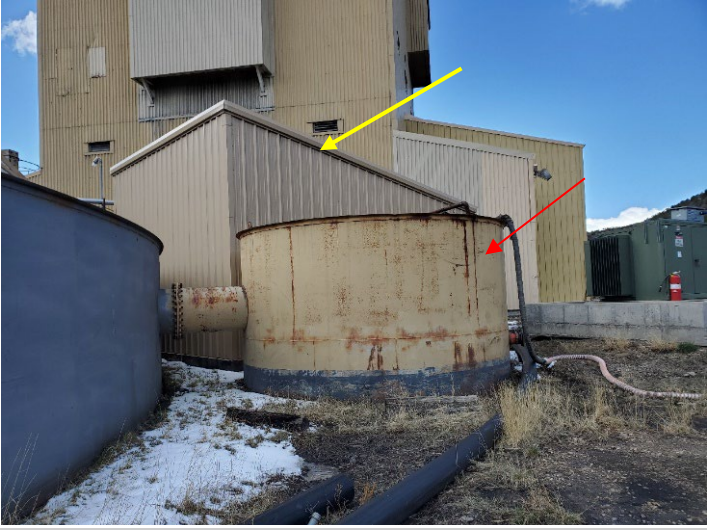
<p>-Yellow arrow points to a Thickener Substation/Control Room for the Thickener Tank. → Approx. 18.5' tall → Metal</p> <p>-Red arrow points to an additional tank → Approx. 10' tall → Metal</p>
10	Transformer

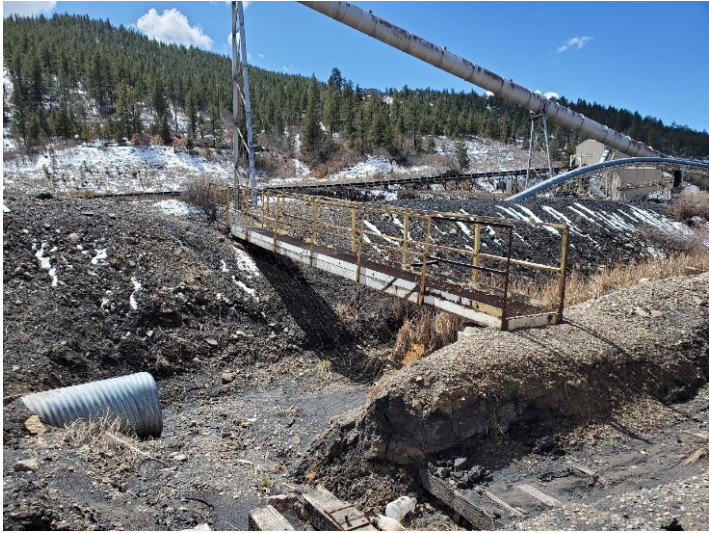
<ul style="list-style-type: none"> -Antiquated structure, no longer serves practical use -Metal bridge
16	Clean Coal Plant Conveyor

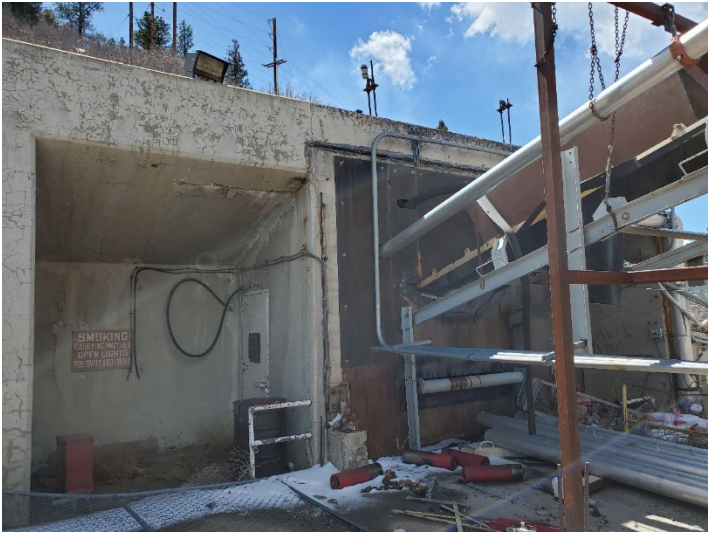
37	East Portal *Allen Portal

-Sealed with 20' concrete wall
38	Belt Slope *Allen Slope Belt

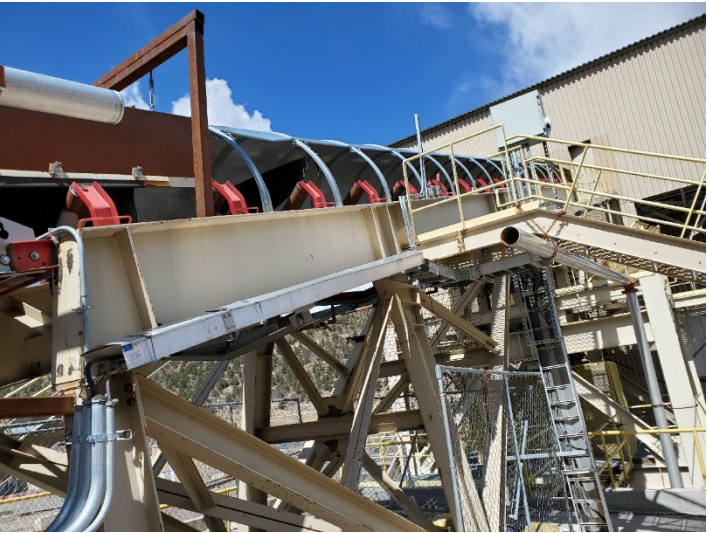
-Connects breaker building to portal -No longer used
39	Breaker Building

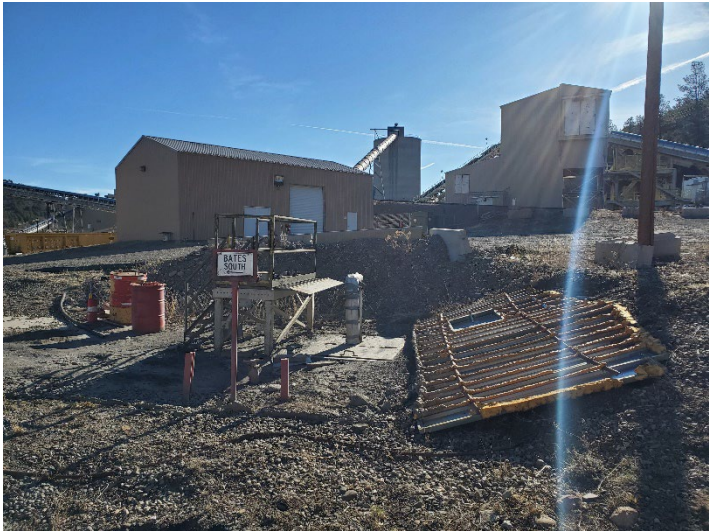
-Gone, the wind blew it down recently. The piece on the right in the photo is all that is left.

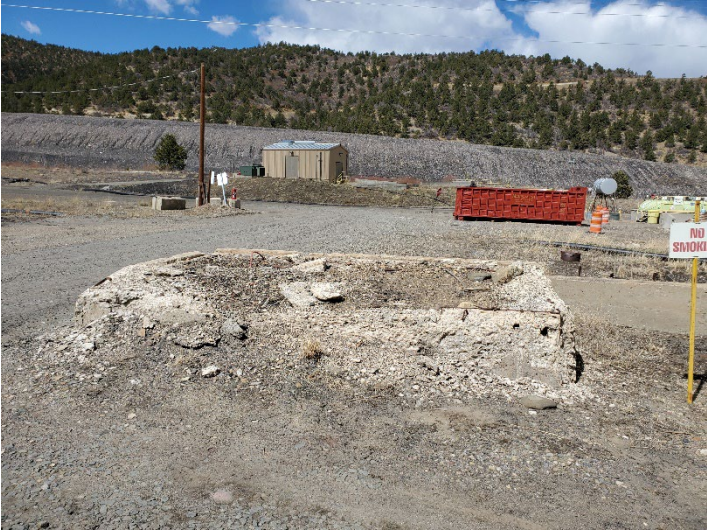
<p>-Unsure of its original purpose -Only elevated concrete leftover</p>
<p>54</p>	<p>Fuel Tank Containment Sumps</p>

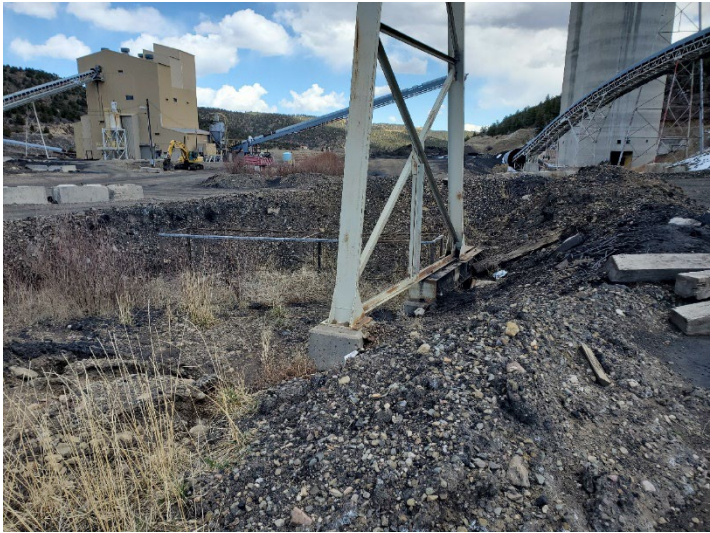
72	Transformer	 	-Concrete pad
73	Transfer Conveyor Belt *Raw Feed Belt

-Goes from transfer building to raw coal pile -Conveyor belt on beams that are on concrete footers
74	Transfer Building

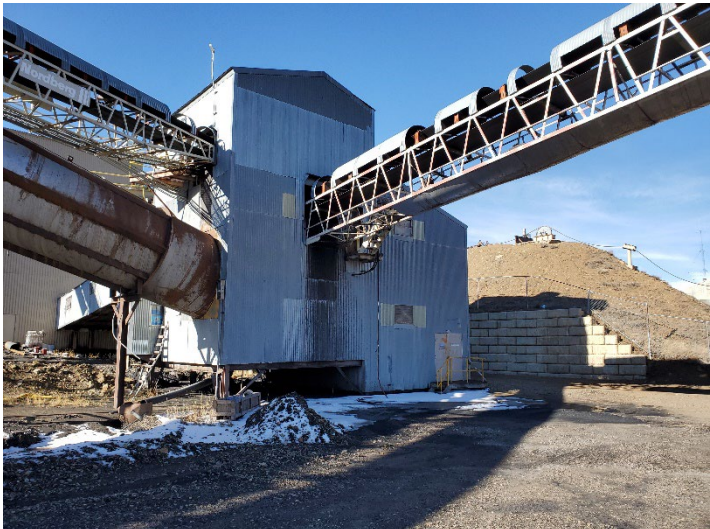
-Approx. 38' tall -Metal building

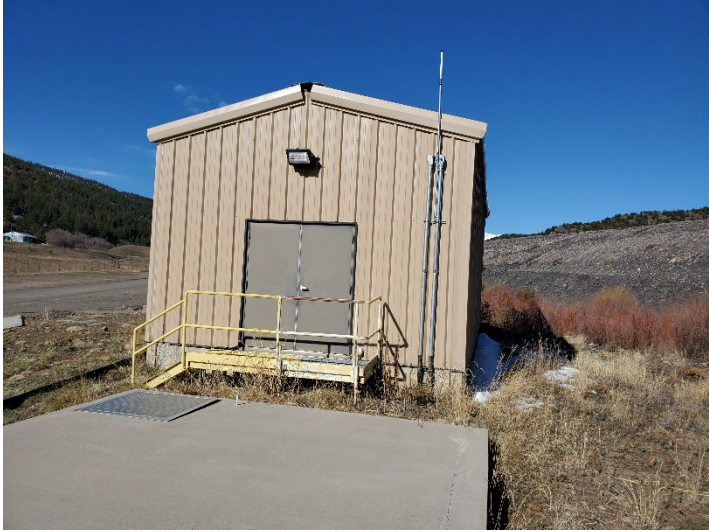
81	* Pump house

<ul style="list-style-type: none">-Used now instead of concrete cistern/pump set up to the east of this structure-Approx. 14.8' tall
82	Catwalk and Old Gate Valve

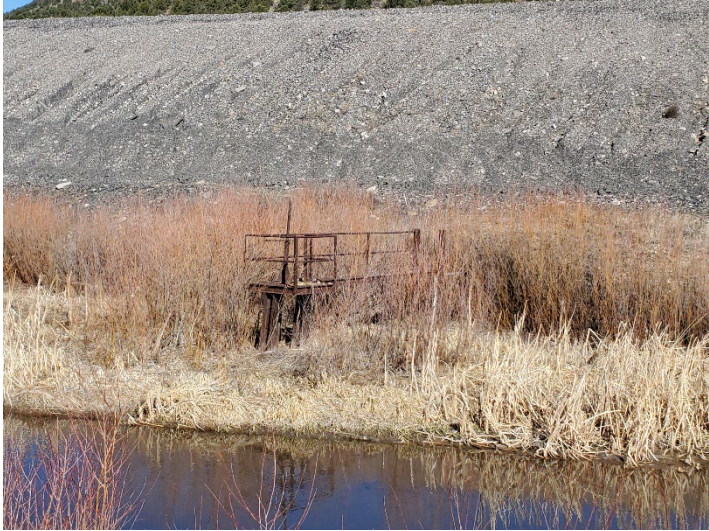
<ul style="list-style-type: none">-Old one, new one is by the new pump house
82.5	New Gate Valve

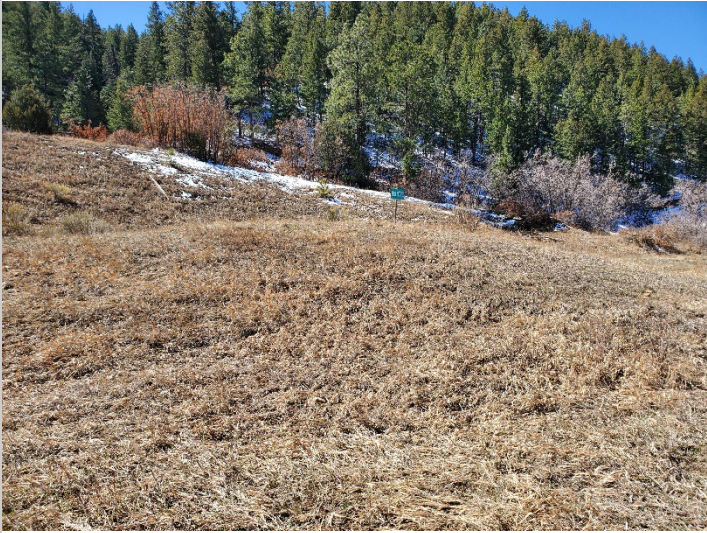
<p>-Actually a topsoil pile (unnumbered on map) located south of Containment #1</p> <p>-Approximately 10' tall</p> <p>-Appears to be stable, Operator stated that it hasn't not been disturbed for a long time.</p>
113	Topsoil pile (unnumbered)	<p>-Not pictured</p> <p>-No pile, Operator believes that it was likely used to reclaim the areas in the west side of the permit.</p>	
114	Just says soil stockpile

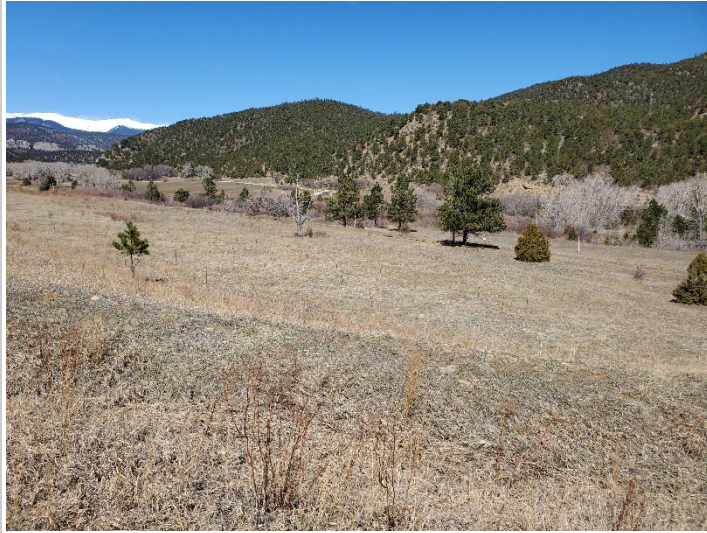
<p>-No stockpile, just a field to the west of Containment #2</p>
115	Diesel Tank Containment	<p>-Not pictured, not there.</p> <p>-Operator stated that it has been gone for a long time.</p>

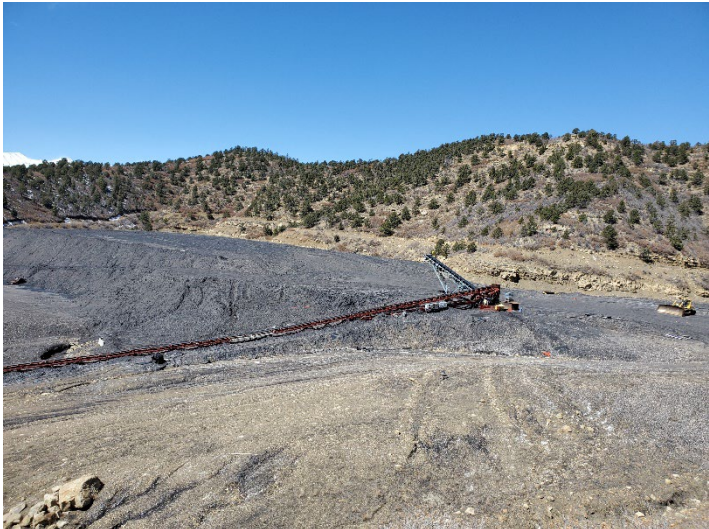
-
124	Refuse Conveyor Belt Extension

<ul style="list-style-type: none">-Accordion belt-Only small portion of extension remains, the last time the RDA area was operating, haul trucks were utilized more than the extended conveyor belt

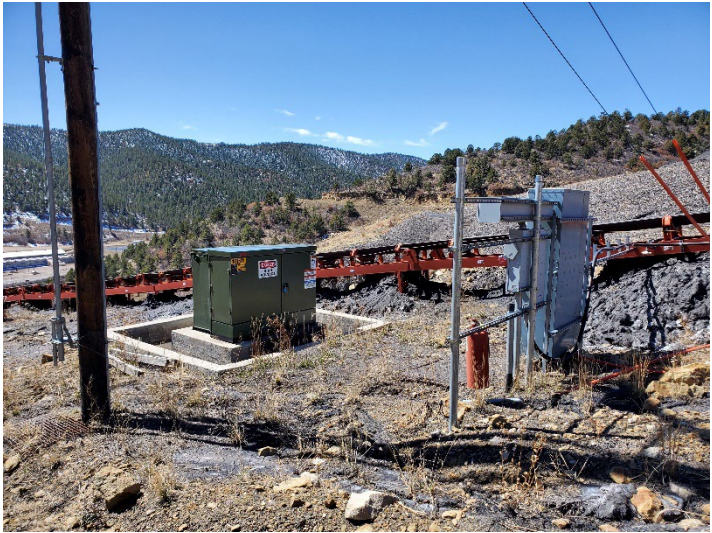
125	Electrical Substation from MR97 *Transformer with electrical panel – not a substation

-Concrete berm around transformer -Gray electrical panel
126	Jansen loadout truck scale	Not there	
127	Jansen coal conveyor

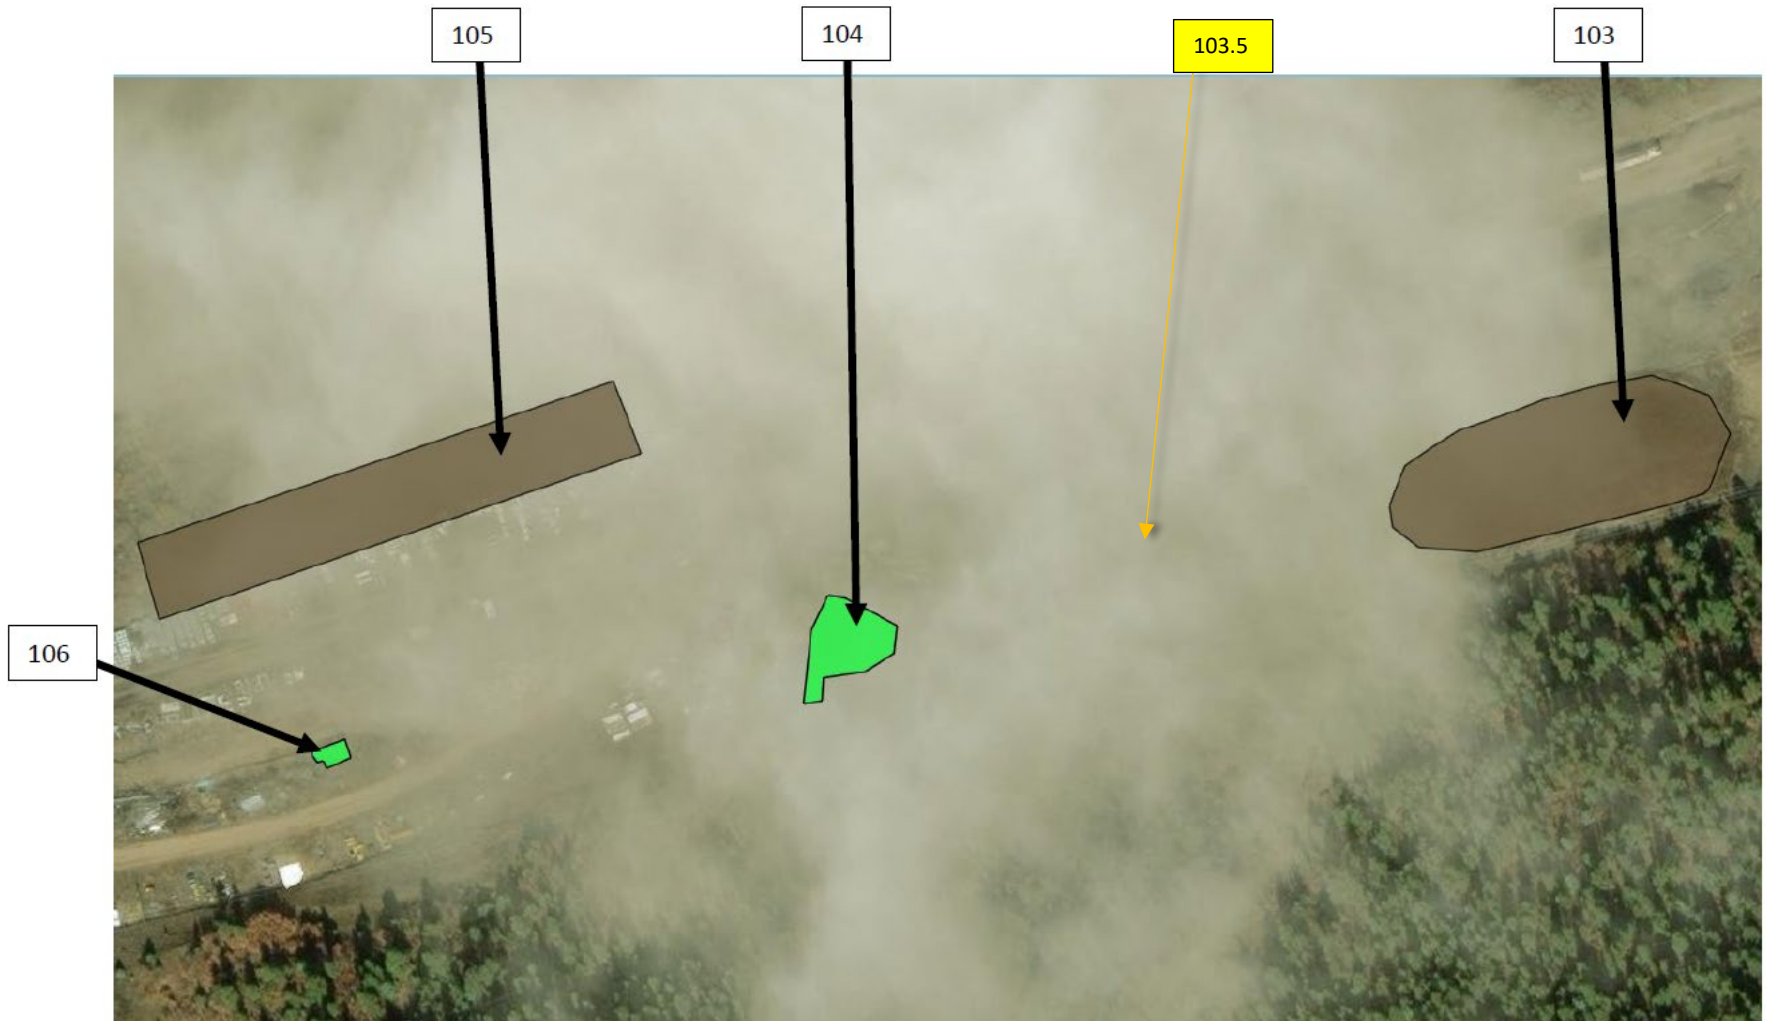
Figure 5

- Topsoil piles were observed throughout the site (see Figures 5, 7, and 9 in the Supplemental Article enclosed with this report). Each pile had been stabilized with vegetative cover (except for the newest one mentioned in the third bullet of this section), and was out of the way of on-going mining operations, and had a sign to identify the stockpiles as topsoil.
