Inspection Report, Foidel Creek Mine, C-1982-056

PERMIT INFORMATION

Permit Number: C-1982-056 Mine Name: Foidel Creek Mine Operator: Twentymile Coal, LLC Operator Address: Ms Miranda Kawcak 29515 Routt County Road No. 27 Oak Creek, CO 80467	County: Routt Operation Type: Underground Permit Status: Active Ownership: Private
	Operator Representative Present: Miranda Kawcak
Operator Representative Signature: (Field Issuance Only)

This was a partial inspection of the Foidel Creek Mine; DRMS Permit No. C-1982-056, operated by Twentymile Coal, LLC. (TC). The inspection was conducted by Hunter Ridley with the Colorado Division of Reclamation, Mining, and Safety (Division). Miranda Kawcak of TC was present at the mine office and Kevin Copeland and Mike Howard of TC accompanied the inspection. **Please address the Bold items below.**

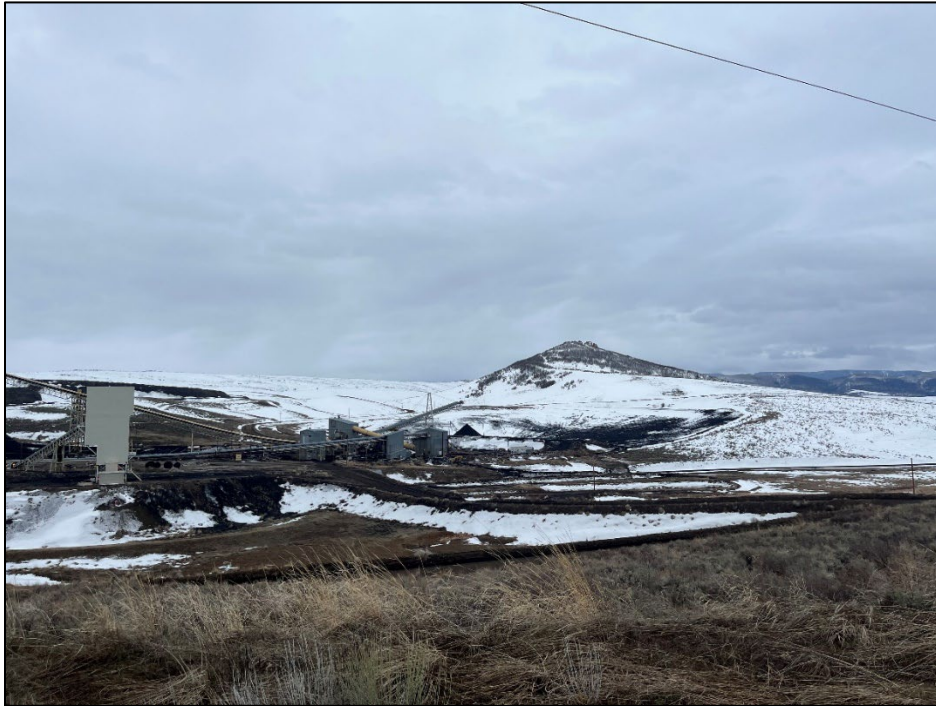
Photo 1: View southeast from CR 27 of the southern portion of the main facilities, the ROM coal storage area and refuse pile are both visible.

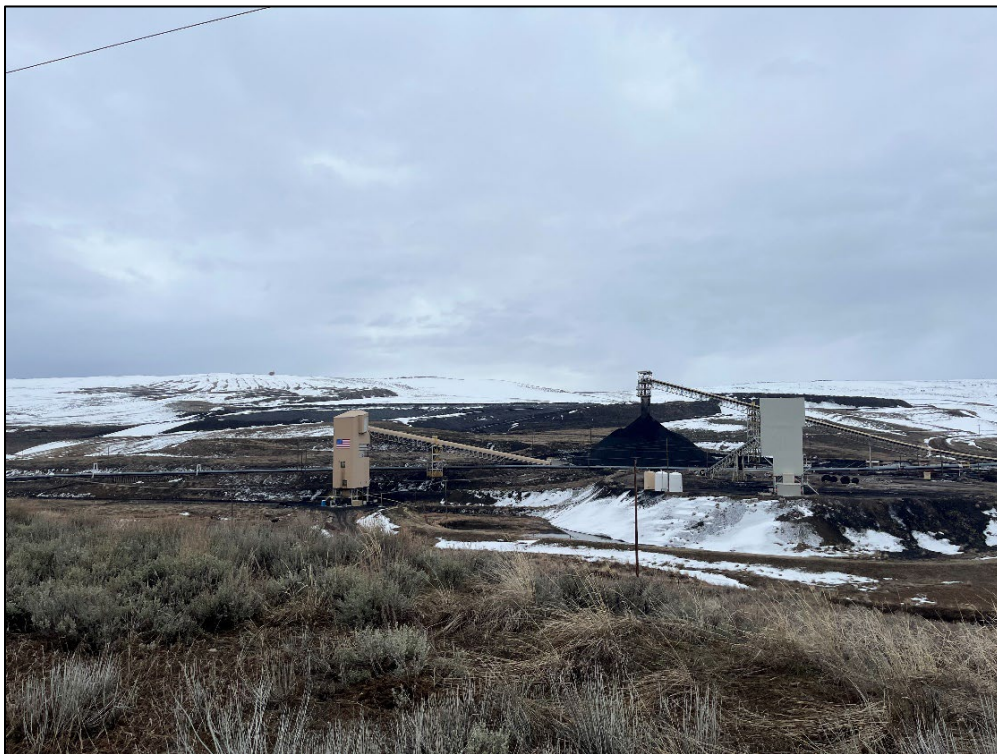
Photo 2: View southeast from CR 27 of the middle of the main facilities area, the train loadout, Pond C, and the coal stockpile location is visible.
