**MINERALS PROGRAM INSPECTION REPORT**  
**PHONE: (303) 866-3567**

| <b>MINE NAME:</b><br>Robinson Sons Gravel Pit No. 1 | <b>MINE/PROSPECTING ID#:</b><br>M-2008-076 | <b>MINERAL:</b><br>Sand and gravel and | <b>COUNTY:</b><br>Las Animas |
| <b>INSPECTION TYPE:</b><br>Monitoring | <b>WEATHER:</b><br>Clear | <b>INSP. DATE:</b><br>March 26, 2024 | <b>INSP. TIME:</b><br>12:47 |
| <b>OPERATOR:</b><br>Robinson Sons Inc. | <b>OPERATOR REPRESENTATIVE:</b><br>Daniel Robinson | <b>TYPE OF OPERATION:</b><br>112c - Construction Regular Operation | |

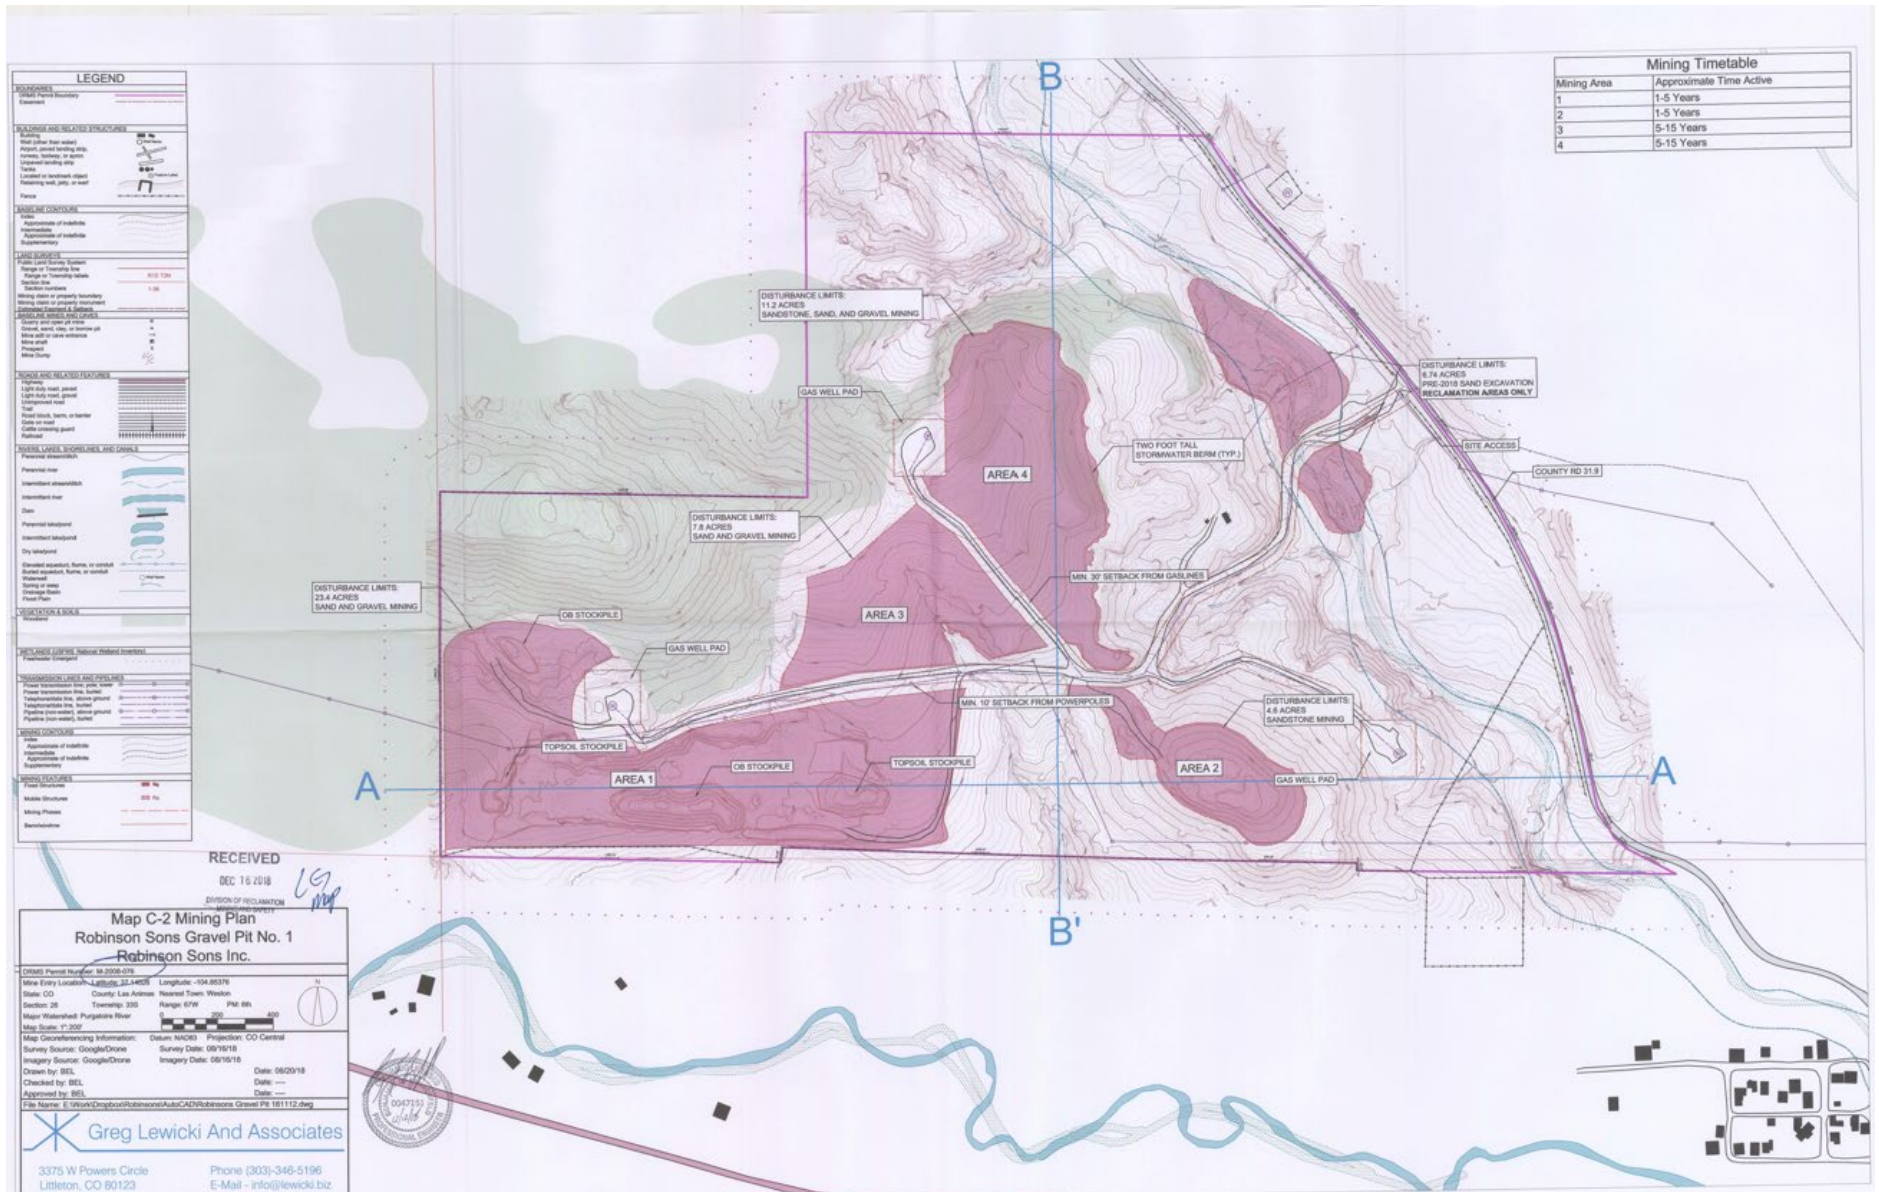
**Map 1:** Copy of the currently approved Mining Plan Map (Map C-2 approved with AM1).

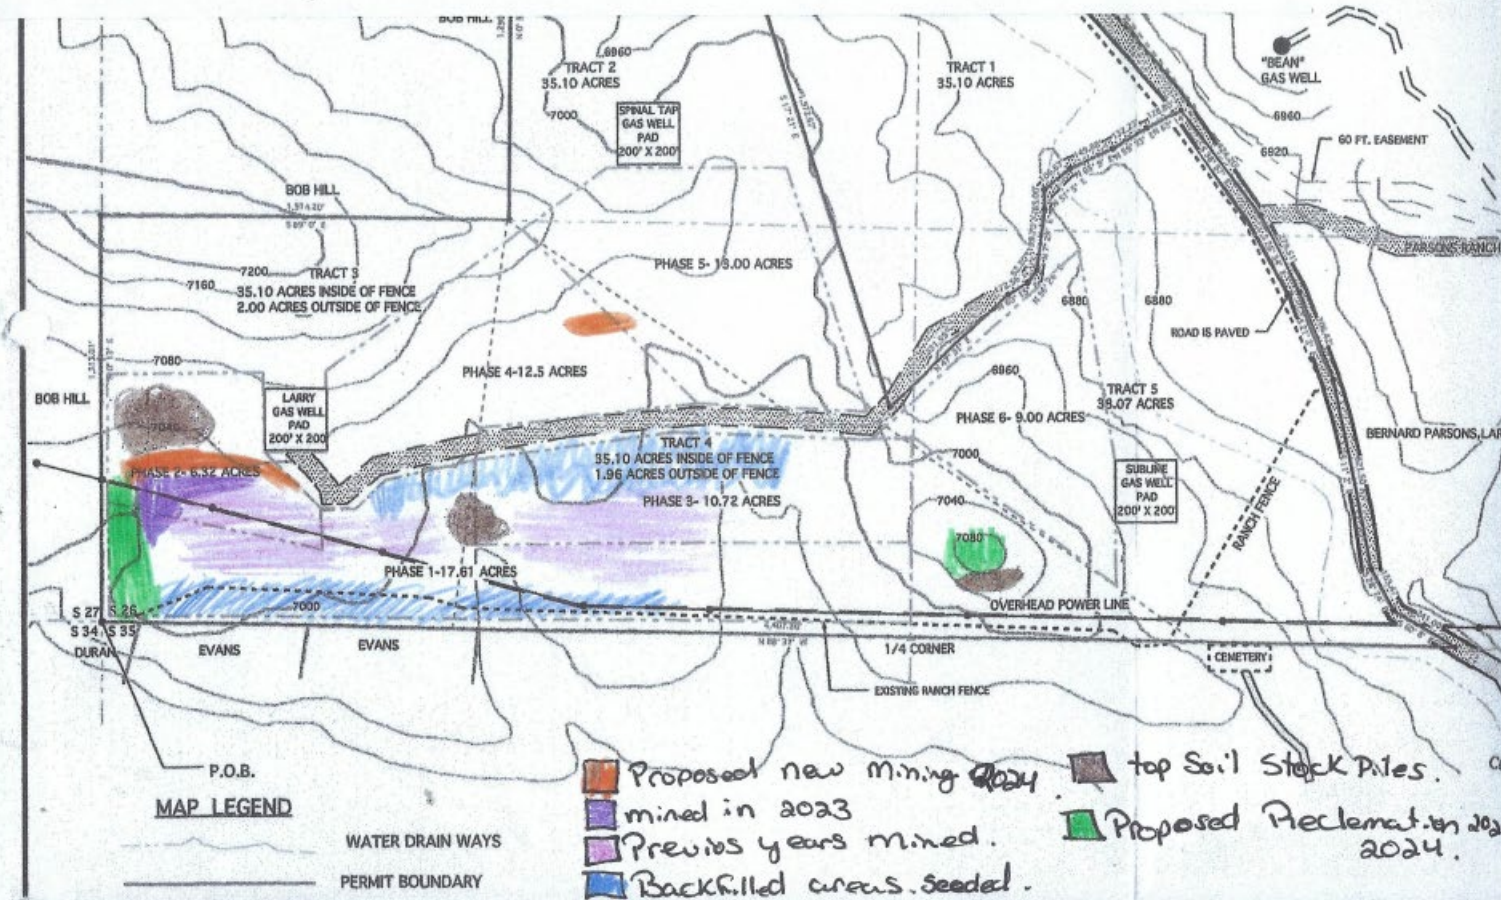
- *Area 3*
  - On the Operator's 2023 annual report map (see Map 2 within this report) an area within Area 3 was proposed for mining during 2024. During the inspection, the Division observed a small pit excavated within the area indicated on the map (Photos 19-21). The Operator stated that they may mine deeper within this pit if they can acquire a crusher strong enough to break up the material. If not, they'll haul the material that they have already excavated and use it as more rip-rap product.

**Map 2:** 2023 Report year annual report map submitted by the Operator on March 26, 2024. The base map image is from the original 112 application, before the re-configuration of the mining areas into the AM1 Areas (see Map 1 above), but the legend is still representative of the conditions in each area relative to the land.

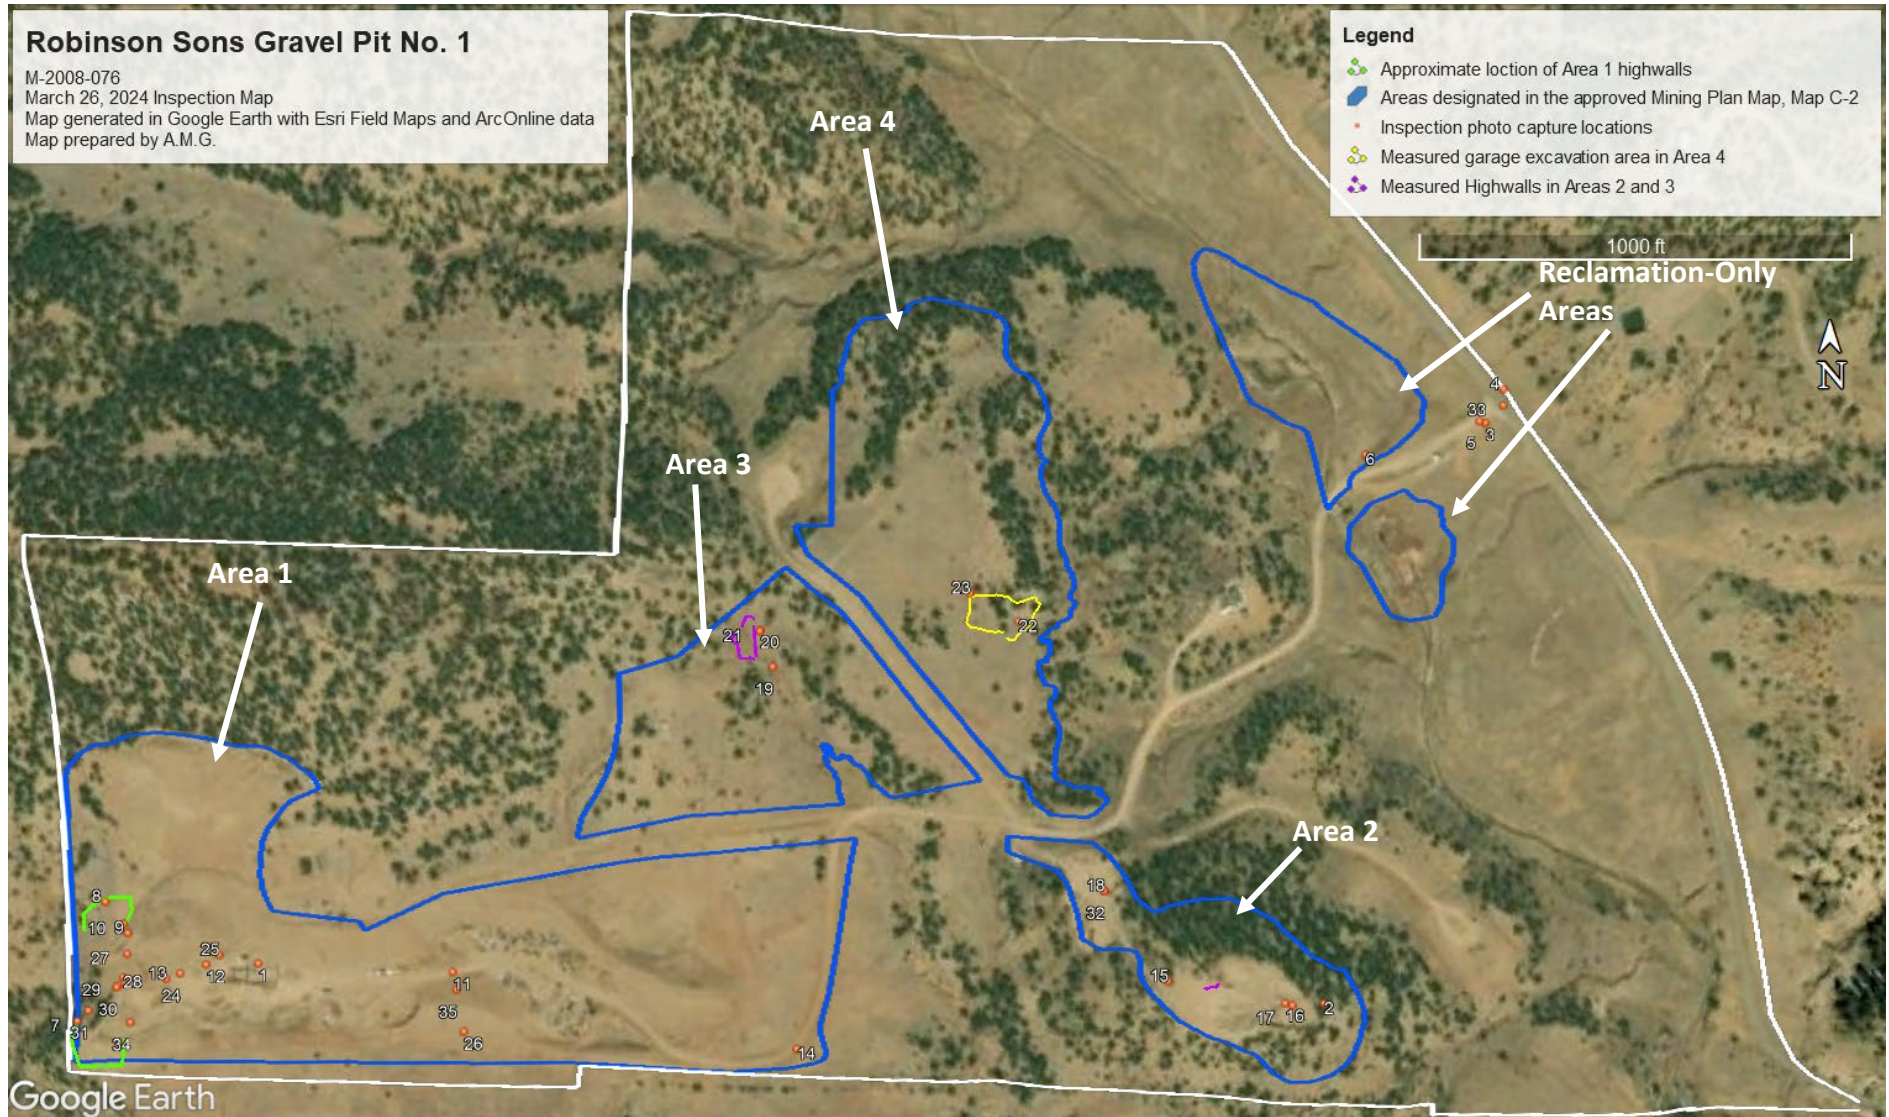
**Map 3:** Inspection Map for the March 26, 2024 inspection. The white polygon represents the approximate permit boundary. The Division walked the length of the highwalls in each Area (purple lines) during the inspection. However, the highwall measurements in Area 1 did not save, and thus the Division used aerial imagery, and the photo locations, to estimate the locations and length of the Area 1 highwalls. The garage excavation was also measured during the inspection (yellow lines) using Esri Field Maps. The Figure above was generated using Google Earth Pro, but the aerial imagery is imposed from Esri ArcOnline Imagery base maps, because the image reflects more recent conditions than the most recent available on Google Earth.
