COLORADO

MINERALS PROGRAM INSPECTION REPORT

MINE NAME: St. Barbara Sand and Gravel Mine	MINE/PROSPECTING ID#: M-2004-013	MINERAL: Sand and gravel	COUNTY: Pueblo
INSPECTION TYPE: Monitoring	WEATHER: Clear	INSP. DATE: March 19, 2024	INSP. TIME: 12:00
OPERATOR: Pete Lien & Sons, Inc.	OPERATOR REPRESENTATIVE: Duane Pollard	TYPE OF OPERATION: 112c - Construction Regular Operation

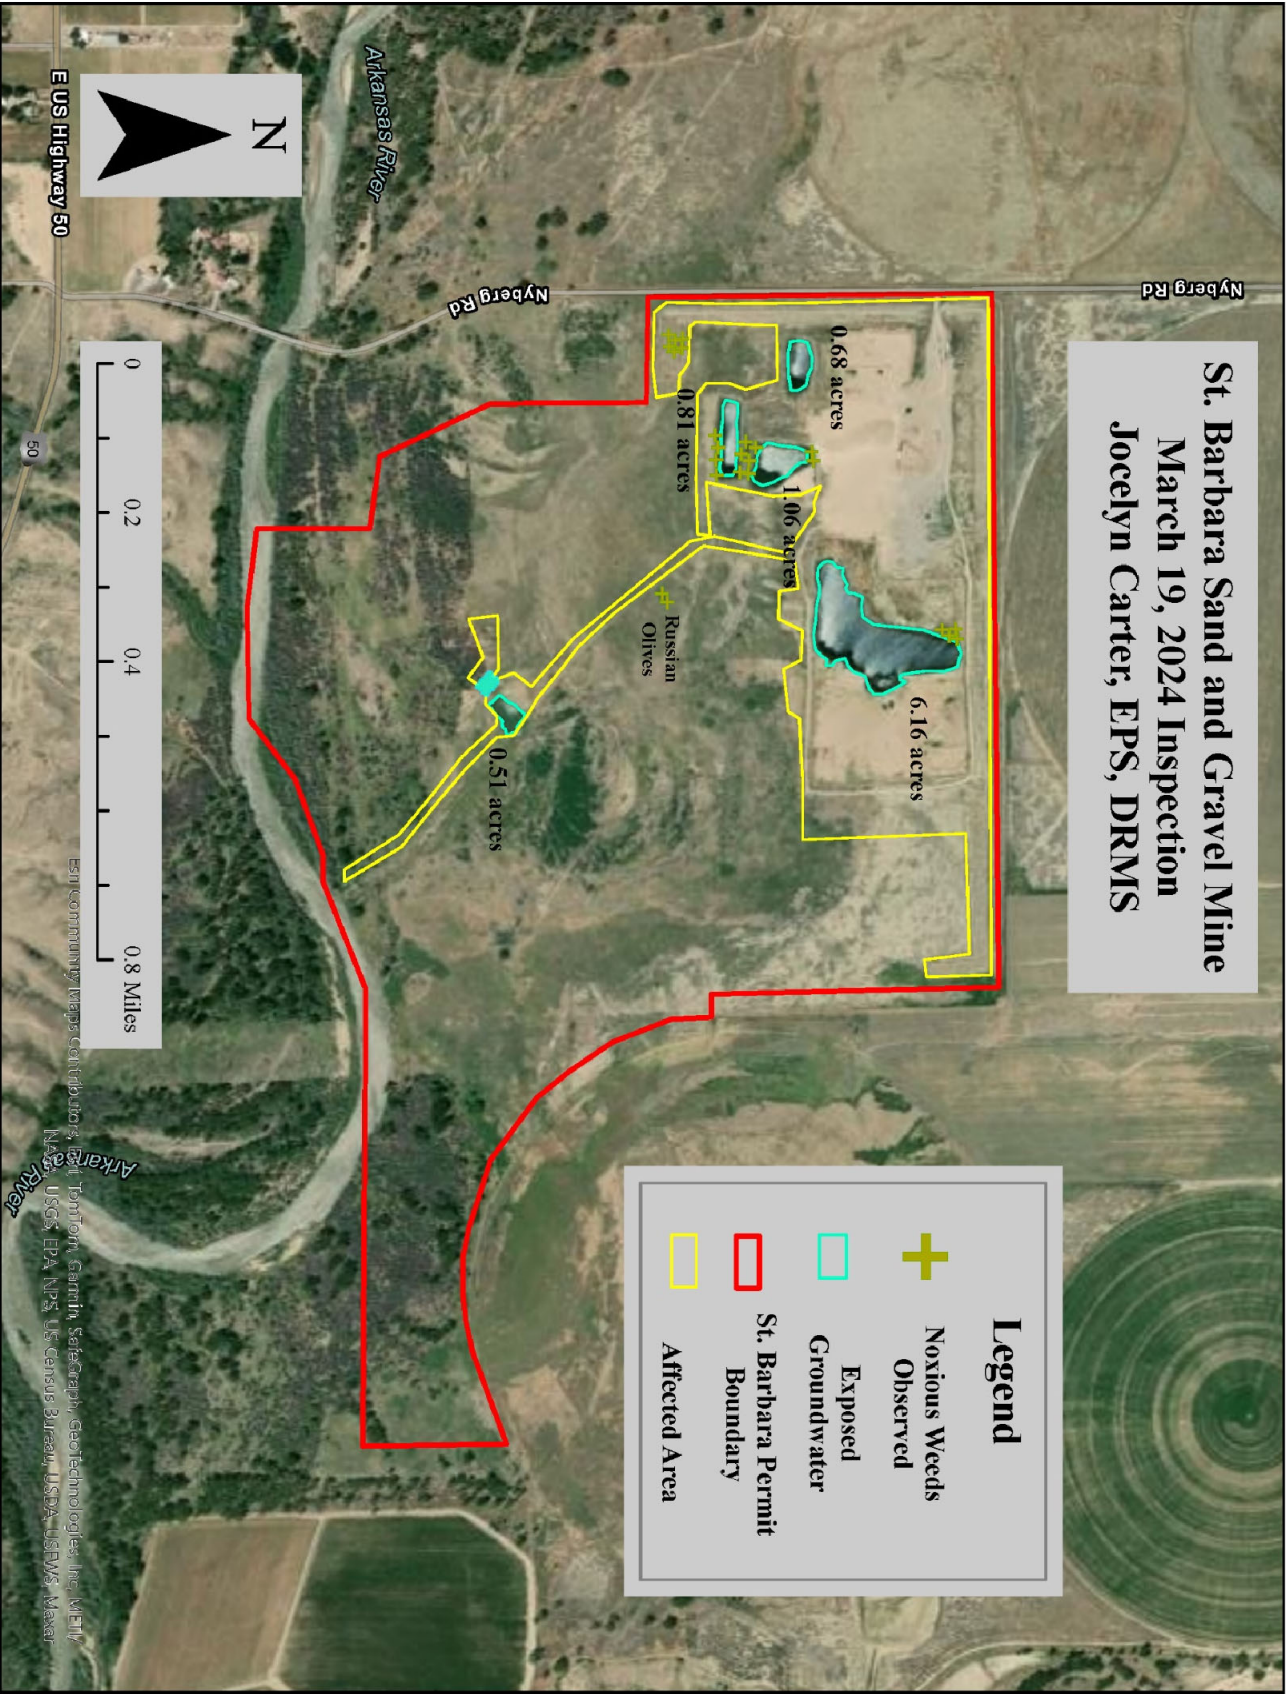
PROBLEM: There are state-listed noxious weeds present on site, tamarisk and Russian Olive trees were observed on site, both list B noxious weeds. This is a problem for failure to employ weed control methods for state listed noxious weed species within the permitted area, and to reduce the spread of weeds to nearby areas as required by Section 3.1.10 (6) of the rule.

Photo #16: Overburden stockpile located to the west of the settling pond; tamarisk has invaded this stockpiled material.
