MINERALS PROGRAM INSPECTION REPORT
PHONE: (303) 866-3567

MINE NAME: Lindsey Pit	MINE/PROSPECTING ID#: M-2013-015	MINERAL: Gravel	COUNTY: Phillips
INSPECTION TYPE: Monitoring	WEATHER: Cloudy	INSP. DATE: April 10, 2024	INSP. TIME: 12:00
OPERATOR: Mike L. Koellner dba L&L Ready Mix	OPERATOR REPRESENTATIVE: NA	TYPE OF OPERATION: 110c - Construction Limited Impact	
REASON FOR INSPECTION: Normal I&E Program	BOND CALCULATION TYPE: None	BOND AMOUNT: \$30,137.39	
DATE OF COMPLAINT: NA	POST INSP. CONTACTS: None	JOINT INSP. AGENCY: None	
INSPECTOR(S): Jocelyn Carter Jared Ebert	INSPECTOR'S SIGNATURE:

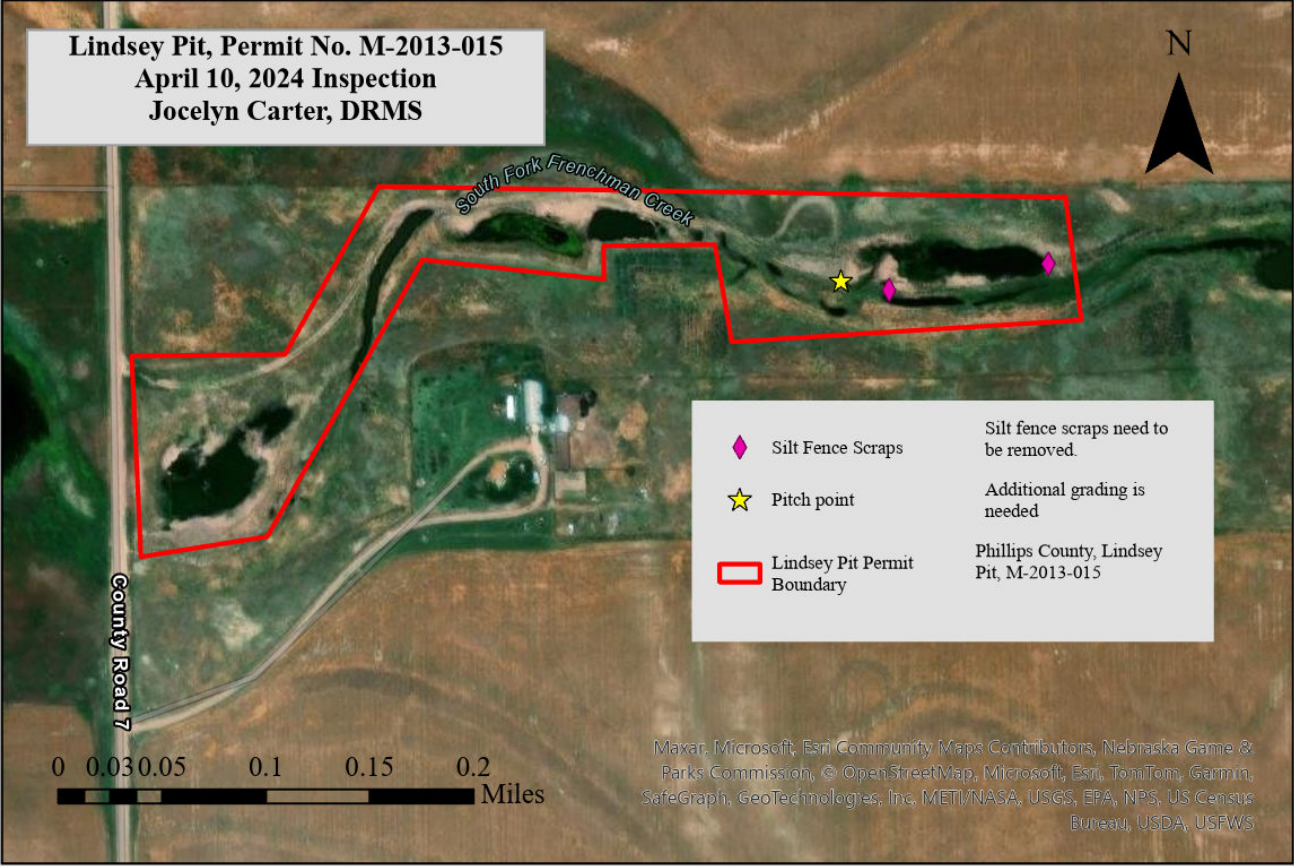
Photo #12: Pitch point/high spot on the south side of the creek and recently graded area, looking northeast, see map below.
