To: Jerald Schnabel  
Castle Aggregate  
File: March 2024 Monitoring Summary

**Reference: March 2024 Geotechnical Monitoring Summary Pikeview Quarry**

PIKEVIEW QUARRY SLOPE  
MONITORING

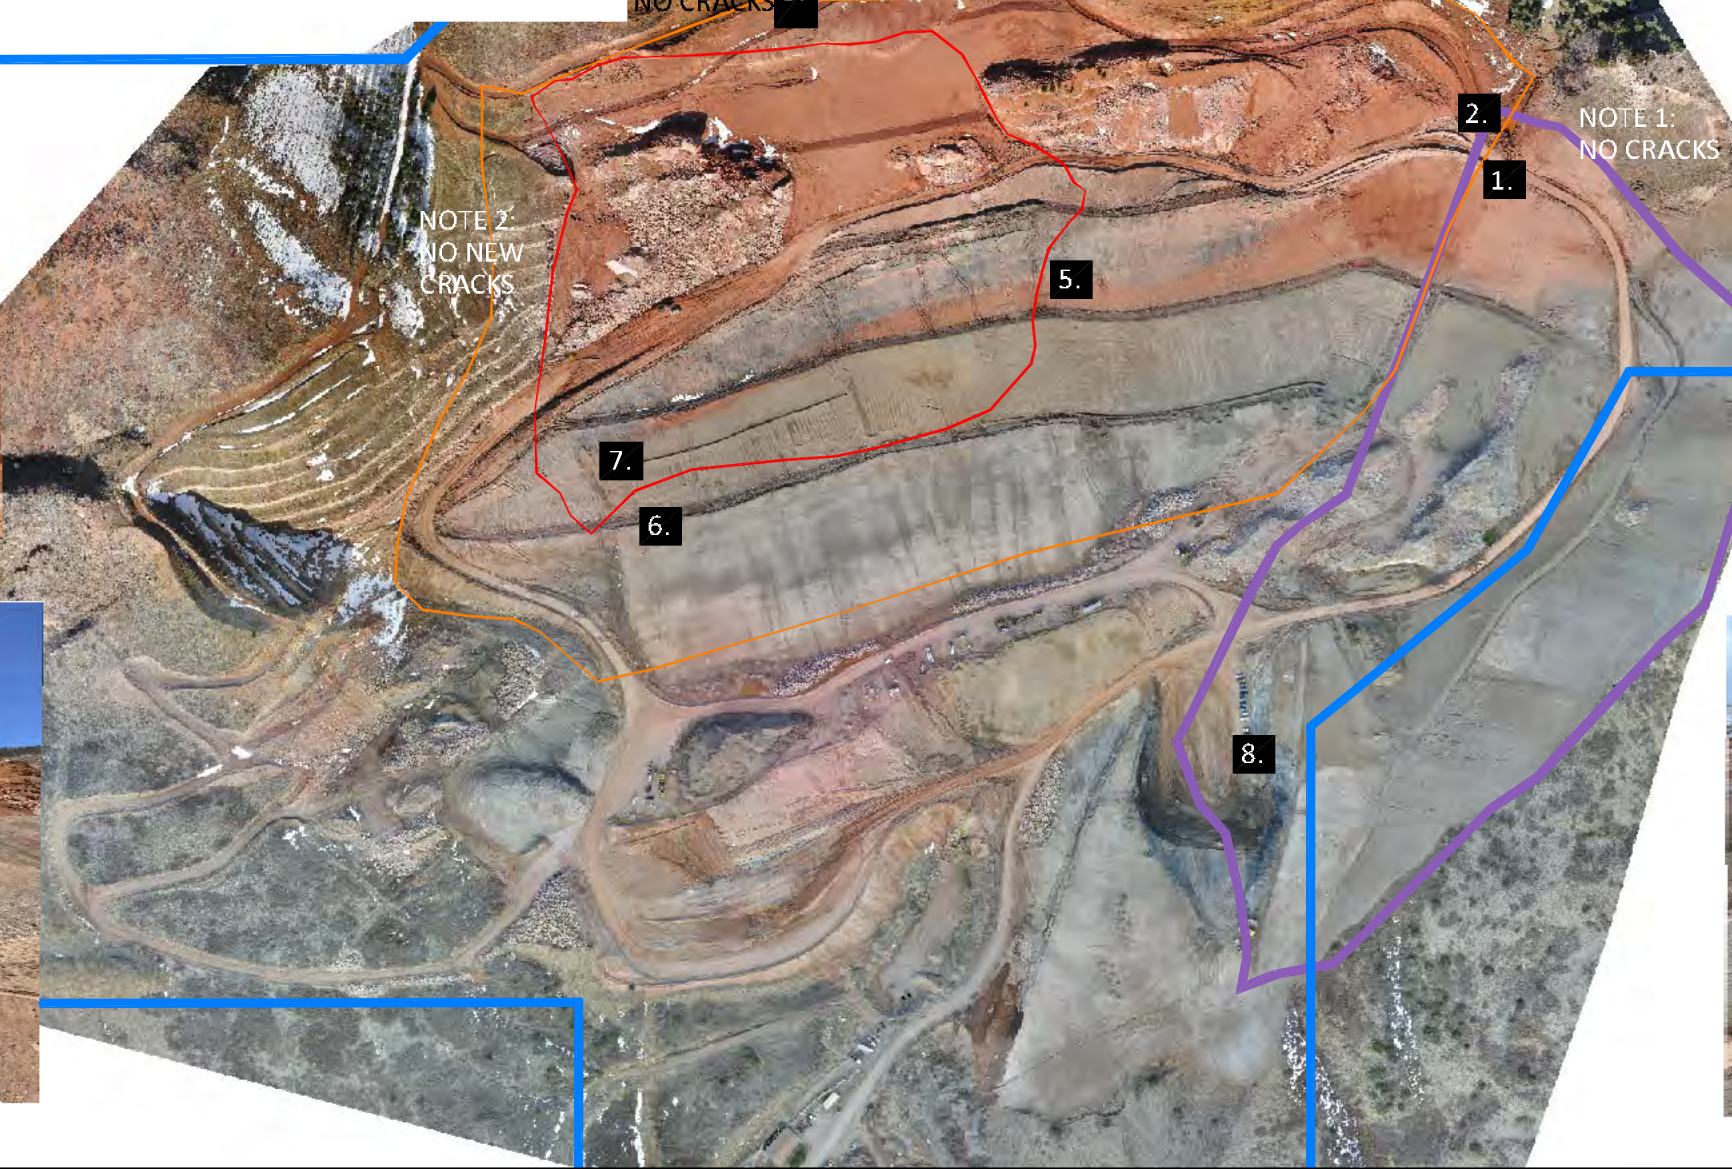
- Seepage was noted from the graded granite slopes. This seepage was observed in previous years and is expected to occur each spring.
- A safety buffer zone is being kept between the active work areas and the toe of the slide to stop any rocks that might come loose during grading operations. Compacted fill is placed in the buffer zone as the buttress fill is placed.

7. SEEPAGE ALONG HAUL ROAD CUT.

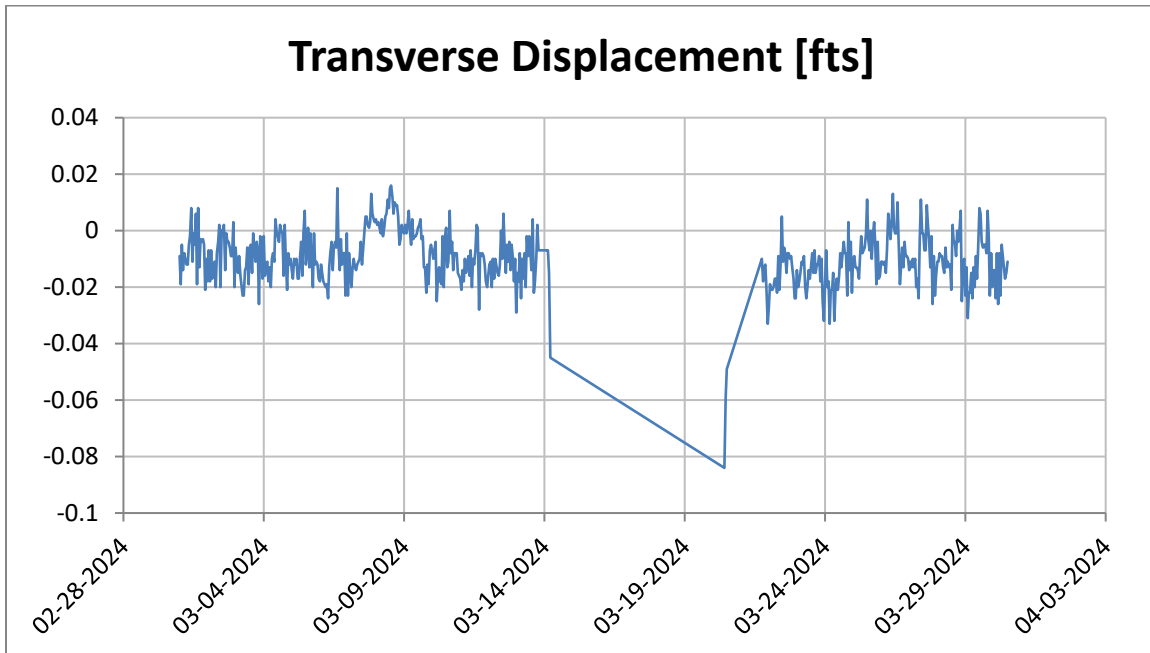
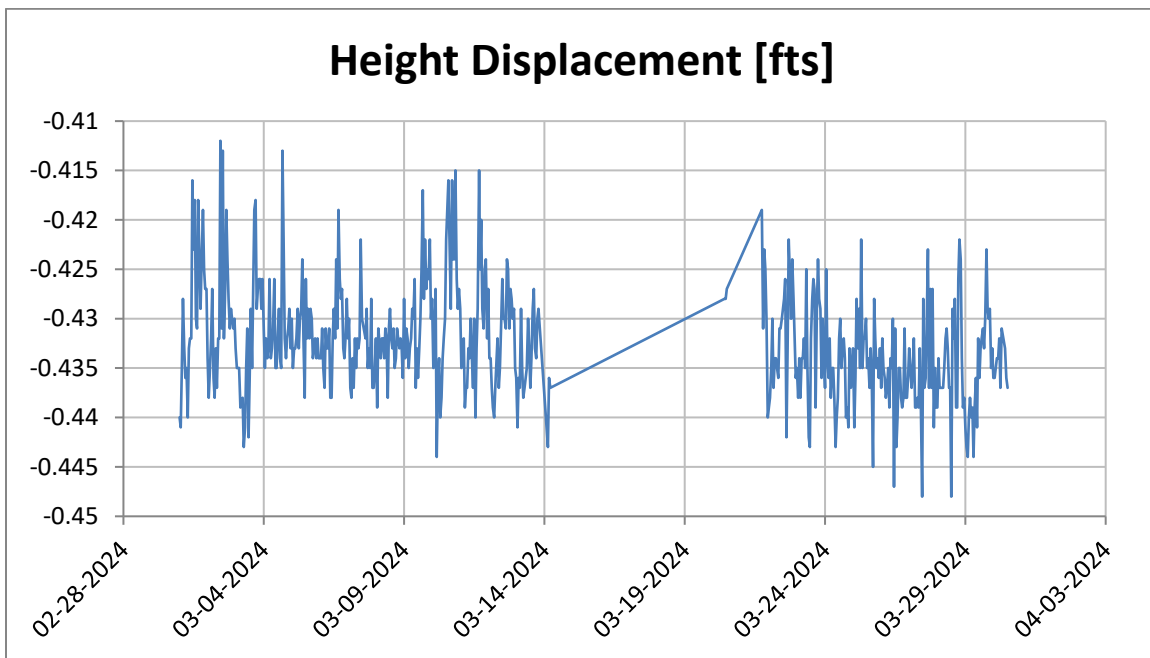
## Prism BR1

1. Survey accuracy is +/-0.016 feet.
2. Alert threshold is +/-0.35 feet.
3. Transverse displacement is in the horizontal direction. Positive direction means closer to the robotic total station.
4. Height displacement is in the vertical direction. Positive direction means higher in elevation.
5. Prism previously recorded slope creep movements.
6. A power outage prevented readings from March 13 to March 21.

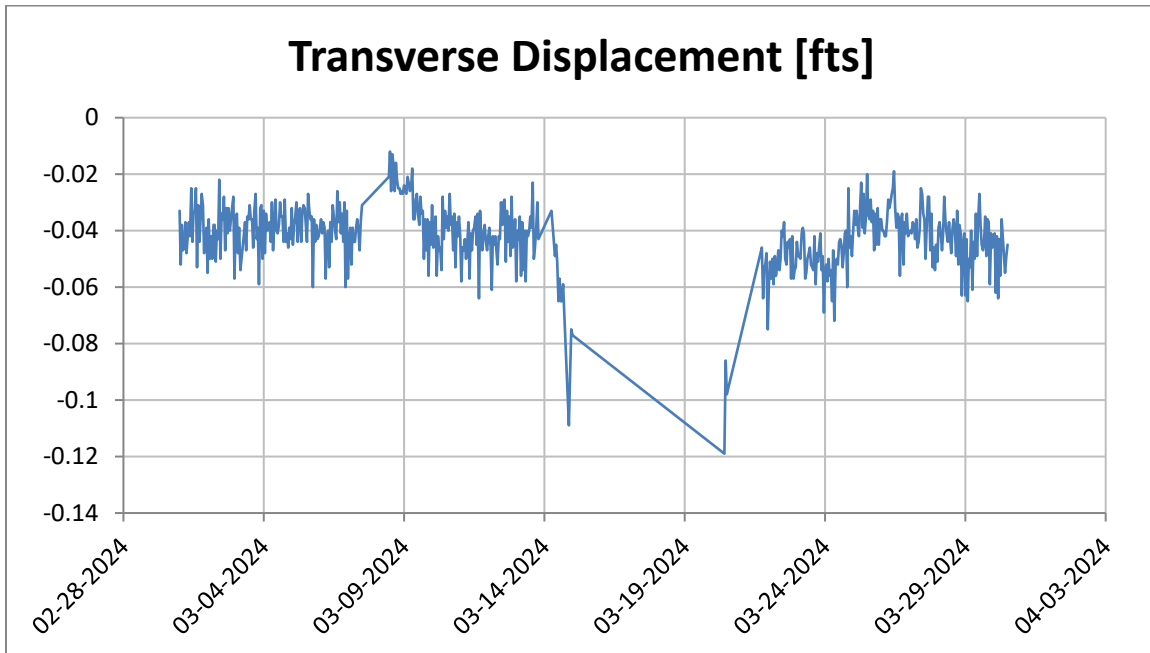
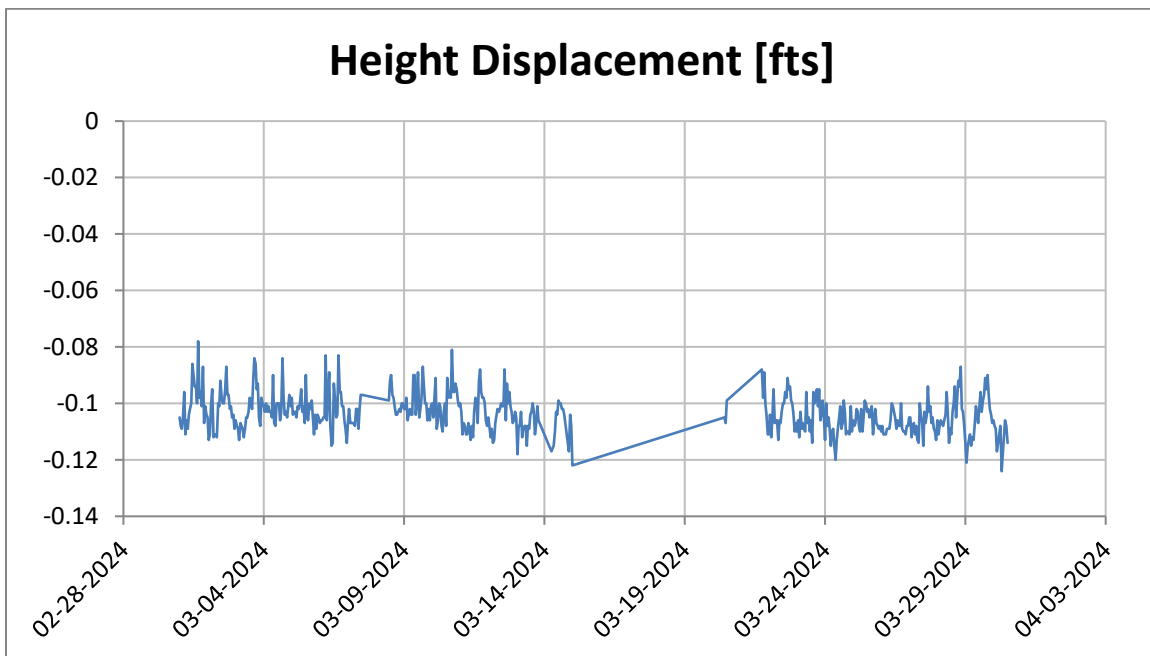
## Prism BR3

1. Survey accuracy is +/-0.016 feet.
2. Alert threshold is +/-0.35 feet.
3. Transverse displacement is in the horizontal direction. Positive direction means closer to the robotic total station.
4. Height displacement is in the vertical direction. Positive direction means higher in elevation.
5. Prism previously recorded slope creep movements.
6. A power outage prevented readings from March 13 to March 21.

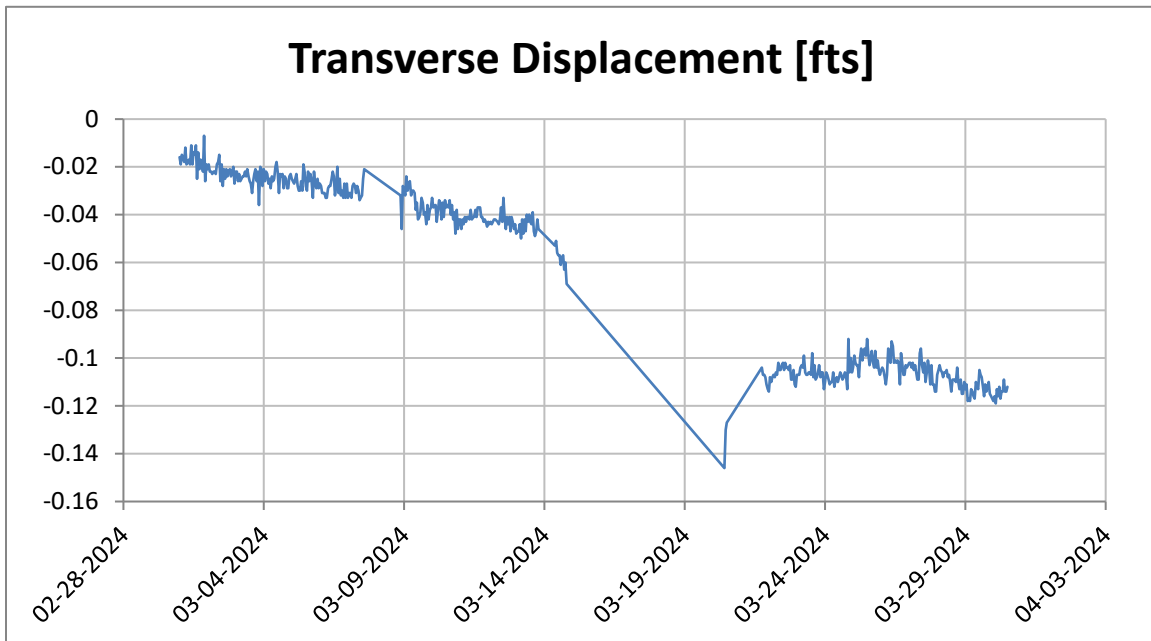
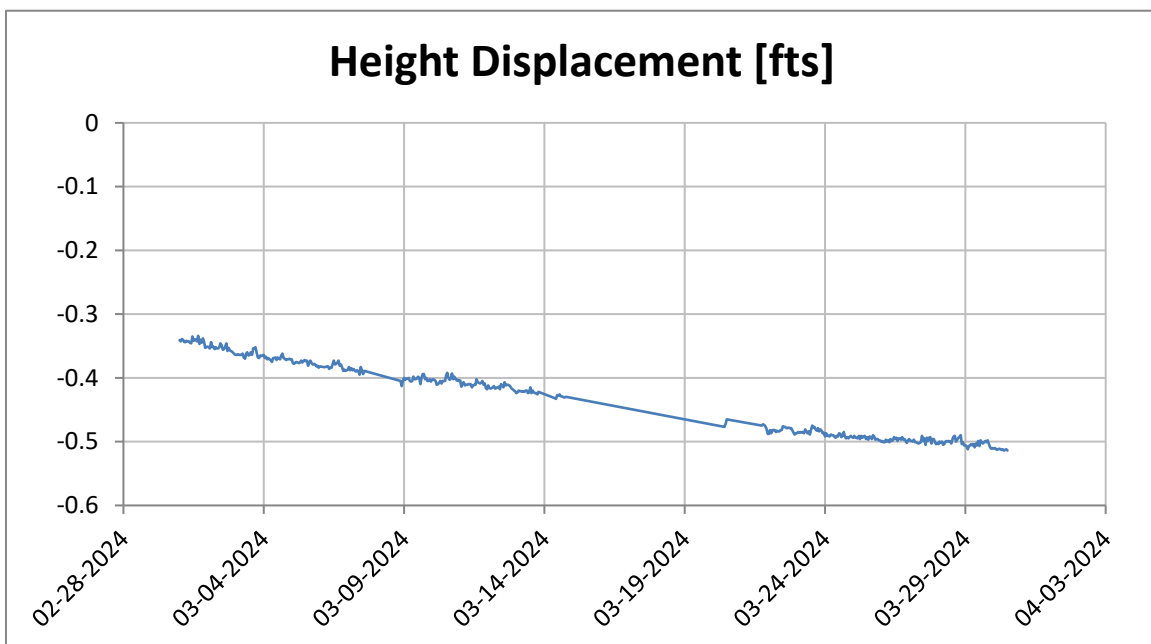
## Prism B7400-1

1. Survey accuracy is +/-0.016 feet.
2. Alert threshold is +/-0.35 feet.
3. Transverse displacement is in the horizontal direction. Positive direction means closer to the robotic total station.
4. Height displacement is in the vertical direction. Positive direction means higher in elevation.
5. Movement believed to be settlement of the compacted fill.
6. A power outage prevented readings from March 13 to March 21.

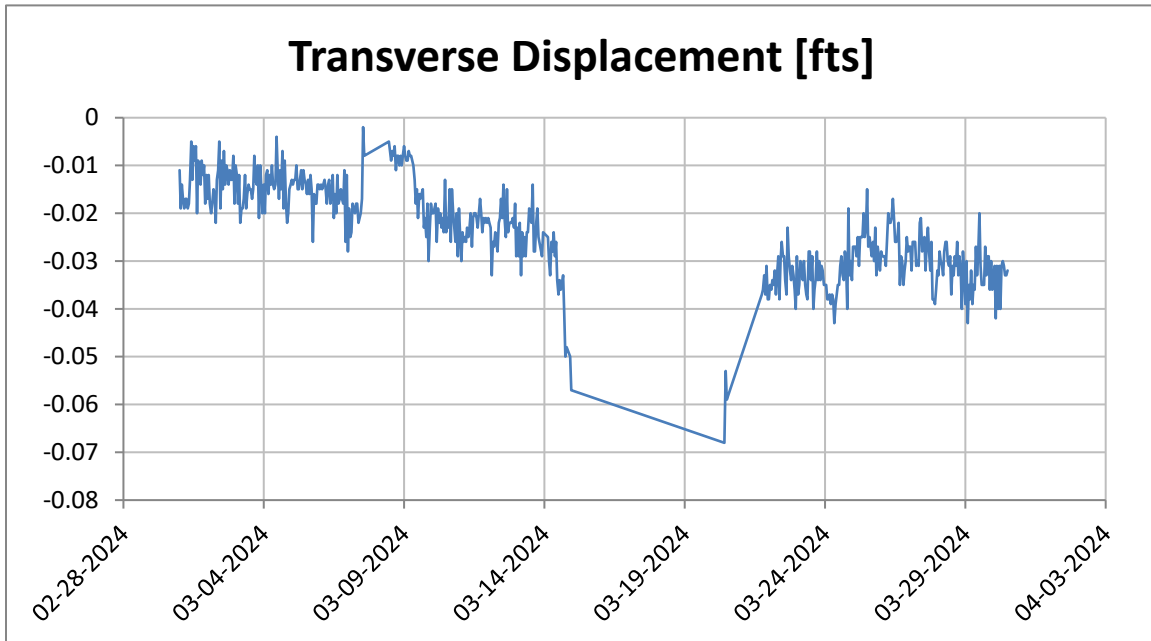
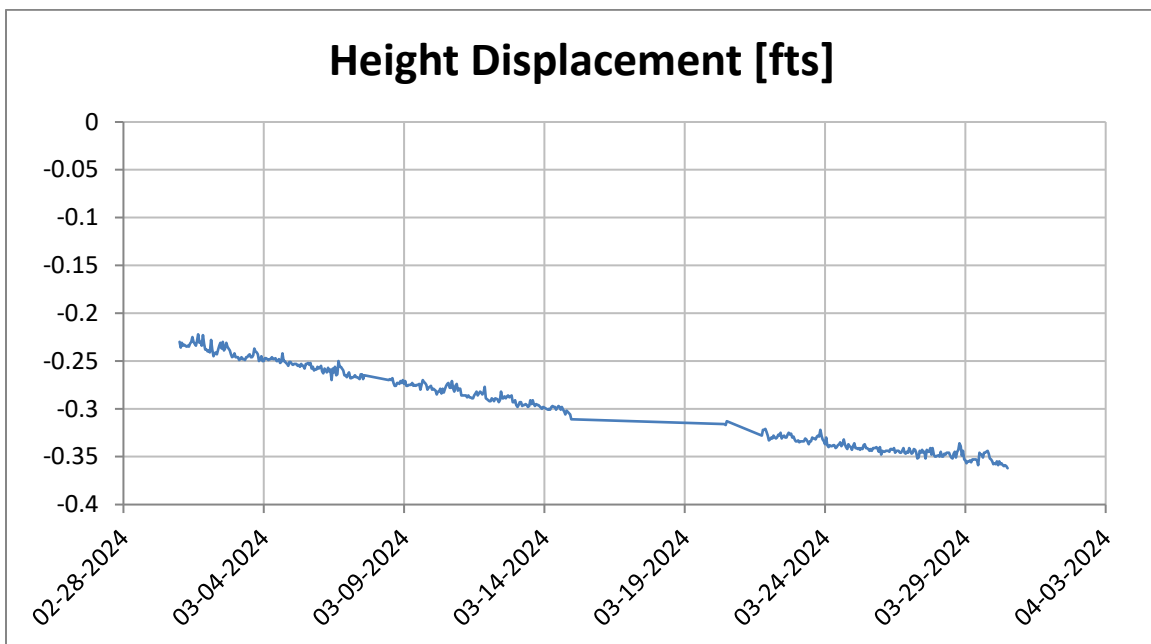
## Prism B7400-2

1. Survey accuracy is  $\pm 0.016$  feet.
2. Alert threshold is  $\pm 0.35$  feet.
3. Transverse displacement is in the horizontal direction. Positive direction means closer to the robotic total station.
4. Height displacement is in the vertical direction. Positive direction means higher in elevation.
5. Movement believed to be settlement of the compacted fill.
6. A power outage prevented readings from March 13 to March 21.

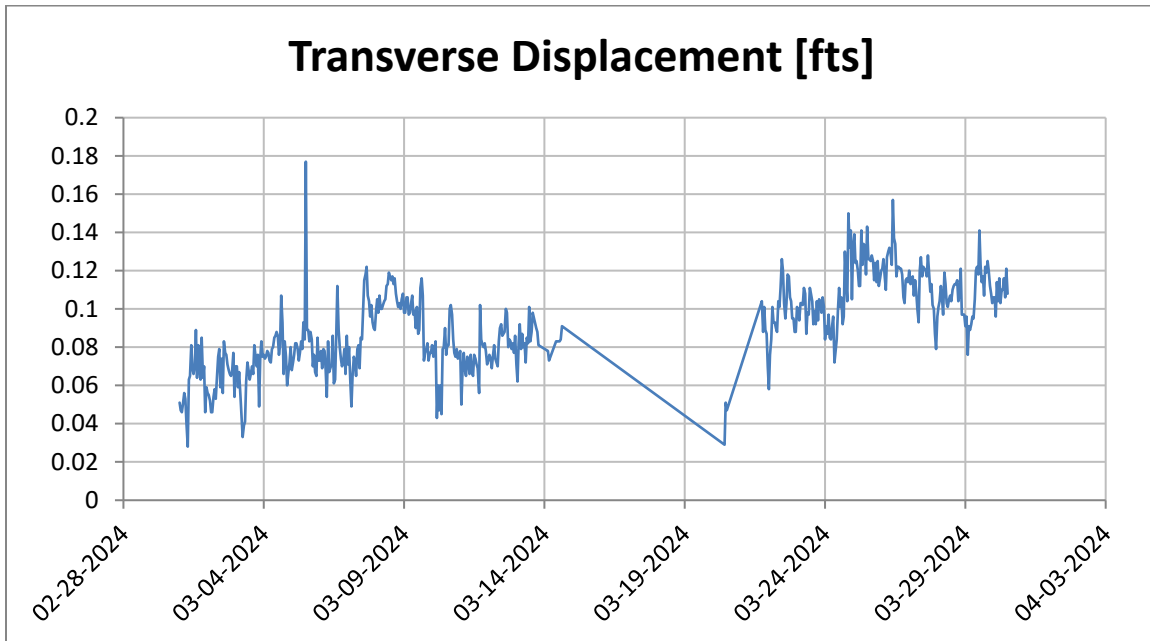
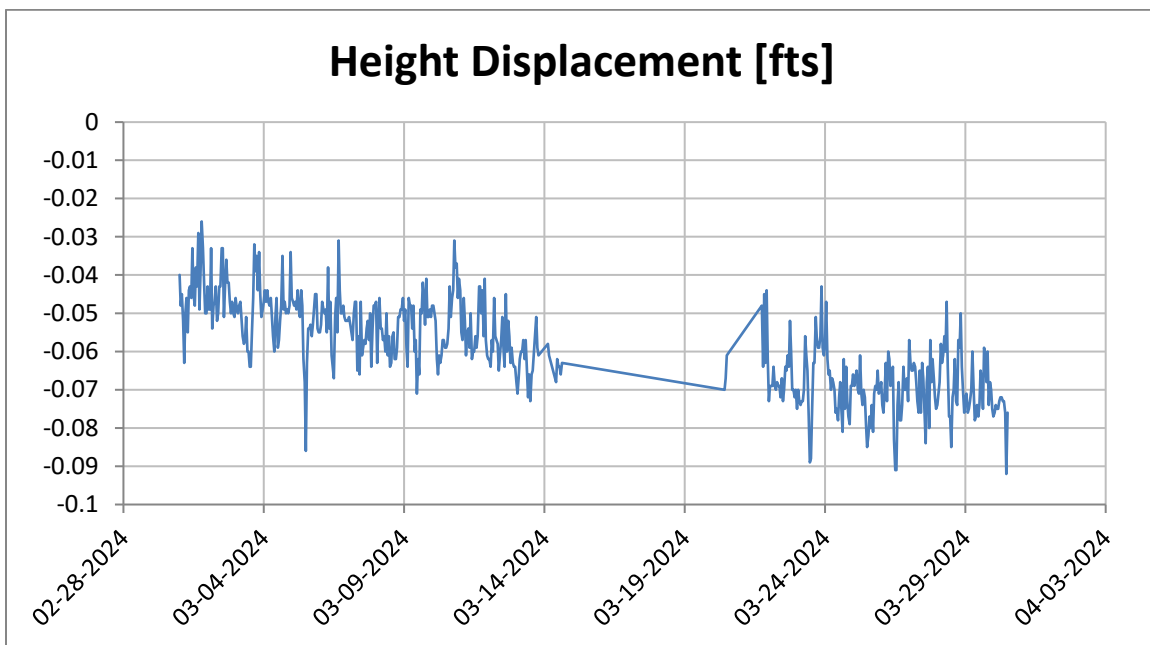
## Prism B7400-5

1. Survey accuracy is  $\pm 0.016$  feet.
2. Alert threshold is  $\pm 0.35$  feet.
3. Transverse displacement is in the horizontal direction. Positive direction means closer to the robotic total station.
4. Height displacement is in the vertical direction. Positive direction means higher in elevation.
5. Settle of compacted fill recorded in early March.
6. A power outage prevented readings from March 13 to March 21.

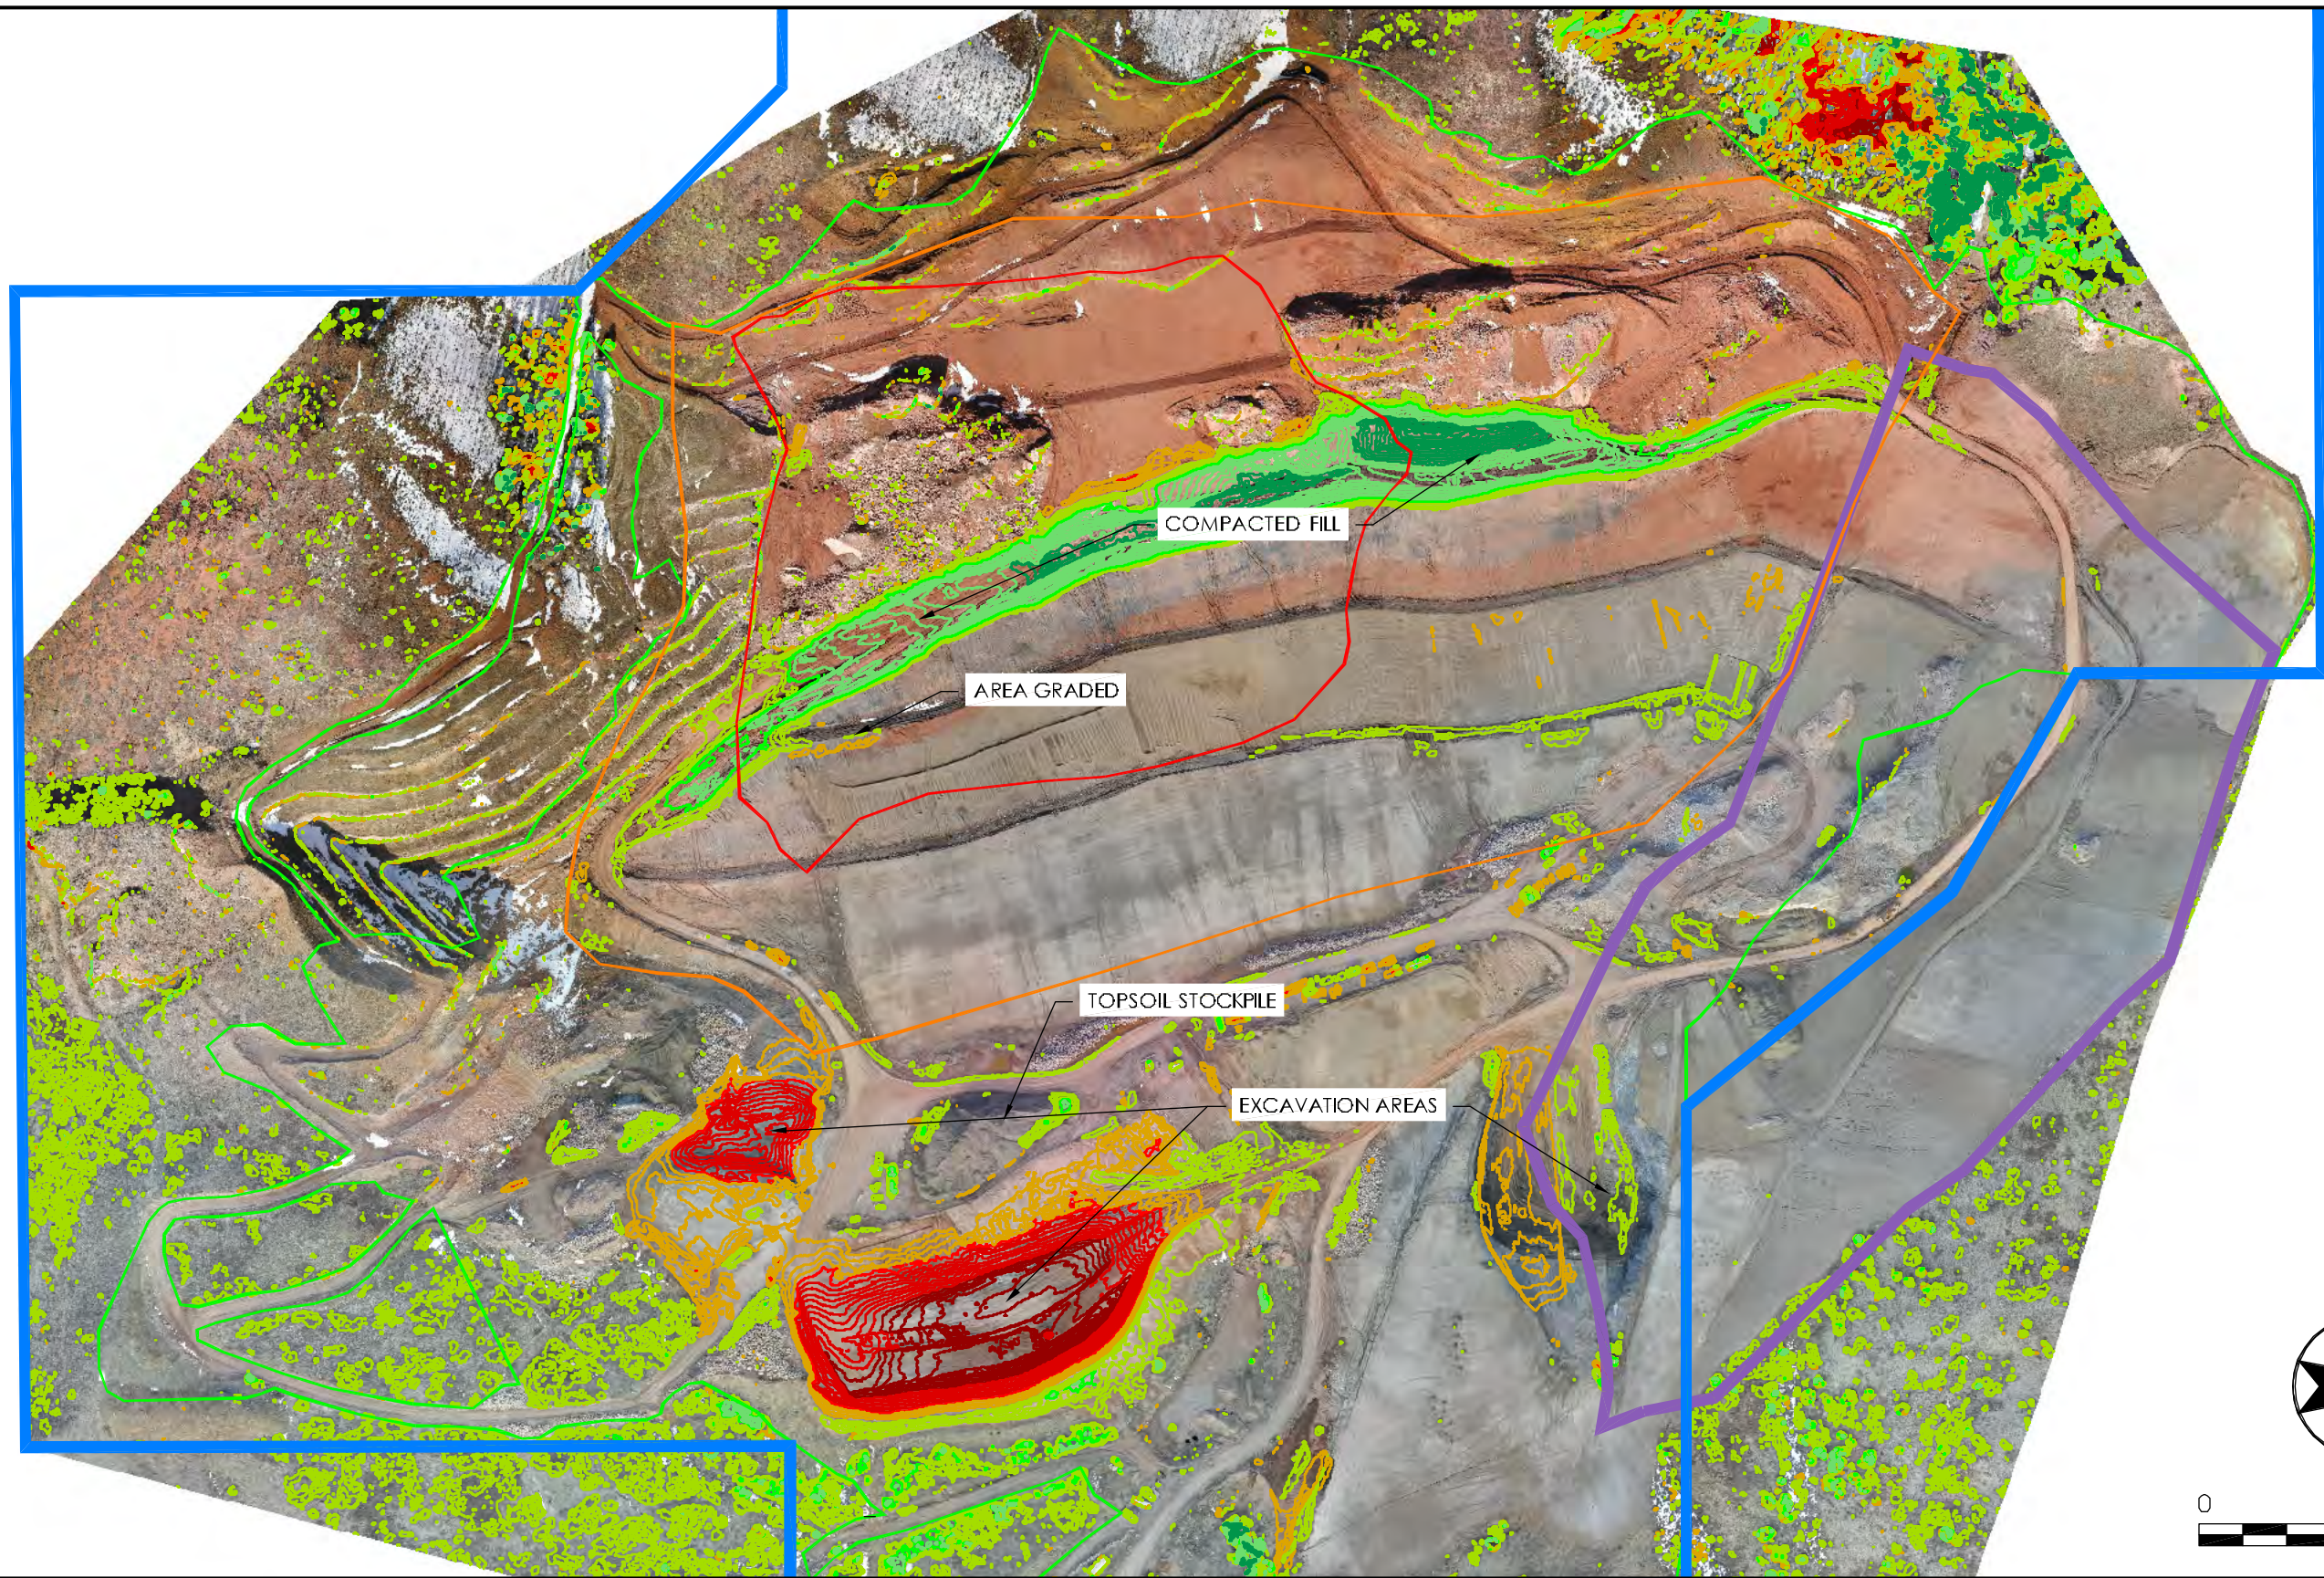
1. COMPARISON OF DRONE FLIGHTS FROM  
02/28/2024 TO 03/28/2024

The site was flown for aerial imagery using an unmanned aircraft system (UAS or 'drone') on March 28, 2024. The imagery was inspected for signs of instability and used to supplement the onsite visual inspections. Features noted in the aerial imagery review were inspected during Stantec's engineering inspection and are summarized in Section 2 above. The imagery was also used to create site topography.

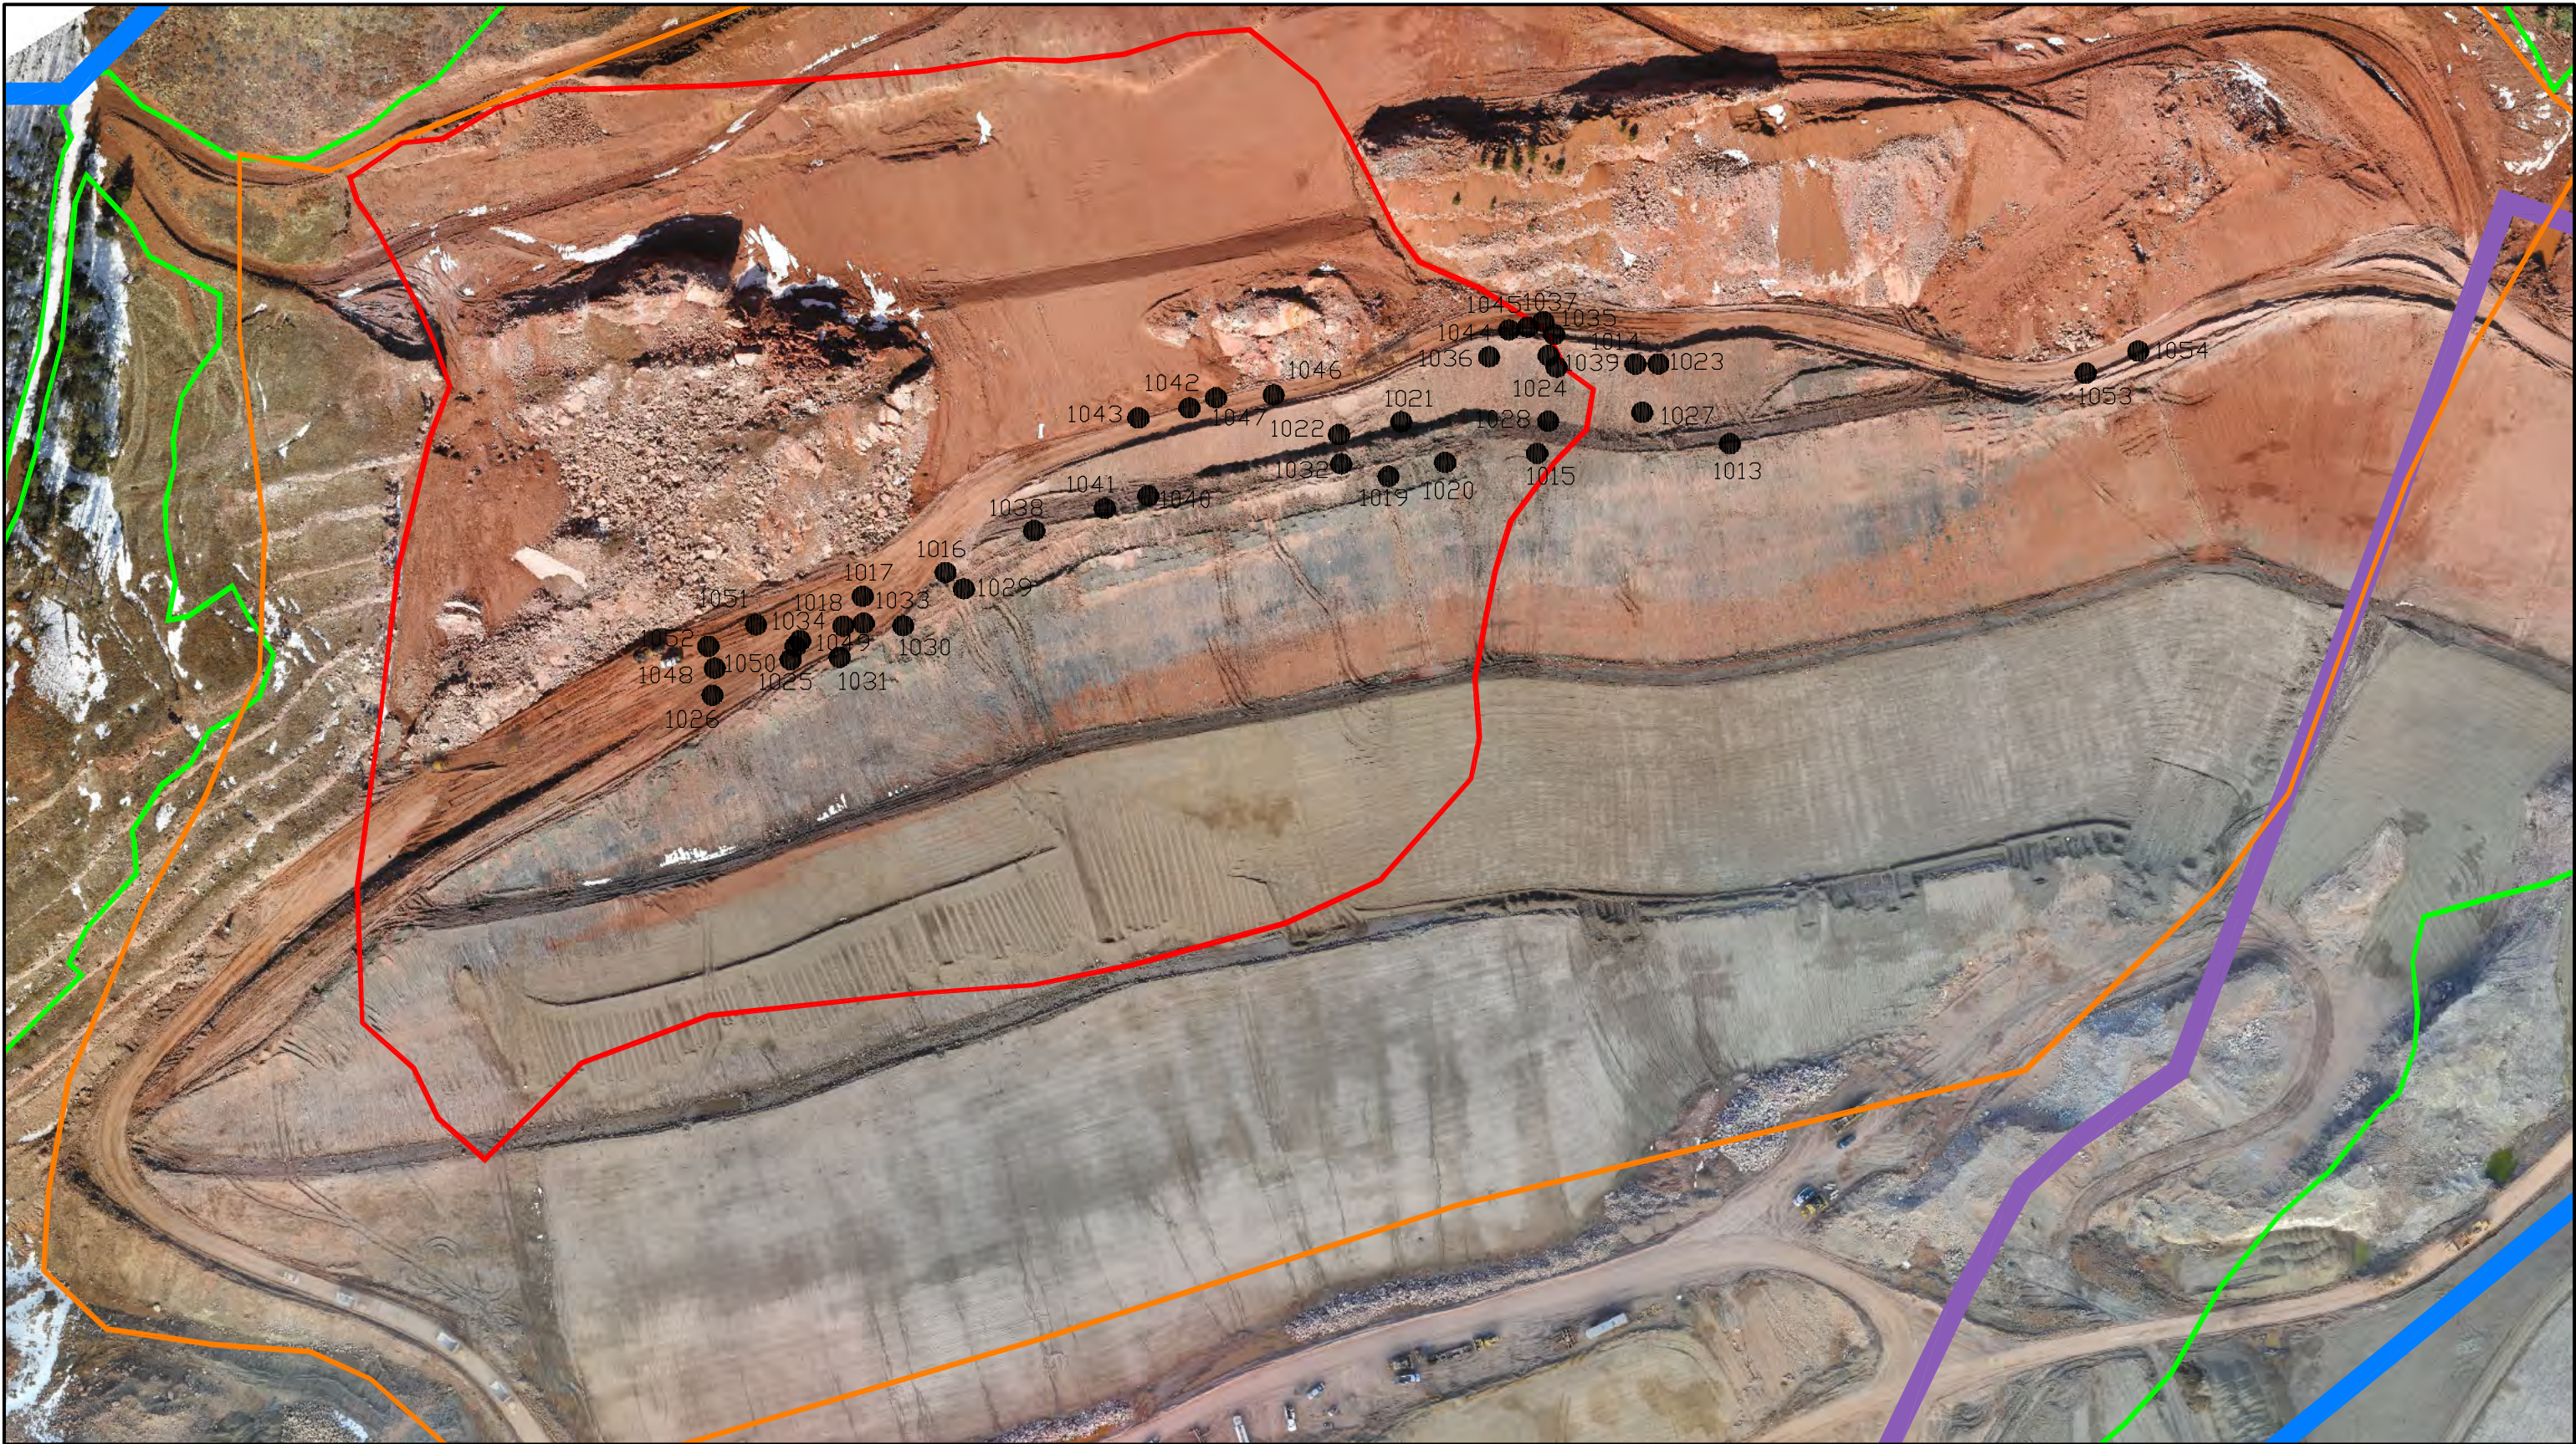
Fill placement occurred from February 2022 through June 2023 and from September 2023 to present. In the month of March 2024, a total of 172,000 yd<sup>3</sup> of material were placed and compacted on the buttress floor. All this material was from the Lower Borrow, Shop, and South Borrow Areas and was hauled to the buttress floor. All fill is moisture conditioned as necessary and then compacted. Compaction testing occurs at the rate of at least one test per 5,000 yd<sup>3</sup> placed. This volume placed in the buttress zone required at least 35 compaction tests. There were 42 compaction tests taken in March. As of March 28, 2024, when the site was surveyed, a total of approximately 3,249,000 yd<sup>3</sup> had been placed and compacted. This required at least 650 compaction tests, and 1,258 tests have been taken.

1. THERE WAS NO TEST 1012.
