MINERALS PROGRAM INSPECTION REPORT
PHONE: (303) 866-3567

MINE NAME: Larson Pit	MINE/PROSPECTING ID#: M-2007-012	MINERAL: Gravel, sand and clay	COUNTY: Phillips
INSPECTION TYPE: Monitoring	WEATHER: Cloudy	INSP. DATE: April 10, 2024	INSP. TIME: 10:00
OPERATOR: Gregory Larson	OPERATOR REPRESENTATIVE: Gregory Larson	TYPE OF OPERATION: 112c - Construction Regular Operation	
REASON FOR INSPECTION: Normal I&E Program	BOND CALCULATION TYPE: None	BOND AMOUNT: \$28,889.00	
DATE OF COMPLAINT: NA	POST INSP. CONTACTS: None	JOINT INSP. AGENCY: None	
INSPECTOR(S): Jocelyn Carter Jared Ebert	INSPECTOR'S SIGNATURE:

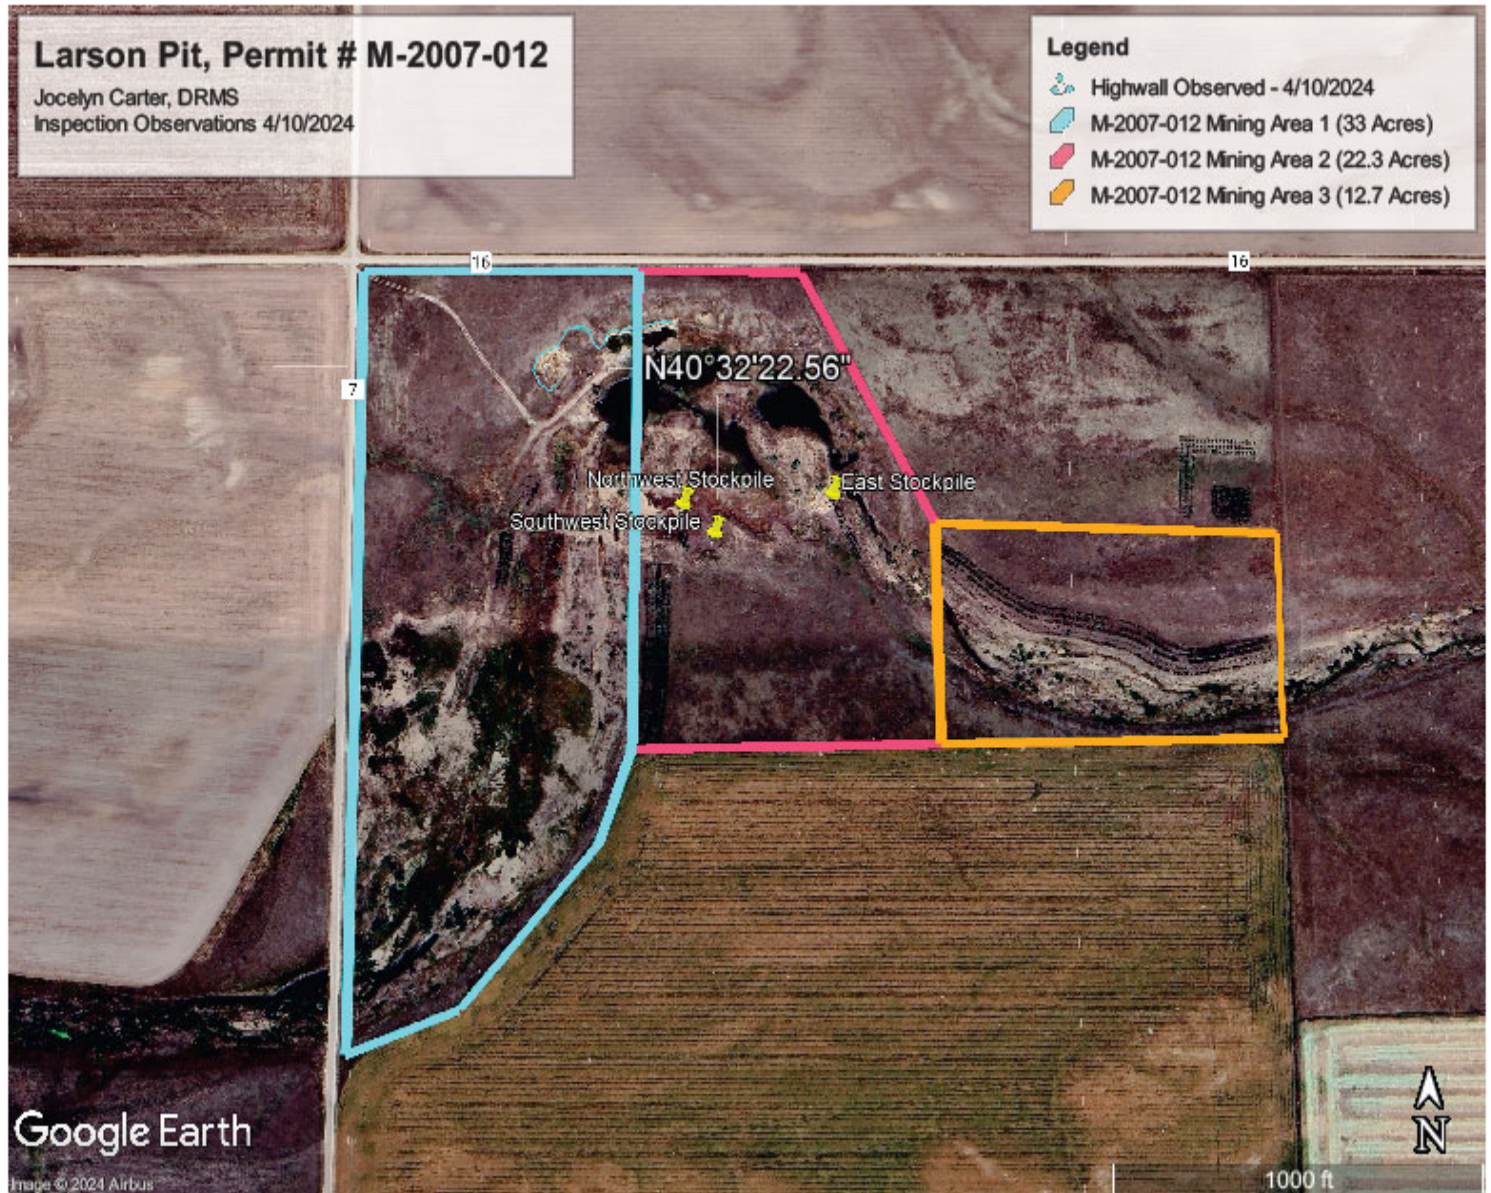
Map created using the most recent aerial image from Google Earth from 9/23/2023. This image does not depict the disturbance that was observed along the north side of the ox bow in Area #1 that was observed during the inspection.
