To: Jerald Schnabel  
Castle Aggregate  
File: April 2024 Monitoring Summary

From: Paul Kos  
Denver, CO 80202  
Date: May 20, 2024

**Reference: April 2024 Geotechnical Monitoring Summary Pikeview Quarry**

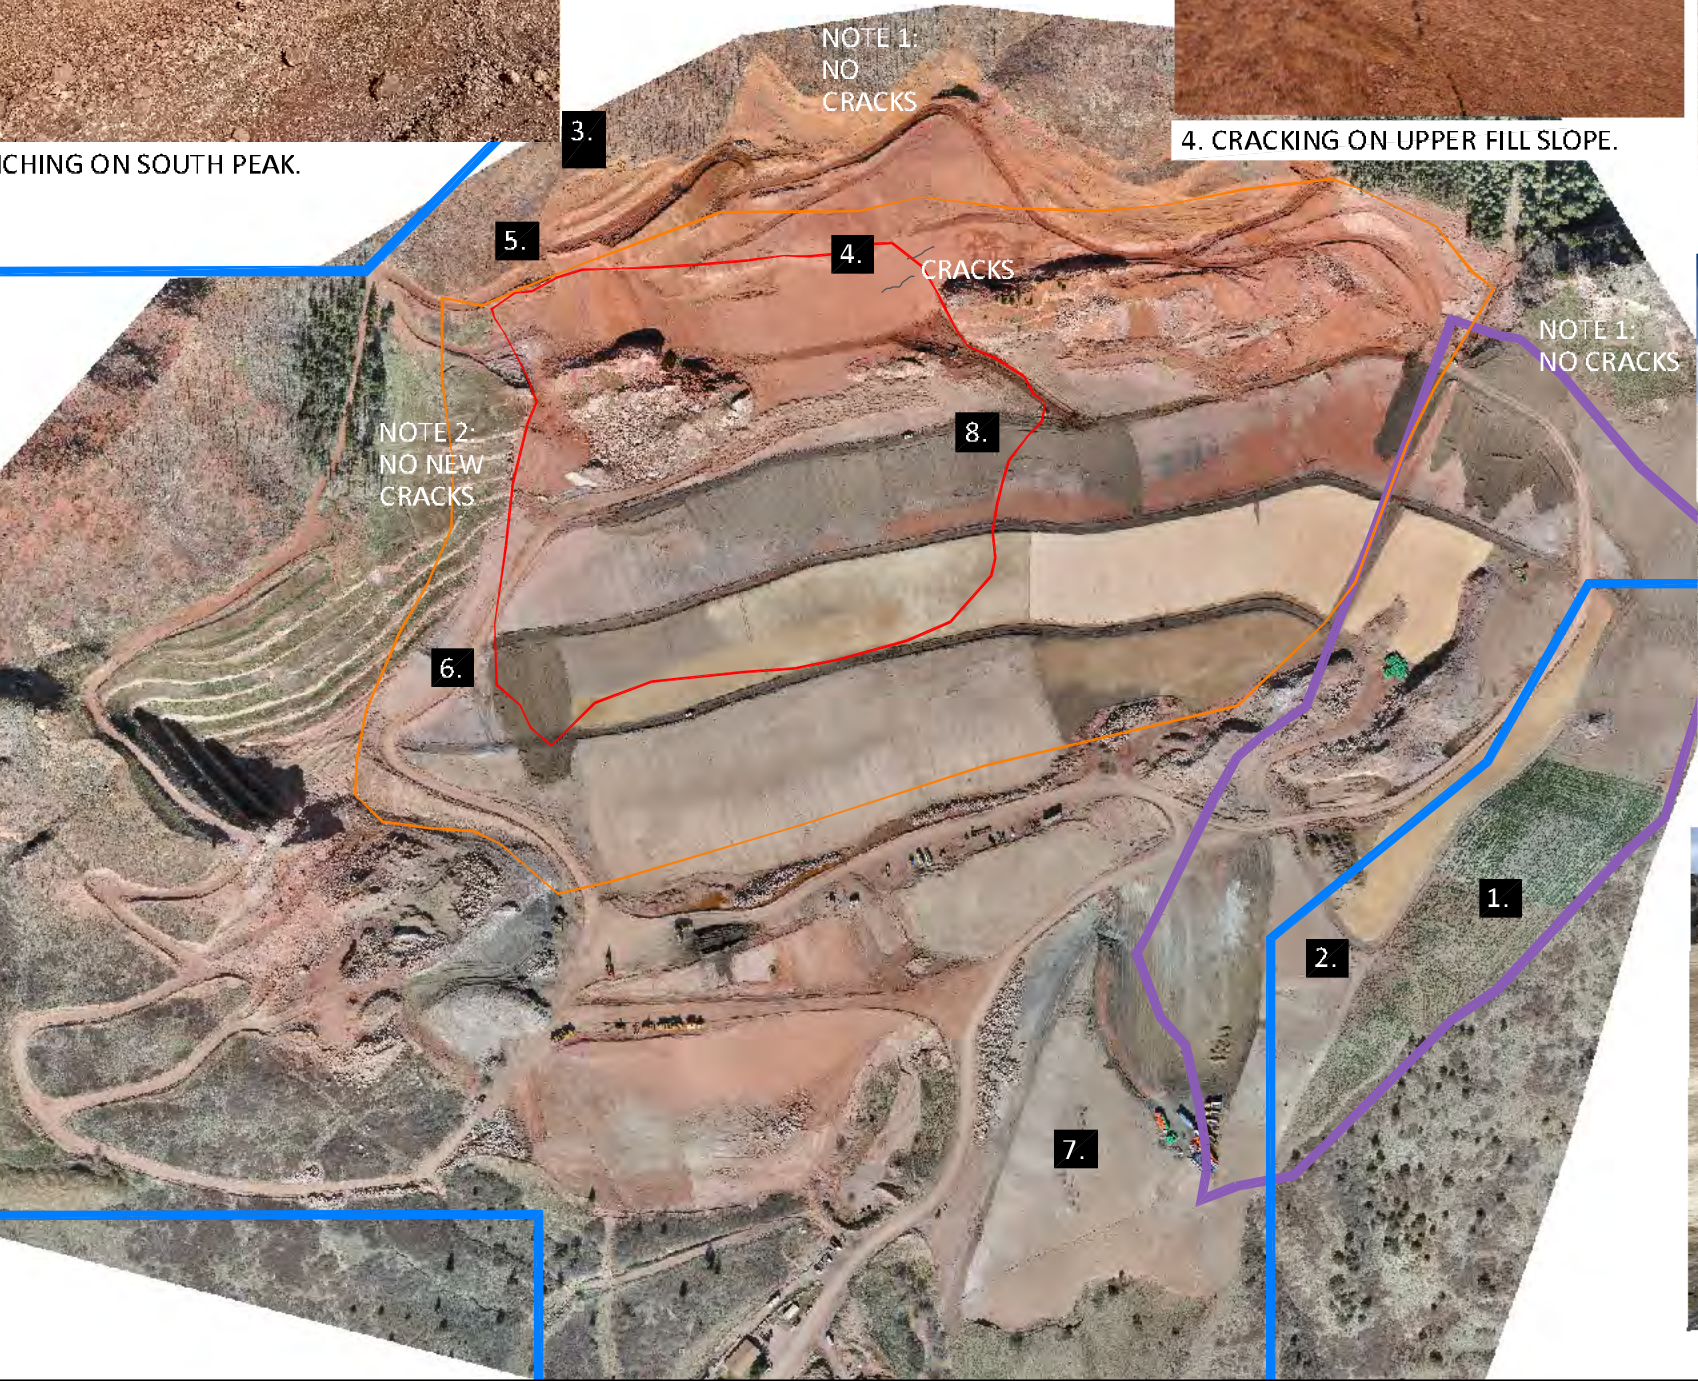
2. GROWTH MEDIUM WITH GRASS ON NORTH SLOPE.

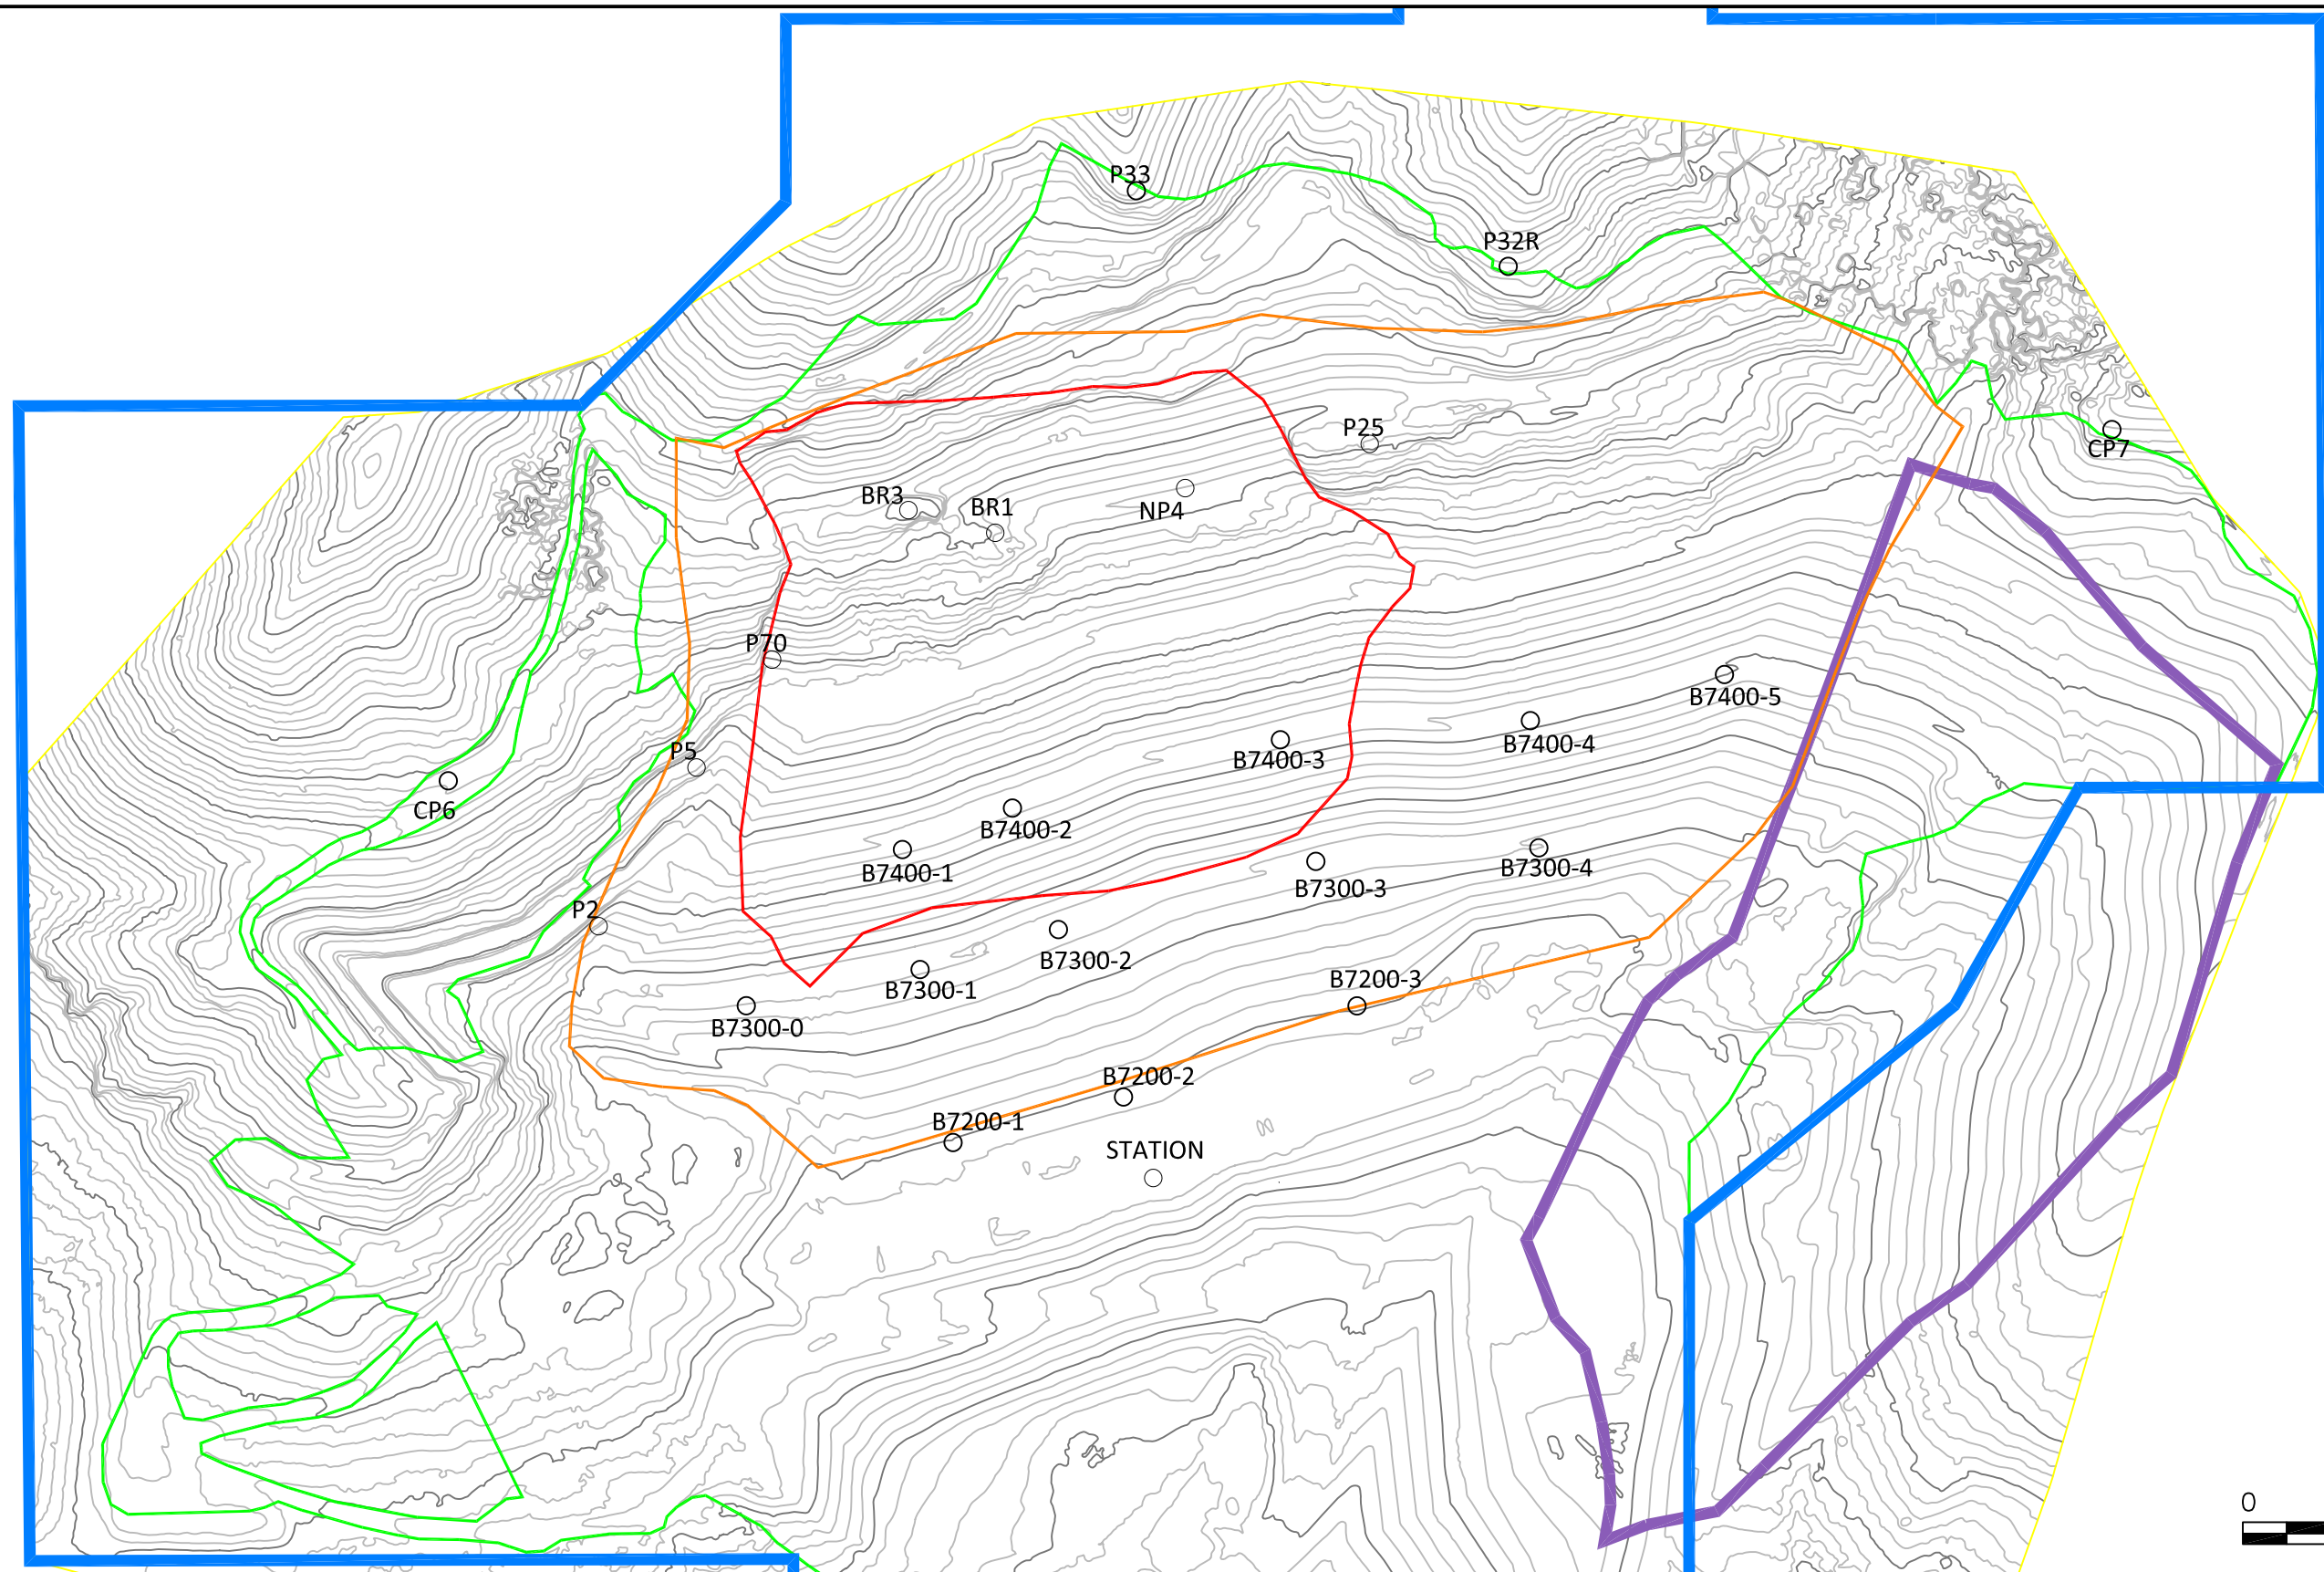
| Drawn By PK | Figure No. 3 |

The April topography was also compared to the March topography to identify changes in the site topography. Comparison of the two surveys showed the placement of the fill material at the toe of the landslide. Fill material was primarily excavated from the Lower Borrow and South Borrow Areas and placed in the Buttress Area. No slope movements or other changes in topography were identified. No slope movements were recorded in the area where cracking was observed. The current imagery and topography are included in Figures 1 and 3, and the comparison surface is included as Figure 5 in Appendix C.

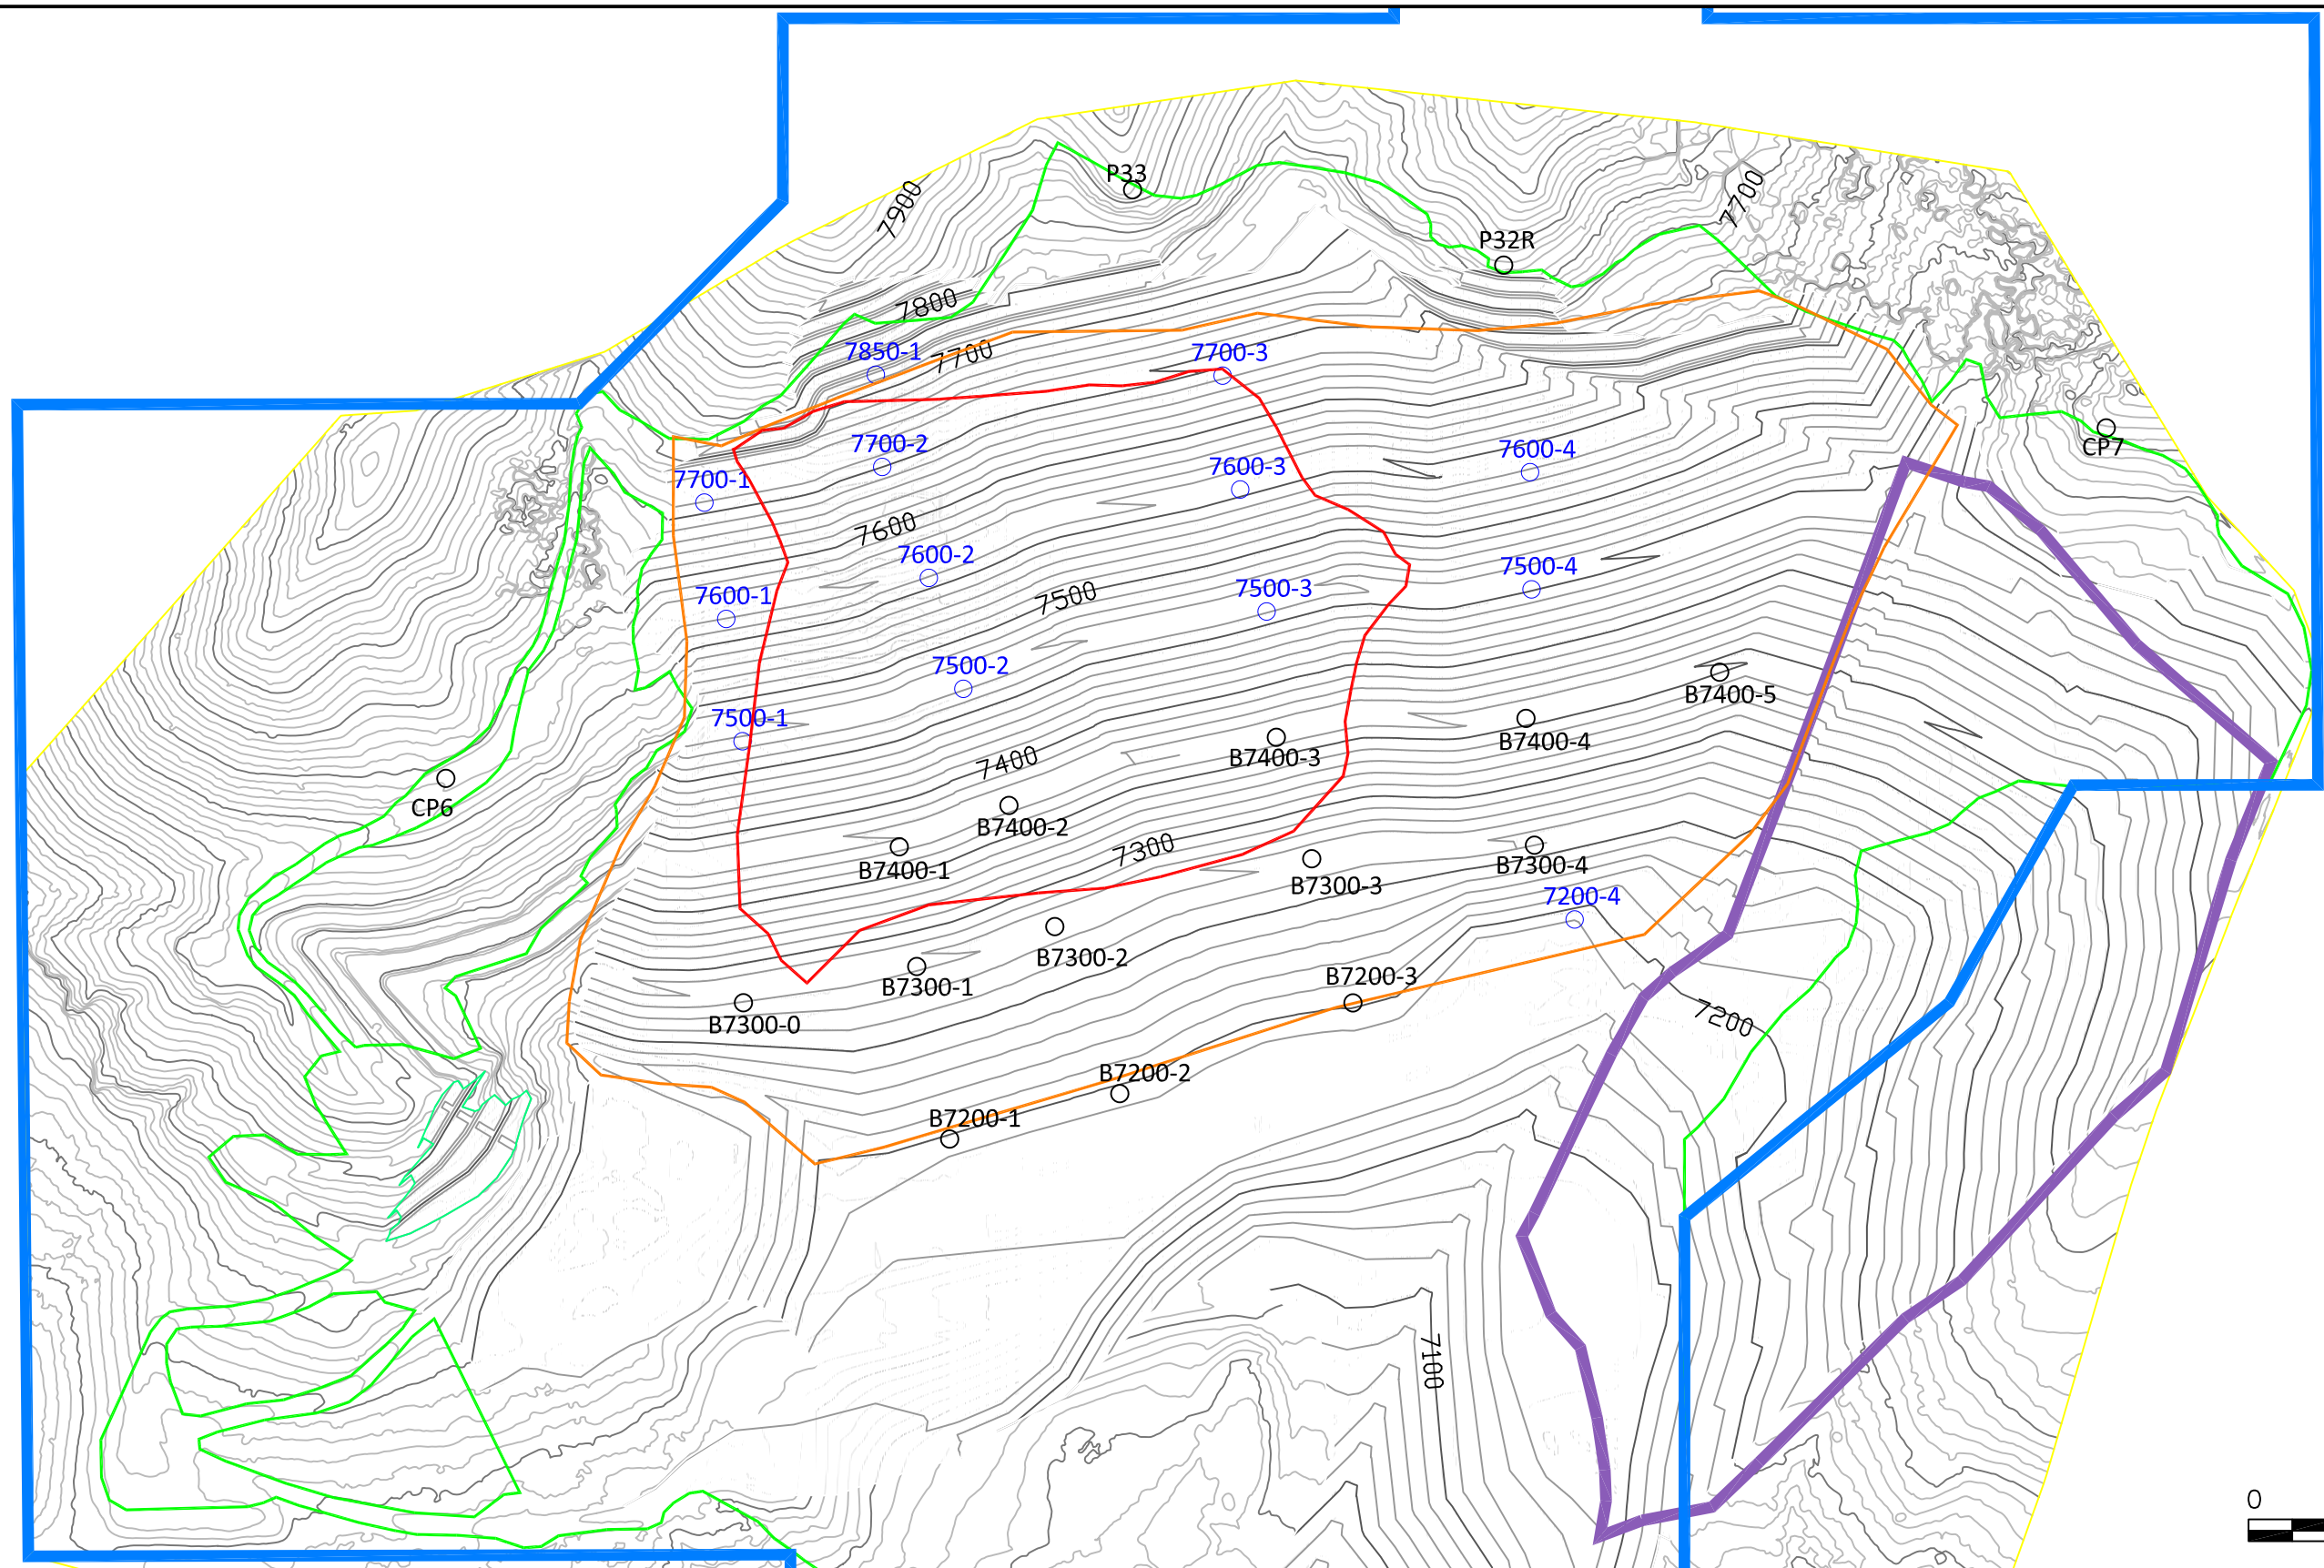
Figure No.  
4

A Leica robotic total station is used to continuously survey the prisms onsite to document slope movements. The robotic total station records the location of each prism every hour. There were 24 prisms active in April; two prisms were control points located outside the slope movement area, six prisms are located on the slopes surrounding the slope movement area, three prisms were located on the slopes within the landslide area, and thirteen prisms were located on the buttress fill. As the slope is backfilled and graded, the existing prisms will be removed, and additional prisms will be installed. No prisms were installed or removed in April. A log of prism removals and installations is included in Appendix B. The prism locations are shown on the current topography in Figure 3, and the proposed prism locations are shown on the reclamation topography in Figure 4. Both figures are included in Appendix B.

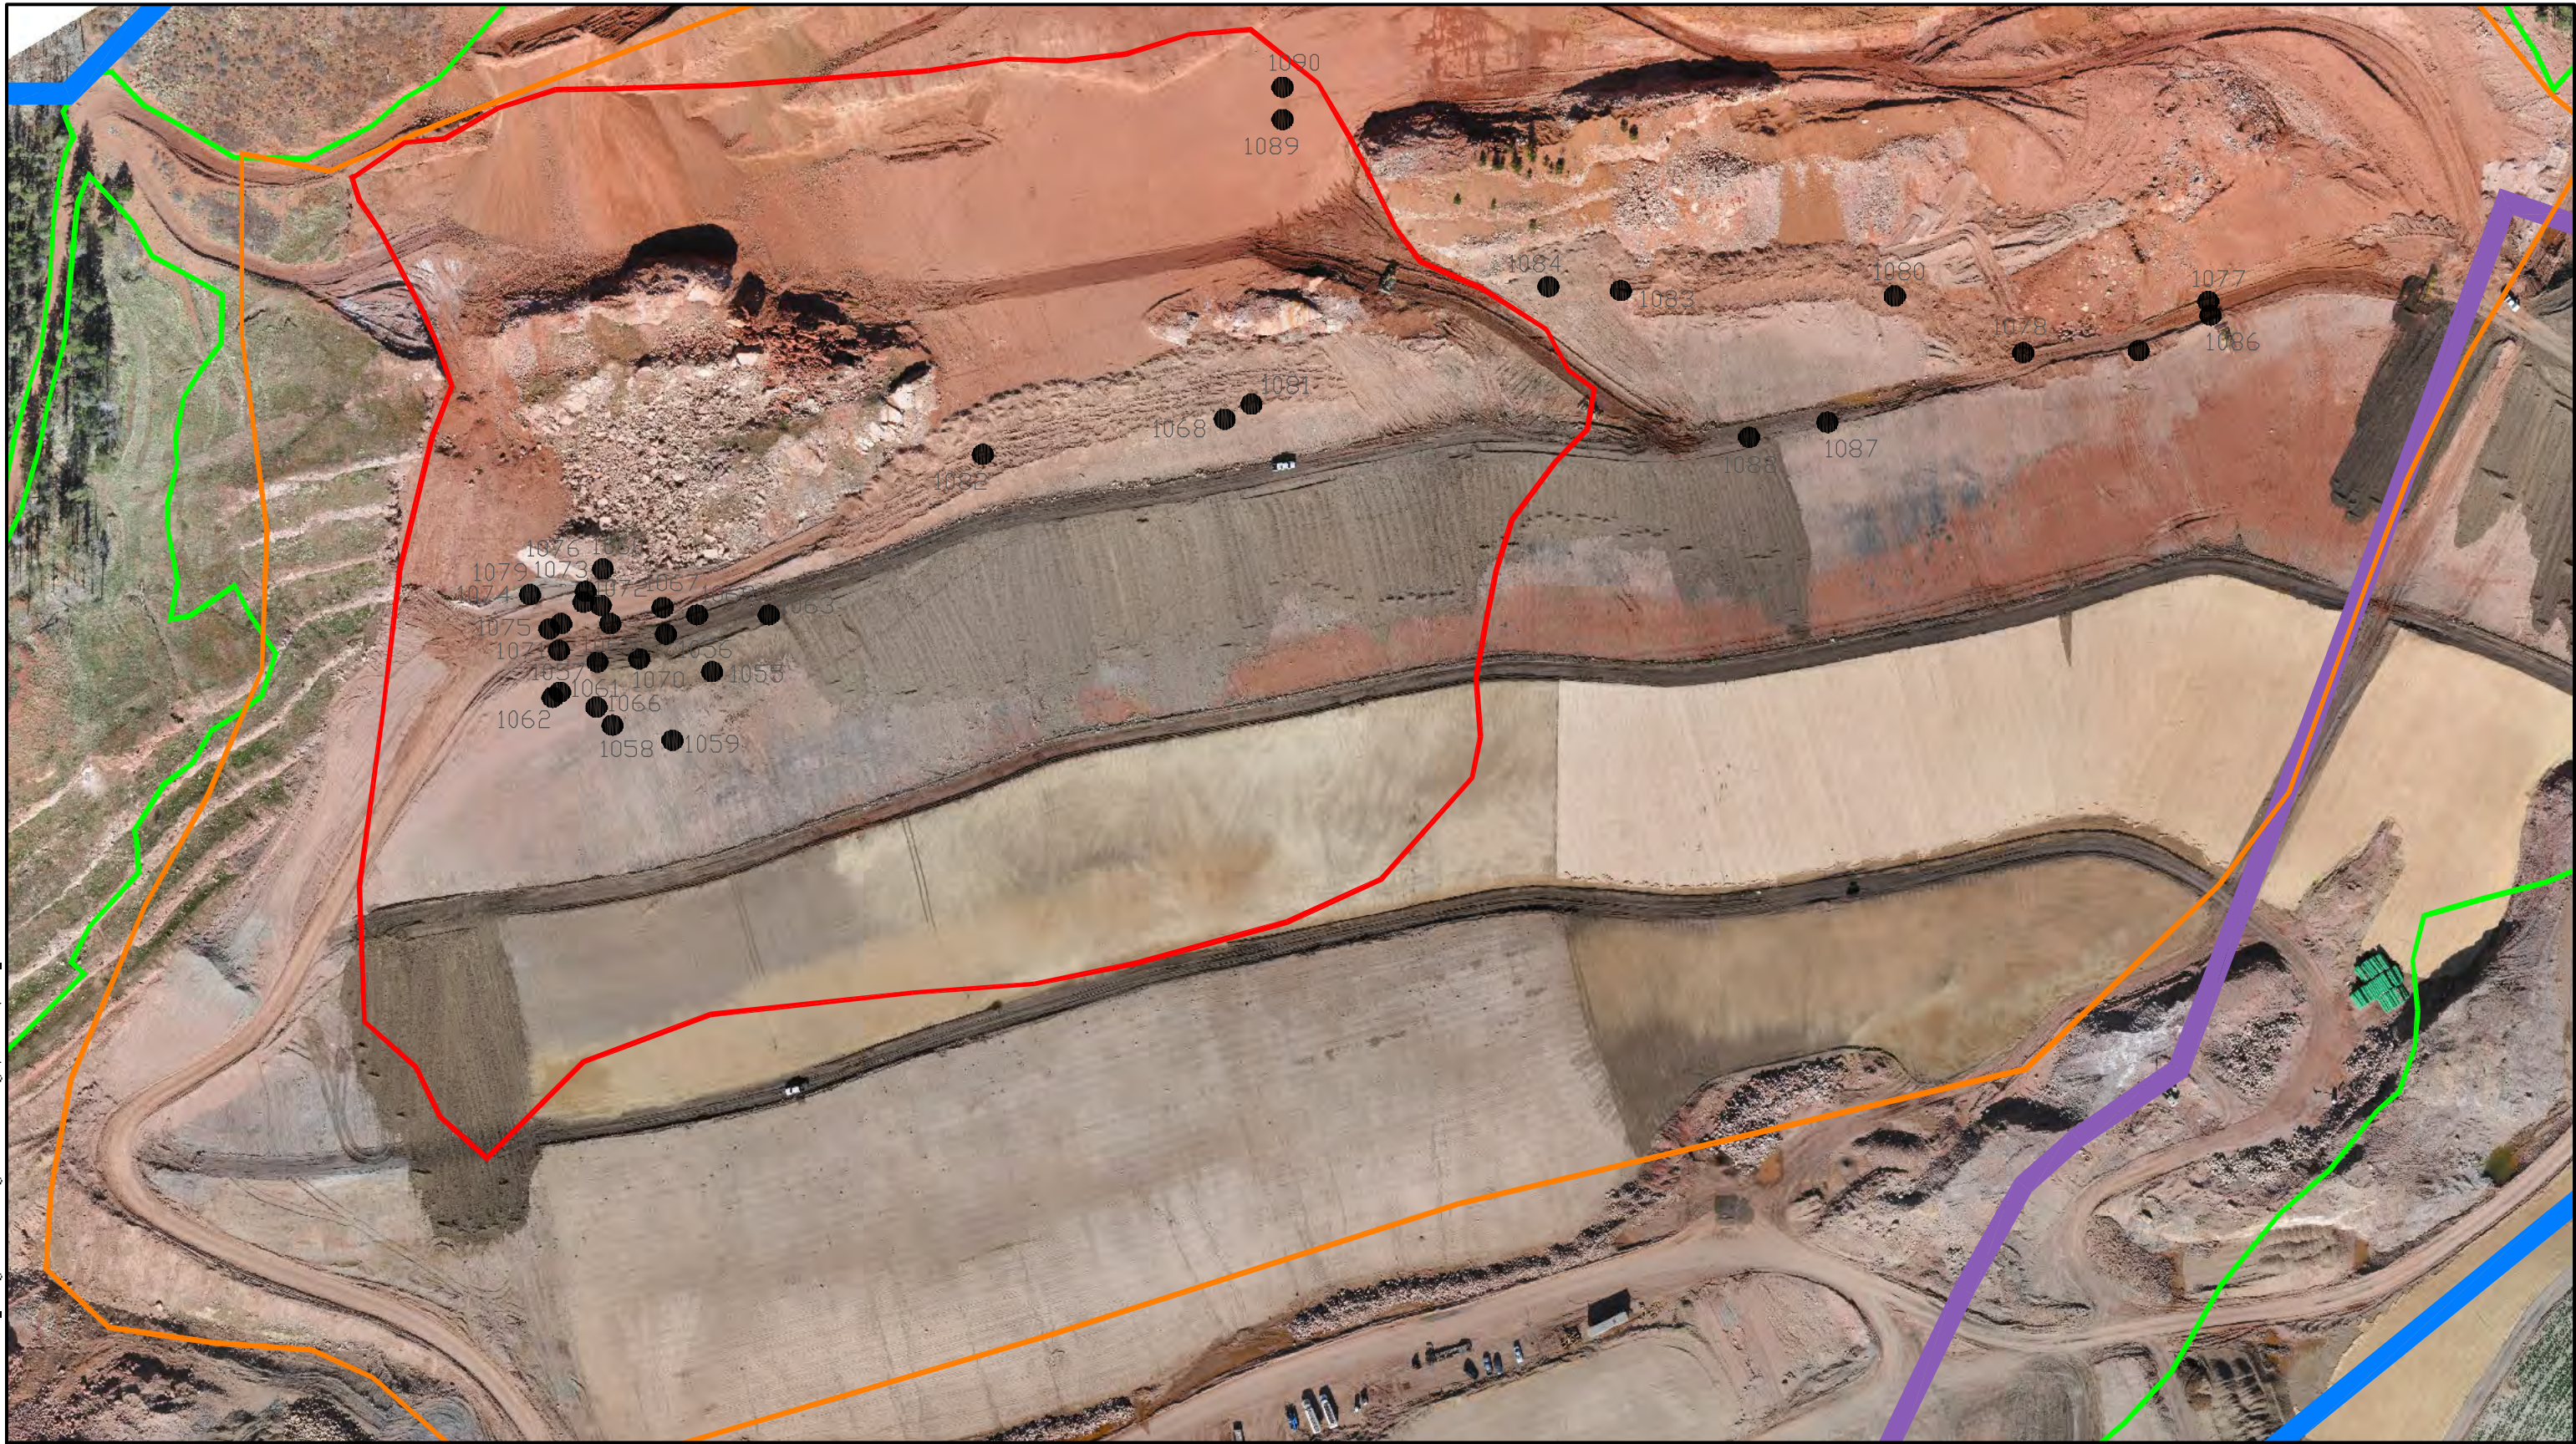
1. THERE WAS NO TEST 1063 OR 1085.
2. TEST 1067 IS A RETEST OF 1063.
3. TESTS 1089 AND 1090 ARE BELOW AND ABOVE THE CRACKING AREA.
