MINERALS PROGRAM INSPECTION REPORT
PHONE: (303) 866-3567

MINE NAME: Sunday Mine	MINE/PROSPECTING ID#: M-1977-285	MINERAL: Uranium and vanadium	COUNTY: San Miguel
INSPECTION TYPE: Monitoring	WEATHER: Clear	INSP. DATE: April 10, 2024	INSP. TIME: 10:00
OPERATOR: Pinon Ridge Mining LLC	OPERATOR REPRESENTATIVE: Micheal Rutter, Bruce Smith	TYPE OF OPERATION: 112d-2 - Designated Mining Operation	
REASON FOR INSPECTION: Normal I&E Program	BOND CALCULATION TYPE: Complete Bond	BOND AMOUNT: \$330,242.00	
DATE OF COMPLAINT: NA	POST INSP. CONTACTS: None	JOINT INSP. AGENCY: U.S.BLM	
INSPECTOR(S): Lucas West	INSPECTOR'S SIGNATURE:

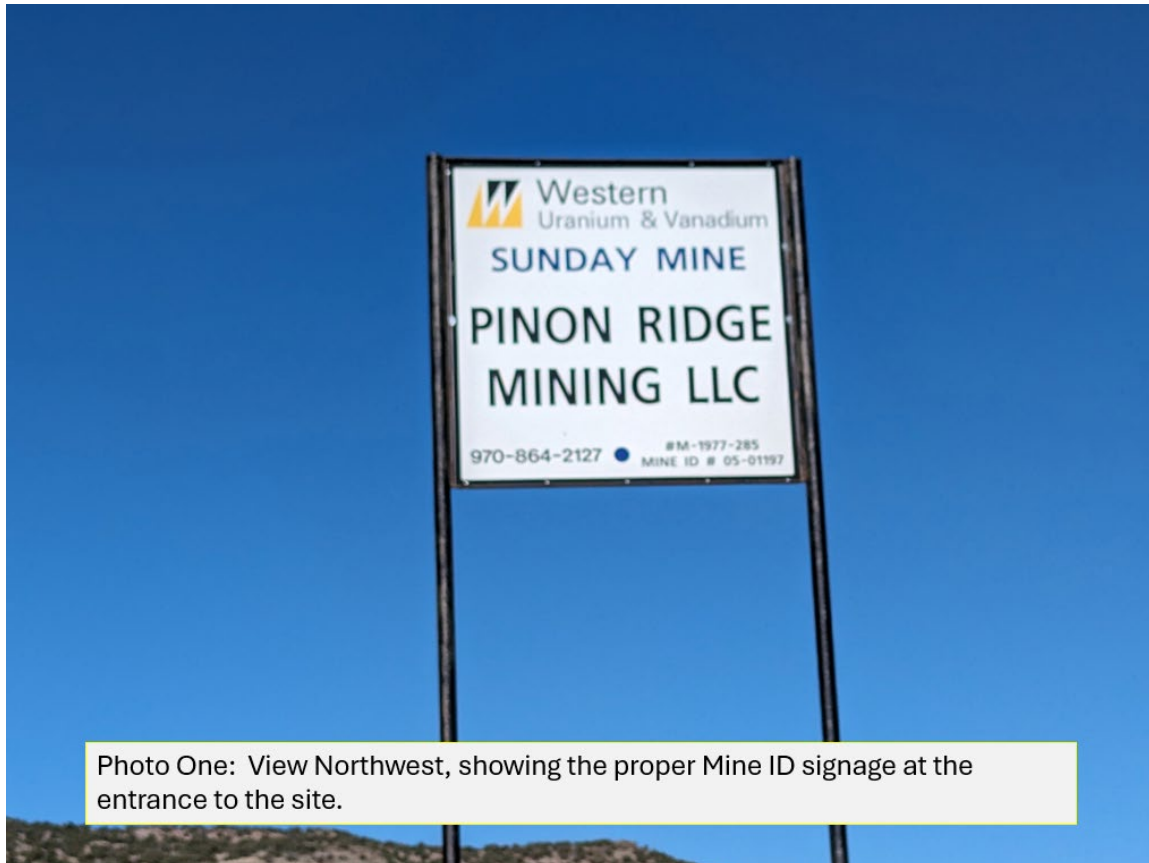
As seen in Photo One, the permit ID sign was observed at the entrance to the site. The permit boundary markers were also observed. Since the Division's previous inspection, the Operator has made significant improvements to the site in an effort to move toward the shipment of ore. The site is currently mining and stockpiling ore underground, but no ore has been brought to the surface. Improvements to security, surface structures and storm water controls have been on going. The shop and office facilities have been upgraded to facilitate constant on-site operations and are in excellent condition. Various mining equipment and supplies were observed on site and were all stored in a neat and orderly fashion. Examples of the equipment and facilities can be seen in Photo Two.
