File: April 2024 Monitoring Summary

Reference: April 2024 Geotechnical Monitoring Summary Pikeview Quarry

Client/Project
CASTLE AGGREGATE
PIKEVIEW QUARRY SLOPE
MONITORING
Project No.
2057288200

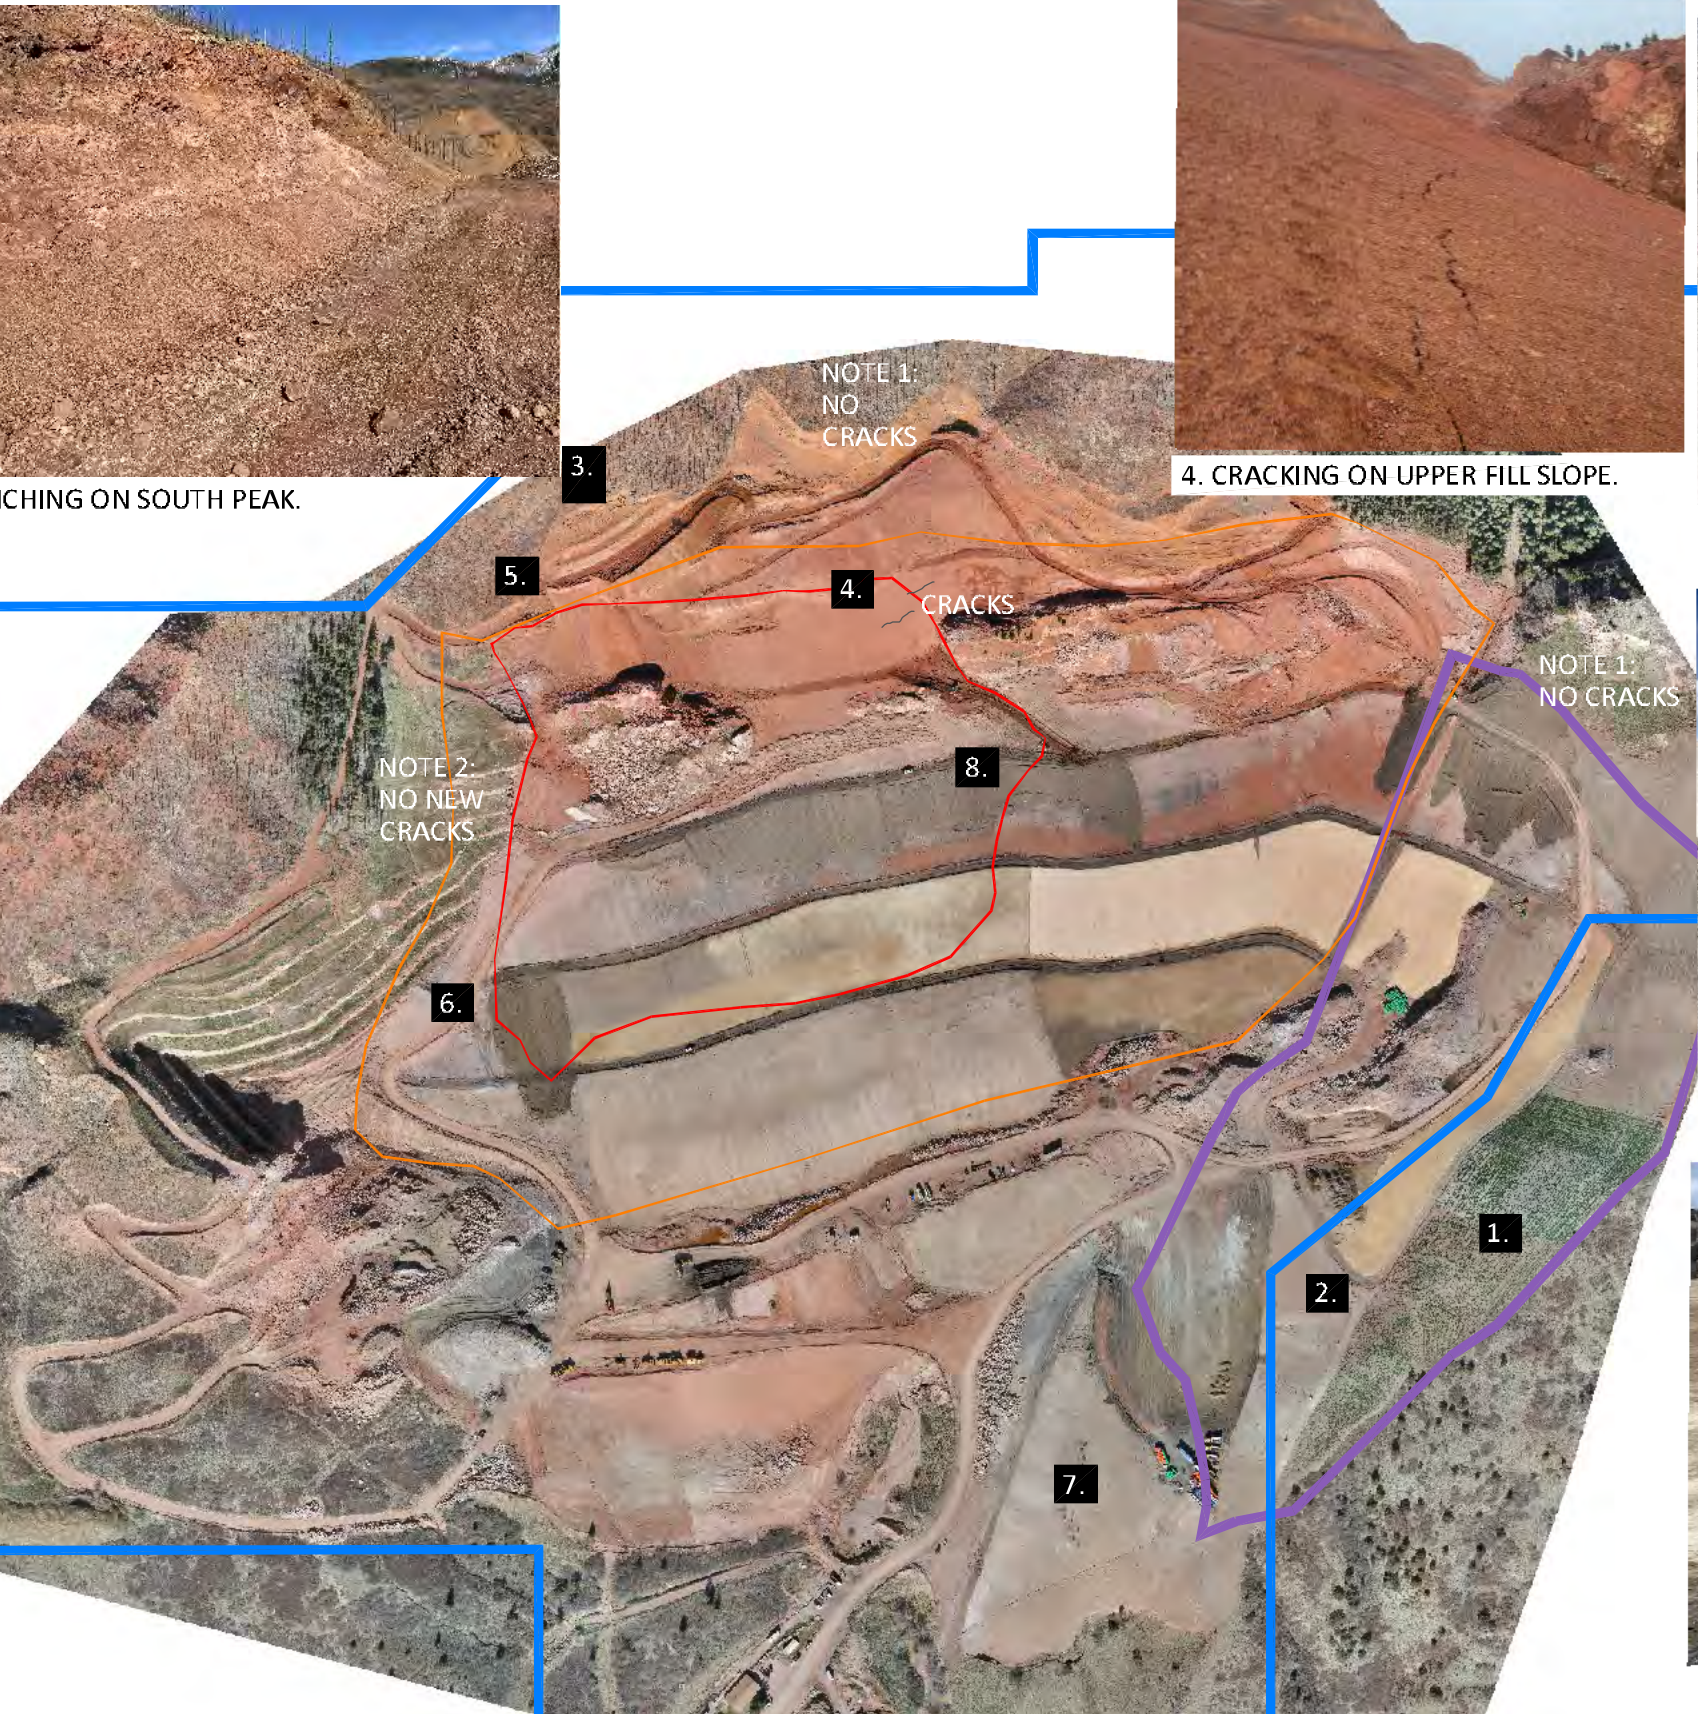
- Cracking was observed on the graded slopes near the upper extents of the fill slope. These tension cracks were observed to be approximately 100 feet long and 2 inches wide. The nature and location of these cracks suggests ongoing settlement of the buttress fill as the likely cause of the cracking. The settlement of the fill on a sloping foundation results in a downslope vector that is causing the cracking. The location near the upper extent of the fill is expected considering the in-situ material further uphill would not experience the settlement that occurs in the fill. Stantec has observed similar cracks on mine slope regrades including sites that did not have a landslide component. The cracks at the other regrade projects also occurred at the upper extent of the fill slope. The vector diagram below shows the settlement due to gravity and the resulting movements normal and parallel to the slope.

8. SLOPE BELOW CRACKING AREA. NO SIGNS OF MOVEMENT.

- Restricted access to the ungraded landslide slopes should continue.
- All monitoring should continue at current frequencies.
- All alerts shall continue to be taken seriously even if data errors are suspected.
- The upper fill slope should continue to be monitored for signs of increased or ongoing cracking. The area where cracking was observed will be covered with topsoil and erosion control matting in the near future, and the cracking will no longer be visible.
- Areas where cracking has been observed should be graded and compacted to prevent infiltration of runoff through the cracks.

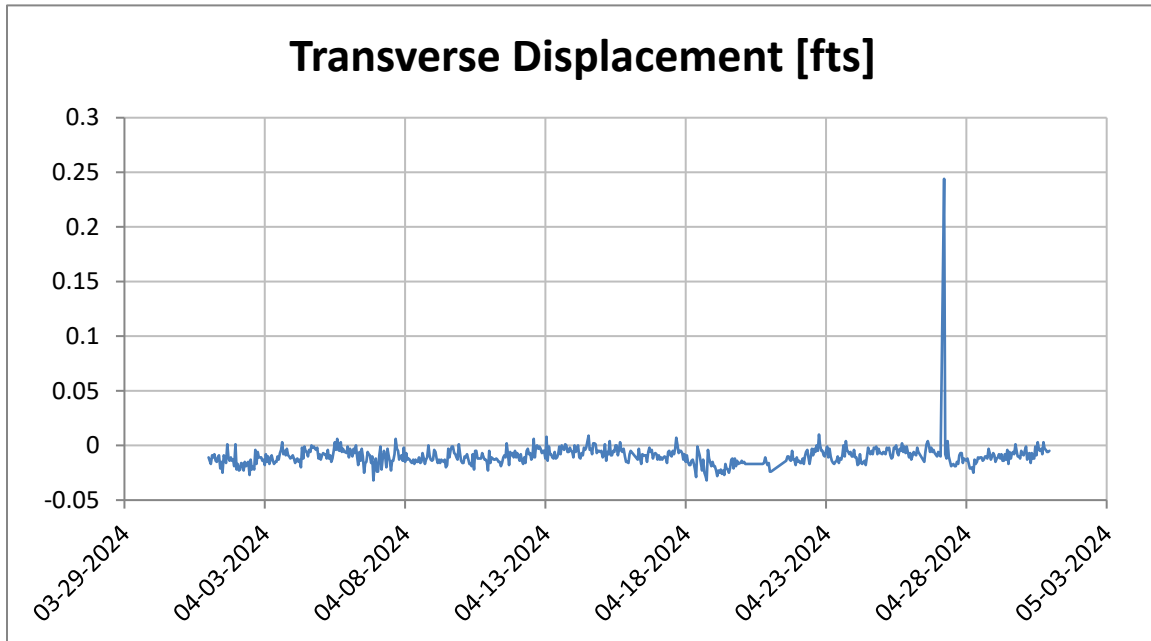
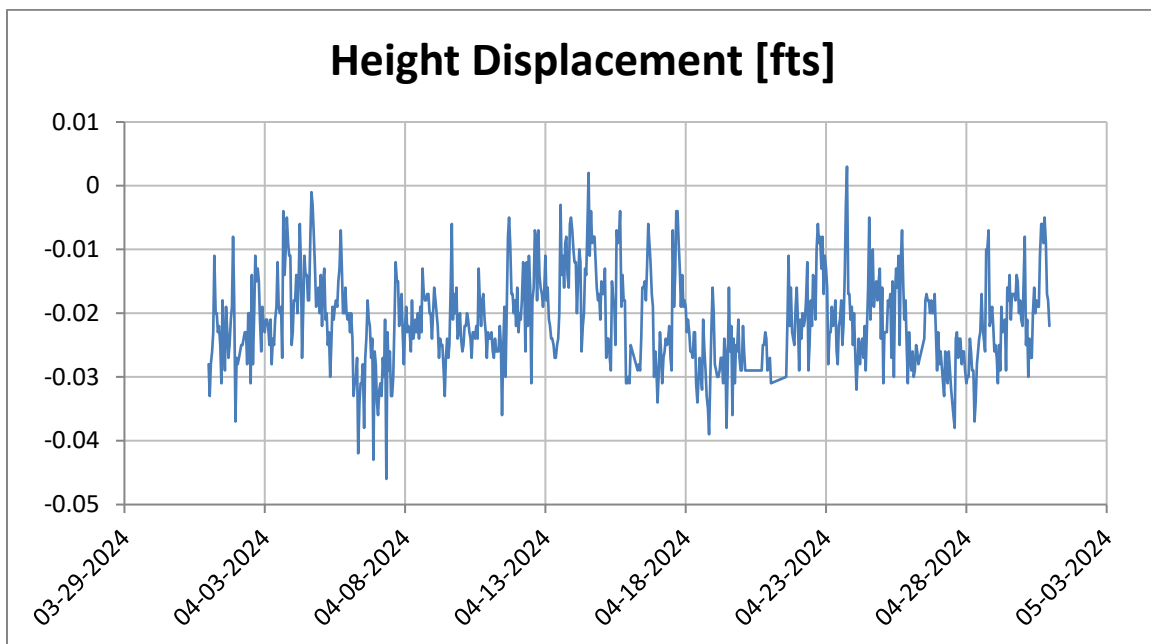
Prism P2

1. Survey accuracy is ± 0.016 feet.
2. Alert threshold is ± 0.35 feet.
3. Transverse displacement is in the horizontal direction. Positive direction means closer to the robotic total station.
4. Height displacement is in the vertical direction. Positive direction means higher in elevation.
5. Regression limit received on April 27.

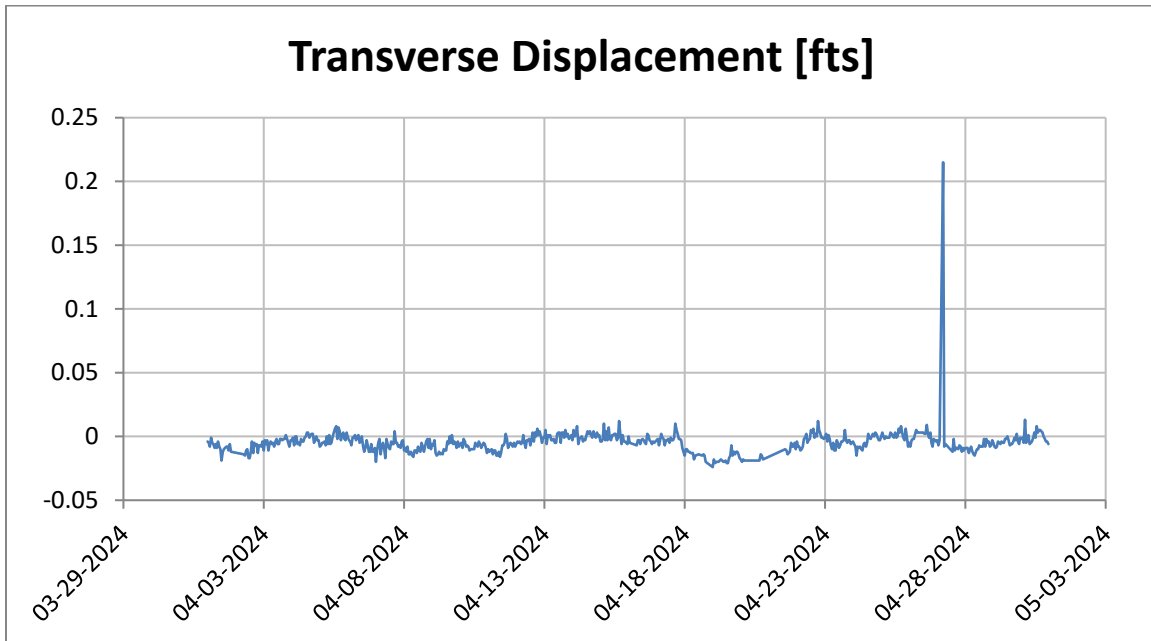
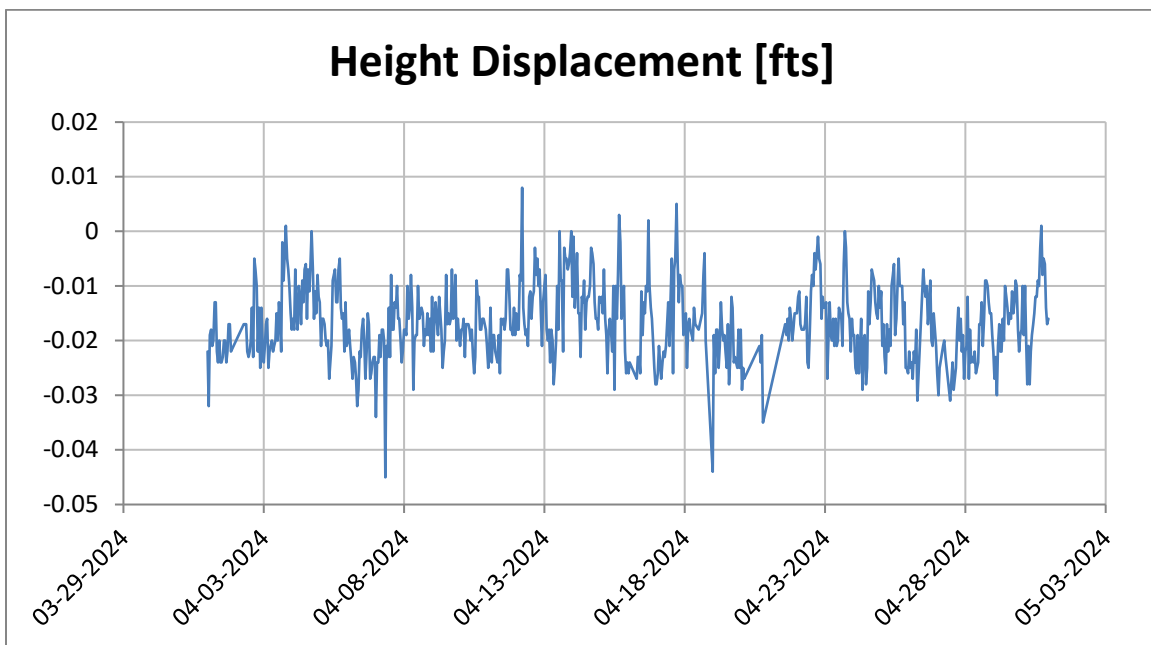
Prism P5

1. Survey accuracy is ± 0.016 feet.
2. Alert threshold is ± 0.35 feet.
3. Transverse displacement is in the horizontal direction. Positive direction means closer to the robotic total station.
4. Height displacement is in the vertical direction. Positive direction means higher in elevation.
5. Regression limit received on April 27.

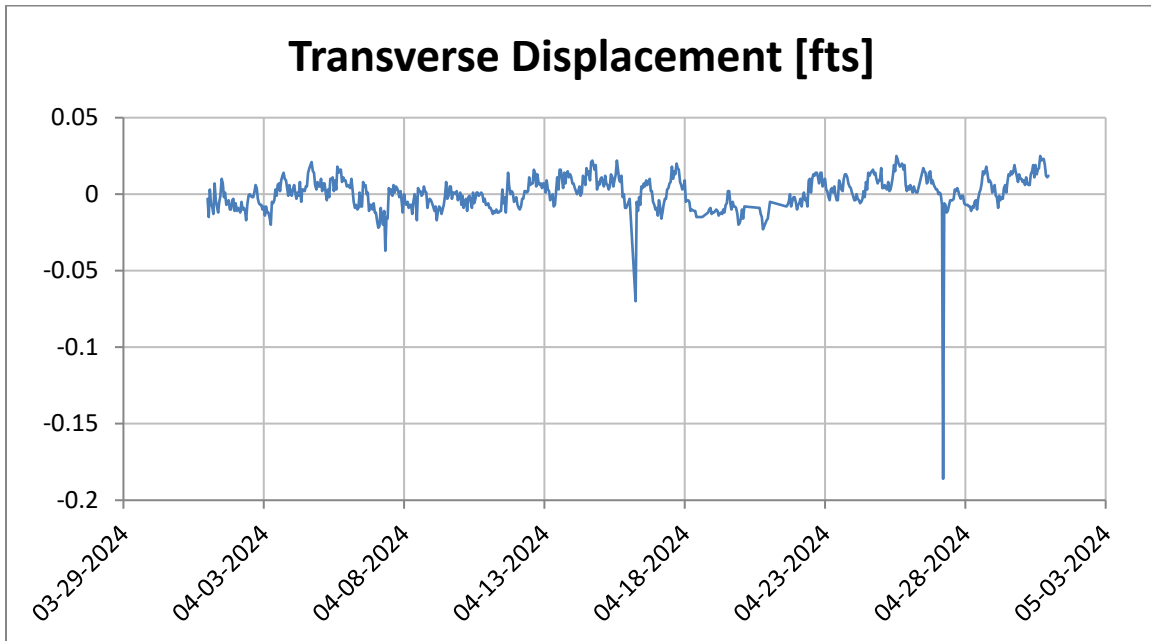
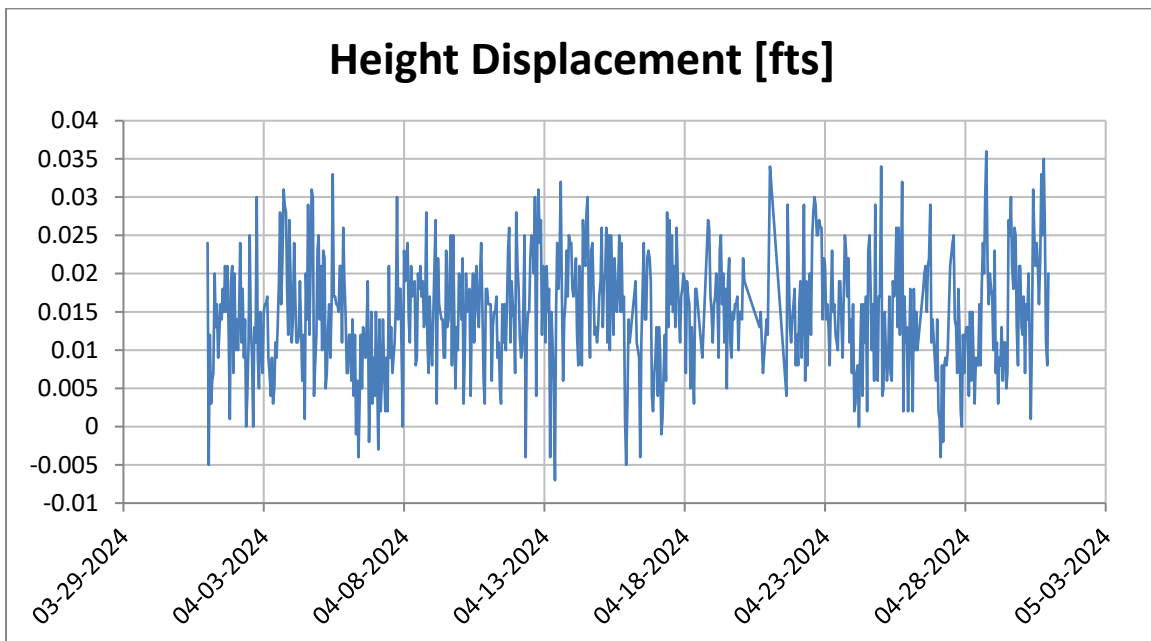
Prism P25

1. Survey accuracy is ± 0.016 feet.
2. Alert threshold is ± 0.35 feet.
3. Transverse displacement is in the horizontal direction. Positive direction means closer to the robotic total station.
4. Height displacement is in the vertical direction. Positive direction means higher in elevation.
5. Regression limits received on April 16 and 27.

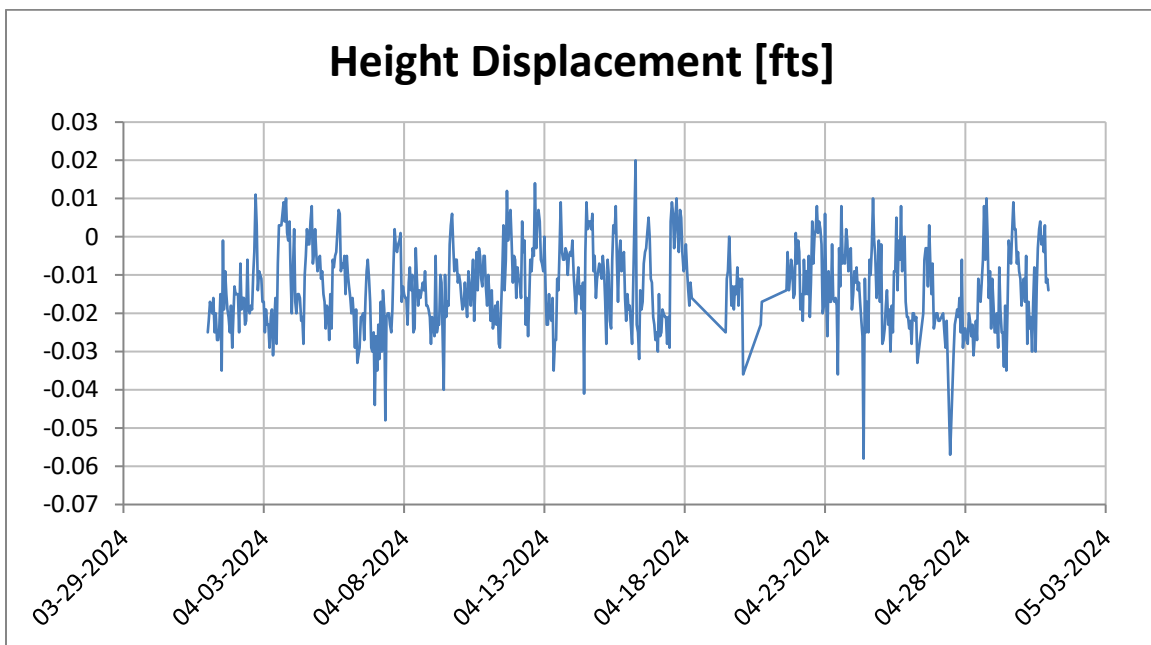
Prism P33

1. Survey accuracy is ± 0.016 feet.
2. Alert threshold is ± 0.35 feet.
3. Transverse displacement is in the horizontal direction. Positive direction means closer to the robotic total station.
4. Height displacement is in the vertical direction. Positive direction means higher in elevation.
5. Regression limits received on April 16 and 27.

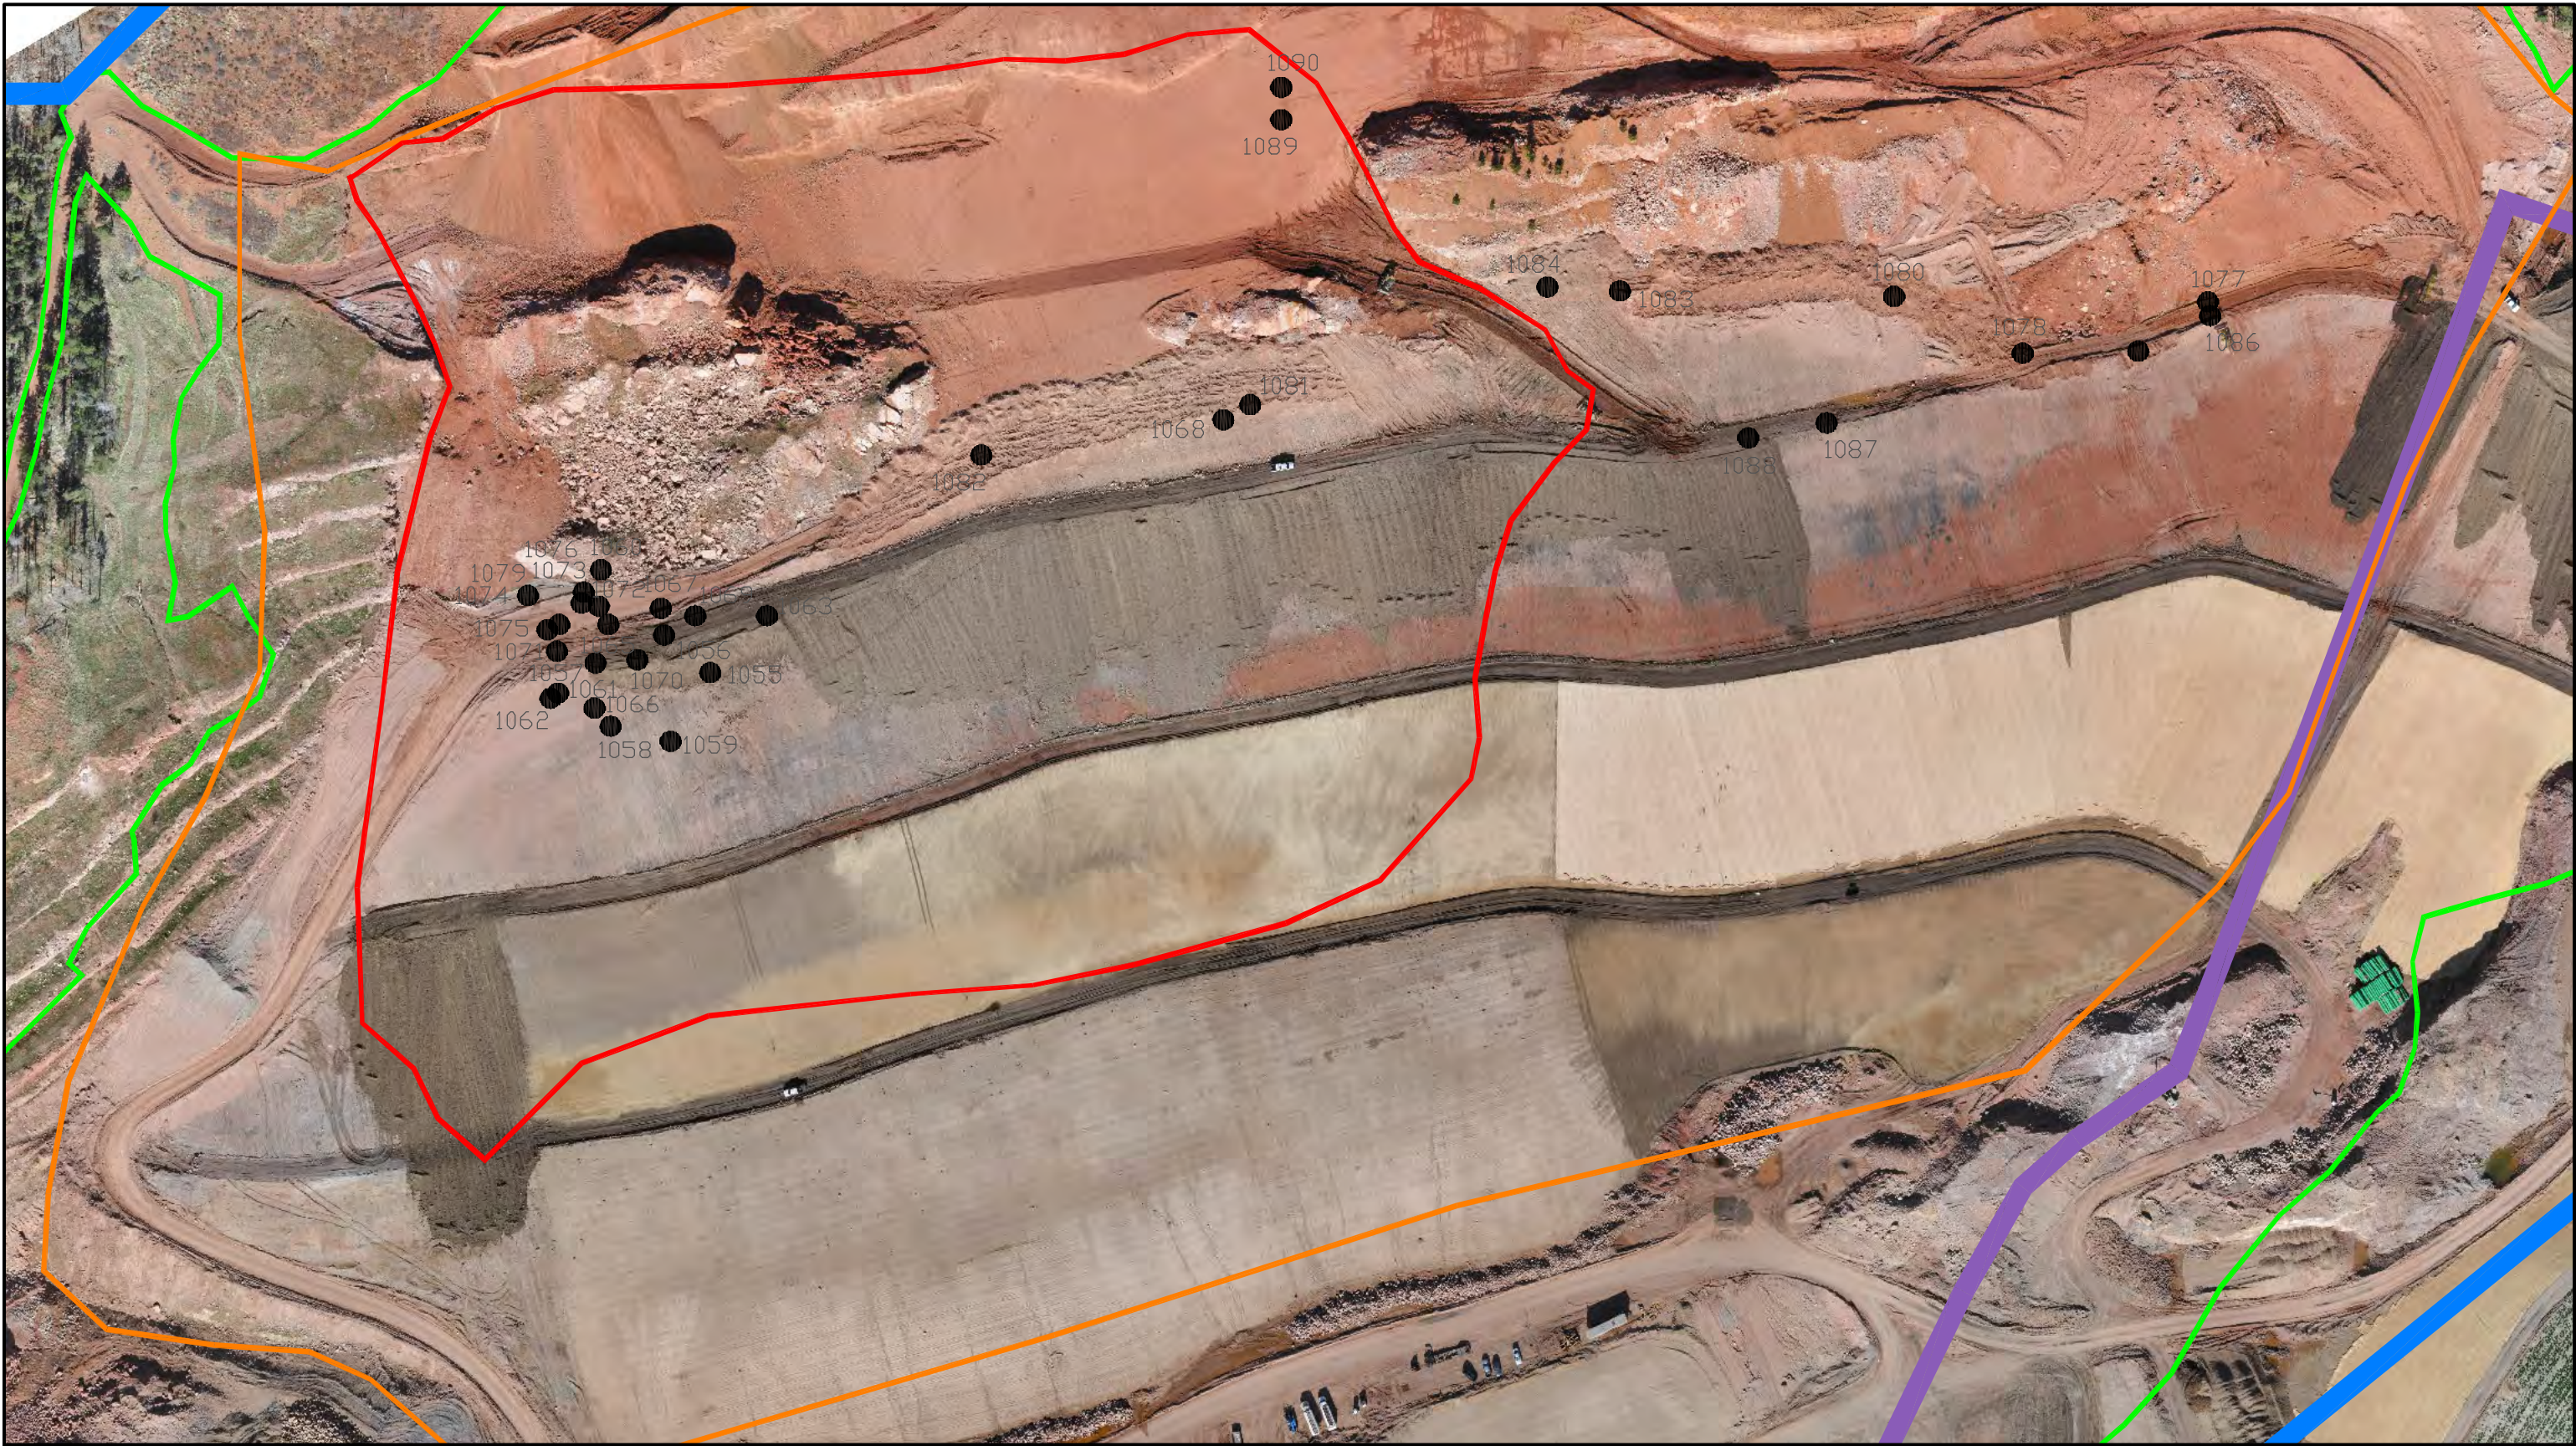
1. THERE WAS NO TEST 1063 OR 1085.
2. TEST 1067 IS A RETEST OF 1063.
3. TESTS 1089 AND 1090 ARE BELOW AND ABOVE THE CRACKING AREA.
