MINERALS PROGRAM INSPECTION REPORT
PHONE: (303) 866-3567

MINE NAME: Knodel Pit	MINE/PROSPECTING ID#: M-2011-042	MINERAL: Gravel and Sand	COUNTY: Yuma
INSPECTION TYPE: Monitoring	WEATHER: Clear and Windy	INSP. DATE: April 24, 2024	INSP. TIME: 10:00
OPERATOR: Yuma County	OPERATOR REPRESENTATIVE: Tom Andersen	TYPE OF OPERATION: 112c - Construction Regular Operation	
REASON FOR INSPECTION: Normal I&E Program	BOND CALCULATION TYPE: N/A County Operator	BOND AMOUNT: N/A County Operator	
DATE OF COMPLAINT: NA	POST INSP. CONTACTS: None	JOINT INSP. AGENCY: None	
INSPECTOR(S): Nikie Gagnon	INSPECTOR'S SIGNATURE:

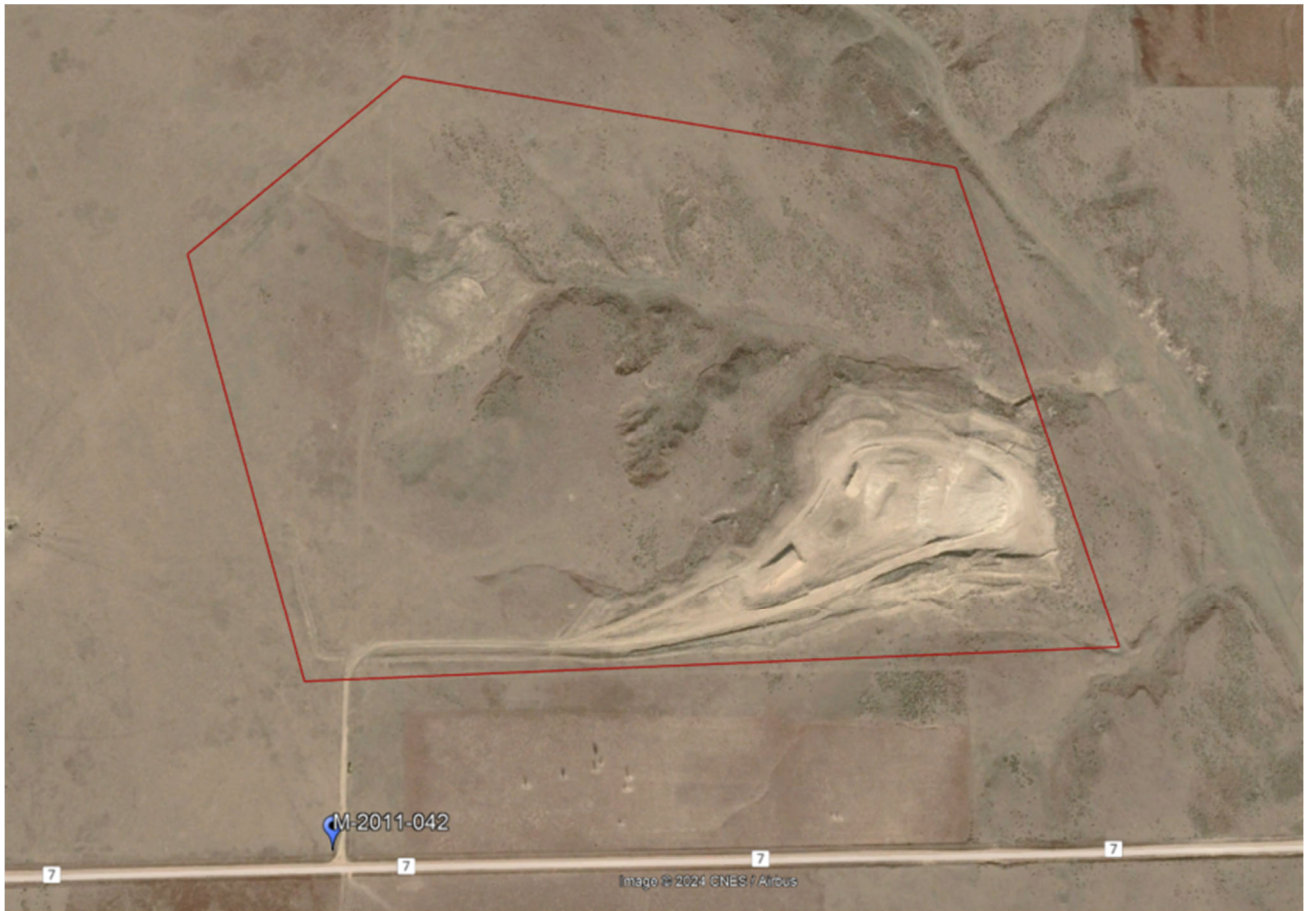
A dry drainage runs through the center of the permit area. Drainage from the site eventually flows to the South Fork of the Republican River. No evidence of sedimentation or stormwater runoff outside the permit boundary was noted. A low spot in the center of the pit showed evidence of standing water, however water likely infiltrates quickly.

Photo 8: Evidence of previous standing water noted in a low spot in the active mining area. This area was dry during the inspection.
