File: May 2024 Monitoring Summary

Date: June 30, 2024

Reference: May 2024 Geotechnical Monitoring Summary Pikeview Quarry

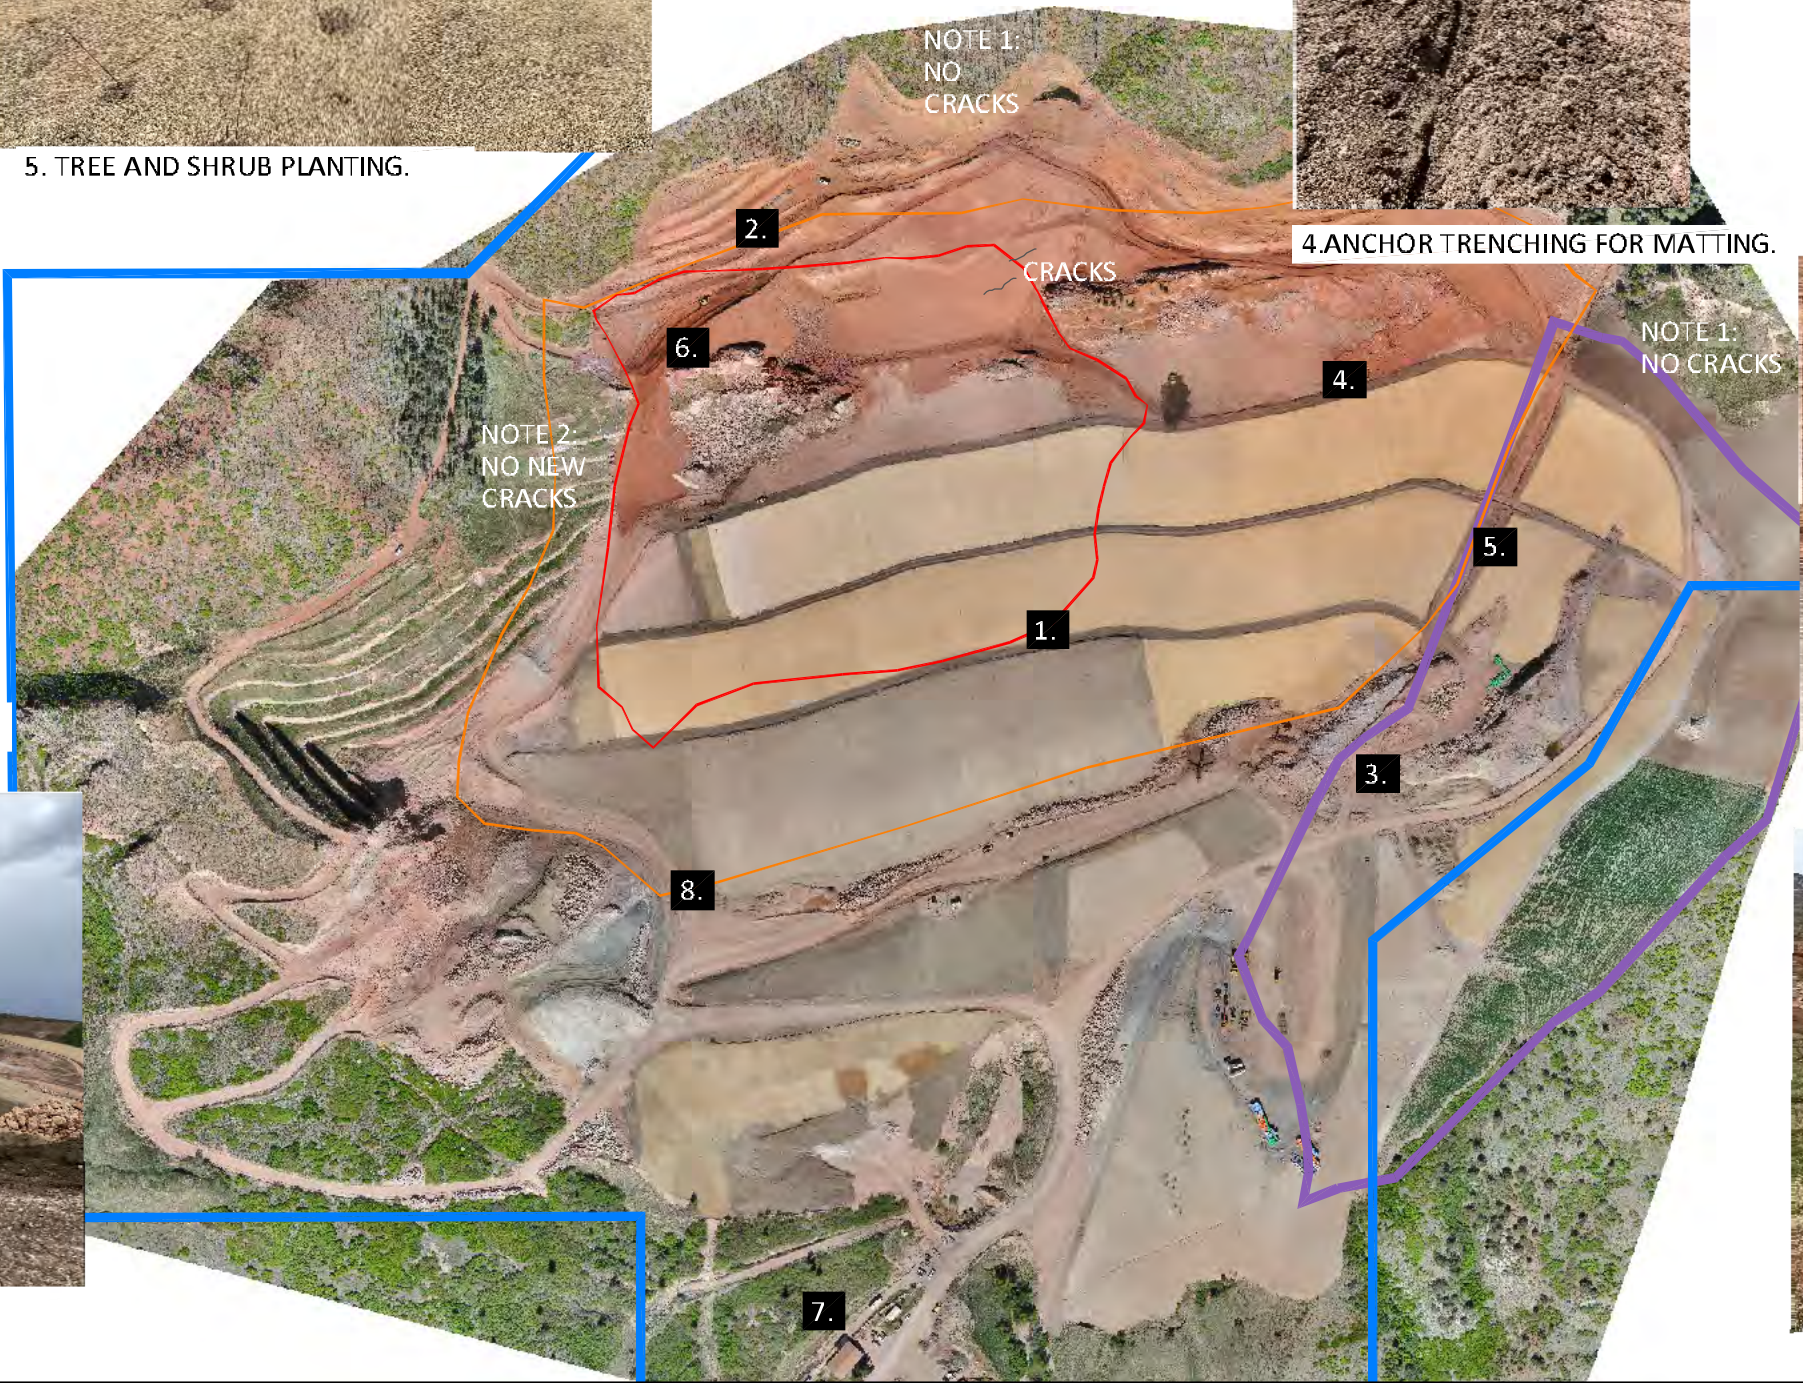
2. SOUTH PEAK BENCH WITH FILL PLACED.

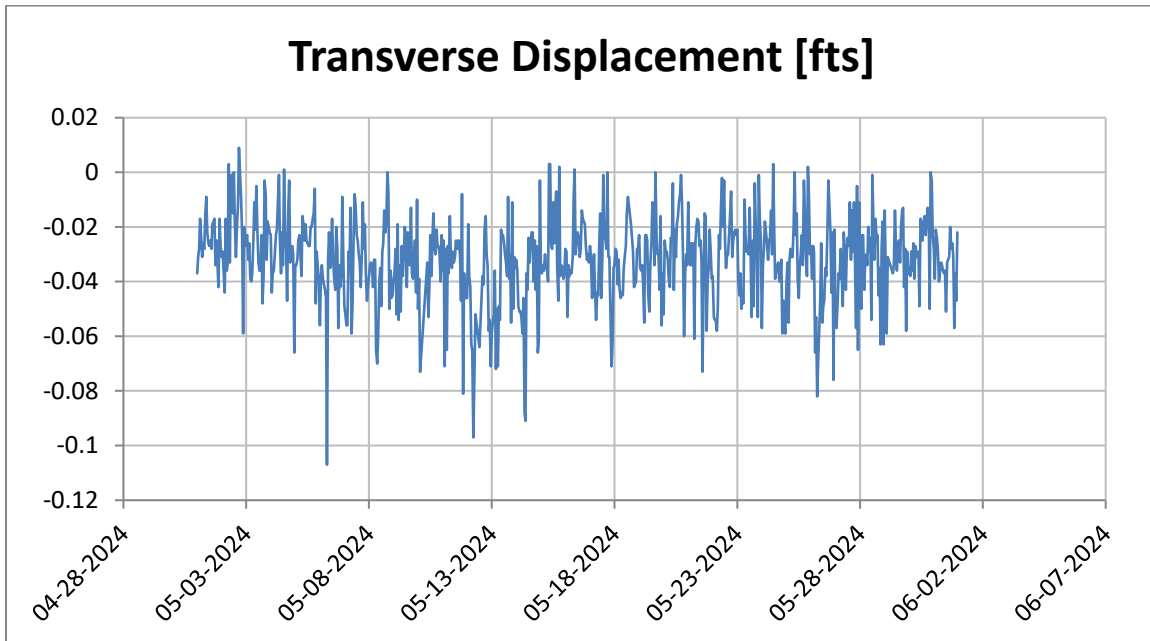
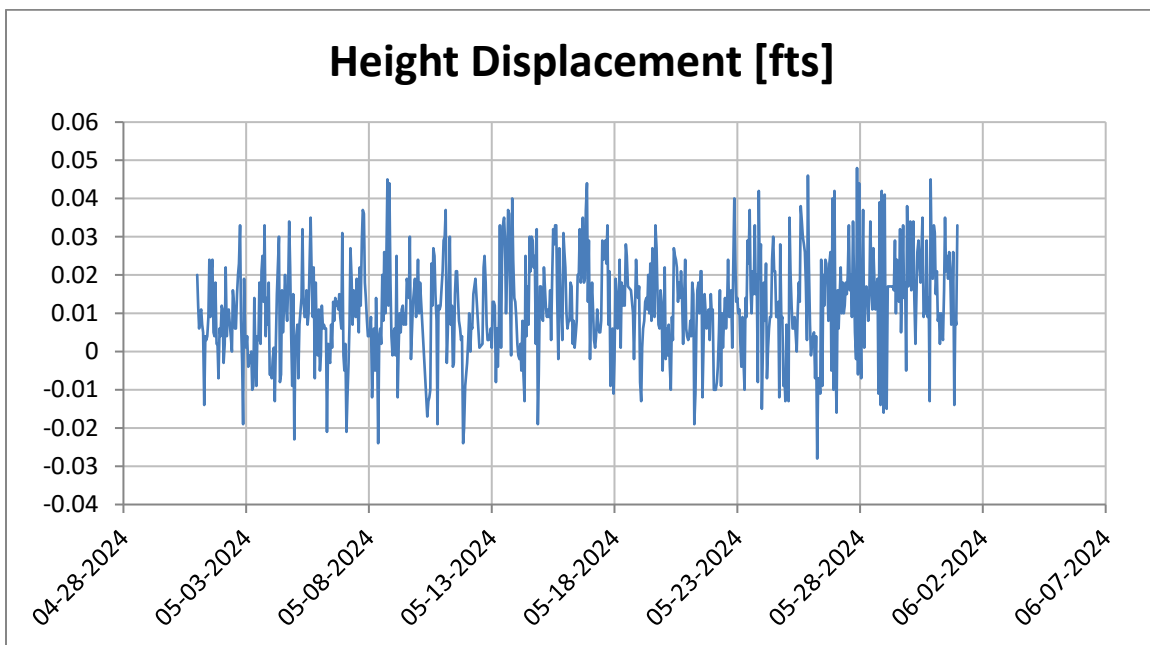
Prism P32R

| Prism | Date | Action | Comment |
|---|---|---|---|
| P32 | 1-Aug-23 | Prism Removed | P32 was damaged by a falling rock. P32R was installed in the same location. |

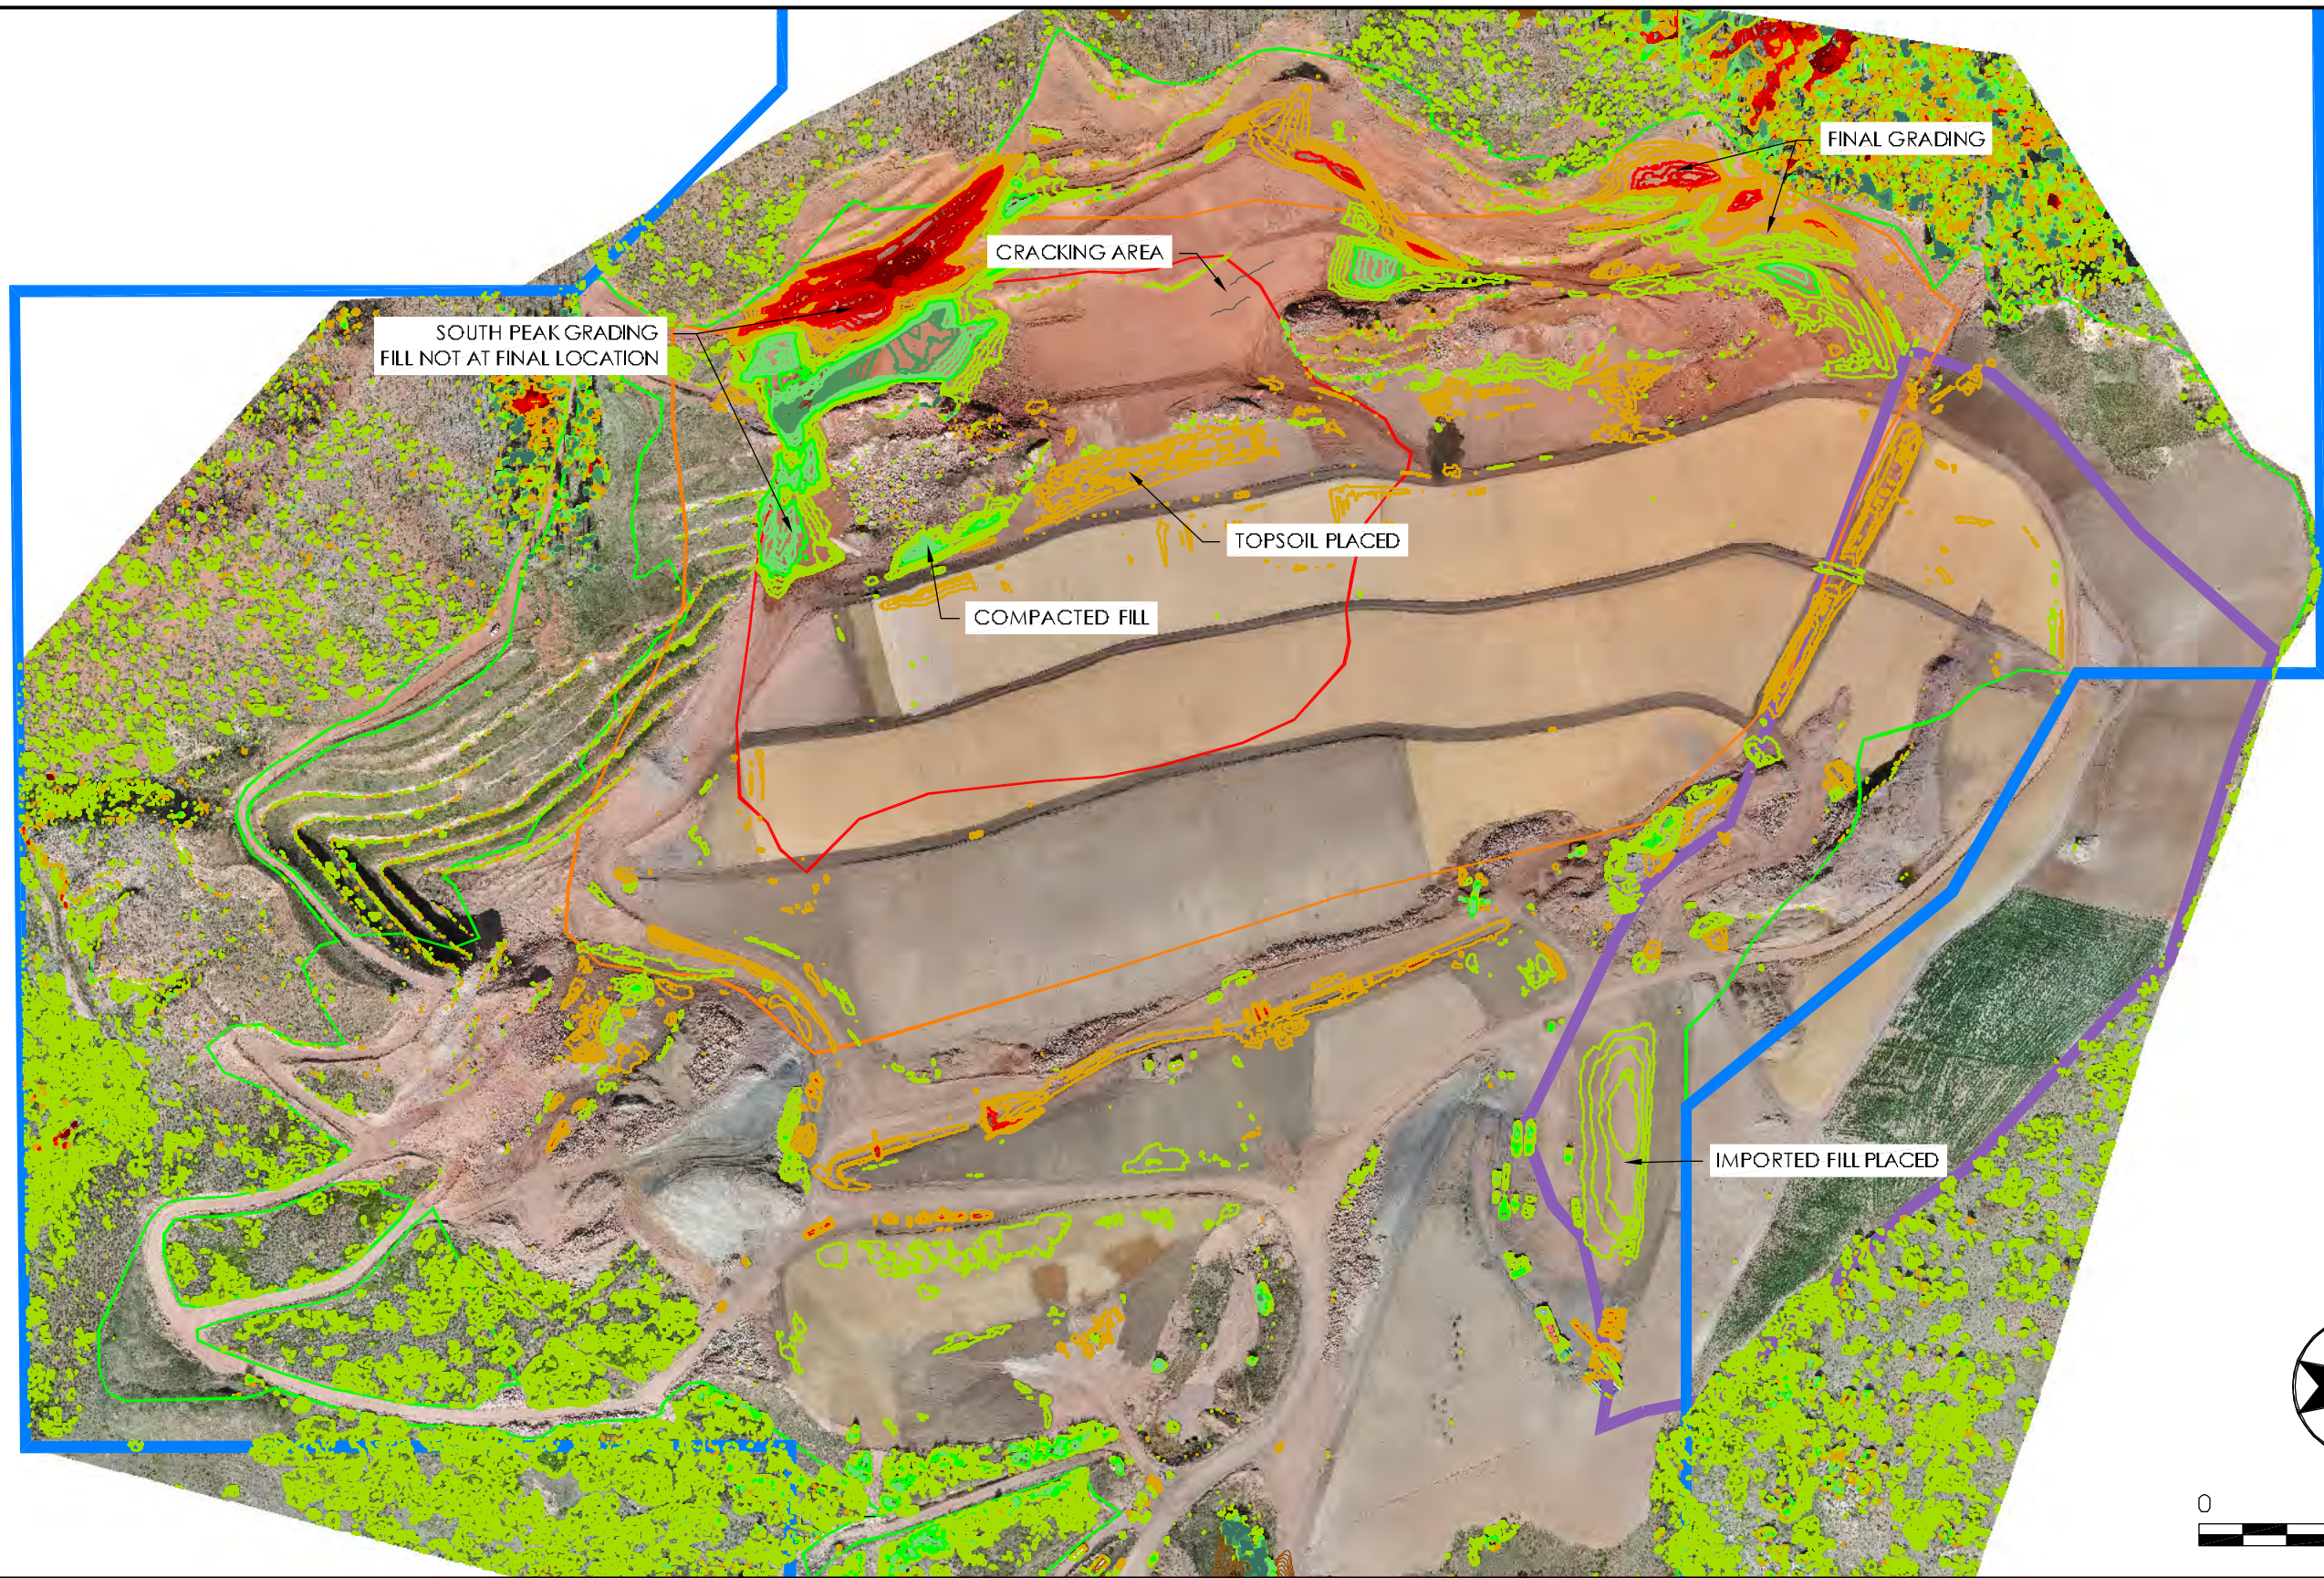
1. THERE WAS NO TEST 1091.
2. TESTS 1089 AND 1090 ARE BELOW AND ABOVE THE CRACKING AREA.
3. LOCATIONS FOR TESTS 1089, 1090, 1100, AND 1101 ARE APPROXIMATE.
