## Hooper Pit, Permit No. M-2020-024, Inspection Problem Abated

# MINERALS PROGRAM INSPECTION REPORT PHONE: (303) 866-3567

MINE NAME:	MINE/PROSPECTING ID#:	MINERAL:	COUNTY:
Hooper Pit	M-2020-024	Sand and gravel	Saguache
INSPECTION TYPE:	WEATHER: Clear	INSP. DATE:	INSP. TIME:
Monitoring		August 10, 2023	07:50
OPERATOR:	<b>OPERATOR REPRESENTATIVE:</b>	TYPE OF OPERATION:	
APC Southern Construction Co., LLC	Jim MacDonald	111 - Construction by Goverment Agency

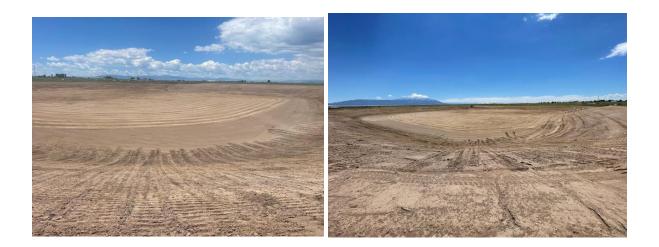
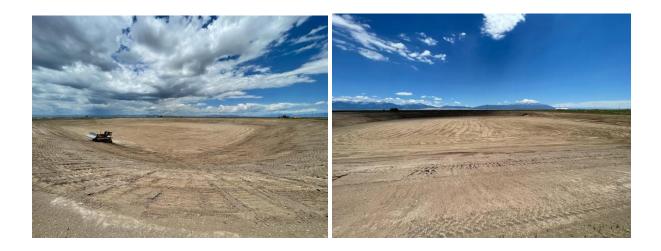
On July 10, 2024, the Division received photos of the pit backfilled to at least two feet above the groundwater surface. This satisfies the corrective action and it is considered abated.
