To: Jerald Schnabel  
Castle Aggregate  
File: June 2024 Monitoring Summary

**Reference: June 2024 Geotechnical Monitoring Summary Pikeview Quarry**

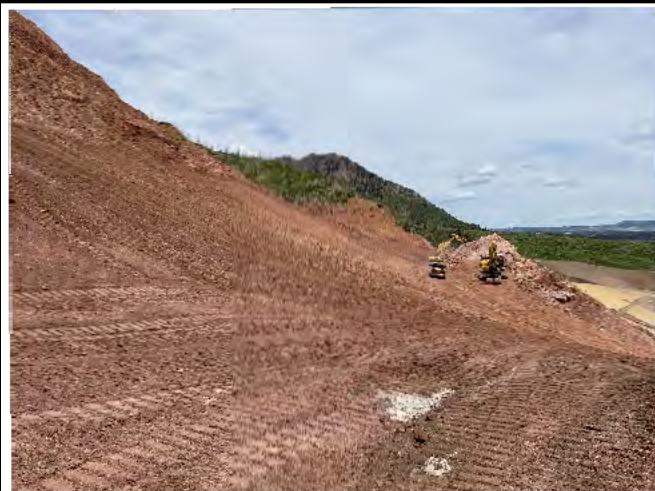
6. REMOVING BIG ROCK AND GRADING AREA.

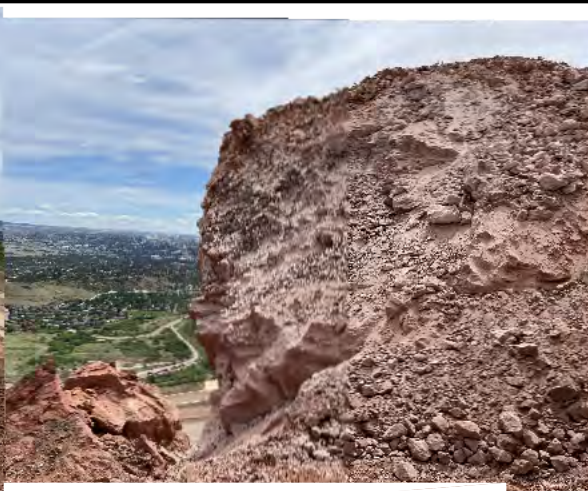
5. BIG ROCK BEFORE REMOVAL.

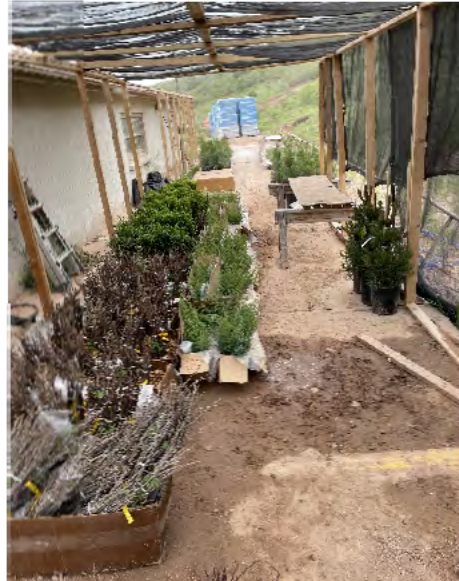
7. CONTAINER STOCK WAITING FOR PLANTING.

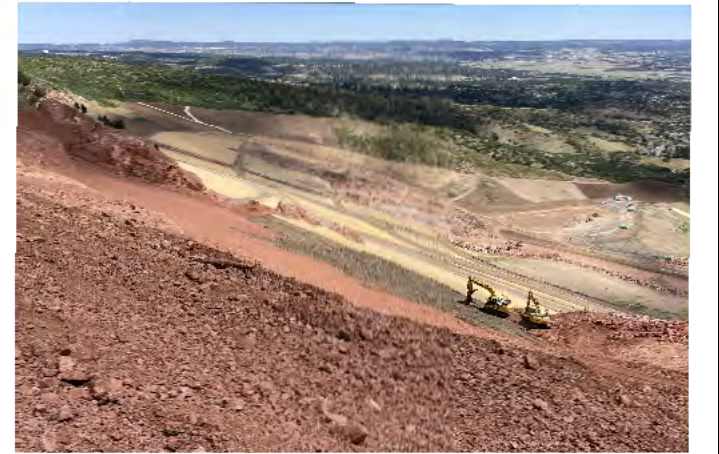
1. VIEW NORTHEAST OF RECLAIMED SLOPES AND GRADING OPERATION.

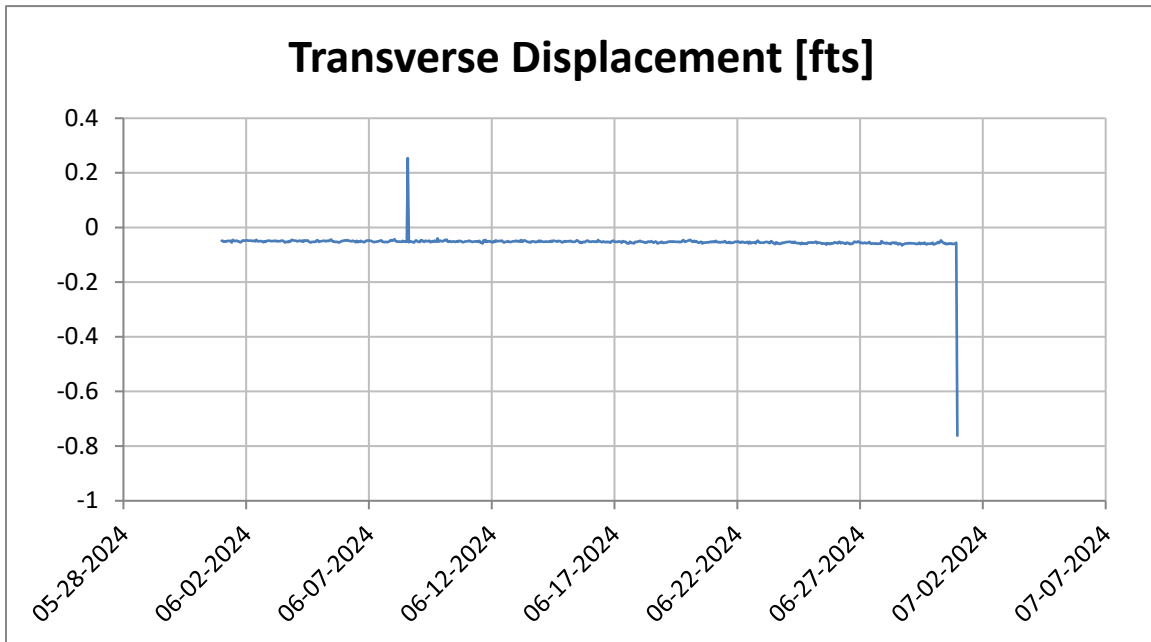
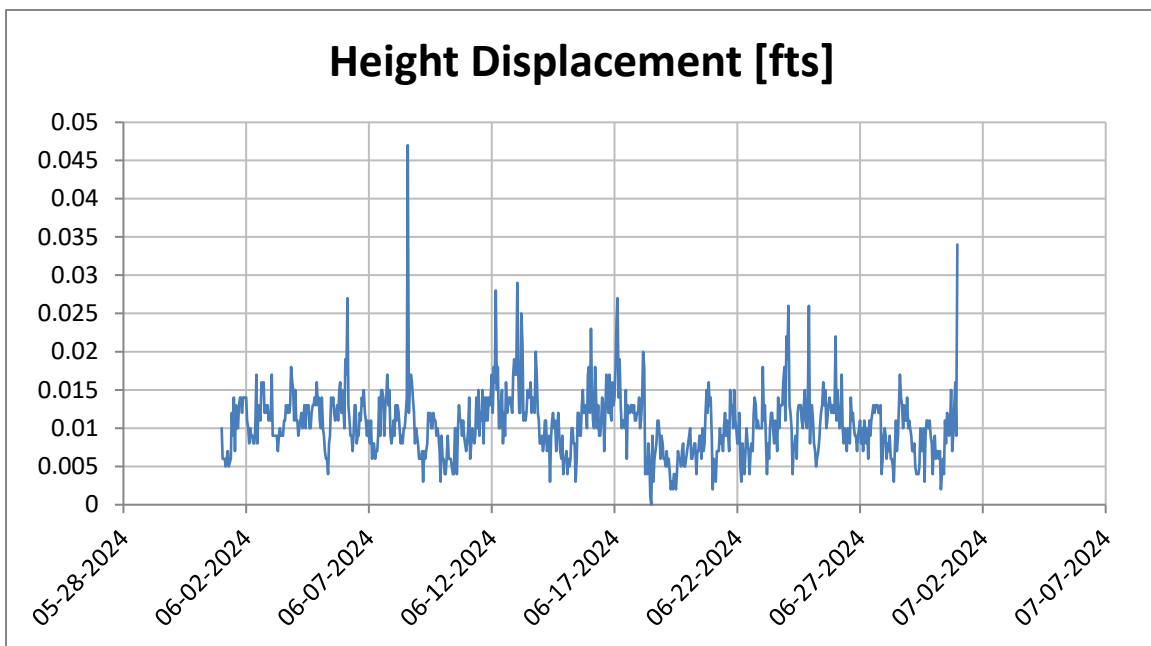
## Prism B7200-1

1. Survey accuracy is  $\pm 0.016$  feet.
2. Alert threshold is  $\pm 0.35$  feet.
3. Transverse displacement is in the horizontal direction. Positive direction means closer to the robotic total station.
4. Height displacement is in the vertical direction. Positive direction means higher in elevation.
5. Rain and fog at end of month caused erroneous readings.

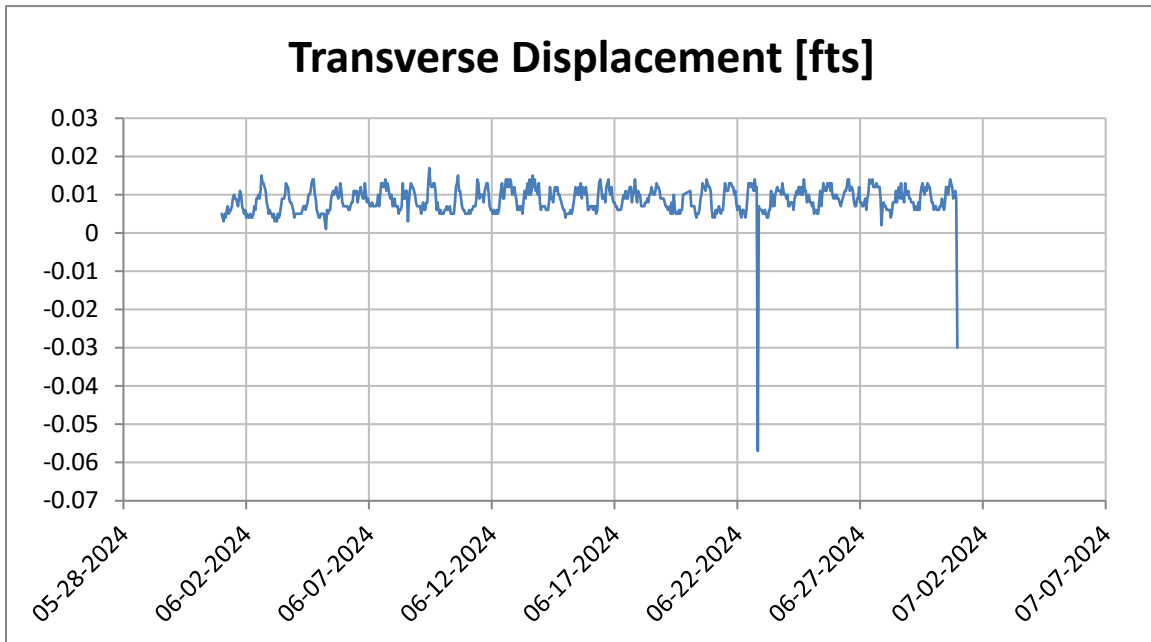
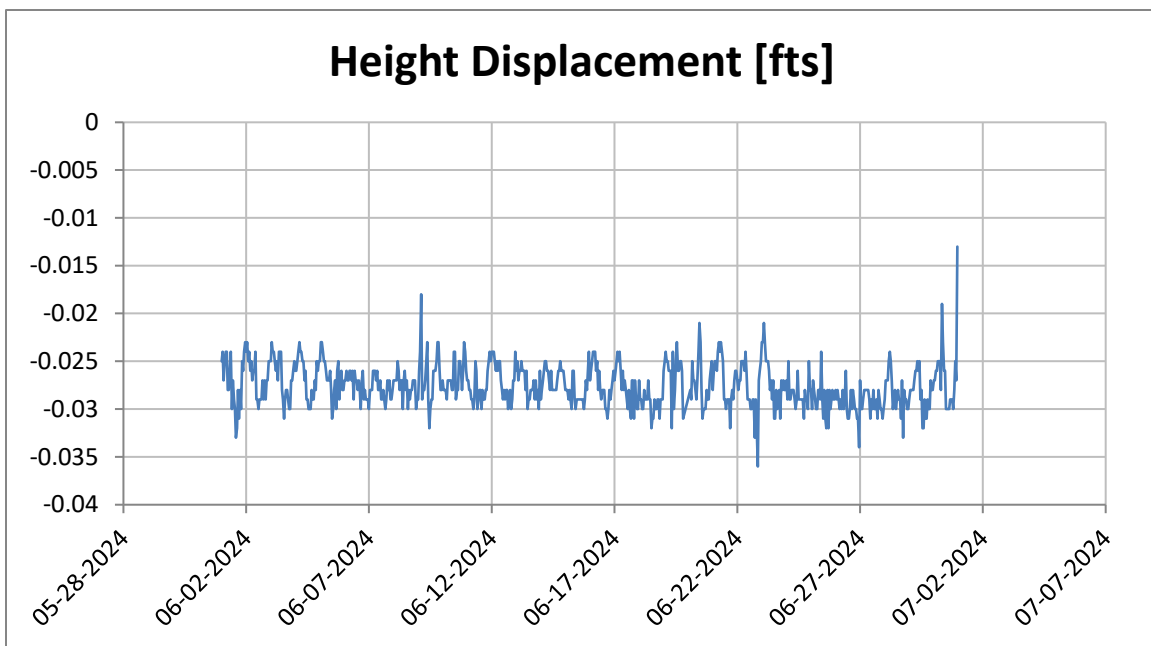
## Prism B7200-2

1. Survey accuracy is +/-0.016 feet.
2. Alert threshold is +/-0.35 feet.
3. Transverse displacement is in the horizontal direction. Positive direction means closer to the robotic total station.
4. Height displacement is in the vertical direction. Positive direction means higher in elevation.
5. Rain and fog at end of month caused erroneous readings.

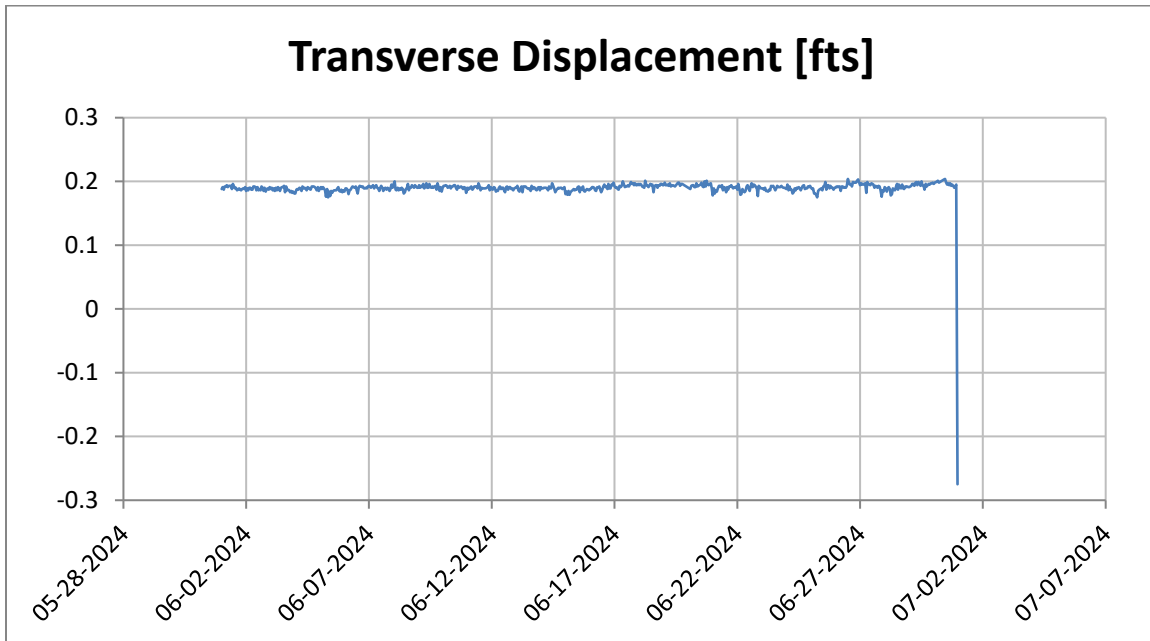
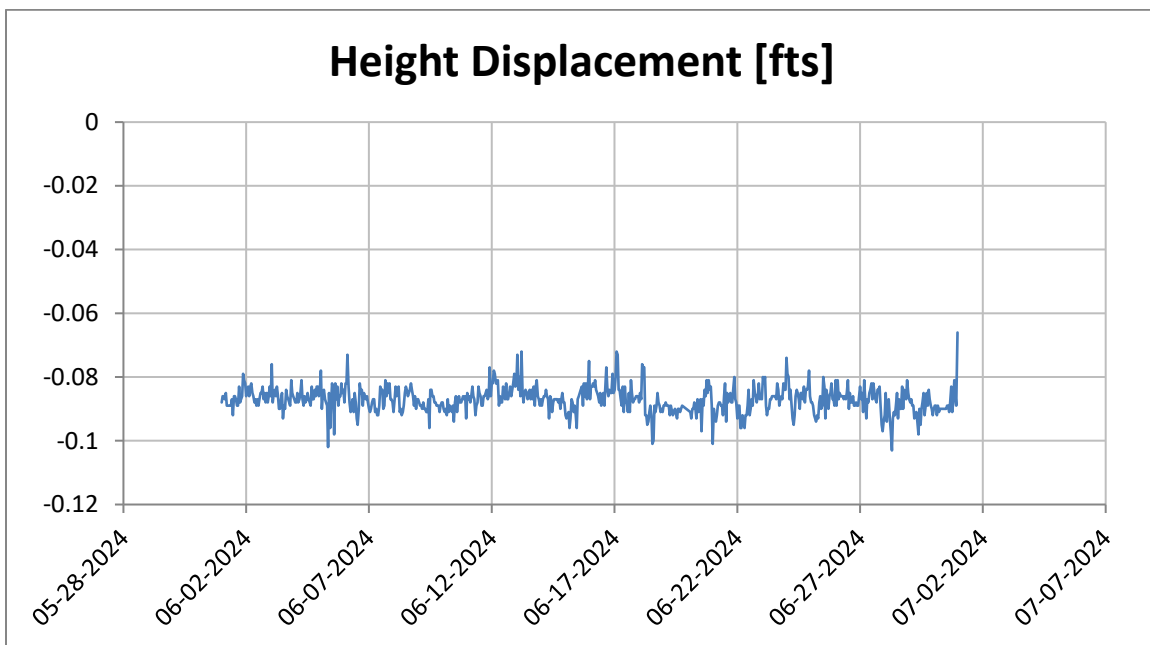
## Prism B7200-3

1. Survey accuracy is  $\pm 0.016$  feet.
2. Alert threshold is  $\pm 0.35$  feet.
3. Transverse displacement is in the horizontal direction. Positive direction means closer to the robotic total station.
4. Height displacement is in the vertical direction. Positive direction means higher in elevation.
5. Rain and fog at end of month caused erroneous readings.

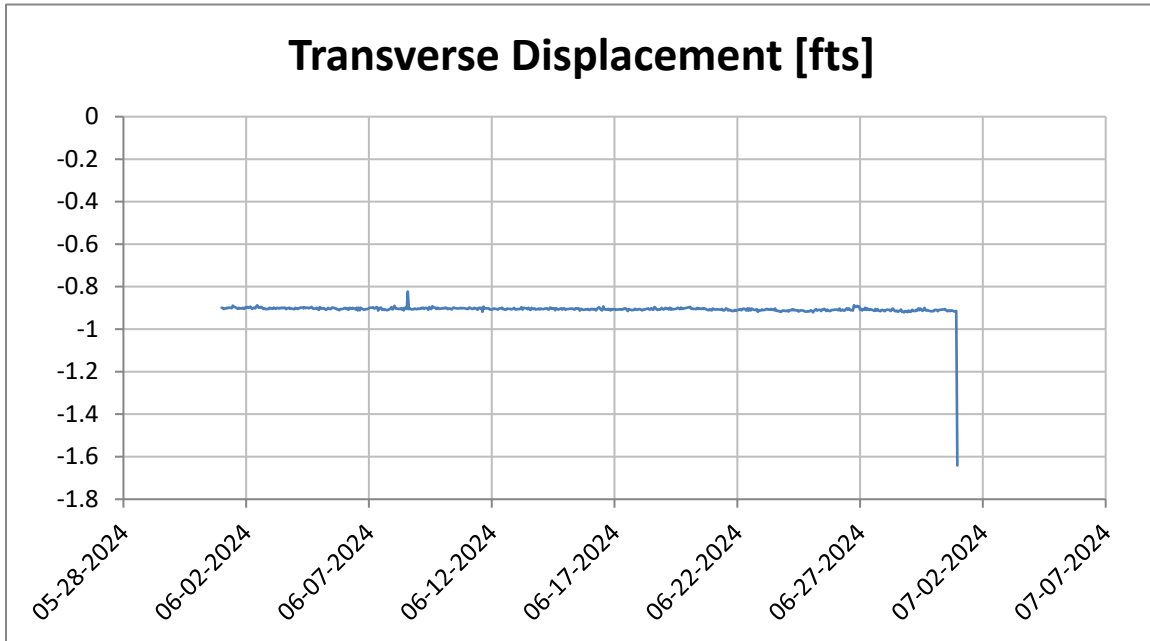
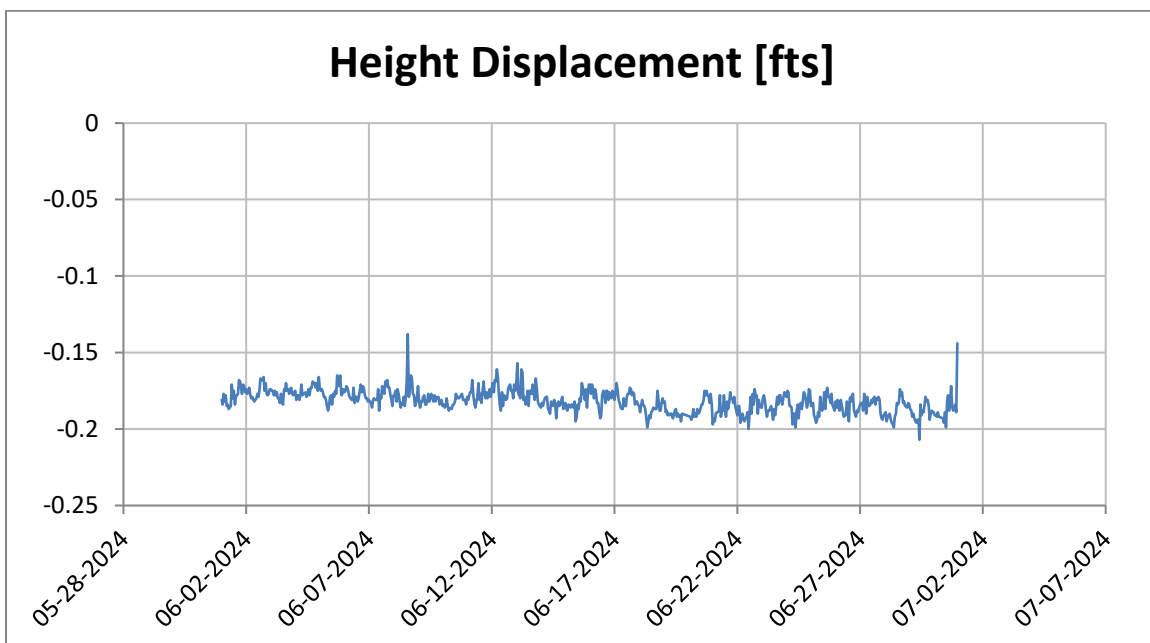
## Prism B7300-0

1. Survey accuracy is +/-0.016 feet.
2. Alert threshold is +/-0.35 feet.
3. Transverse displacement is in the horizontal direction. Positive direction means closer to the robotic total station.
4. Height displacement is in the vertical direction. Positive direction means higher in elevation.
5. Rain and fog at end of month caused erroneous readings.

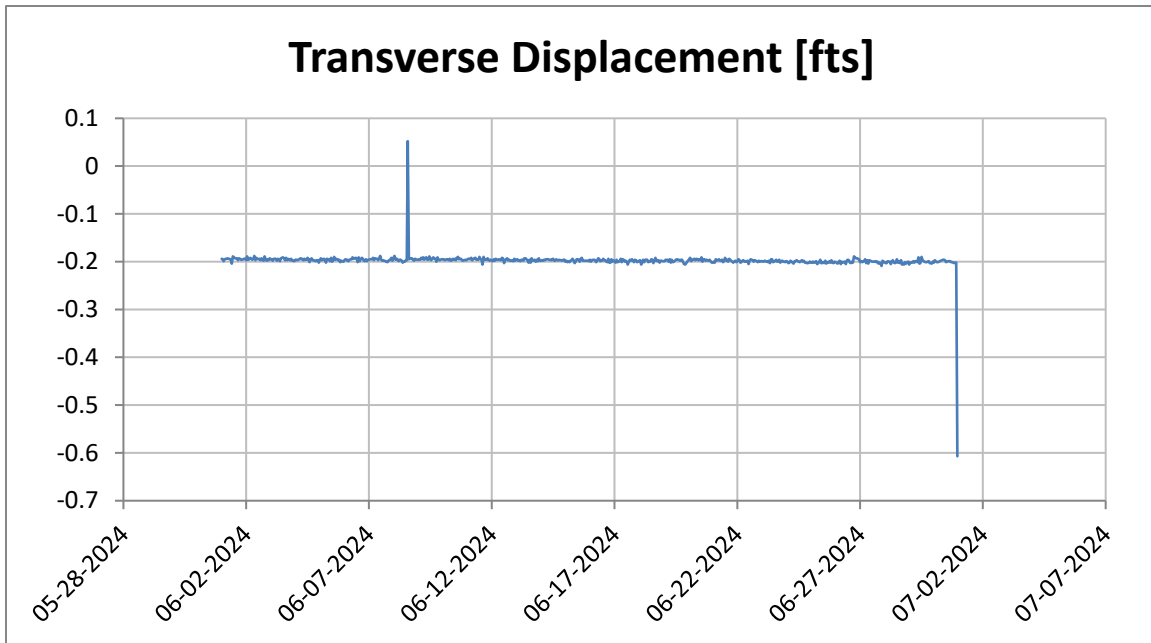
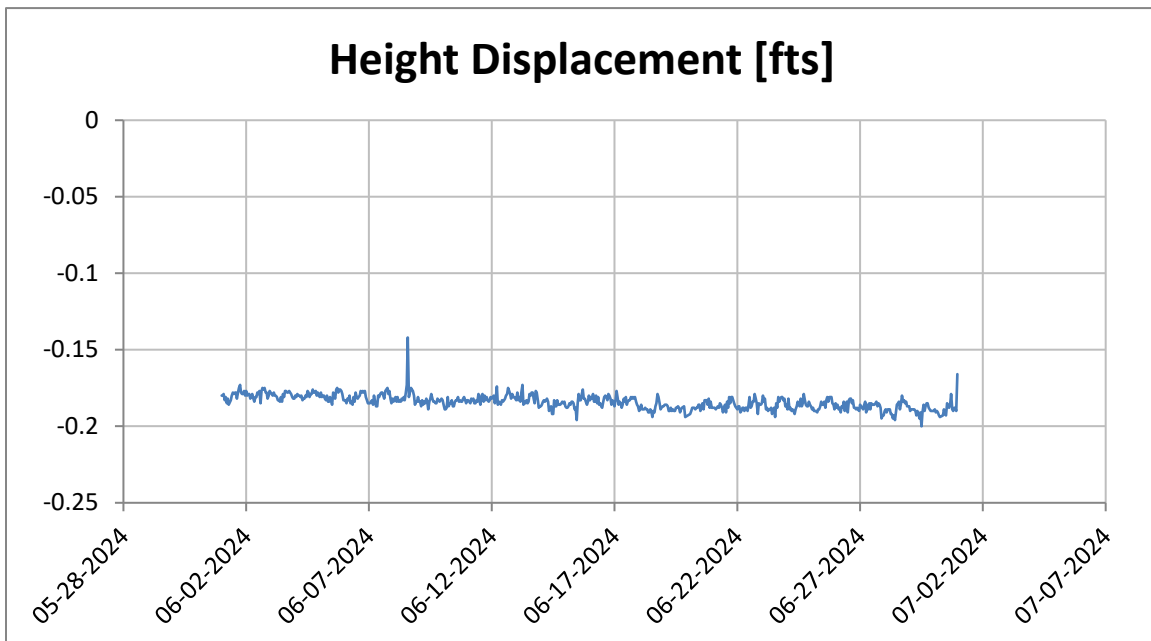
## Prism B7300-1

1. Survey accuracy is +/-0.016 feet.
2. Alert threshold is +/-0.35 feet.
3. Transverse displacement is in the horizontal direction. Positive direction means closer to the robotic total station.
4. Height displacement is in the vertical direction. Positive direction means higher in elevation.
5. Rain and fog at end of month caused erroneous readings.

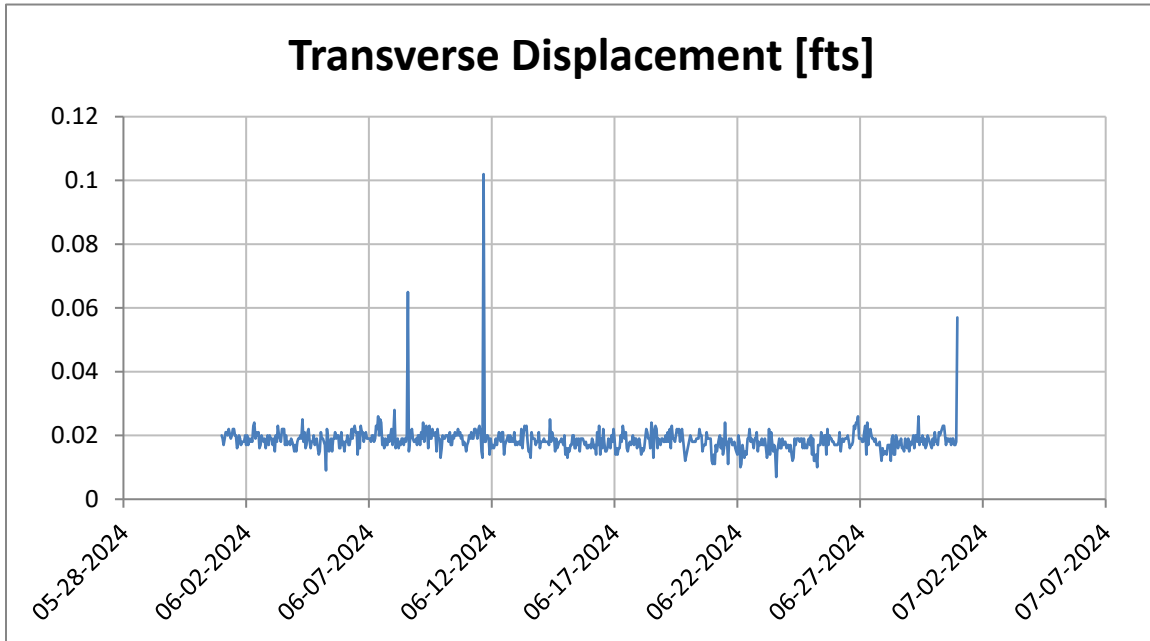
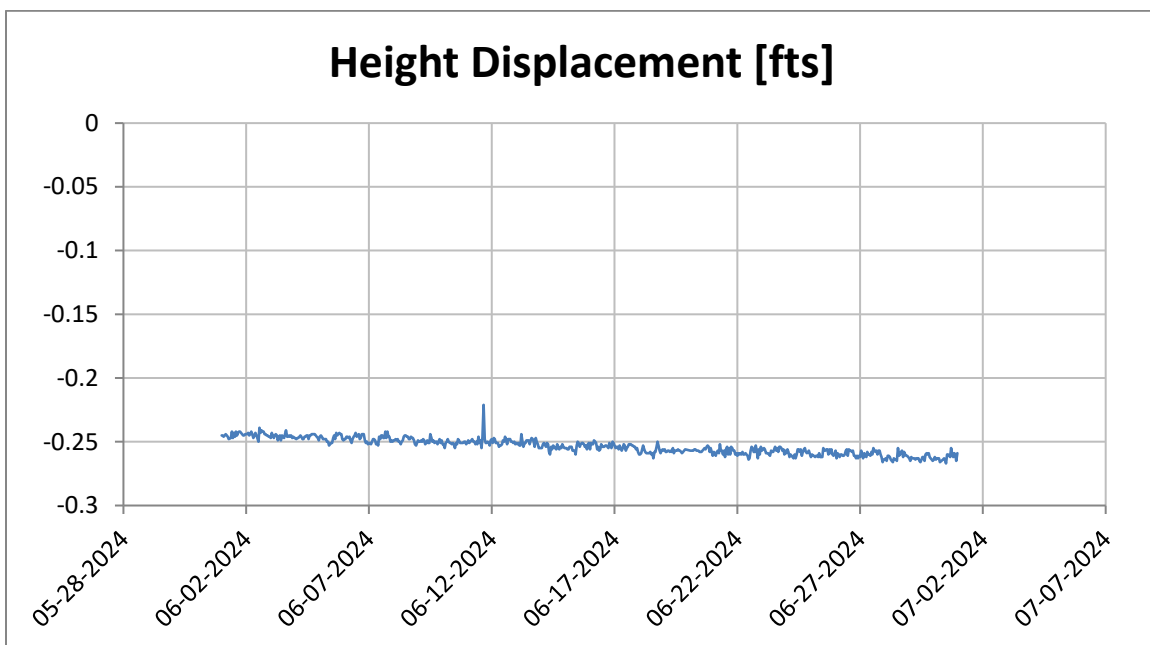
## Prism B7300-2

1. Survey accuracy is  $\pm 0.016$  feet.
2. Alert threshold is  $\pm 0.35$  feet.
3. Transverse displacement is in the horizontal direction. Positive direction means closer to the robotic total station.
4. Height displacement is in the vertical direction. Positive direction means higher in elevation.
5. Rain and fog at end of month caused erroneous readings.

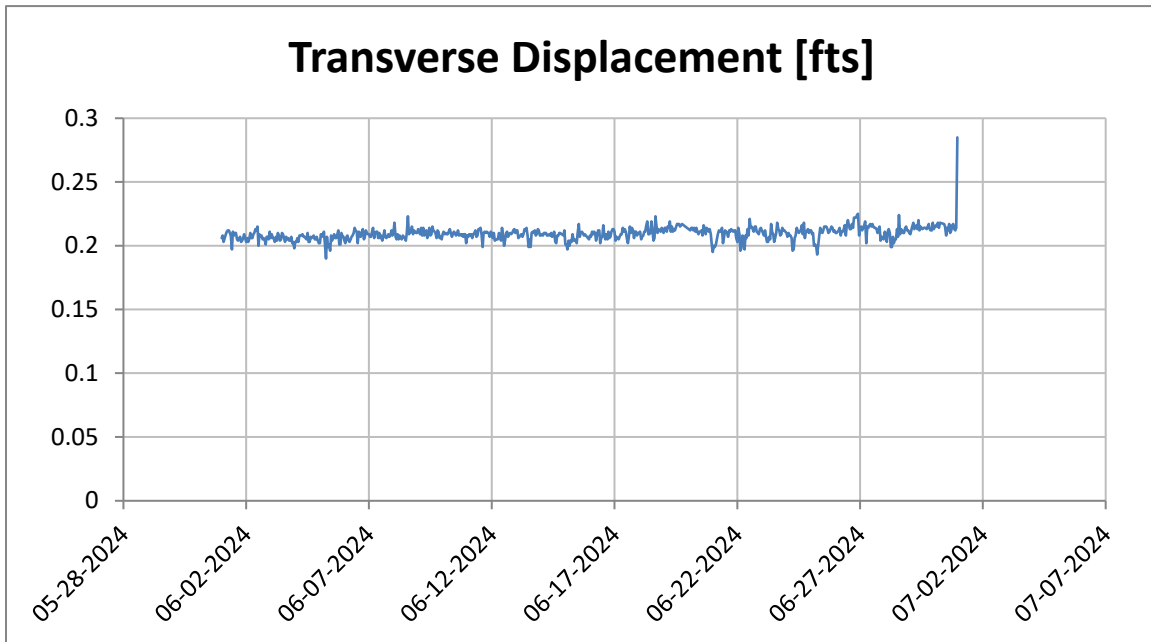
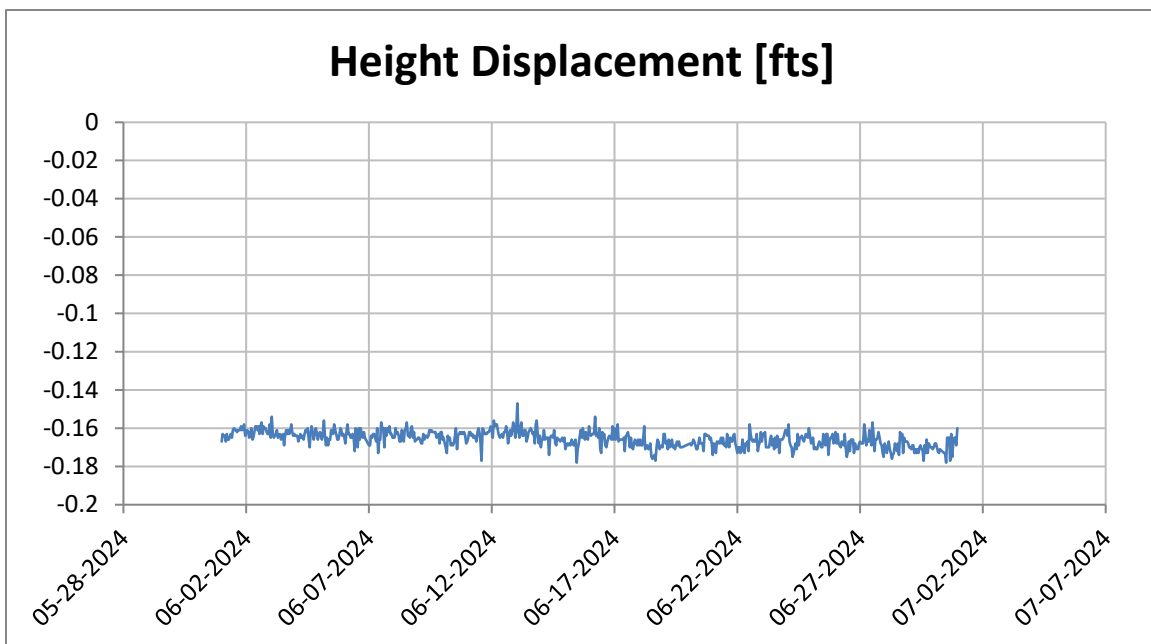
## Prism B7300-3

1. Survey accuracy is  $\pm 0.016$  feet.
2. Alert threshold is  $\pm 0.35$  feet.
3. Transverse displacement is in the horizontal direction. Positive direction means closer to the robotic total station.
4. Height displacement is in the vertical direction. Positive direction means higher in elevation.
5. Rain and fog at end of month caused erroneous readings.

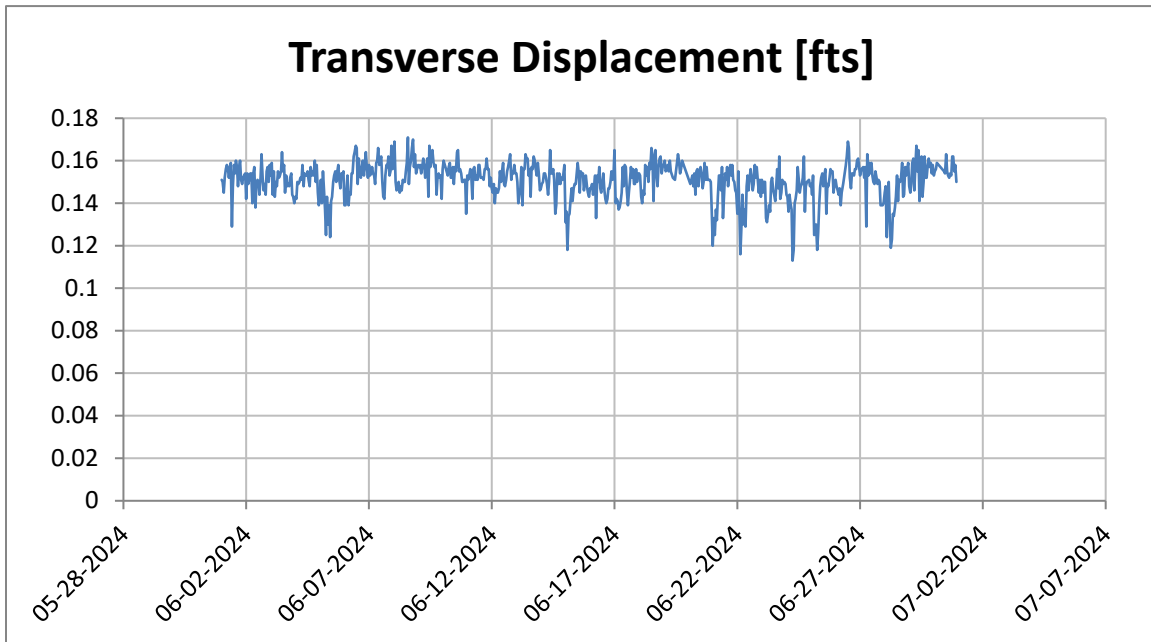
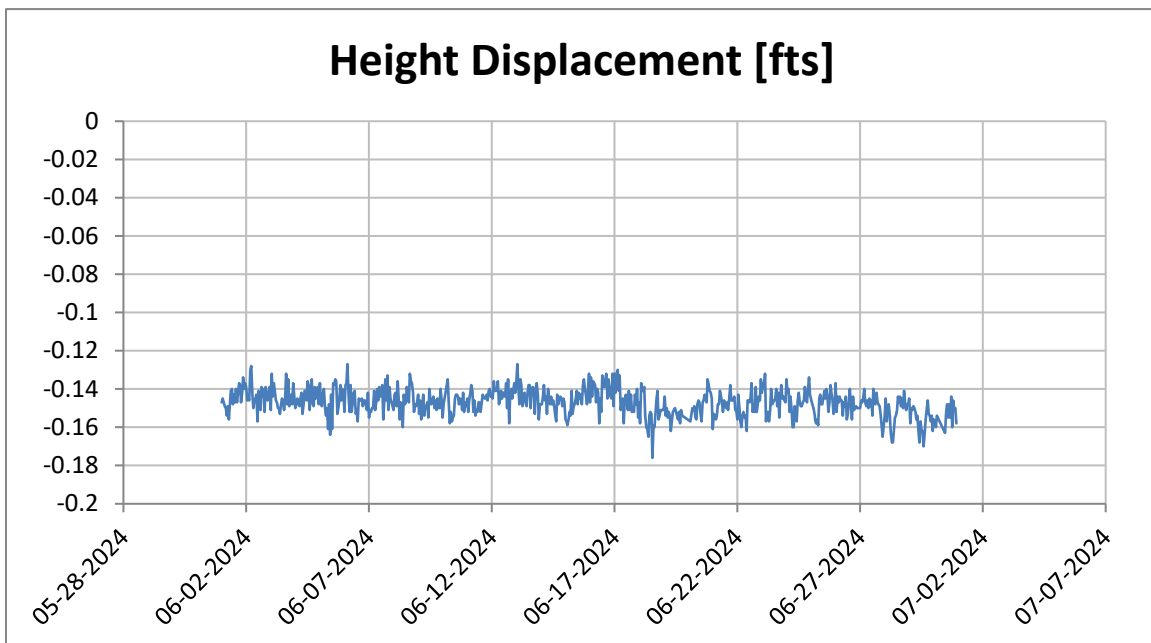
## Prism B7300-4

1. Survey accuracy is  $\pm 0.016$  feet.
2. Alert threshold is  $\pm 0.35$  feet.
3. Transverse displacement is in the horizontal direction. Positive direction means closer to the robotic total station.
4. Height displacement is in the vertical direction. Positive direction means higher in elevation.
5. Rain and fog at end of month caused erroneous readings.

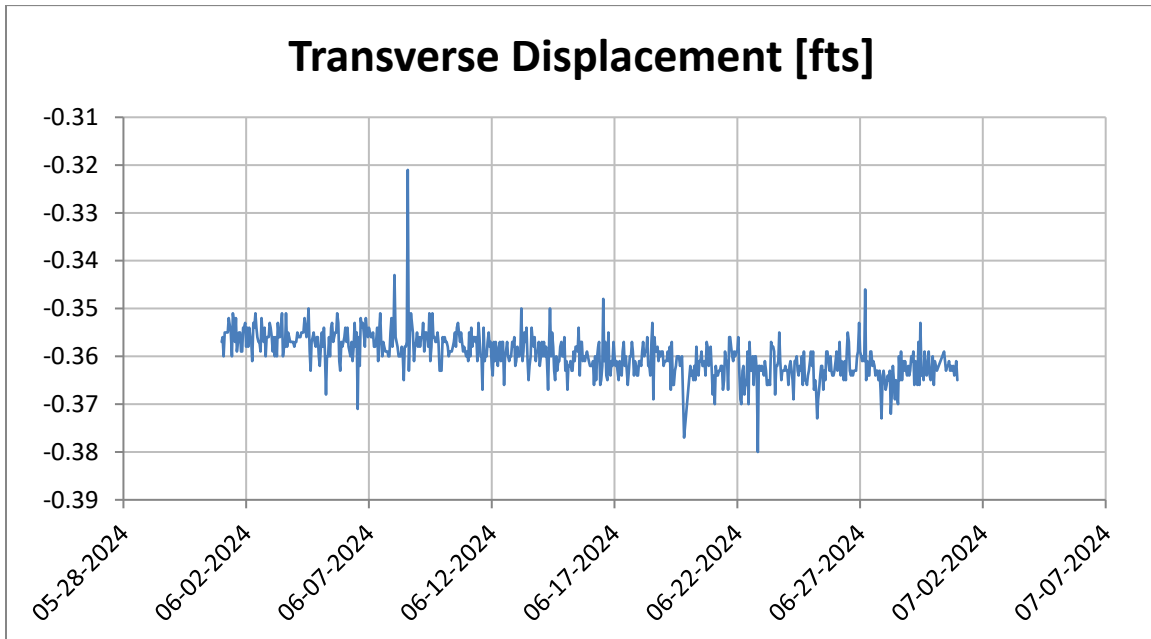
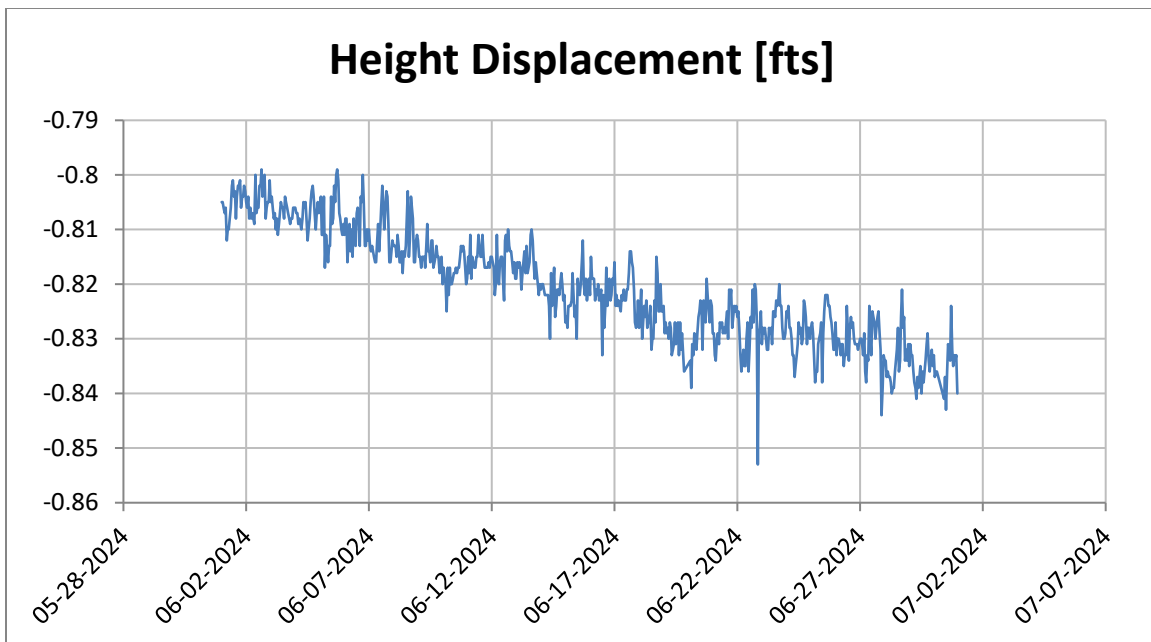
## Prism B7400-1

1. Survey accuracy is  $\pm 0.016$  feet.
2. Alert threshold is  $\pm 0.35$  feet.
3. Transverse displacement is in the horizontal direction. Positive direction means closer to the robotic total station.
4. Height displacement is in the vertical direction. Positive direction means higher in elevation.
5. Rain and fog at end of month caused erroneous readings.

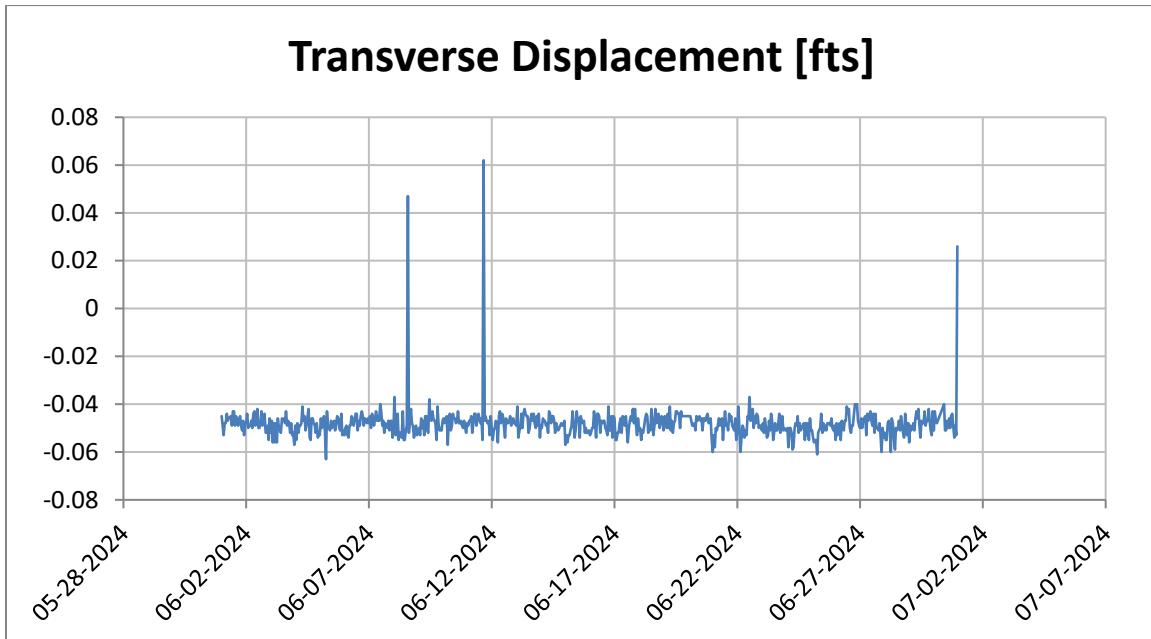
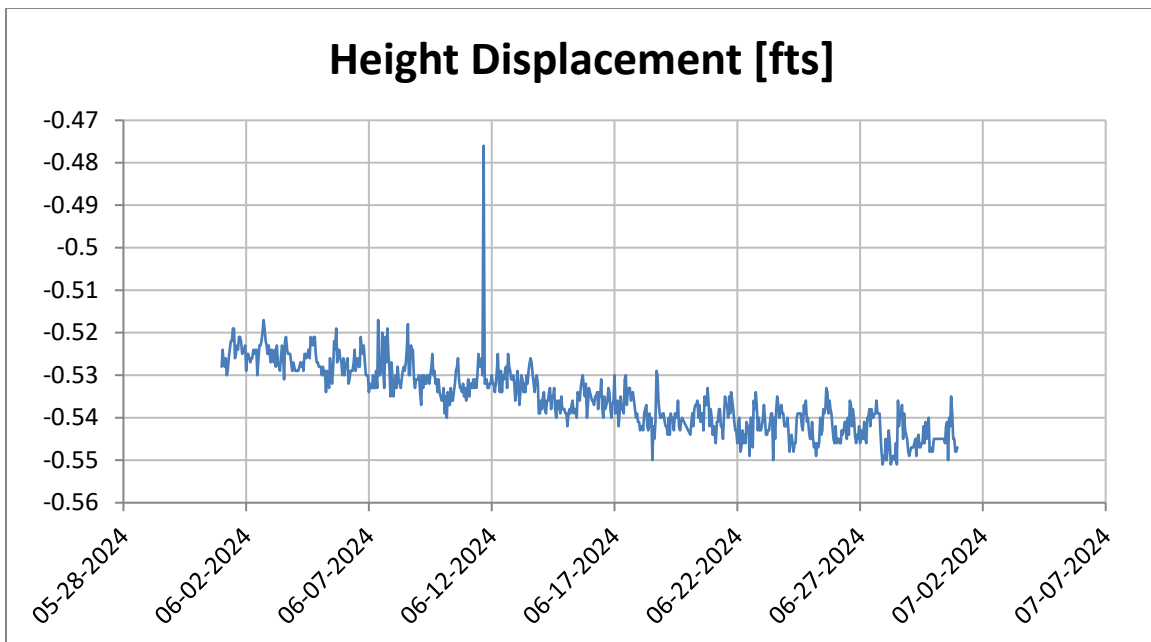
## Prism B7400-2

1. Survey accuracy is +/-0.016 feet.
2. Alert threshold is +/-0.35 feet.
3. Transverse displacement is in the horizontal direction. Positive direction means closer to the robotic total station.
4. Height displacement is in the vertical direction. Positive direction means higher in elevation.
5. Rain and fog at end of month caused erroneous readings.

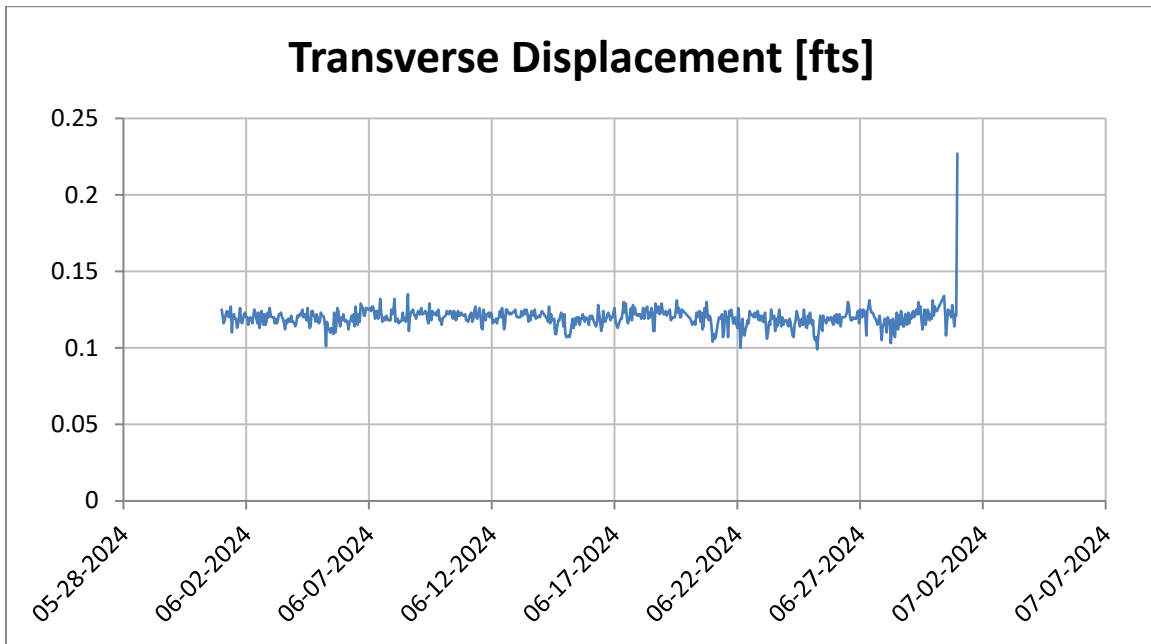
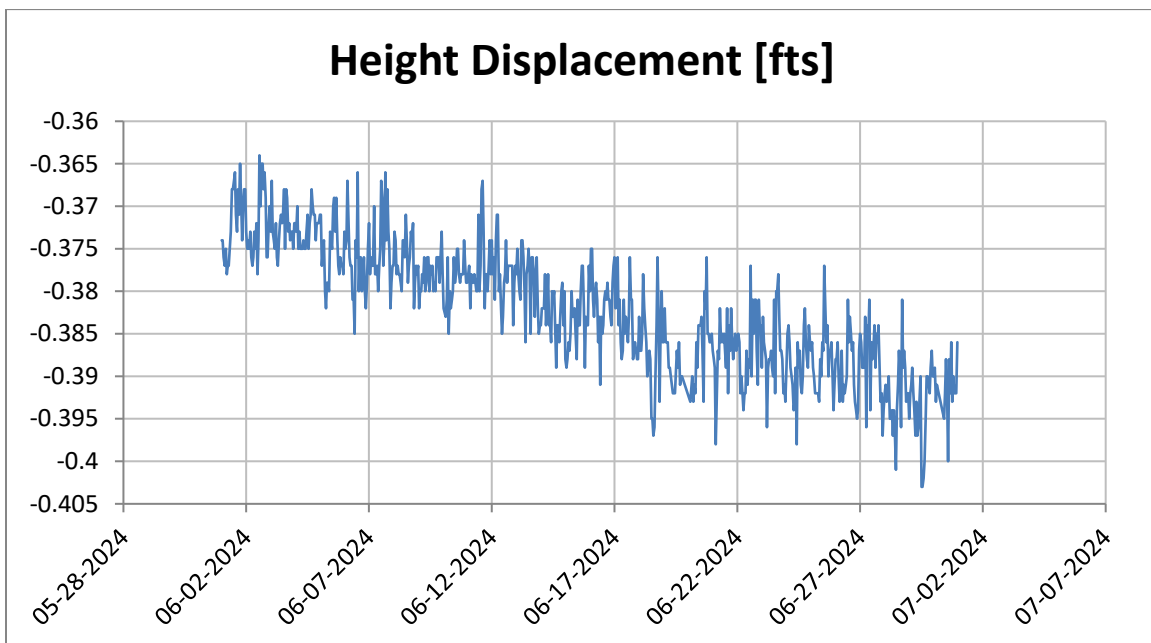
### Prism B7400-3

1. Survey accuracy is +/-0.016 feet.
2. Alert threshold is +/-0.35 feet.
3. Transverse displacement is in the horizontal direction. Positive direction means closer to the robotic total station.
4. Height displacement is in the vertical direction. Positive direction means higher in elevation.
5. Rain and fog at end of month caused erroneous readings.

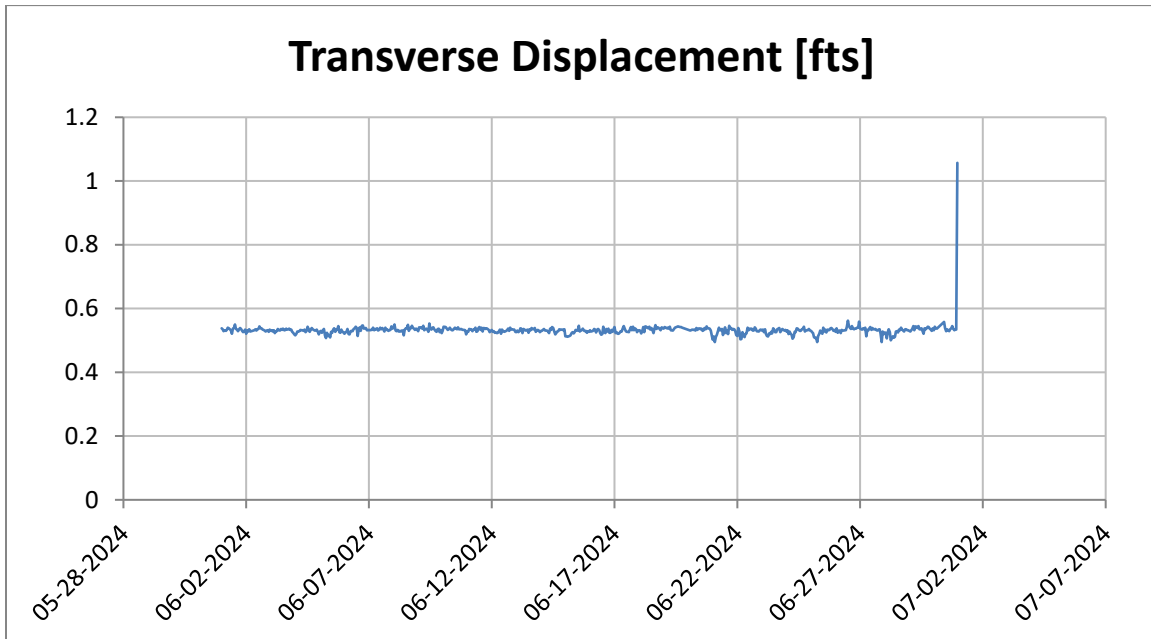
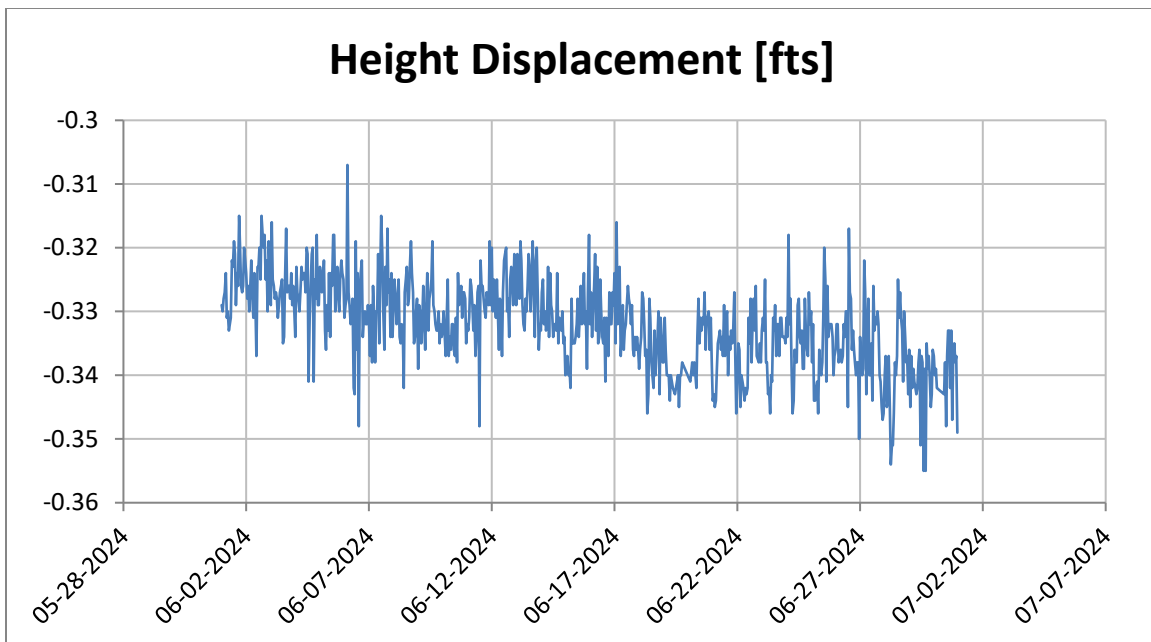
## Prism B7400-4

1. Survey accuracy is  $\pm 0.016$  feet.
2. Alert threshold is  $\pm 0.35$  feet.
3. Transverse displacement is in the horizontal direction. Positive direction means closer to the robotic total station.
4. Height displacement is in the vertical direction. Positive direction means higher in elevation.
5. Rain and fog at end of month caused erroneous readings.

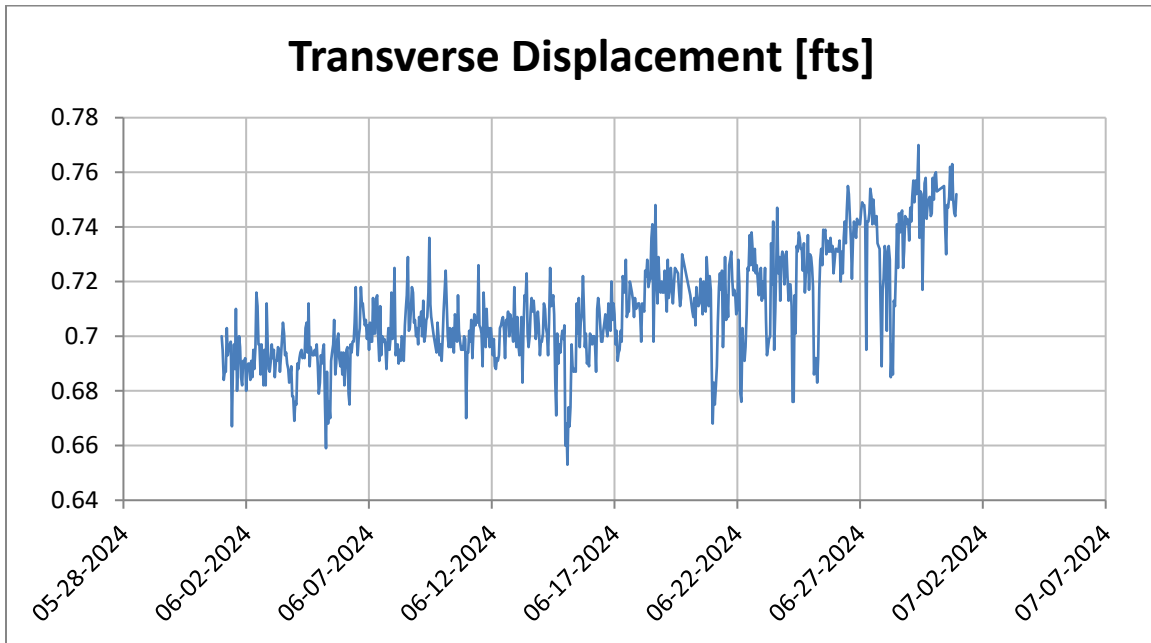
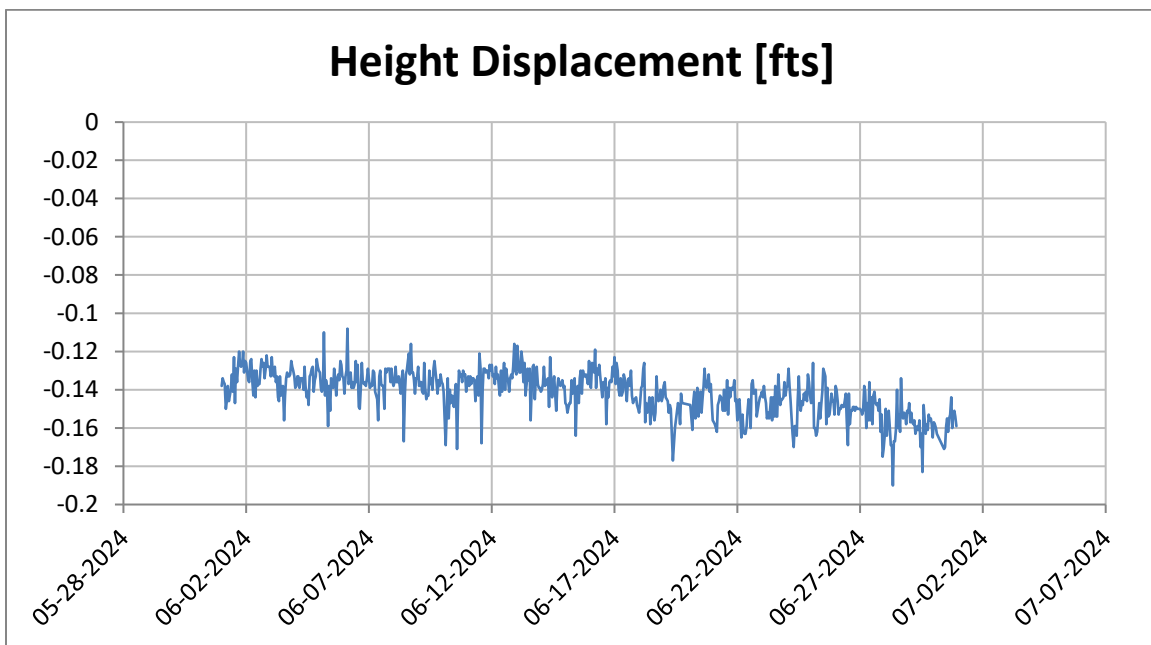
## Prism B7400-5

1. Survey accuracy is  $\pm 0.016$  feet.
2. Alert threshold is  $\pm 0.35$  feet.
3. Transverse displacement is in the horizontal direction. Positive direction means closer to the robotic total station.
4. Height displacement is in the vertical direction. Positive direction means higher in elevation.
5. Rain and fog at end of month caused erroneous readings.
