To: Jerald Schnabel  
Castle Aggregate  
File: June 2024 Monitoring Summary

**Reference: June 2024 Geotechnical Monitoring Summary Pikeview Quarry**

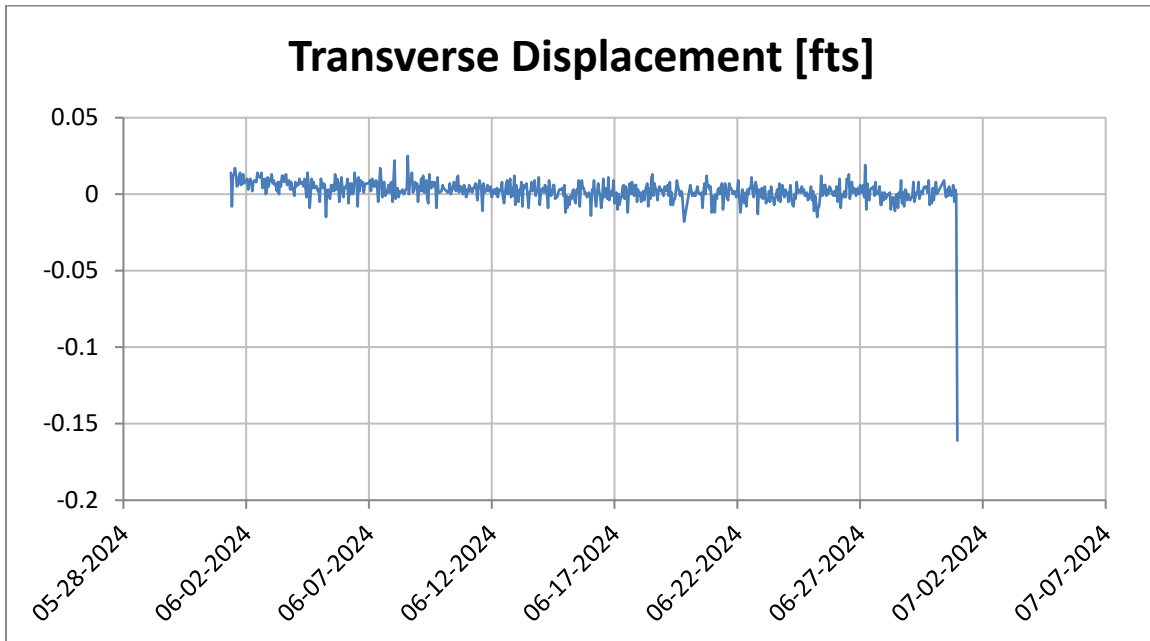
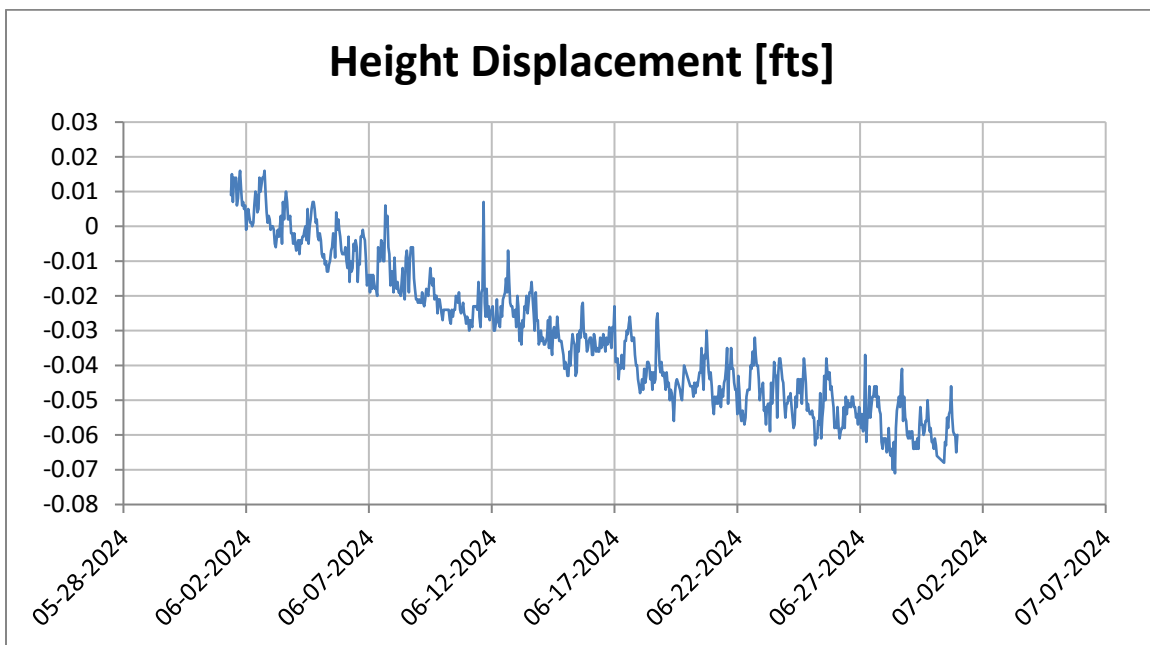
## B7500-1

1. Survey accuracy is  $\pm 0.016$  feet.
2. Alert threshold is  $\pm 0.35$  feet.
3. Transverse displacement is in the horizontal direction. Positive direction means closer to the robotic total station.
4. Height displacement is in the vertical direction. Positive direction means higher in elevation.
5. New instrument installed June 25.
6. Rain and fog at end of month caused erroneous readings.

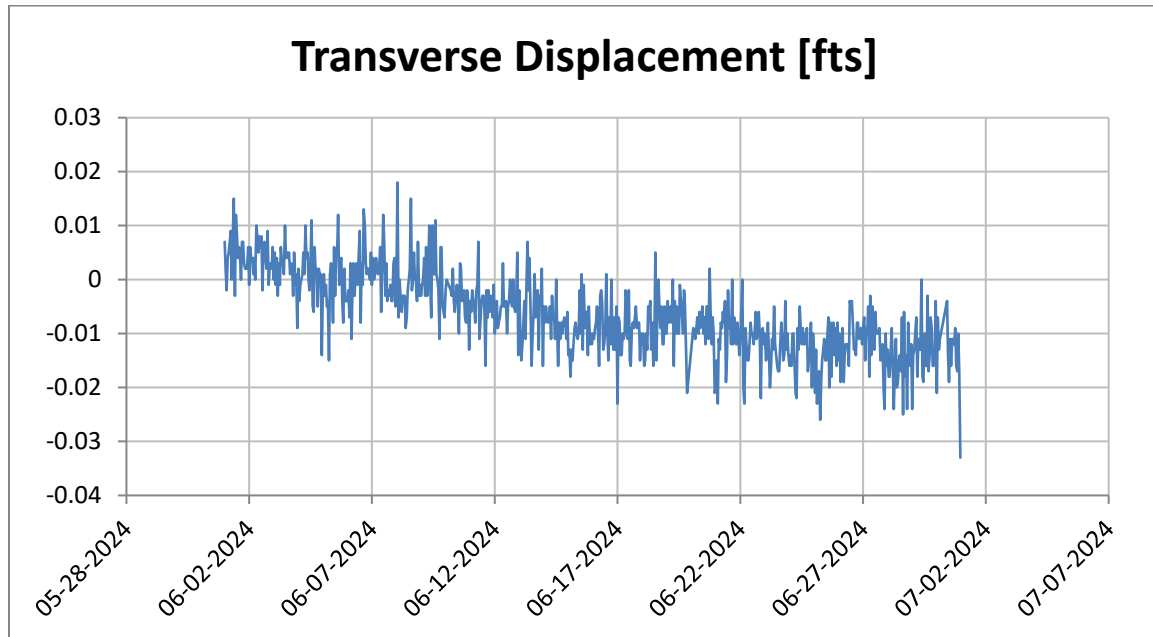
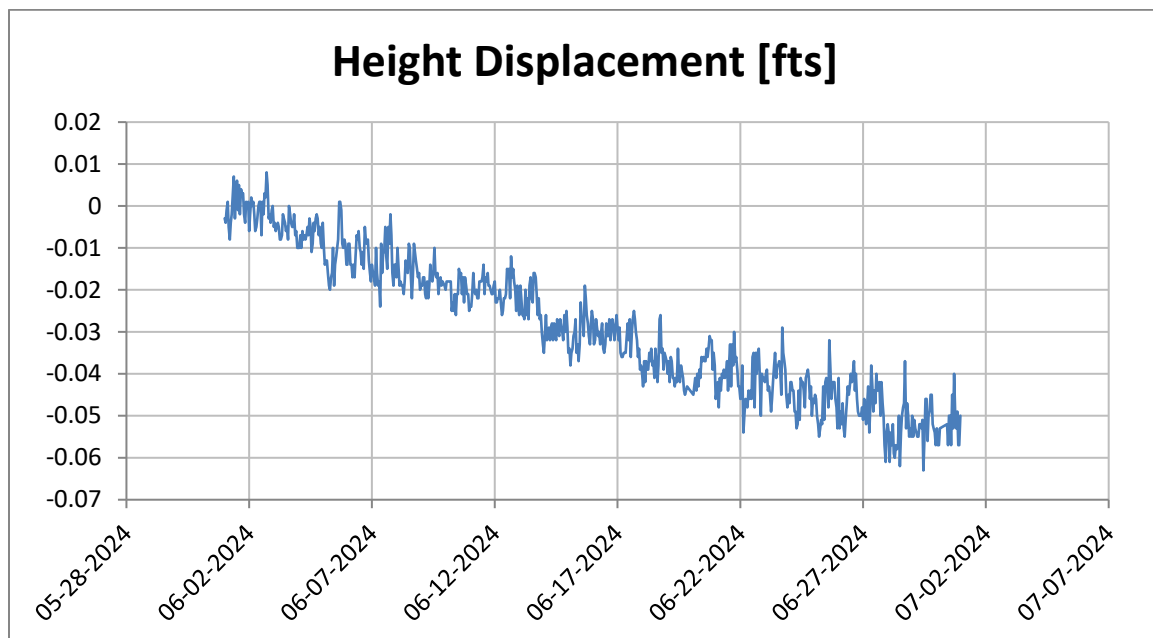
**B7500-2**

1. Survey accuracy is +/-0.016 feet.
2. Alert threshold is +/-0.35 feet.
3. Transverse displacement is in the horizontal direction. Positive direction means closer to the robotic total station.
4. Height displacement is in the vertical direction. Positive direction means higher in elevation.
5. New instrument installed June 25.
6. Rain and fog at end of month caused erroneous readings.
