To: Jerald Schnabel
Castle Aggregate
File: July 2024 Monitoring Summary

From: Paul Kos
Denver, CO 80202
Date: August 23, 2024

Reference: July 2024 Geotechnical Monitoring Summary Pikeview Quarry

Client/Project
CASTLE AGGREGATE
PIKEVIEW QUARRY SLOPE
MONITORING
Project No.
2057288200

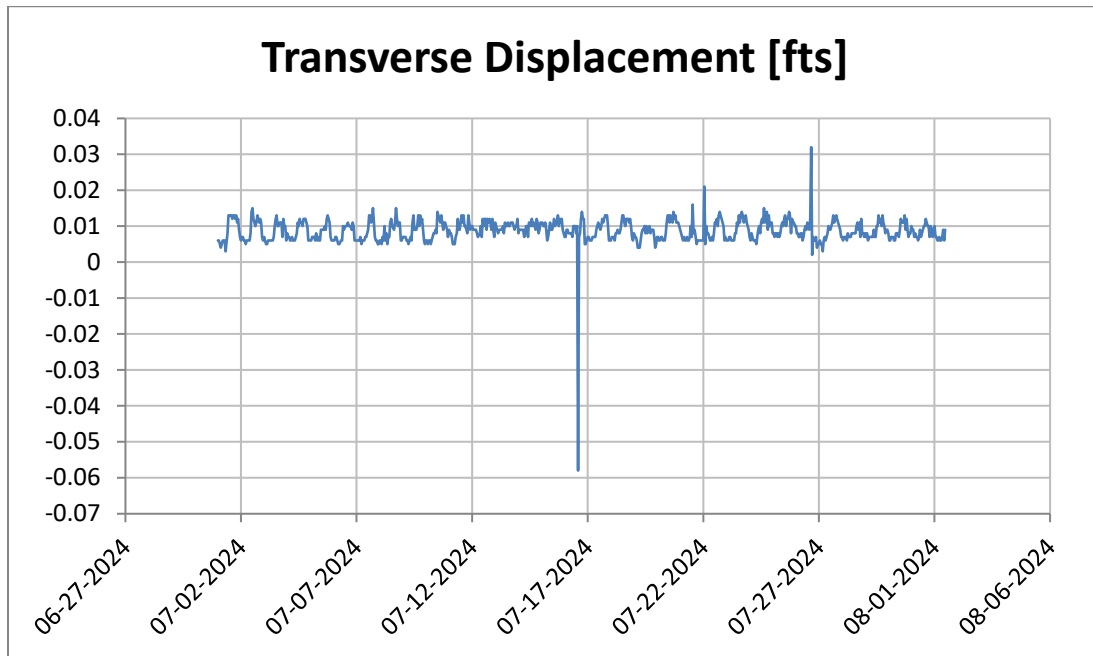
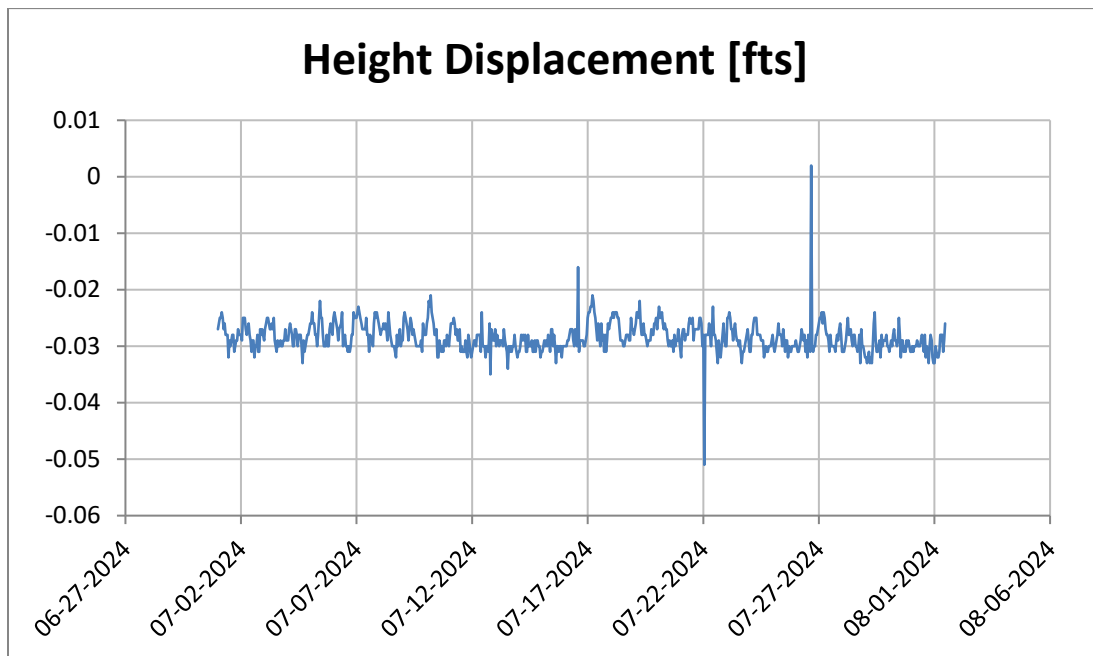
Prism B7200-2

Date(s)	Alert	Cause/Actions taken	Resolved
30-Jun to 1-Jul	P5 regression limits	Rain and fog. No work being performed at time of alerts. Readings in positive and negative directions.	1-Jul
6-Jul	B7200-2 not found	Single event in morning. Prism obscured by sun glare.	6-Jul
6-Jul to 8-Jul	B7500-4 not found	Prism damaged, potentially by animals or equipment operations.	8-Jul
7-Jul	B7200-2 not found	Single event in morning. Prism obscured by sun glare.	7-Jul
9-Jul	B7200-2 not found	Single event in morning. Prism obscured by sun glare.	9-Jul
10-Jul	B7200-2 not found	Single event in morning. Prism obscured by sun glare.	10-Jul
12-Jul	P70R not found	Prism moved by wildlife.	12-Jul
12-Jul	B7300-3 not found	Single alert. Equipment operations in area.	12-Jul
15-Jul	P32 regression limit	Single event when no operations in area. P32 was replaced by P32R at the same location, and no alert was received for P32R.	15-Jul

1. Survey accuracy is ± 0.016 feet.
2. Alert threshold is ± 0.35 feet.
3. Transverse displacement is in the horizontal direction. Positive direction means closer to the robotic total station.
4. Height displacement is in the vertical direction. Positive direction means higher in elevation.
5. Rain and fog on July 16 and 26 resulted in increased data scatter.

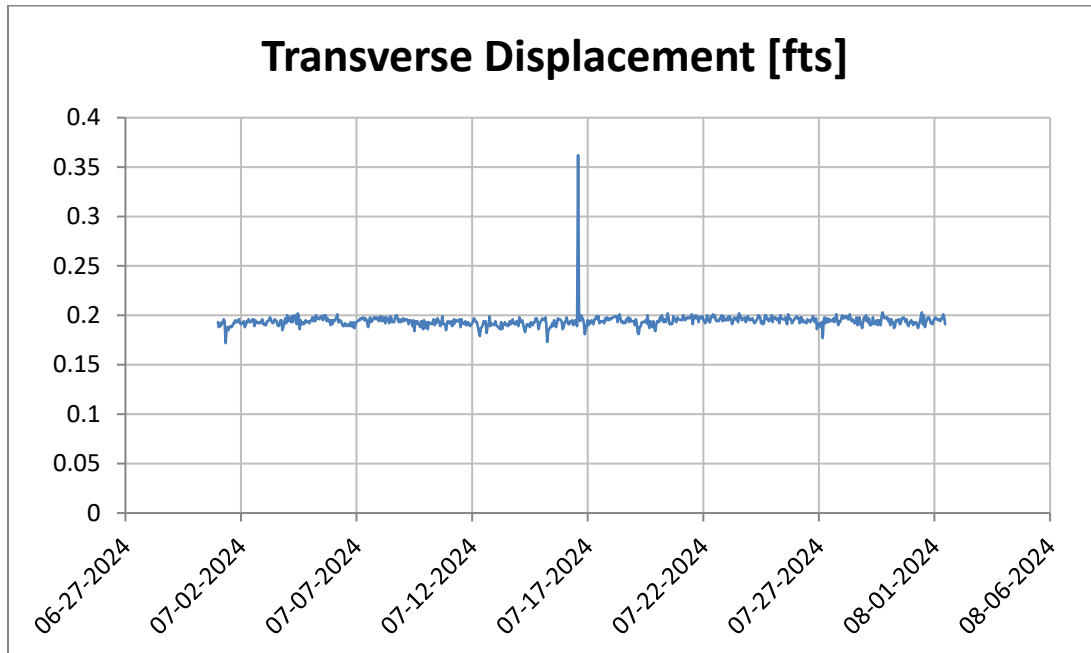
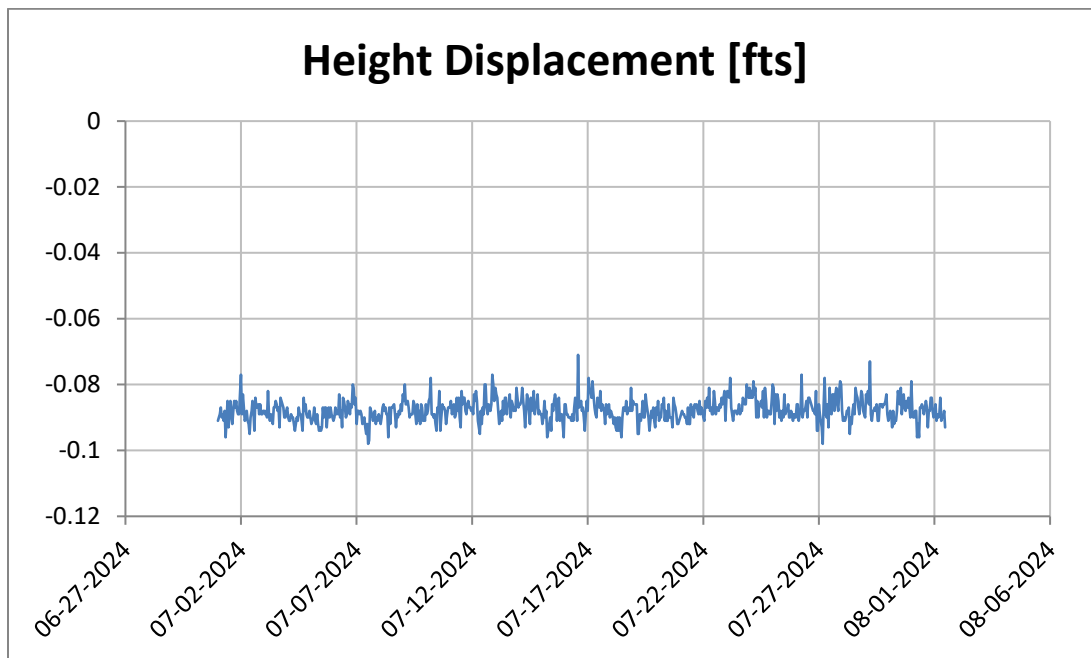
Prism B7200-3

1. Survey accuracy is +/-0.016 feet.
2. Alert threshold is +/-0.35 feet.
3. Transverse displacement is in the horizontal direction. Positive direction means closer to the robotic total station.
4. Height displacement is in the vertical direction. Positive direction means higher in elevation.
5. Rain and fog on July 16 and 26 resulted in increased data scatter.

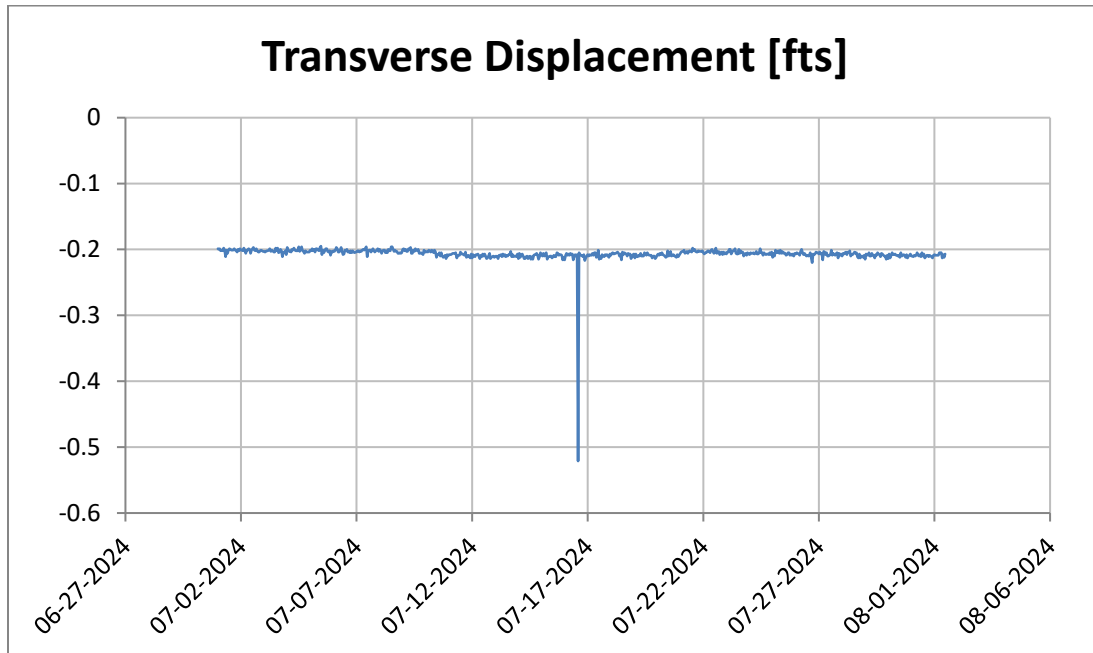
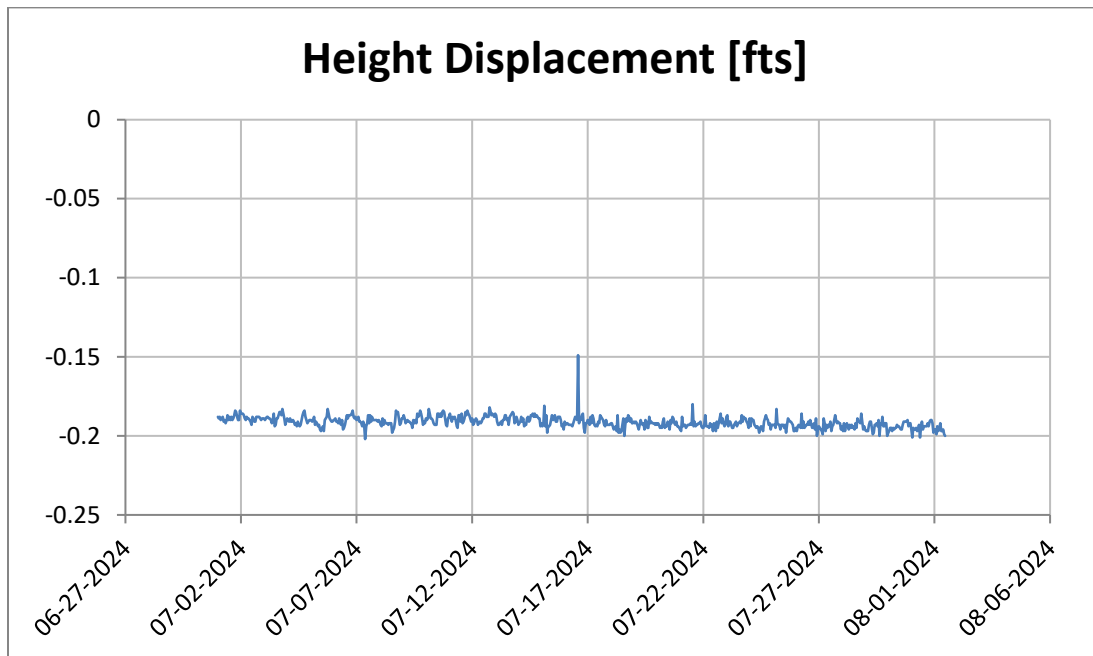
Prism B7300-1

1. Survey accuracy is ± 0.016 feet.
2. Alert threshold is ± 0.35 feet.
3. Transverse displacement is in the horizontal direction. Positive direction means closer to the robotic total station.
4. Height displacement is in the vertical direction. Positive direction means higher in elevation.
5. Rain and fog on July 16 and 26 resulted in increased data scatter.

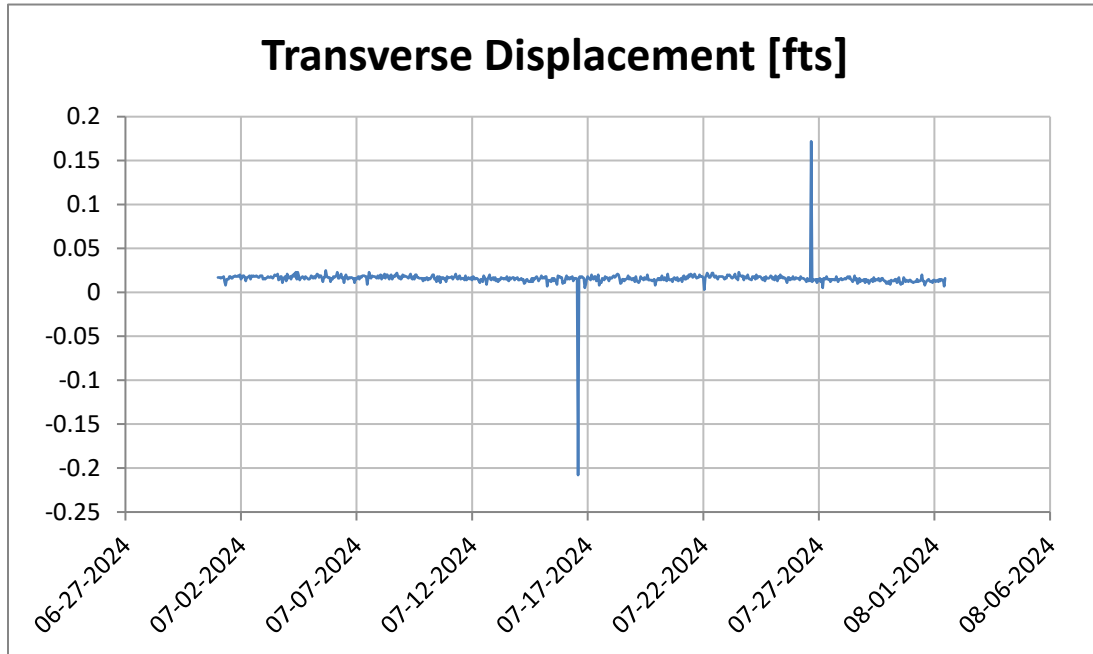
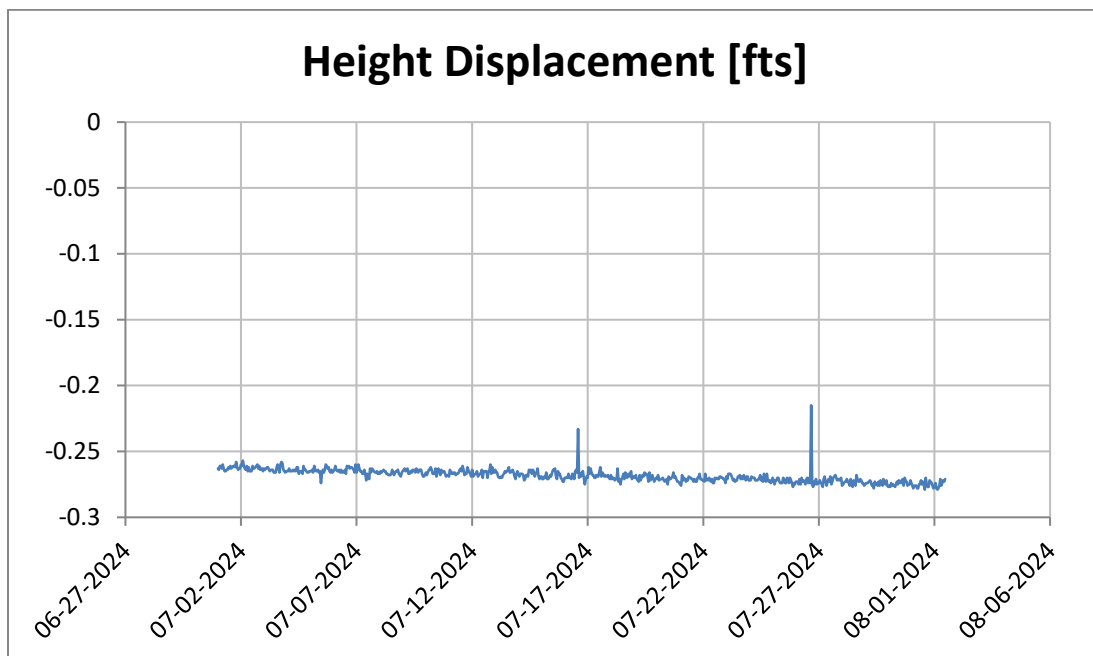
Prism B7300-2

1. Survey accuracy is +/-0.016 feet.
2. Alert threshold is +/-0.35 feet.
3. Transverse displacement is in the horizontal direction. Positive direction means closer to the robotic total station.
4. Height displacement is in the vertical direction. Positive direction means higher in elevation.
5. Rain and fog on July 16 and 26 resulted in increased data scatter.

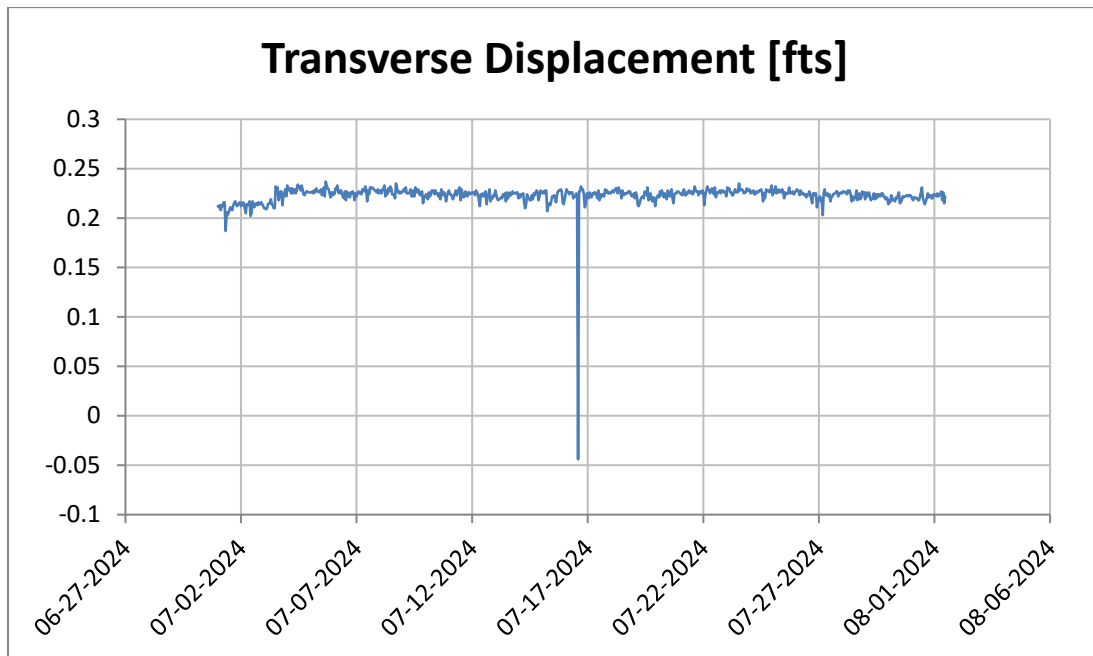
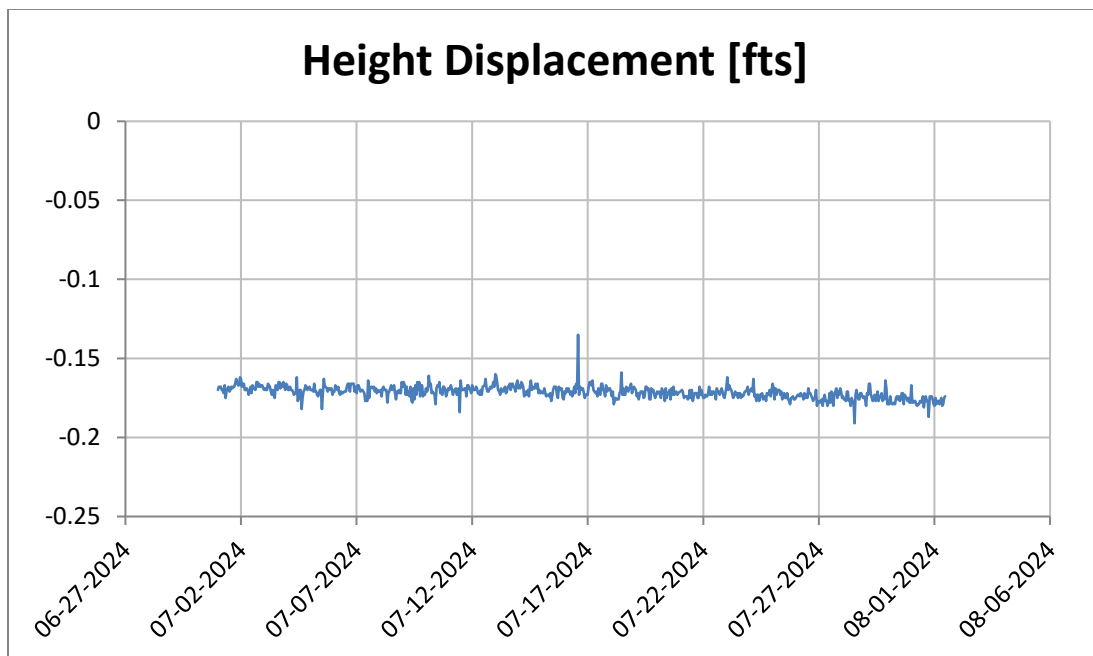
Prism B7300-3

1. Survey accuracy is ± 0.016 feet.
2. Alert threshold is ± 0.35 feet.
3. Transverse displacement is in the horizontal direction. Positive direction means closer to the robotic total station.
4. Height displacement is in the vertical direction. Positive direction means higher in elevation.
5. Rain and fog on July 16 and 26 resulted in increased data scatter.

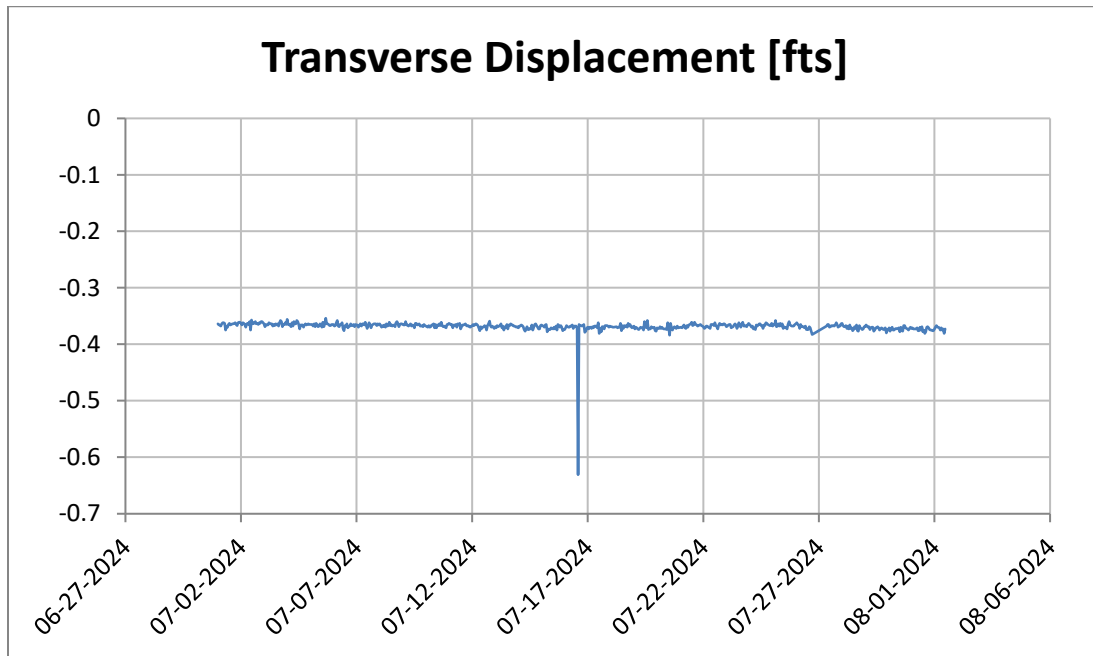
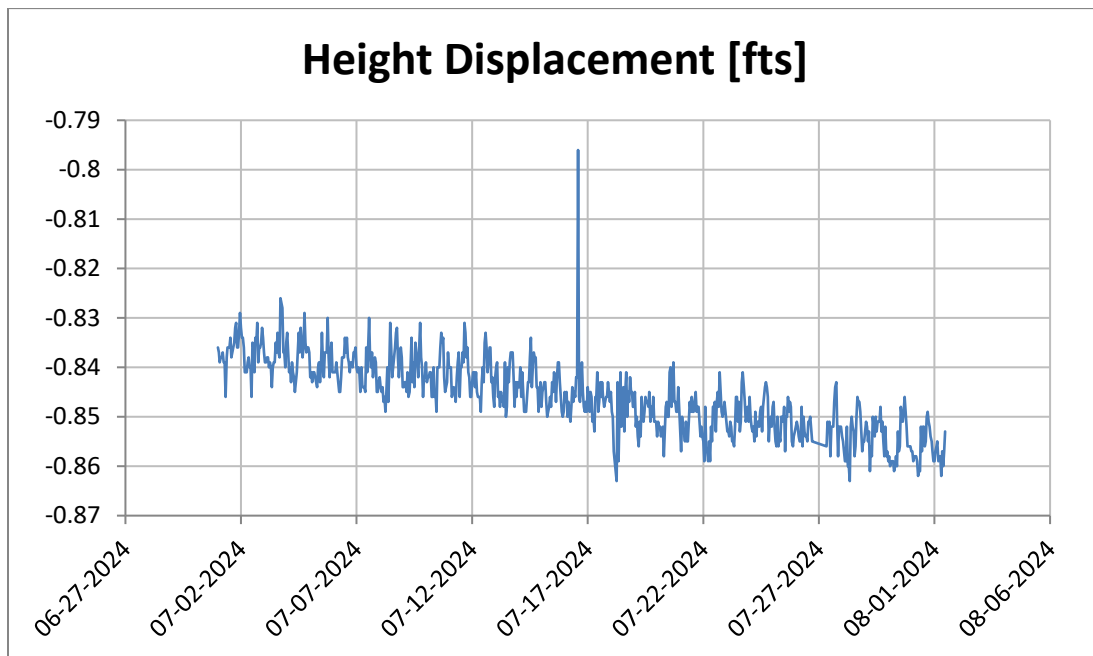
Prism B7400-1

1. Survey accuracy is ± 0.016 feet.
2. Alert threshold is ± 0.35 feet.
3. Transverse displacement is in the horizontal direction. Positive direction means closer to the robotic total station.
4. Height displacement is in the vertical direction. Positive direction means higher in elevation.
5. Rain and fog on July 16 and 26 resulted in increased data scatter.

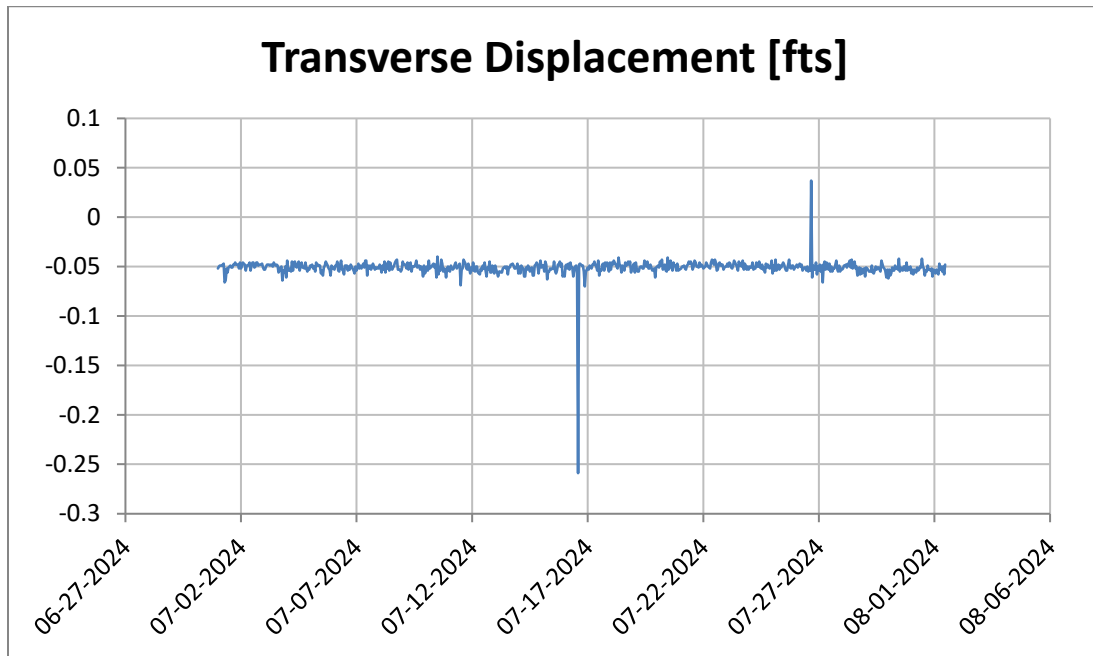
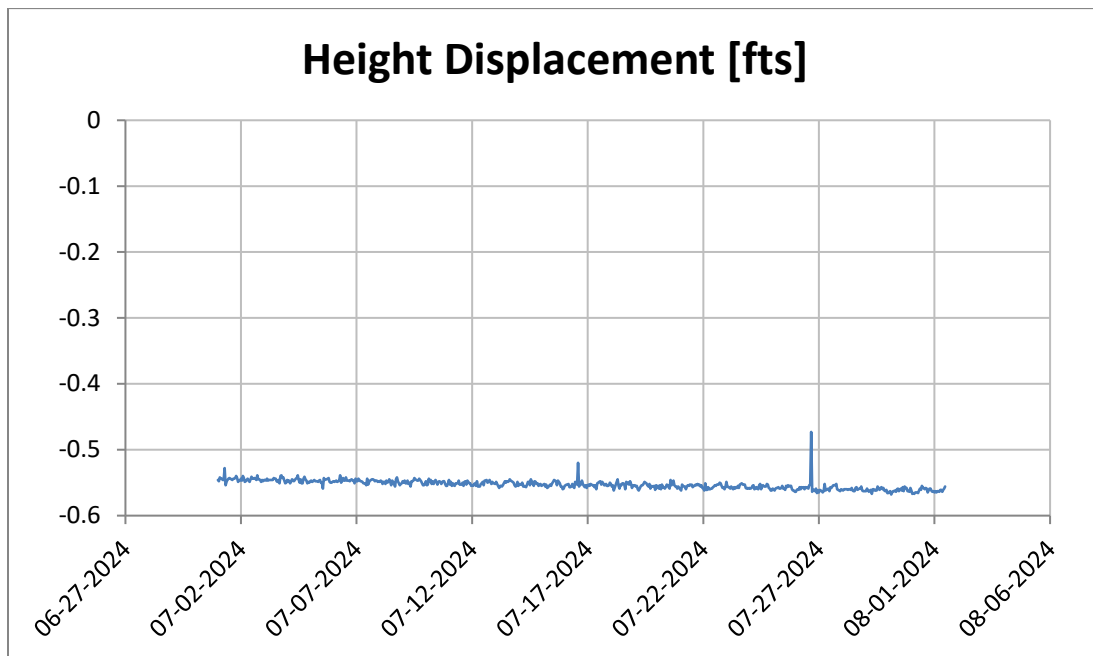
Prism B7400-2

1. Survey accuracy is ± 0.016 feet.
2. Alert threshold is ± 0.35 feet.
3. Transverse displacement is in the horizontal direction. Positive direction means closer to the robotic total station.
4. Height displacement is in the vertical direction. Positive direction means higher in elevation.
5. Rain and fog on July 16 and 26 resulted in increased data scatter.

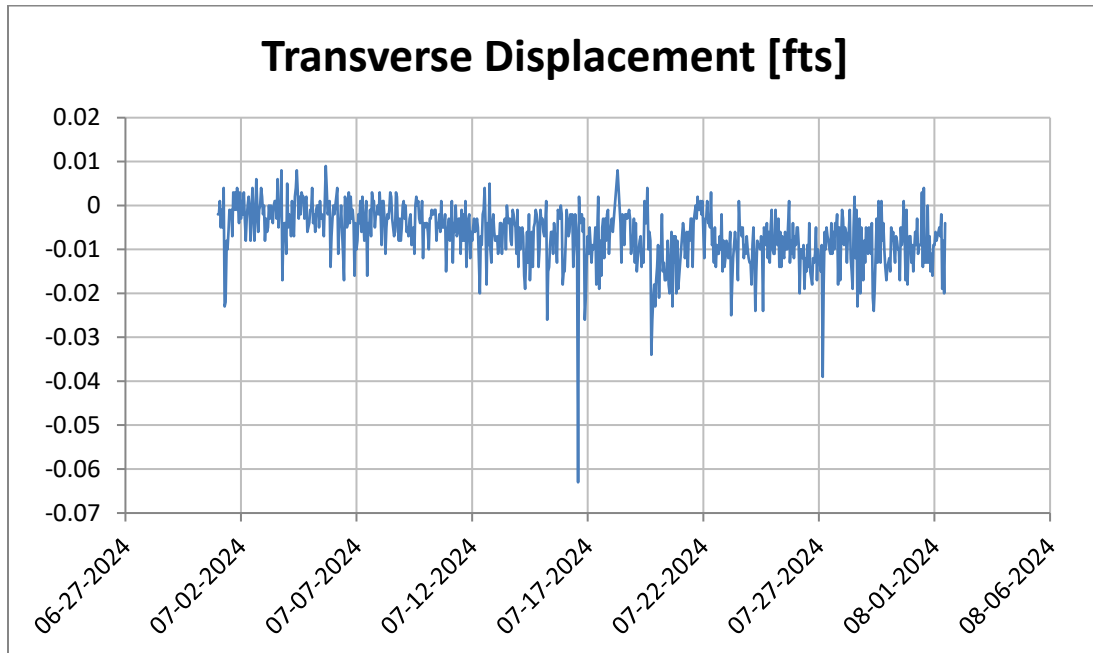
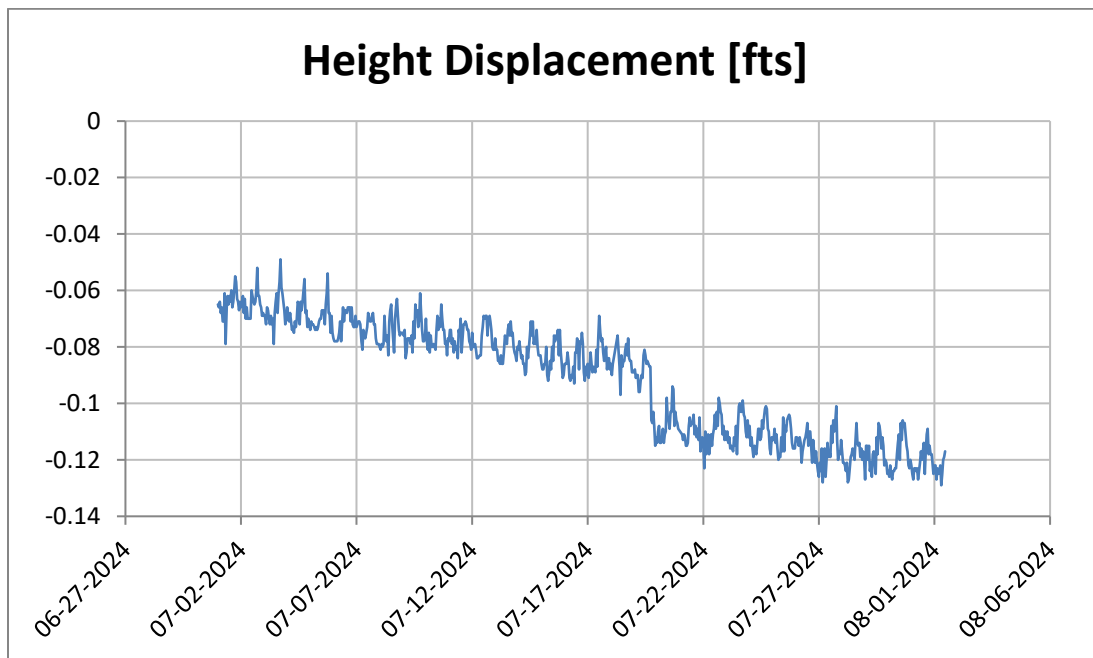
B7500-1

1. Survey accuracy is ± 0.016 feet.
2. Alert threshold is ± 0.35 feet.
3. Transverse displacement is in the horizontal direction. Positive direction means closer to the robotic total station.
4. Height displacement is in the vertical direction. Positive direction means higher in elevation.
5. Animals in prism area on July 13 is likely cause for small movement recorded.
6. Rain and fog on July 16 and 26 resulted in increased data scatter.

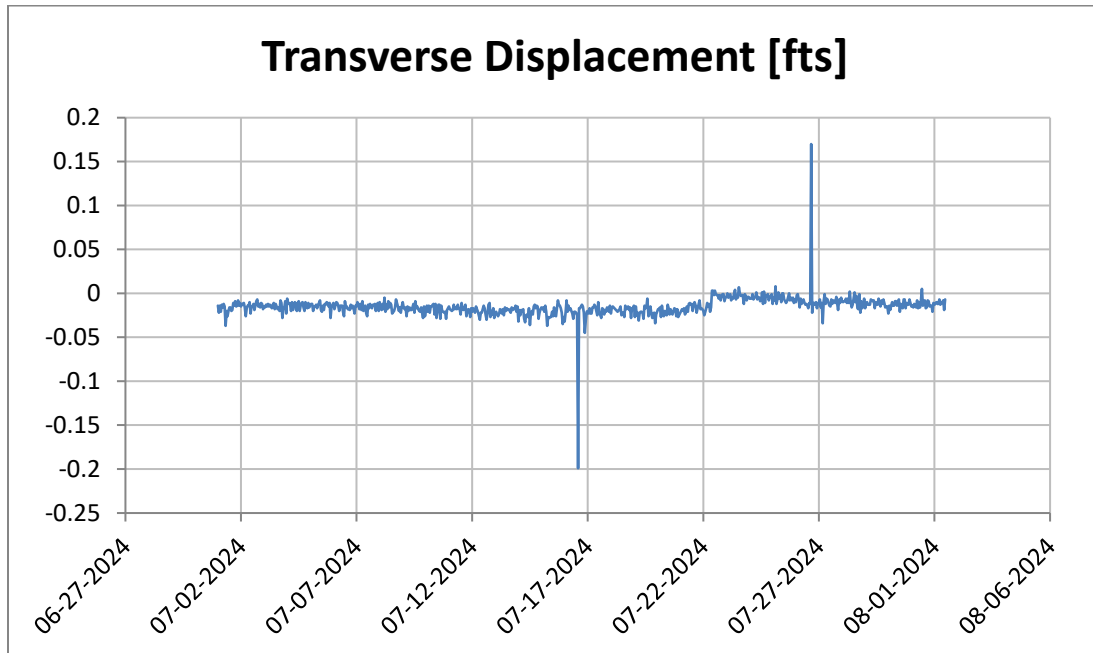
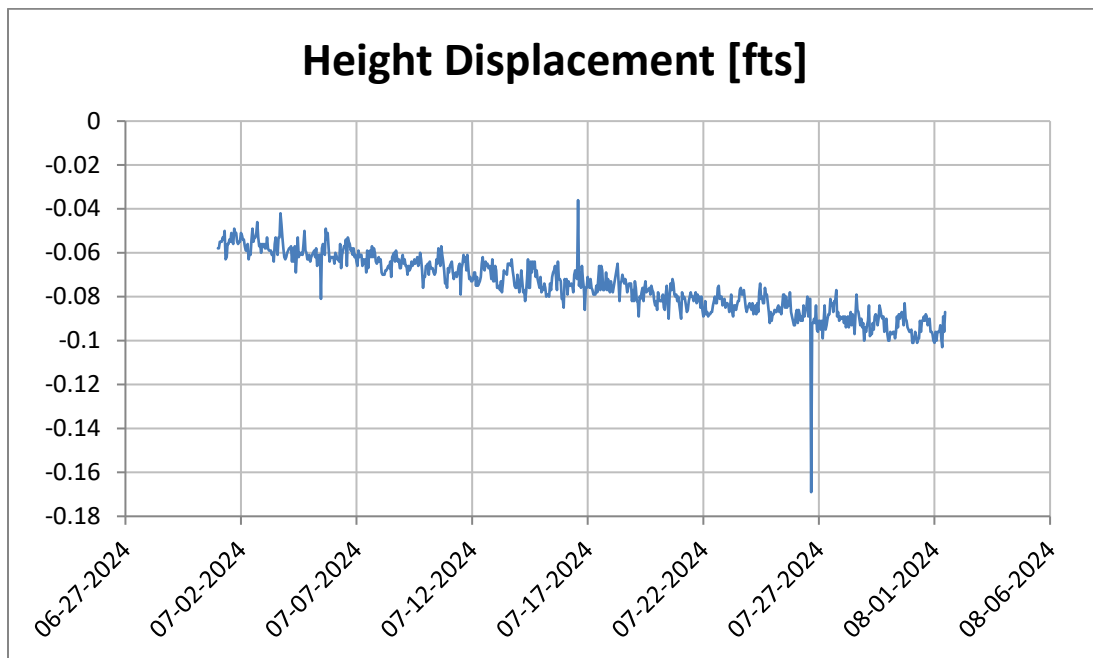
B7500-2

1. Survey accuracy is ± 0.016 feet.
2. Alert threshold is ± 0.35 feet.
3. Transverse displacement is in the horizontal direction. Positive direction means closer to the robotic total station.
4. Height displacement is in the vertical direction. Positive direction means higher in elevation.
5. Rain and fog on July 16 and 26 resulted in increased data scatter.

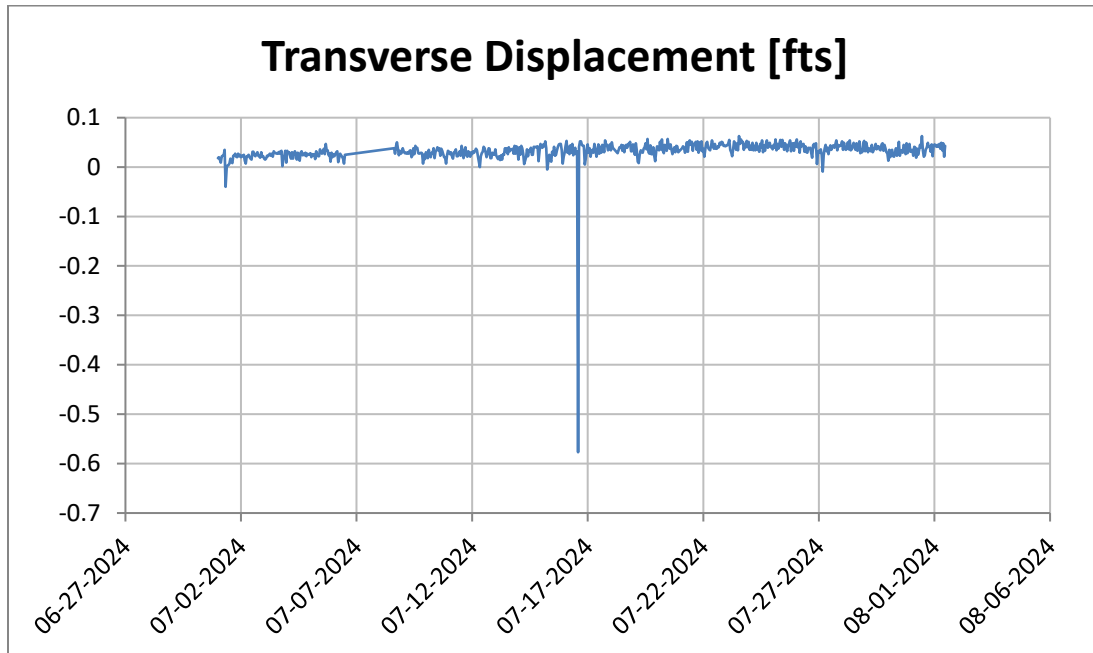
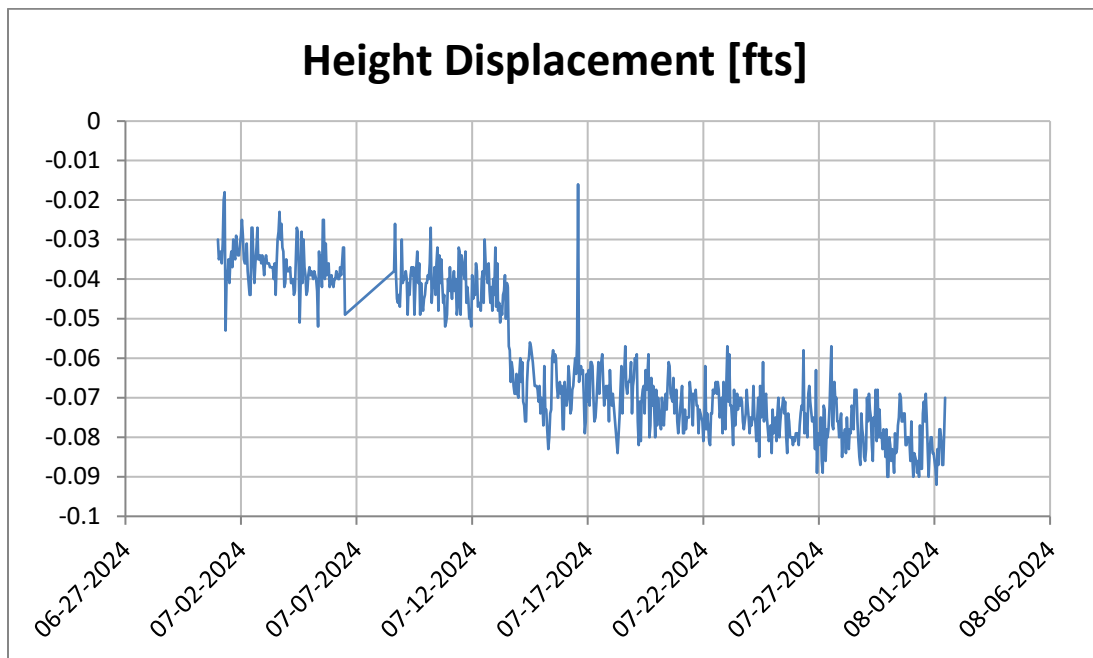
B7500-4

1. Survey accuracy is ± 0.016 feet.
2. Alert threshold is ± 0.35 feet.
3. Transverse displacement is in the horizontal direction. Positive direction means closer to the robotic total station.
4. Height displacement is in the vertical direction. Positive direction means higher in elevation.
5. Prism dislodged on July 6 potentially by animals or equipment operations.
6. Animals in prism area on July 13 is likely cause for small movement recorded.
7. Rain and fog on July 16 and 26 resulted in increased data scatter.

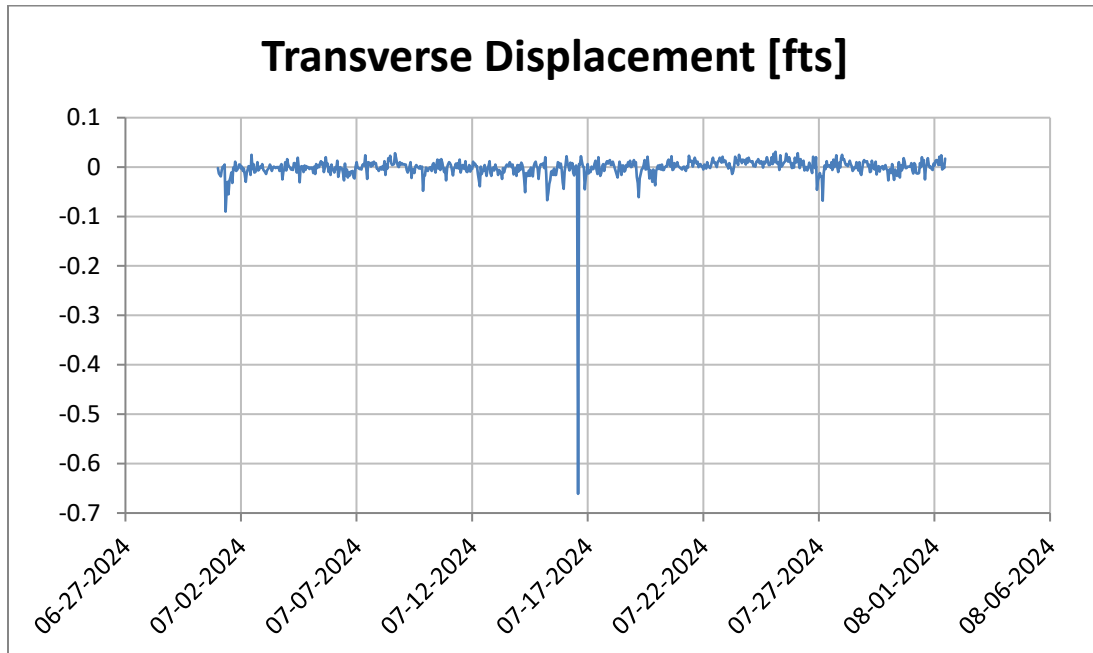
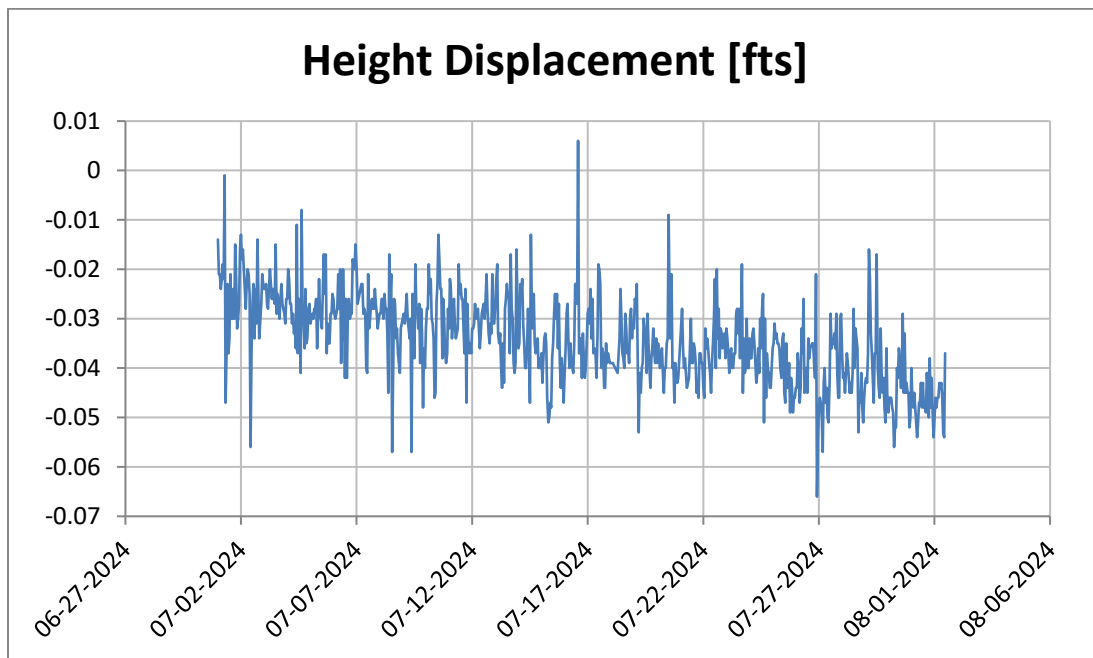
B7500-5

1. Survey accuracy is ± 0.016 feet.
2. Alert threshold is ± 0.35 feet.
3. Transverse displacement is in the horizontal direction. Positive direction means closer to the robotic total station.
4. Height displacement is in the vertical direction. Positive direction means higher in elevation.
5. Rain and fog on July 16 and 26 resulted in increased data scatter.

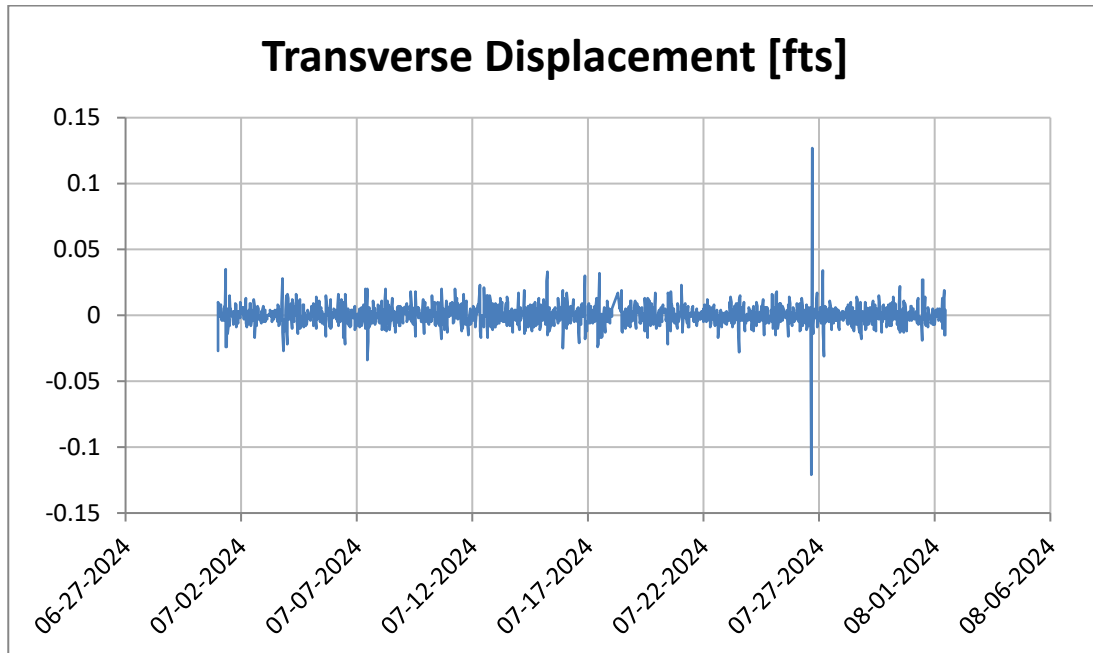
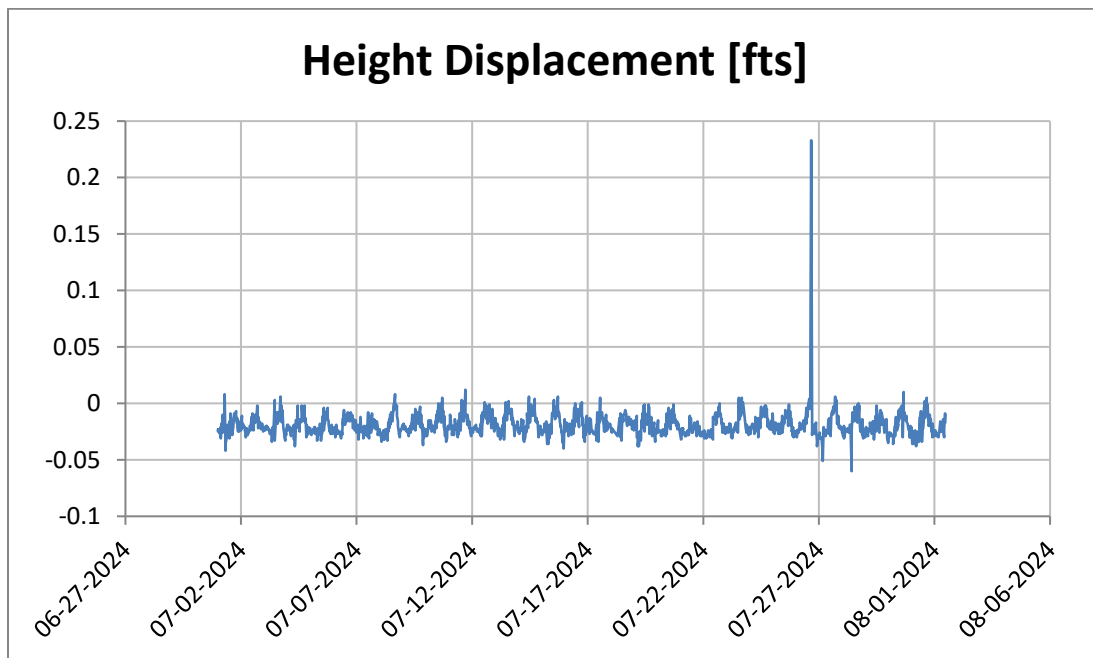
Prism CP6

1. Survey accuracy is ± 0.016 feet.
2. Alert threshold is ± 0.35 feet.
3. Transverse displacement is in the horizontal direction. Positive direction means closer to the robotic total station.
4. Height displacement is in the vertical direction. Positive direction means higher in elevation.
5. Rain and fog on July 16 and 26 resulted in increased data scatter.

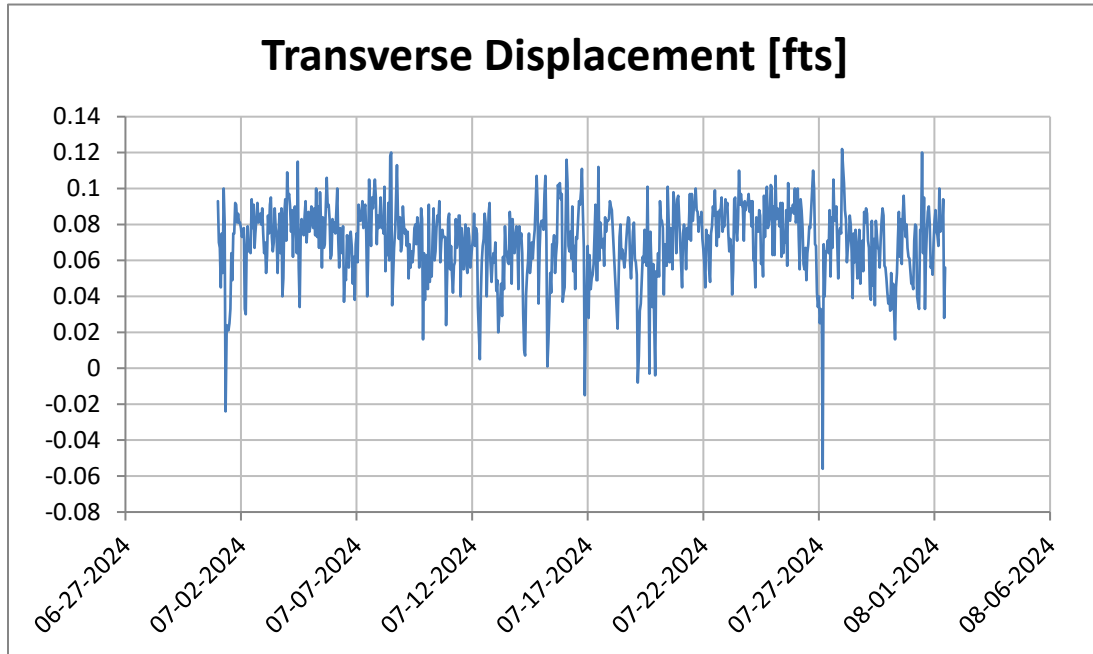
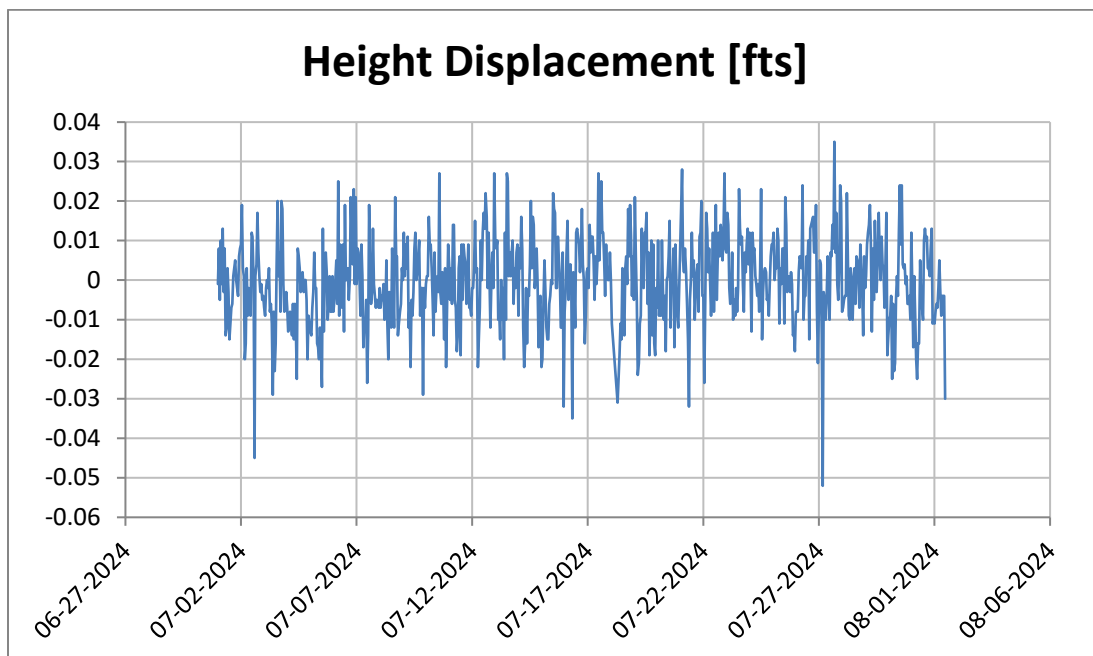
Prism CP7

1. Survey accuracy is ± 0.016 feet.
2. Alert threshold is ± 0.35 feet.
3. Transverse displacement is in the horizontal direction. Positive direction means closer to the robotic total station.
4. Height displacement is in the vertical direction. Positive direction means higher in elevation.

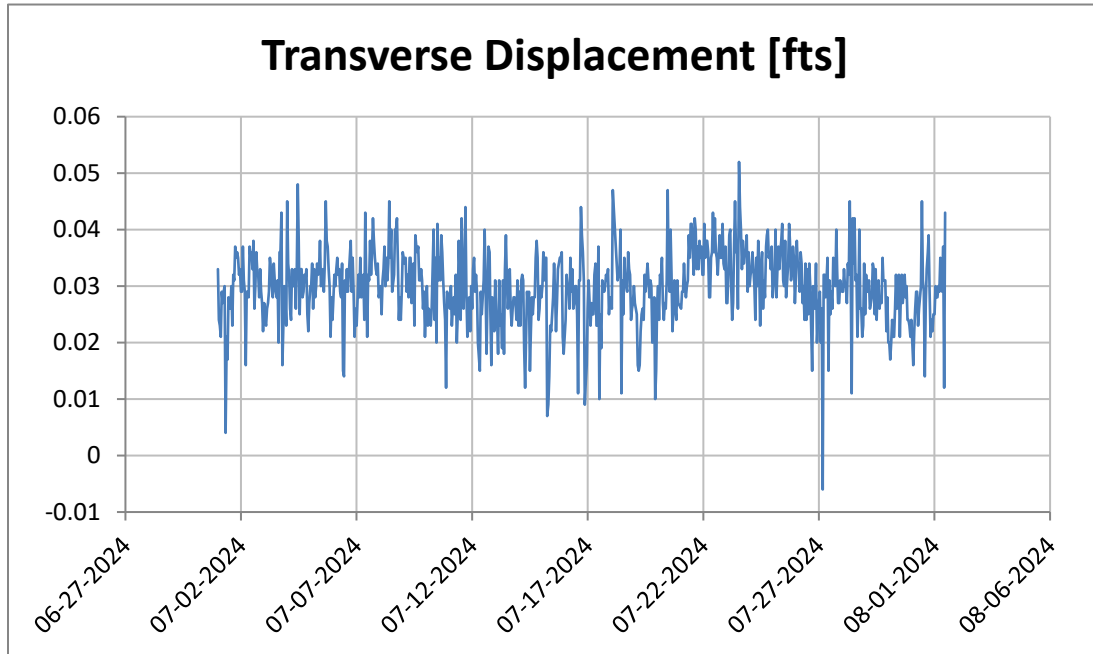
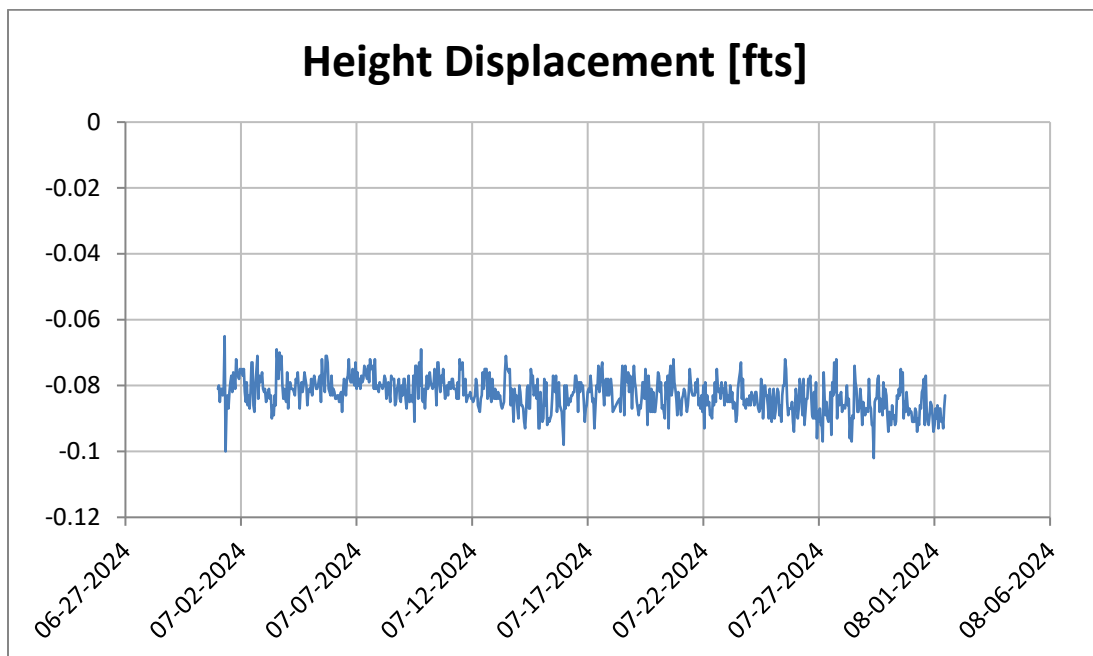
Prism NP4

1. Survey accuracy is ± 0.016 feet.
2. Alert threshold is ± 0.35 feet.
3. Transverse displacement is in the horizontal direction. Positive direction means closer to the robotic total station.
4. Height displacement is in the vertical direction. Positive direction means higher in elevation.
