To: Jerald Schnabel
Castle Aggregate
File: July 2024 Monitoring Summary

From: Paul Kos
Denver, CO 80202
Date: August 23, 2024

Reference: July 2024 Geotechnical Monitoring Summary Pikeview Quarry

Client/Project
CASTLE AGGREGATE
PIKEVIEW QUARRY SLOPE
MONITORING
Project No.
2057288200

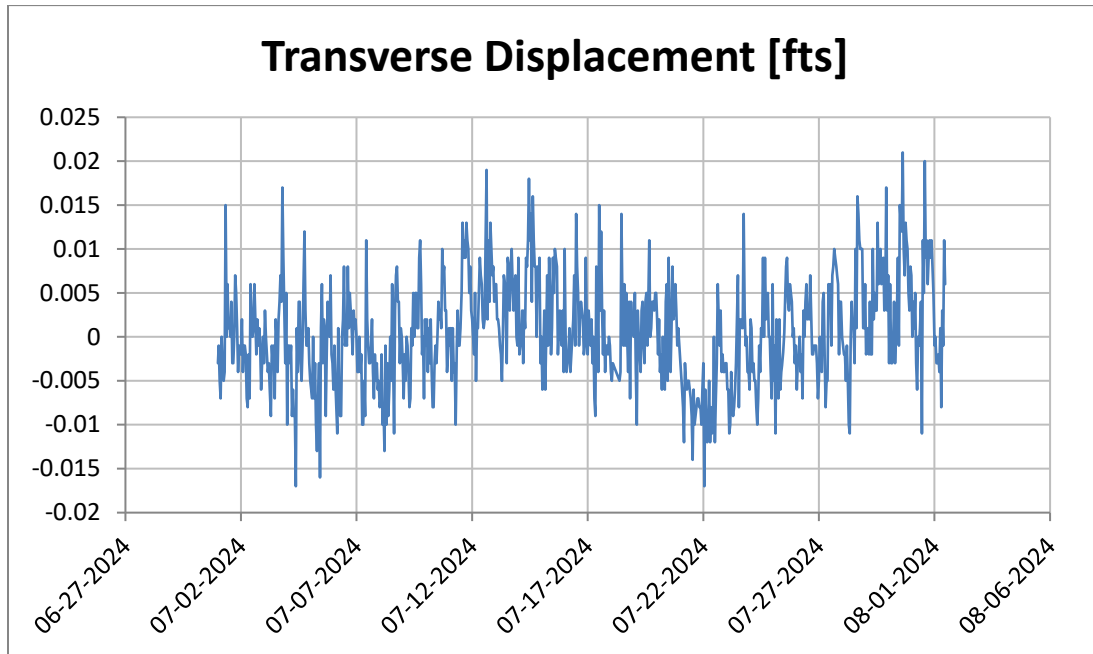
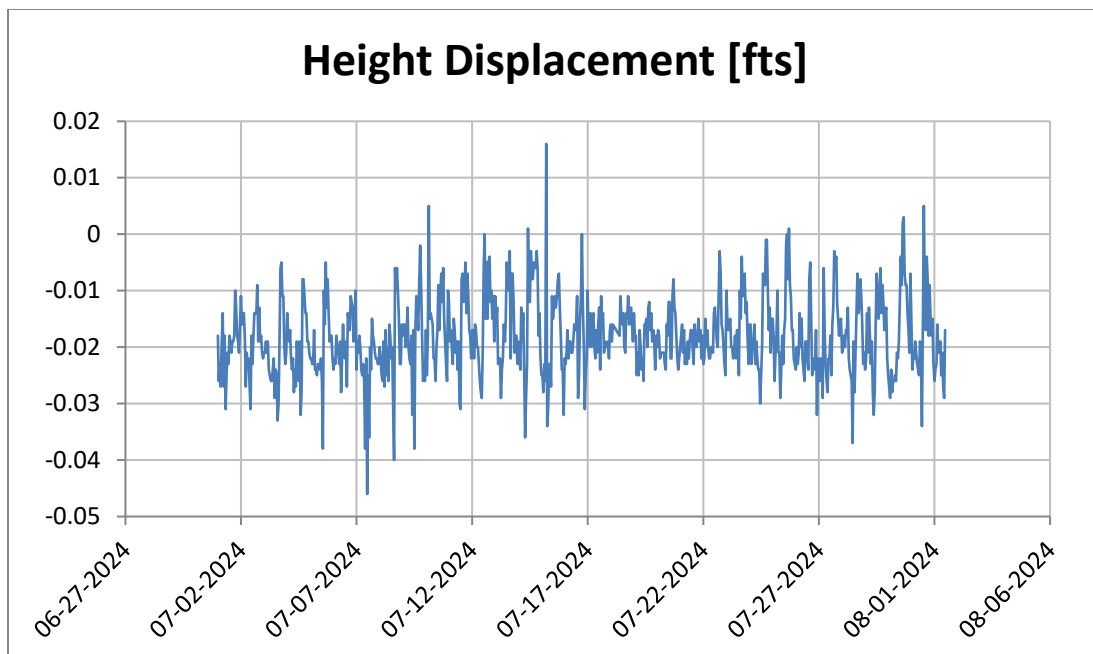
Prism P2

1. Survey accuracy is ± 0.016 feet.
2. Alert threshold is ± 0.35 feet.
3. Transverse displacement is in the horizontal direction. Positive direction means closer to the robotic total station.
4. Height displacement is in the vertical direction. Positive direction means higher in elevation.

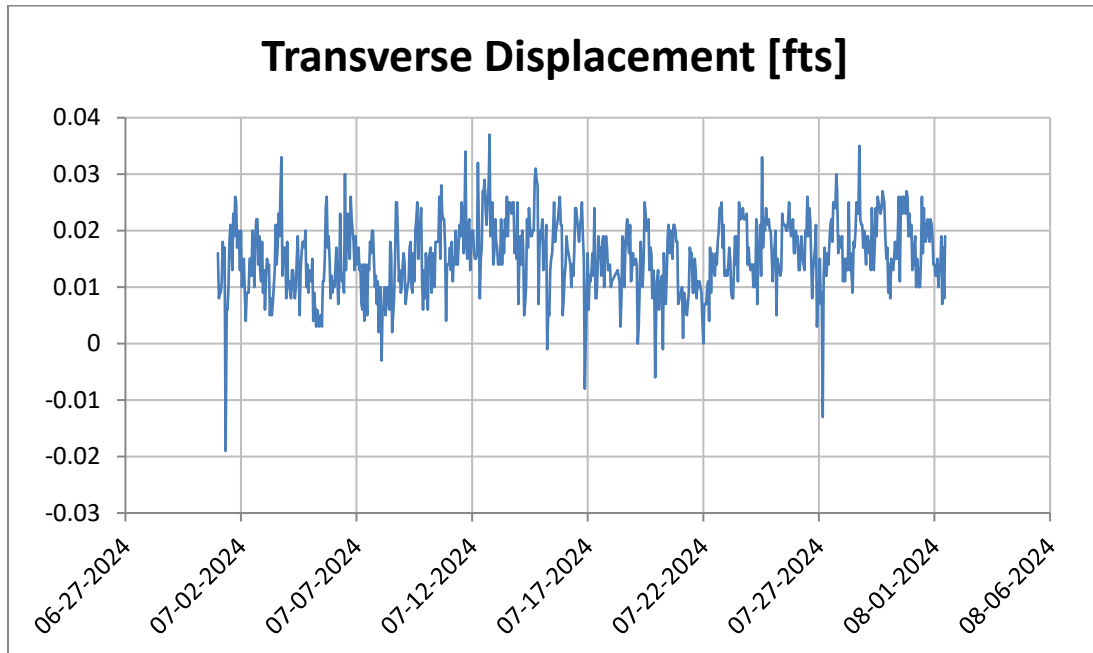
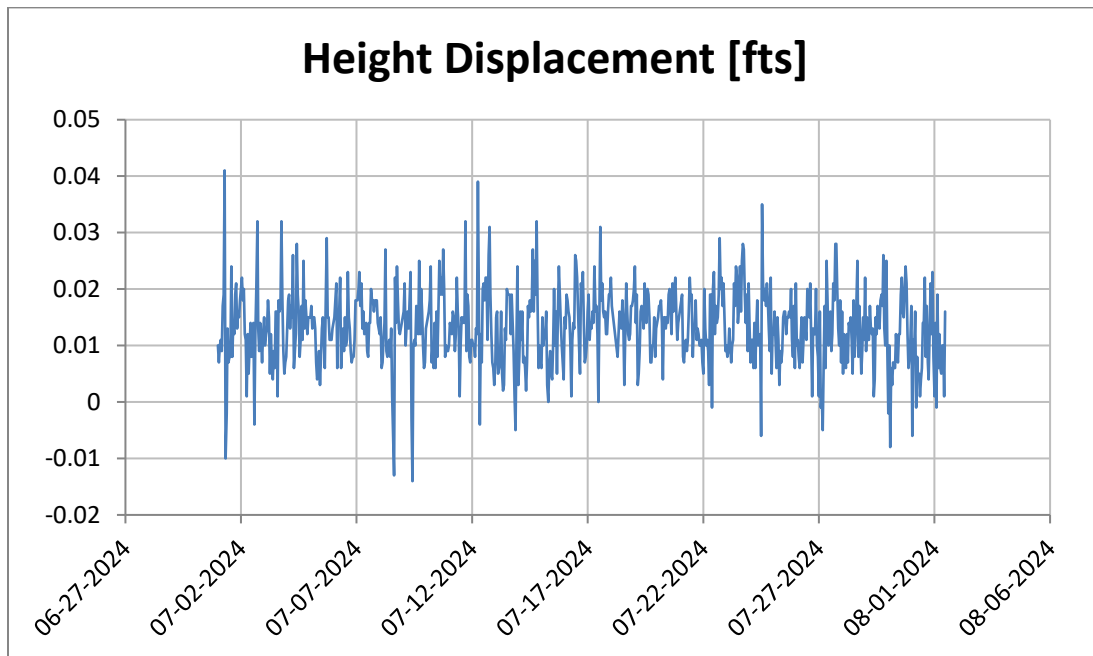
Prism P25

1. Survey accuracy is ± 0.016 feet.
2. Alert threshold is ± 0.35 feet.
3. Transverse displacement is in the horizontal direction. Positive direction means closer to the robotic total station.
4. Height displacement is in the vertical direction. Positive direction means higher in elevation.
5. Regression limit alert received on June 19.

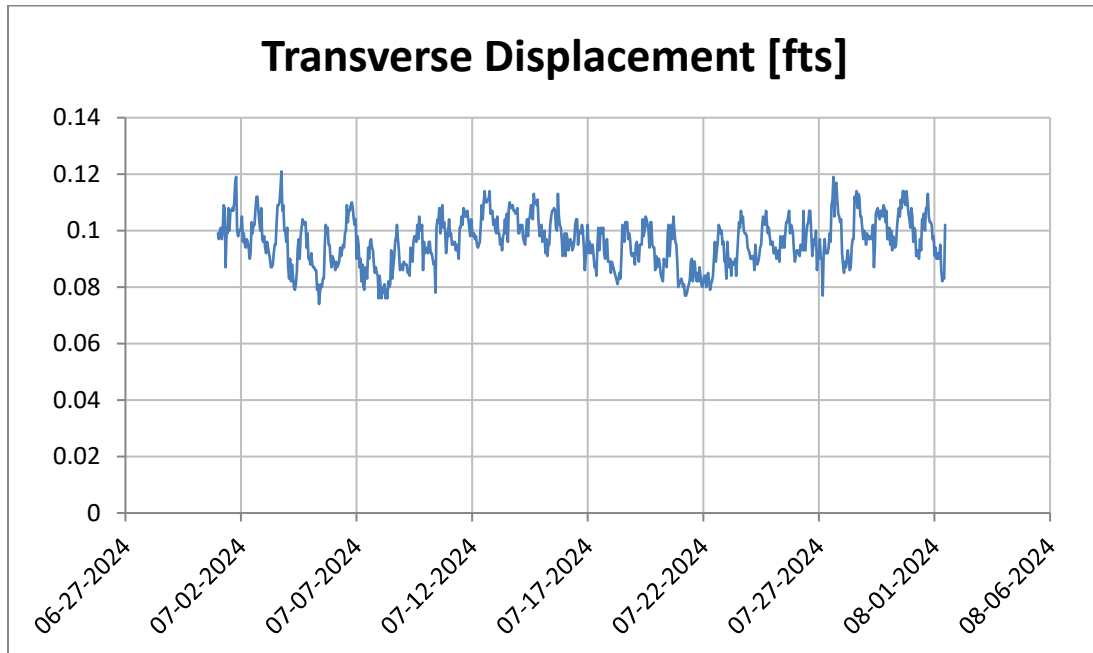
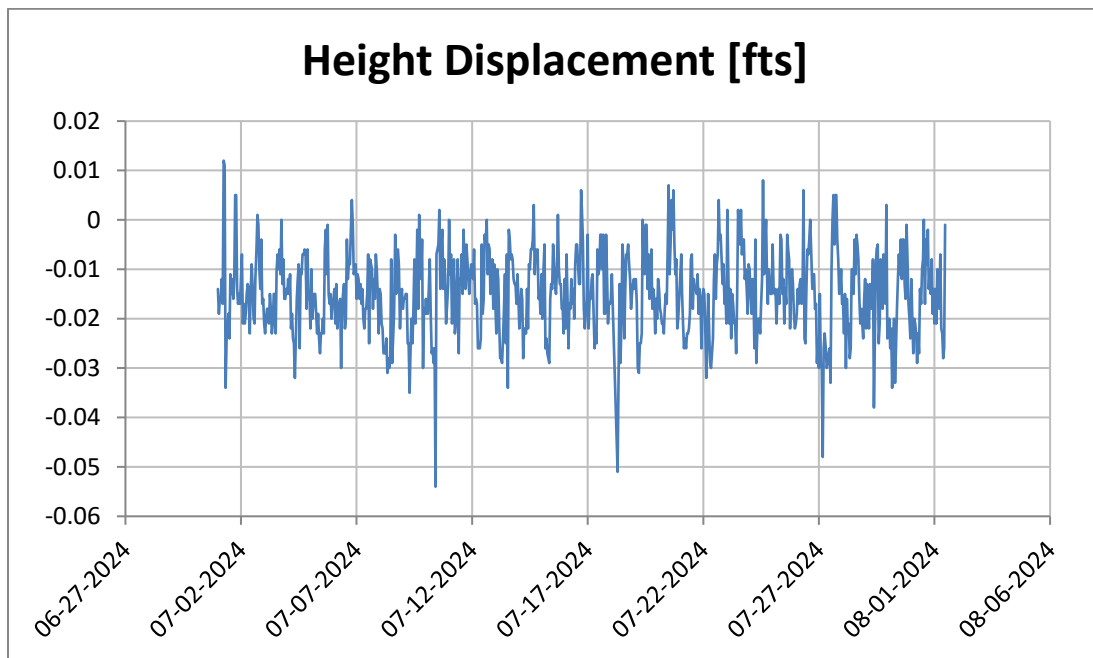
Prism P33

1. Survey accuracy is ± 0.016 feet.
2. Alert threshold is ± 0.35 feet.
3. Transverse displacement is in the horizontal direction. Positive direction means closer to the robotic total station.
4. Height displacement is in the vertical direction. Positive direction means higher in elevation.
