**MINERALS PROGRAM INSPECTION REPORT**  
**PHONE: (303) 866-3567**

<b>MINE NAME:</b> Revenue Mine	<b>MINE/PROSPECTING ID#:</b> M-2012-032	<b>MINERAL:</b> Lead, silver and gold	<b>COUNTY:</b> Ouray
<b>INSPECTION TYPE:</b> Multi Person Inspection	<b>WEATHER:</b> Clear	<b>INSP. DATE:</b> July 23, 2024	<b>INSP. TIME:</b> 10:40
<b>OPERATOR:</b> Thorin Resources, LLC	<b>OPERATOR REPRESENTATIVE:</b> Chris Skerik	<b>TYPE OF OPERATION:</b> 112d-1 - Designated Mining Operation	
<b>REASON FOR INSPECTION:</b> Normal I&E Program	<b>BOND CALCULATION TYPE:</b> None	<b>BOND AMOUNT:</b> \$517,219.00	
<b>DATE OF COMPLAINT:</b> NA	<b>POST INSP. CONTACTS:</b> None	<b>JOINT INSP. AGENCY:</b> None	
<b>INSPECTOR(S):</b> Lucas West Amber Gibson Hunter Ridley	<b>INSPECTOR'S SIGNATURE:</b>

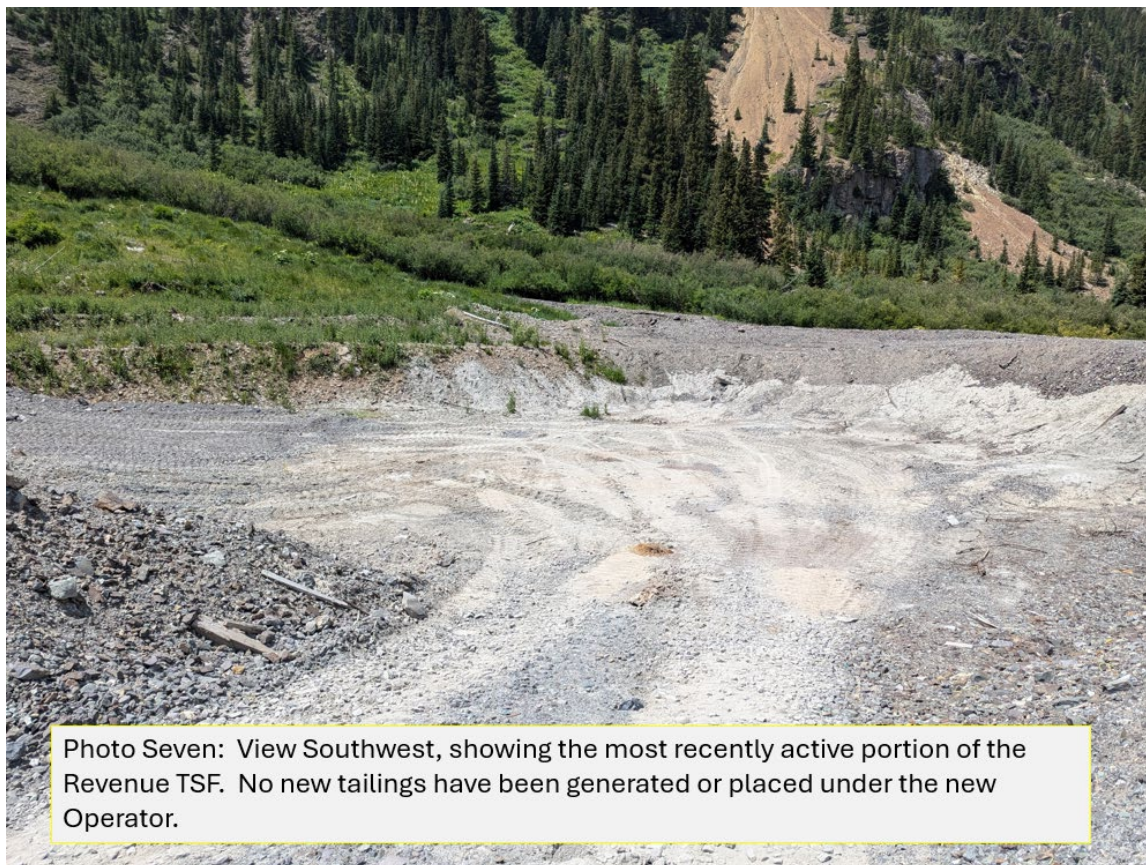
Adjacent to the admin building the Revenue Tailings Storage Facility and lay down yard was observed. The tailings storage area is free from trash and debris and no additional tailings have been placed since the Division's previous inspection. The most recently active portion of the TSF can be seen in Photo Seven. The laydown yard near the Revenue TSF is neat and organized and can be seen in Photo Eight.

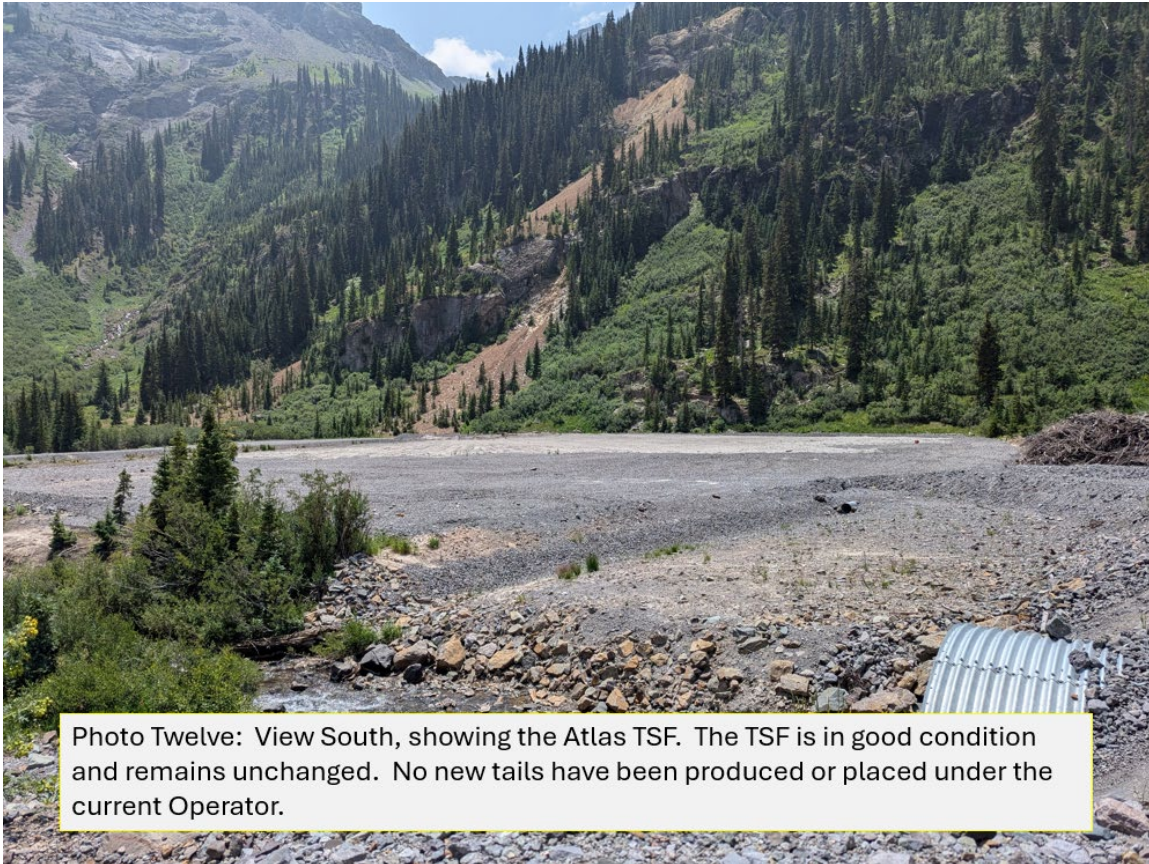
Located just west of the main revenue, separated by Atlas Creek, is the Atlas Tailings Storage Facility. Access to the TSF is gained by a separate locked gate just off County Road 26. The main pad of the facility is graded to the east to promote positive drainage. The surface is constructed of waste rock material that was compacted and stable at the time of the inspection. All drainage generated from the facility is directed to the sediment pond located on the east end of the TSF. The pond was observed with minimal standing water from surface runoff of recent precipitation. Around the perimeter of the facility, an upland diversion and storm water channel was constructed in order to prevent run on from surrounding areas from impacting the TSF. All tailings that are stored on the pad have been spread and compacted to the extent possible. No evidence of material transport or erosion of the tailings material was noted. The Atlas TSF can be seen in Photo Twelve.
