**MINERALS PROGRAM INSPECTION REPORT**  
**PHONE: (303) 866-3567**

<b>MINE NAME:</b> Logan Mill Site and Adjoining Lands	<b>MINE/PROSPECTING ID#:</b> P-1999-009	<b>MINERAL:</b> Gold and silver	<b>COUNTY:</b> Boulder
<b>INSPECTION TYPE:</b> Monitoring	<b>WEATHER:</b> Cloudy	<b>INSP. DATE:</b> September 4, 2024	<b>INSP. TIME:</b> 11:15
<b>OPERATOR:</b> Deward E. Walker Jr.	<b>OPERATOR REPRESENTATIVE:</b> Joe Ben Walker	<b>TYPE OF OPERATION:</b> MP - Mineral Prospecting	
<b>REASON FOR INSPECTION:</b> Normal I&E Program	<b>BOND CALCULATION TYPE:</b> Partial Bond	<b>BOND AMOUNT:</b> \$1,800.00	
<b>DATE OF COMPLAINT:</b> NA	<b>POST INSP. CONTACTS:</b> None	<b>JOINT INSP. AGENCY:</b> None	
<b>INSPECTOR(S):</b> Patrick Lennberg	<b>INSPECTOR'S SIGNATURE:</b>

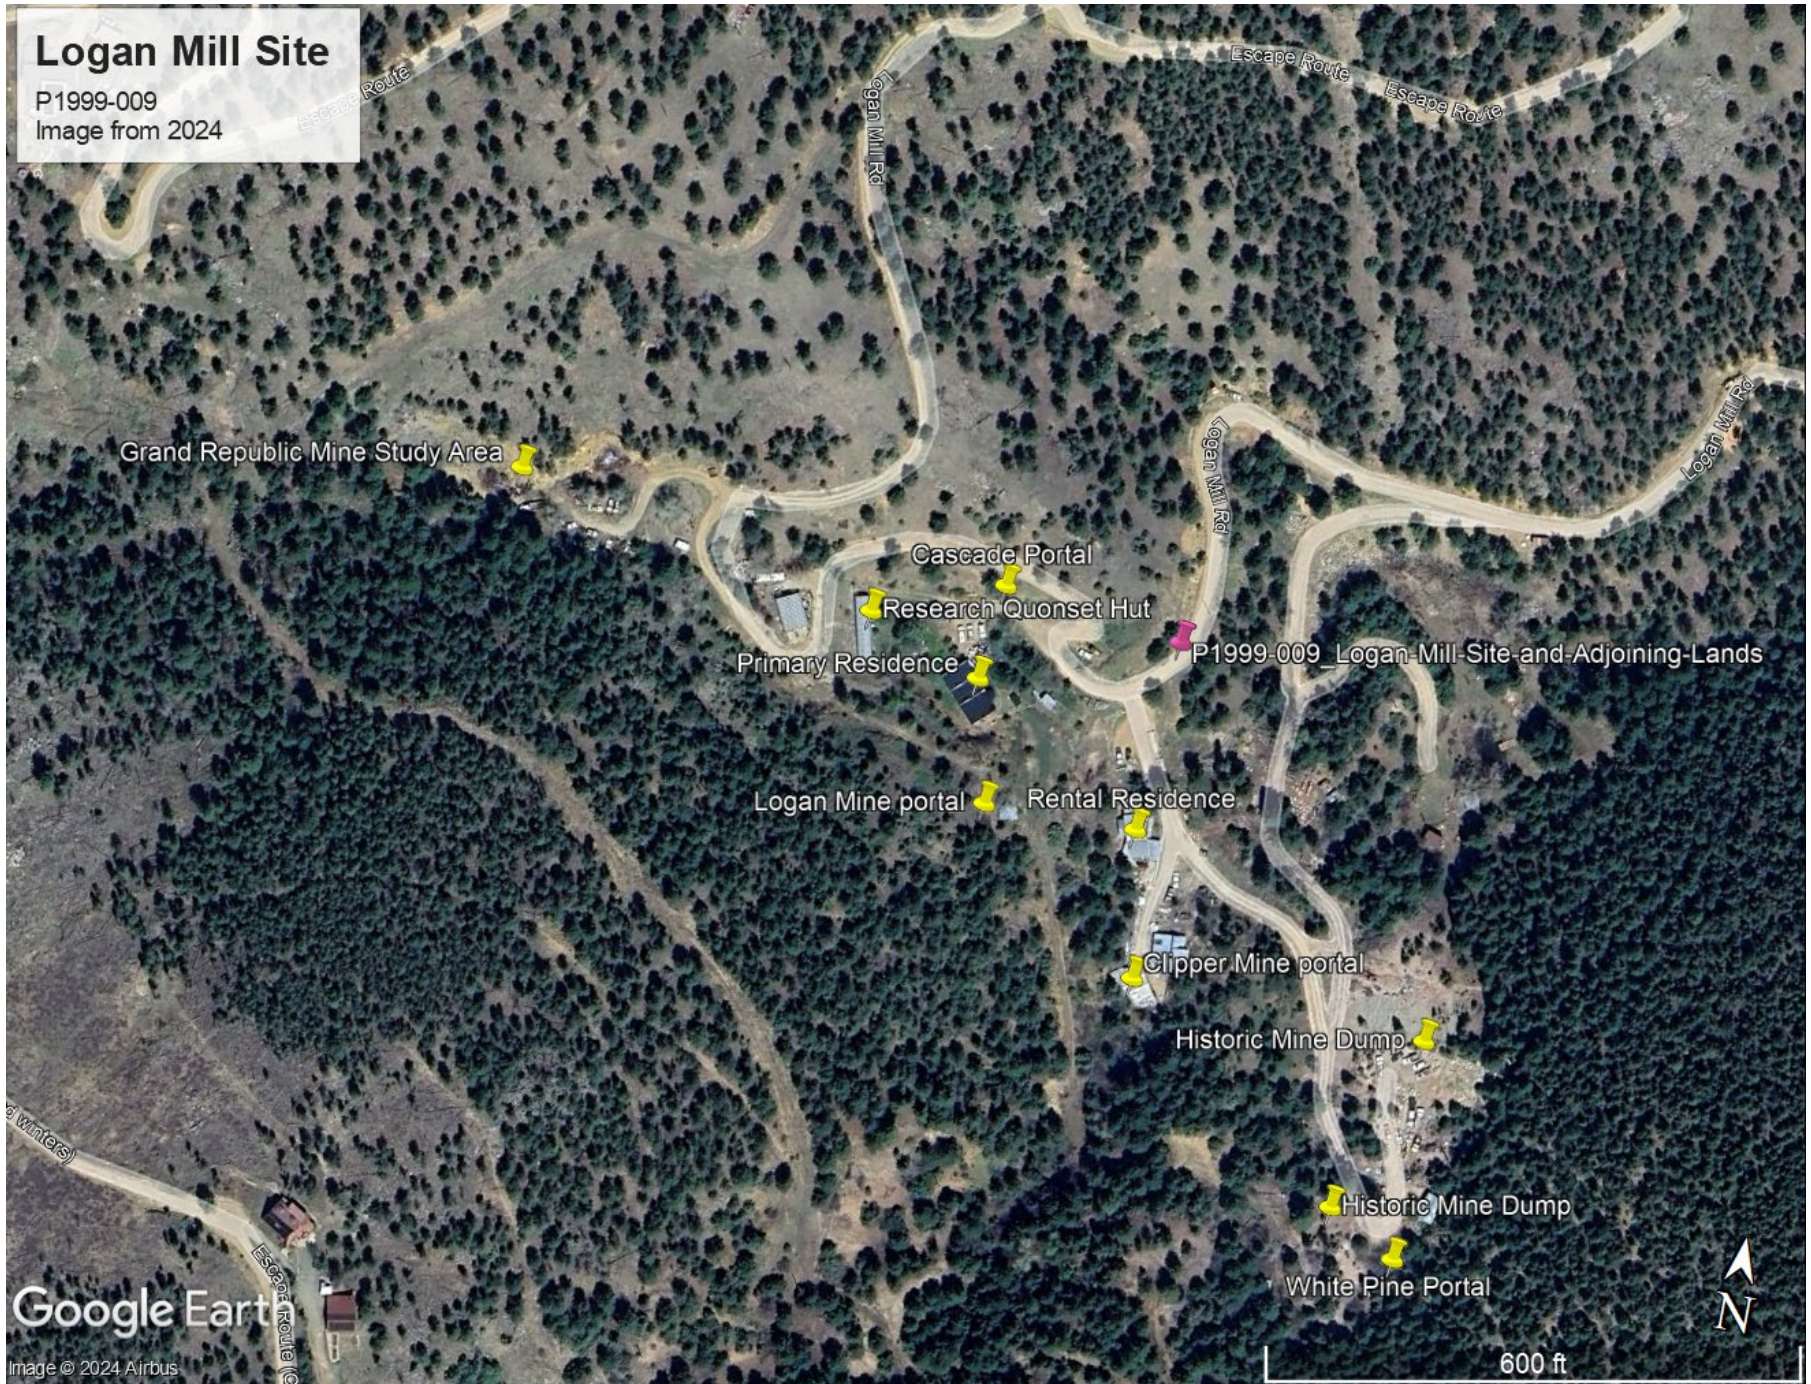
The site was not active at the time of inspection. The Division also viewed several of the old waste rock dumps. All dumps are in good condition and in stable condition. The Clipper portal was inspected, located just south of a residence. The operator plans on continuing to rehabilitate the shed that covers the portal entry along with getting the fire assay lab equipment up and running. The White Pine Portal, previously identified as the Clipper Portal, has collapsed over time and would need extensive rehabilitation to safely access. The Operator intends to evaluate the waste rock pile at the entrance of the portal. The Division reiterated if they do not plan on rehabilitating the portal entry, they may reach out to the Inactive Mine Program, 303-866-3567, to inquire if it was a candidate for their closure program.

**Photo 8:** Clipper Portal.
