MINERALS PROGRAM INSPECTION REPORT
PHONE: (303) 866-3567

MINE NAME: Lykins Gulch	MINE/PROSPECTING ID#: M-2000-090	MINERAL: Dolomite and sandstone stone, quartzite)	COUNTY: Boulder
INSPECTION TYPE: Monitoring	WEATHER: Clear	INSP. DATE: September 19, 2024	INSP. TIME: 11:00
OPERATOR: Loukonen Bros. Stone Company	OPERATOR REPRESENTATIVE: Michael Loukonen	TYPE OF OPERATION: 110c - Construction Limited Impact	
REASON FOR INSPECTION: Normal I&E Program	BOND CALCULATION TYPE: Complete Bond	BOND AMOUNT: \$21,000.00	
DATE OF COMPLAINT: NA	POST INSP. CONTACTS: None	JOINT INSP. AGENCY: None	
INSPECTOR(S): Patrick Lennberg	INSPECTOR'S SIGNATURE:

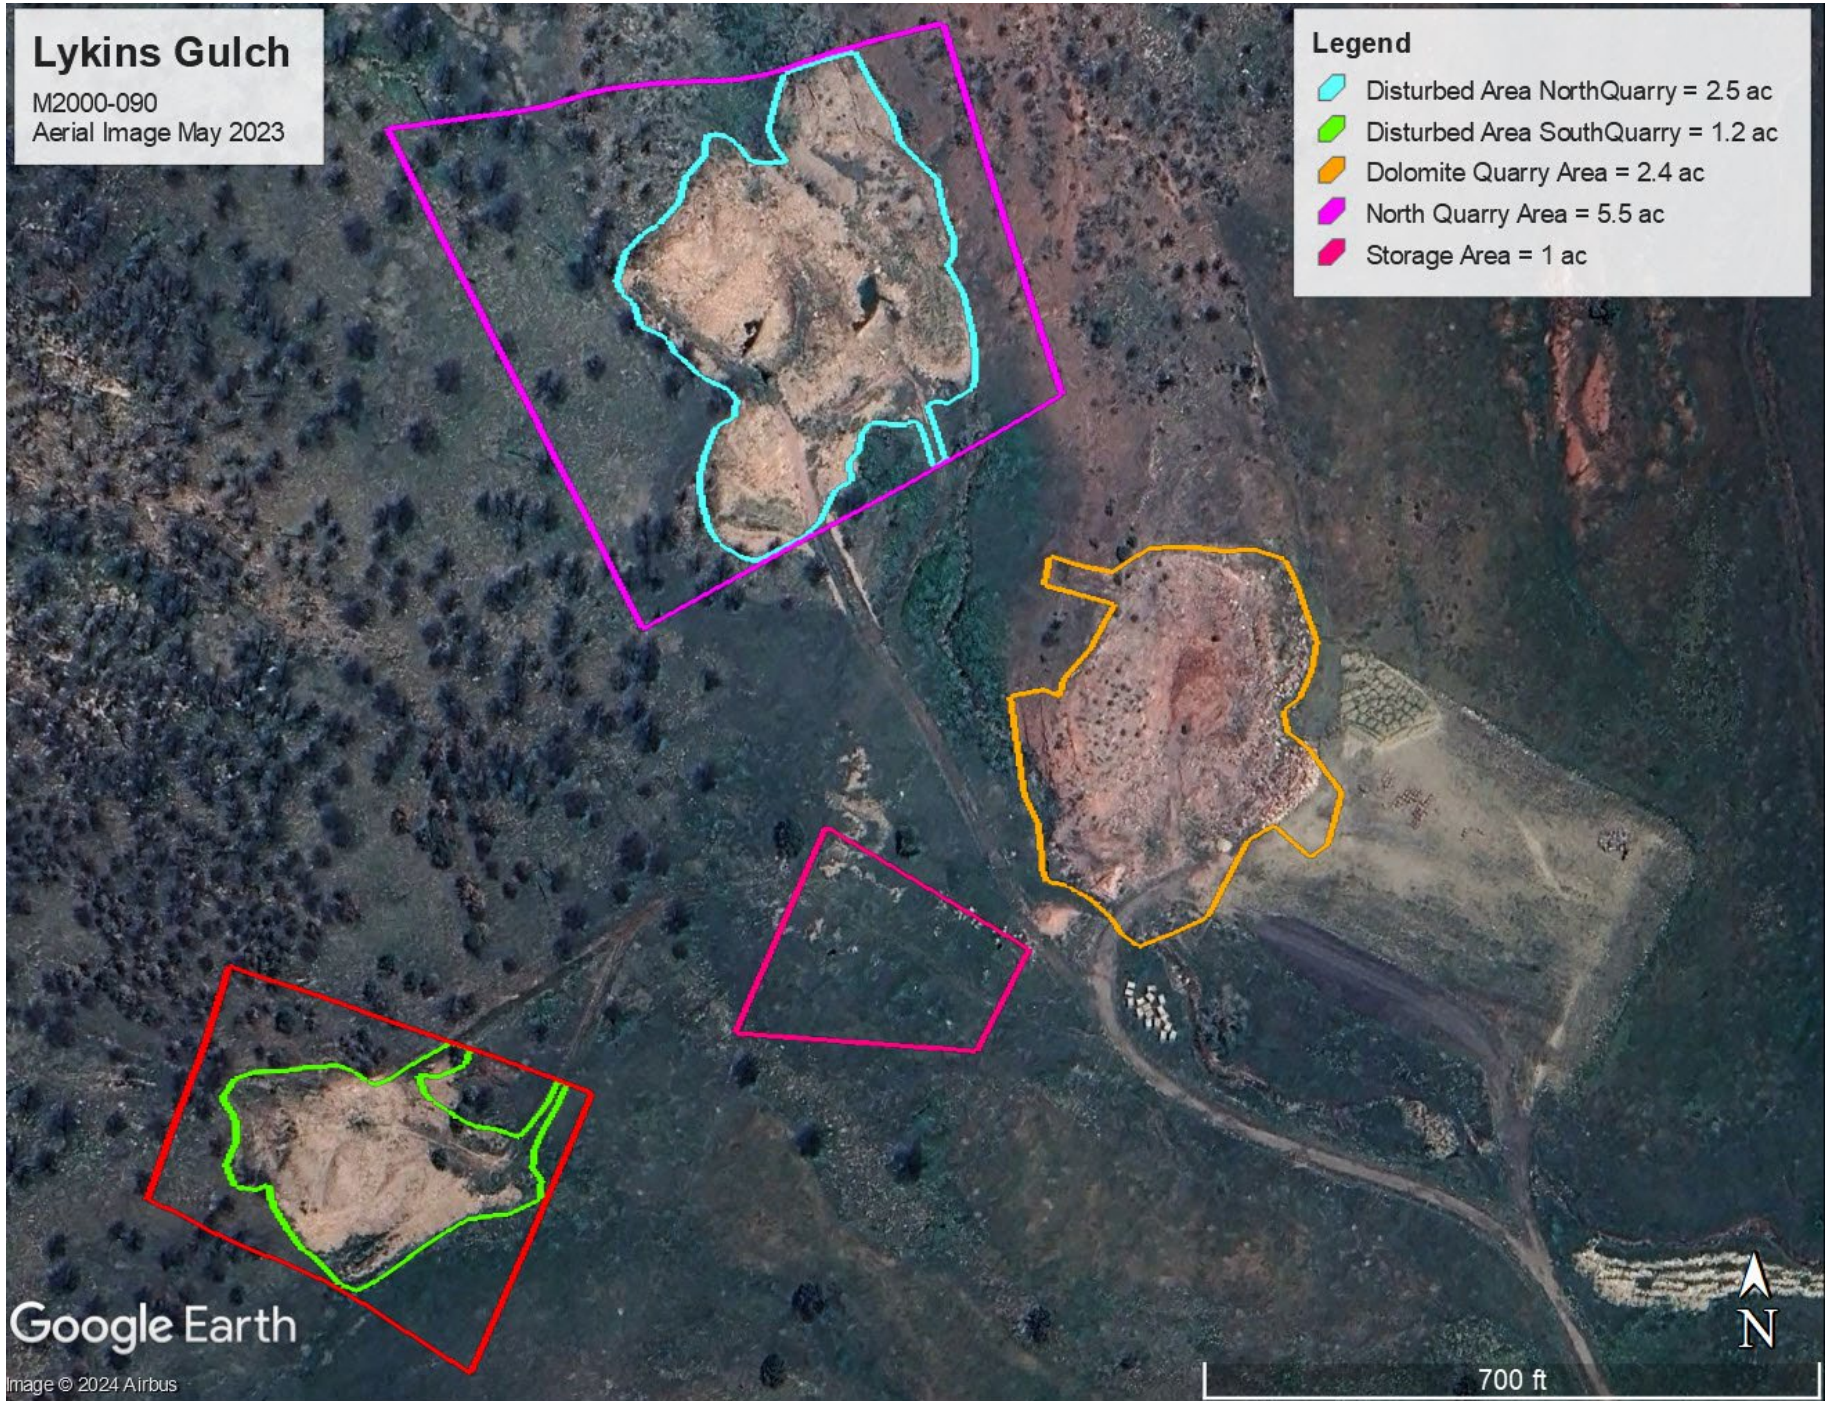
The Division observed the south quarry, which includes two primary working benches and various stockpiles of overburden and waste rock at the toe of the excavations. The operator appears to be mining the south quarry generally westward. The permitted acreage for the south quarry is 2.5 acres. The Division estimates the operation has disturbed approximately 1.2 acres in the south quarry area. The Division observed the north

Photo 10: South quarry area looking uphill to the west
