MINERALS PROGRAM INSPECTION REPORT
PHONE: (303) 866-3567

| MINE NAME: Golden Wonder Mine | MINE/PROSPECTING ID#: M-1978-091-UG | MINERAL: Gold | COUNTY: Hinsdale |
| INSPECTION TYPE: Multi Person Inspection | WEATHER: Clear | INSP. DATE: September 25, 2024 | INSP. TIME: 09:10 |
| OPERATOR: LKA International Inc. | OPERATOR REPRESENTATIVE: Kye Abraham | TYPE OF OPERATION: 110d - Designated Limited Impact | |

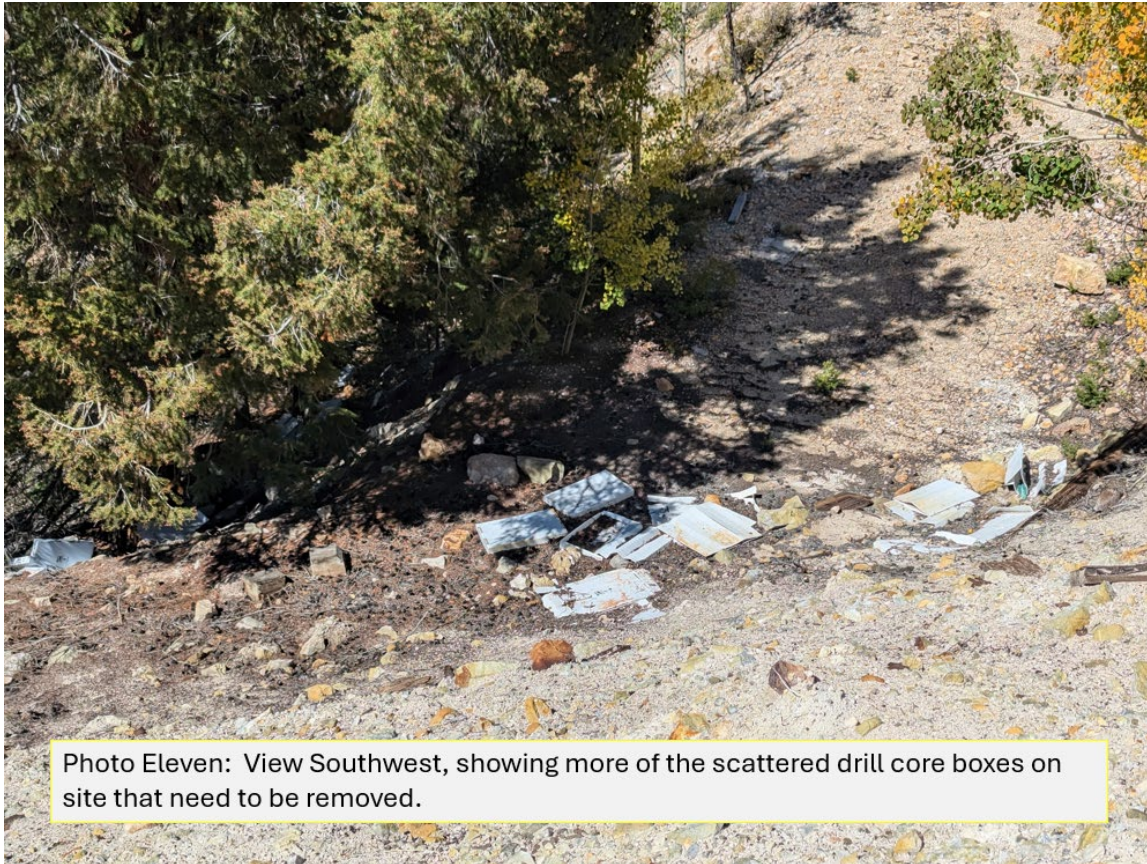
The 3-level portal area has been used as a staging area for drilling operations associated with the Operator's currently held NOI, file no P-2018-010. As a result of using the area for staging, a significant pile of cardboard drill core boxes was left unsecured on site. The main pile, seen in Photo Nine has been exposed to the elements and dispersed across the site and surrounding areas by wind. Photos Ten and Eleven show the scattered boxes that were observed. This is being cited as a problem for failure to dispose of refuse in a

Photo Ten: View Southeast, showing the wind-blown drill core boxes that need to be removed as part of the Corrective Actions.
