MINERALS PROGRAM INSPECTION REPORT PHONE: (303) 866-3567

MINE NAME:	MINE/PROSPECTING ID#:	MINERAL:	COUNTY:
JH Sand & Gravel Pit #1	M-1979-131	Sand and gravel	Crowley
INSPECTION TYPE:	WEATHER:	INSP. DATE:	INSP. TIME:
Surety-Related Inspection	Cloudy	August 21, 2024	11:30
OPERATOR:	OPERATOR REPRESENTATIVE:	TYPE OF OPERATION:	
JH Sand & Gravel, LLC	Jim McCuistion and Gerald Korinek	112c - Construction Regular Operation	
REASON FOR INSPECTION:	BOND CALCULATION TYPE:	BOND AMOUNT:	
Surety Related	None	\$77,365.00	
DATE OF COMPLAINT:	POST INSP. CONTACTS:	JOINT INSP. AGE	NCY:
NA	None	None	
INSPECTOR(S):	INSPECTOR'S SIGNATURE:	SIGNATURE DATE:	
Jocelyn Carter	Jon Rato	October 10, 2024

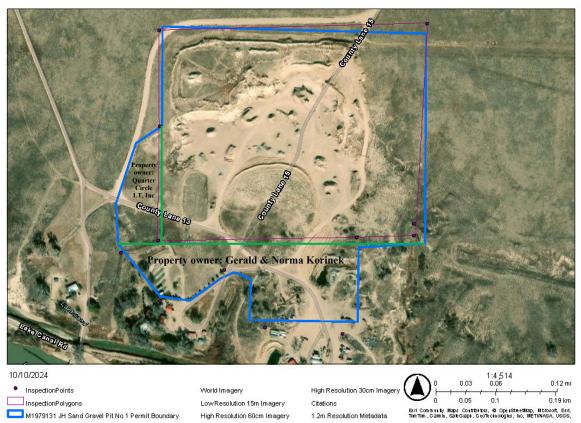
Inspection map showing current permit boundary in blue, approximate proposed permit boundary in purple inspected polygon, purple inspection points mark where permit or property boundaries were verified. The green lines indicate the approximate property boundary lines
