MINERALS PROGRAM INSPECTION REPORT PHONE: (303) 866-3567

MINE NAME:	MINE/PROSPECTING ID#:	MINERAL:	COUNTY:
Knox Pit	M-2017-036	Sand and gravel	Larimer
INSPECTION TYPE:	WEATHER:	INSP. DATE:	INSP. TIME:
Monitoring	Clear	September 24, 2024	09:15
OPERATOR:	OPERATOR REPRESENTATIVE:	TYPE OF OPERATION:	
Loveland Ready-Mix Concrete, Inc.	Corey Sheldon	112c - Construction Regular Operation	
REASON FOR INSPECTION:	BOND CALCULATION TYPE:	BOND AMOUNT:	
Normal I&E Program	Complete Bond	\$788,900.00	
DATE OF COMPLAINT:	POST INSP. CONTACTS:	JOINT INSP. AGE	NCY:
NA	None	None	
INSPECTOR(S):	INSPECTOR'S SIGNATURE:	SIGNATURE DAT	E:
Joel Renfro	$\bigcirc 10$	October 30, 2024	
	AUKINTE		
	Under and

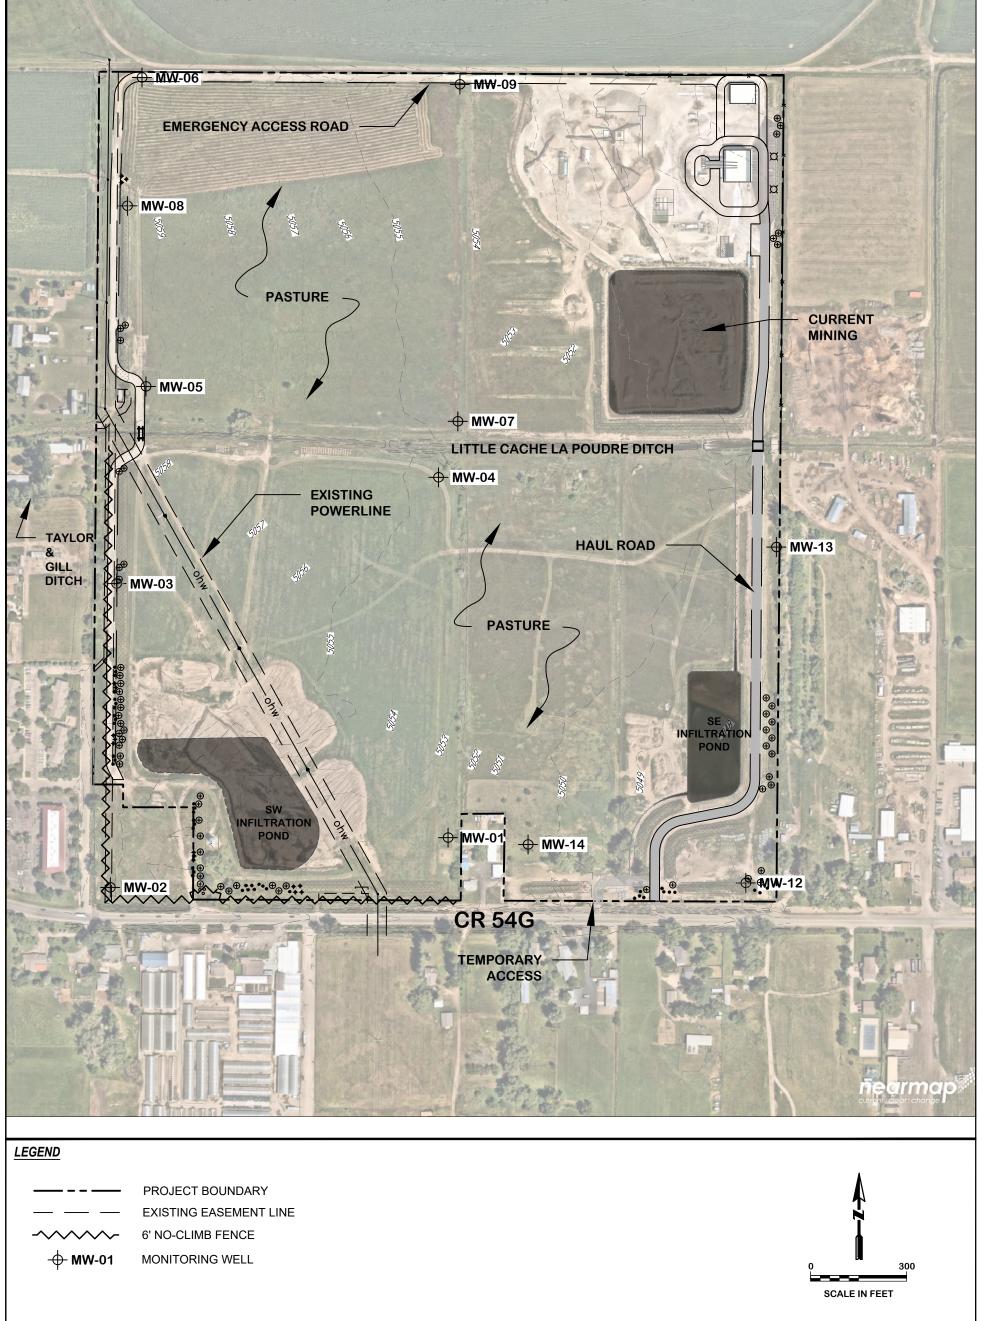
PERIMETER BERMS HAVE BEEN SEEDED WEED MANAGEMENT INCLUDES MOWING AND SPOT WEED SPRAYING AGGREGATE FROM WATER MANAGEMENT POND BEING USED FOR ONSITE DEVELOPMENT ONLY
