To: Jerald Schnabel  
Castle Aggregate  
File: September 2024 Monitoring Summary

From: Paul Kos  
Denver, CO 80202  
Date: October 31, 2024

**Reference: September 2024 Geotechnical Monitoring Summary Pikeview Quarry**

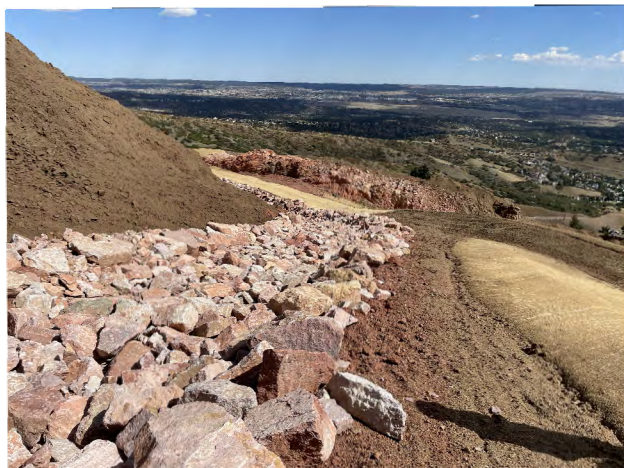
6. RIPRAP CHANNEL.

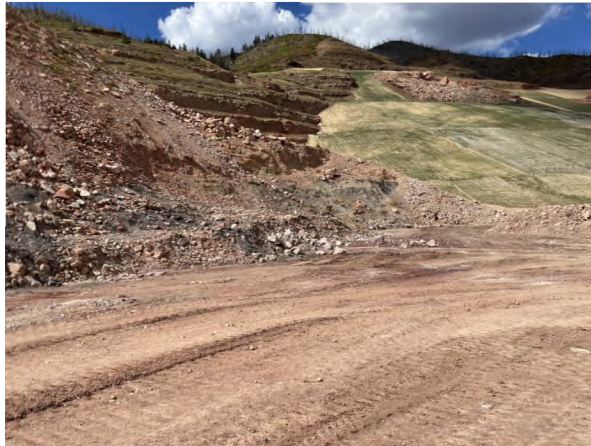
5. VIEW OF MIDDLE PEAK FROM PIT FLOOR.

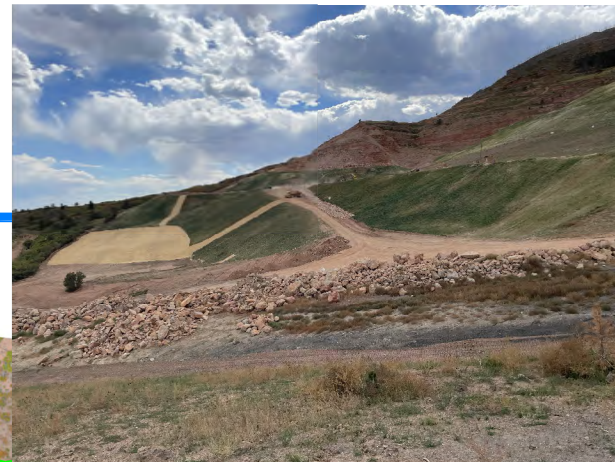
4. VIEW OF SITE FROM NORTH.

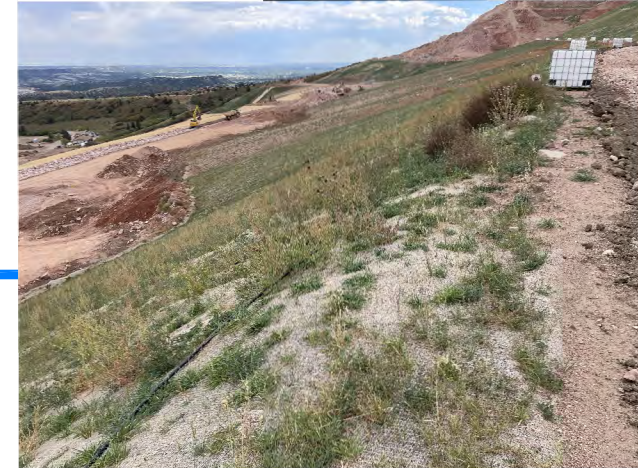
3. IRRIGATION TANKS ABOVE SEEDED SLOPES.

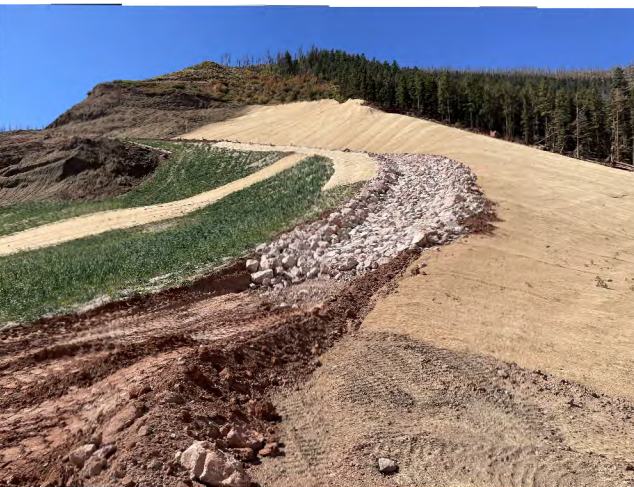
7. RIPRAP CHANNEL.

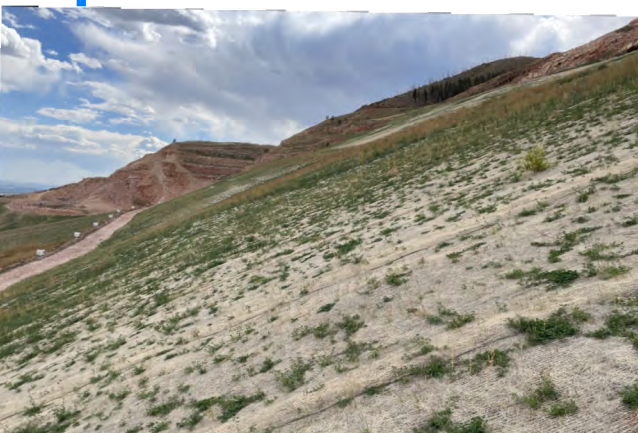
2. VEGETATION GROWING ON SLOPE.

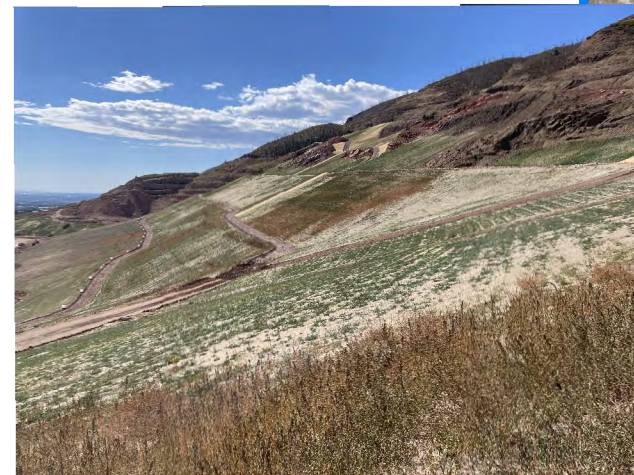
8. VIEW SOUTH OF RECLAMATION SLOPES AND BENCHES.

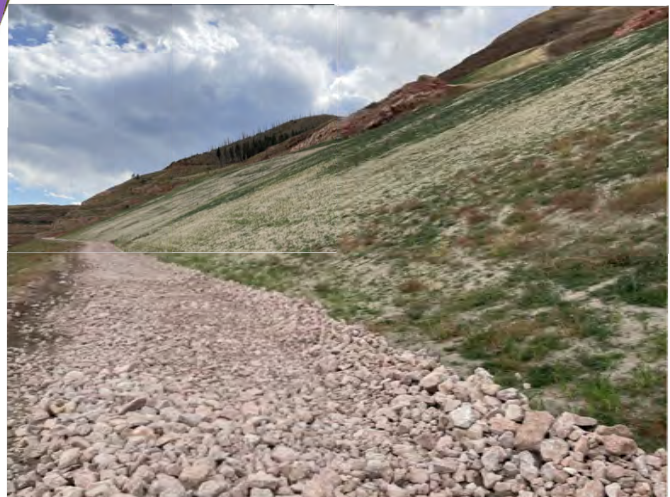
1. RIPRAP ON BENCH.

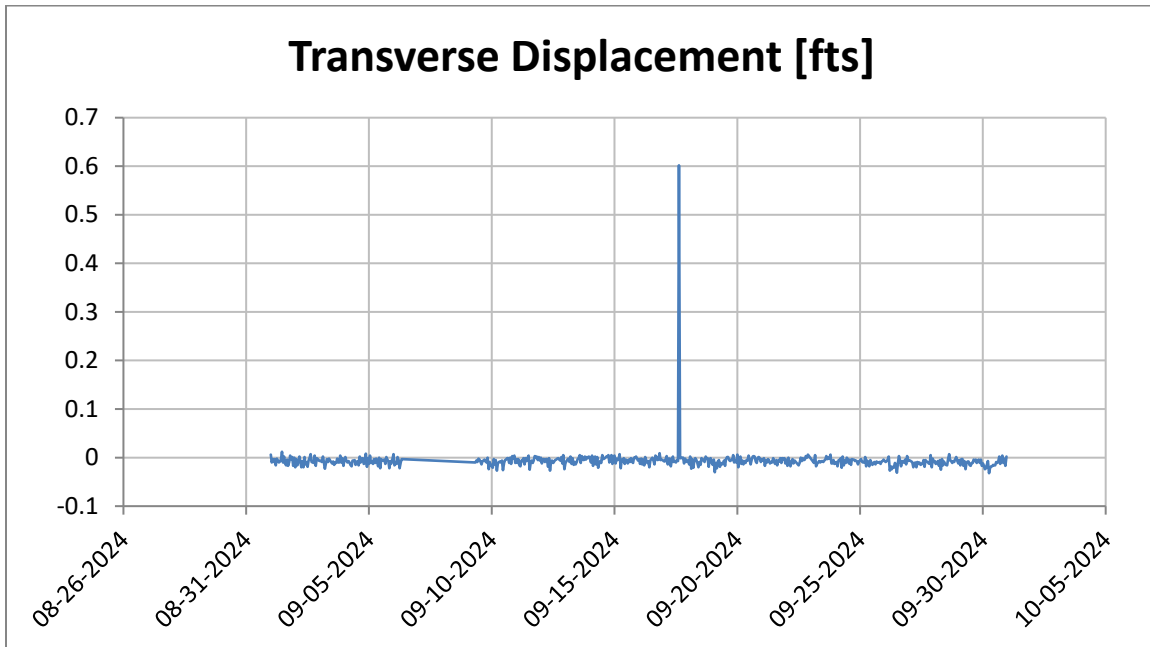
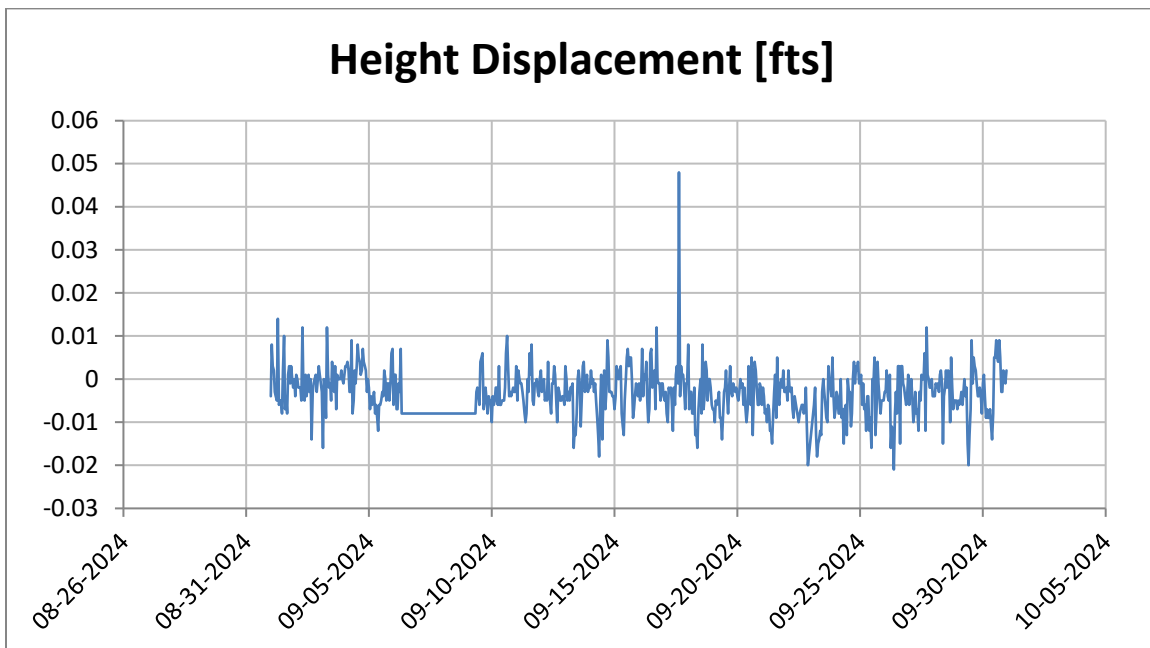
## Prism BR4

1. Survey accuracy is  $\pm 0.016$  feet.
2. Alert threshold is  $\pm 0.35$  feet.
3. Transverse displacement is in the horizontal direction. Positive direction means closer to the robotic total station.
4. Height displacement is in the vertical direction. Positive direction means higher in elevation.
5. Rain and fog caused erroneous data on September 17.

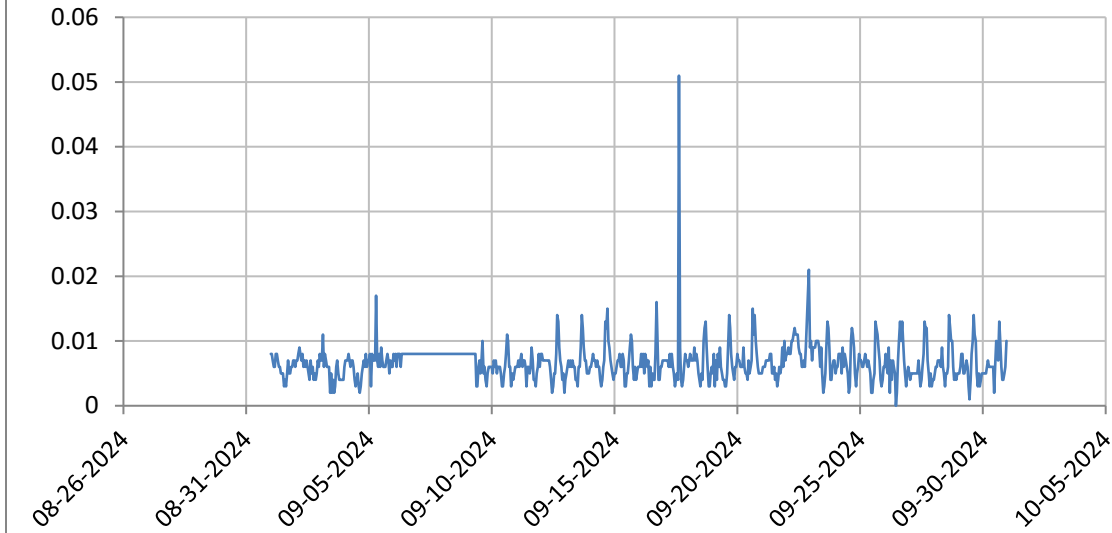
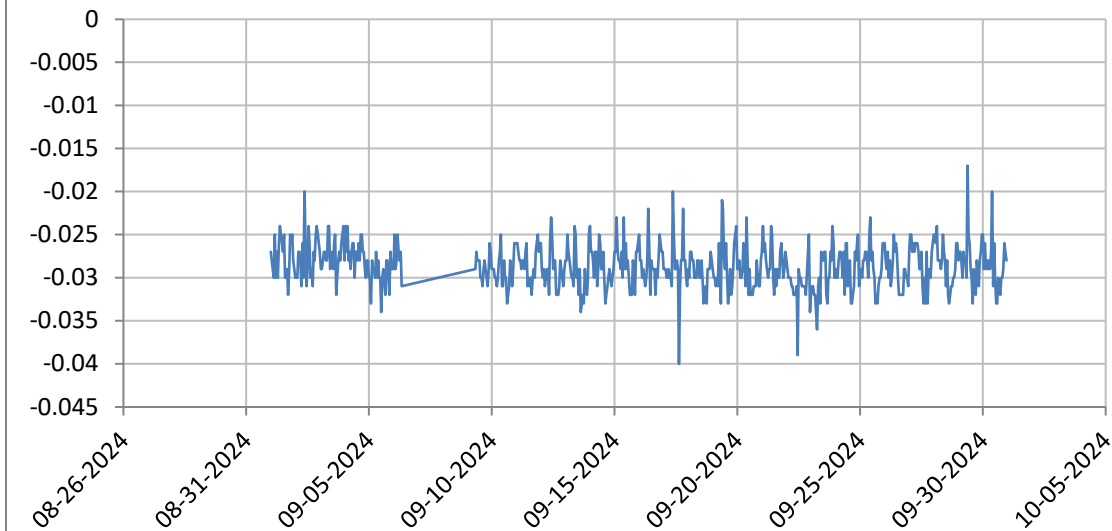
## Prism B7200-2

1. Survey accuracy is  $\pm 0.016$  feet.
2. Alert threshold is  $\pm 0.35$  feet.
3. Transverse displacement is in the horizontal direction. Positive direction means closer to the robotic total station.
4. Height displacement is in the vertical direction. Positive direction means higher in elevation.
5. Rain and fog caused erroneous data on September 17.

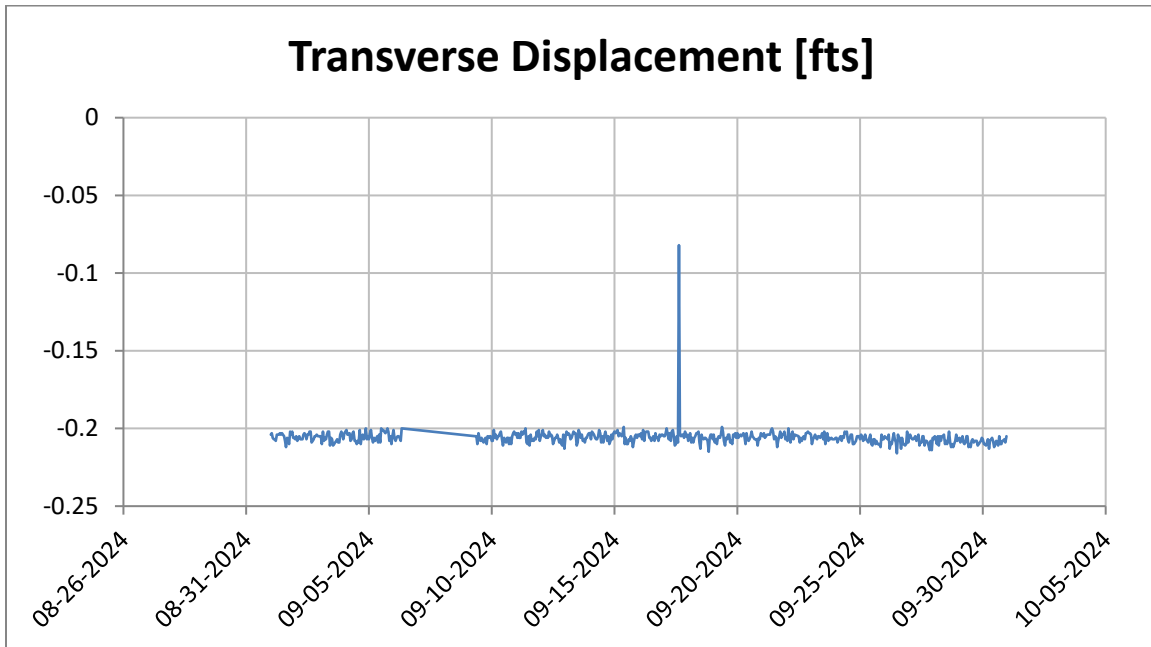
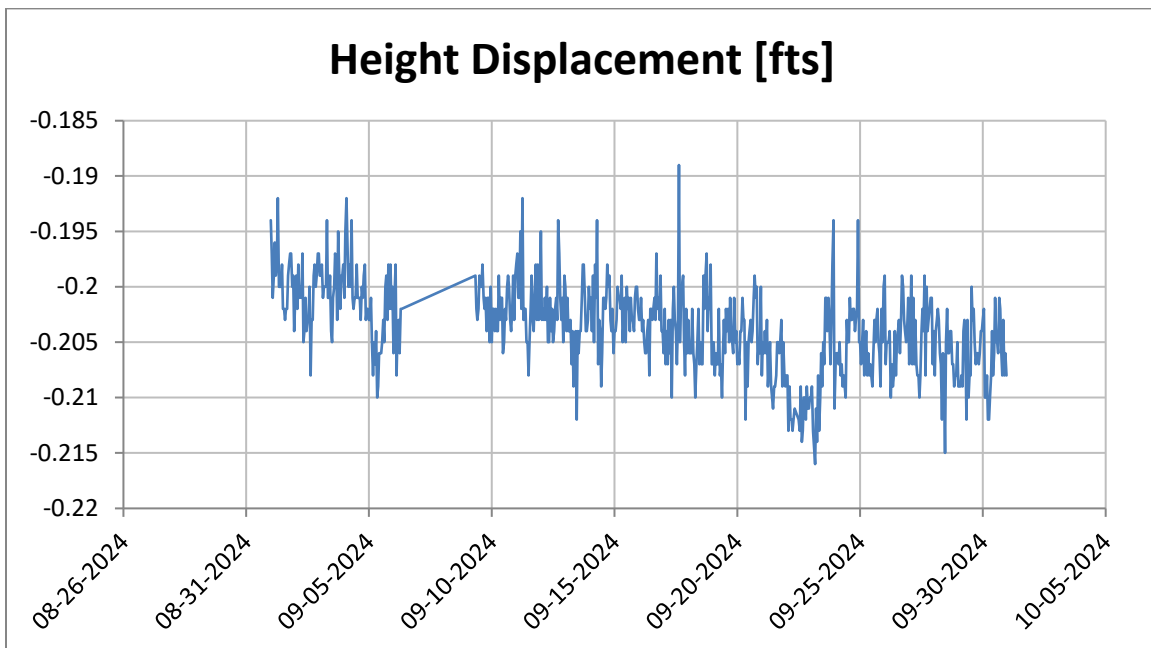
## Prism B7300-1

1. Survey accuracy is  $\pm 0.016$  feet.
2. Alert threshold is  $\pm 0.35$  feet.
3. Transverse displacement is in the horizontal direction. Positive direction means closer to the robotic total station.
4. Height displacement is in the vertical direction. Positive direction means higher in elevation.
5. Rain and fog caused erroneous data on September 17.

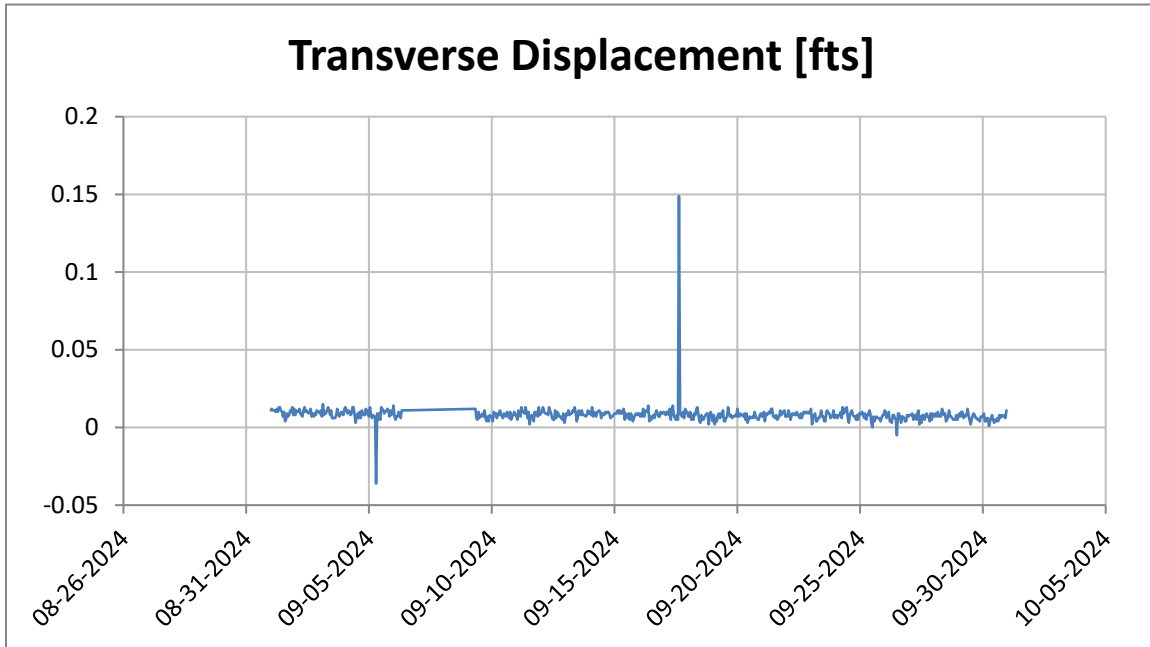
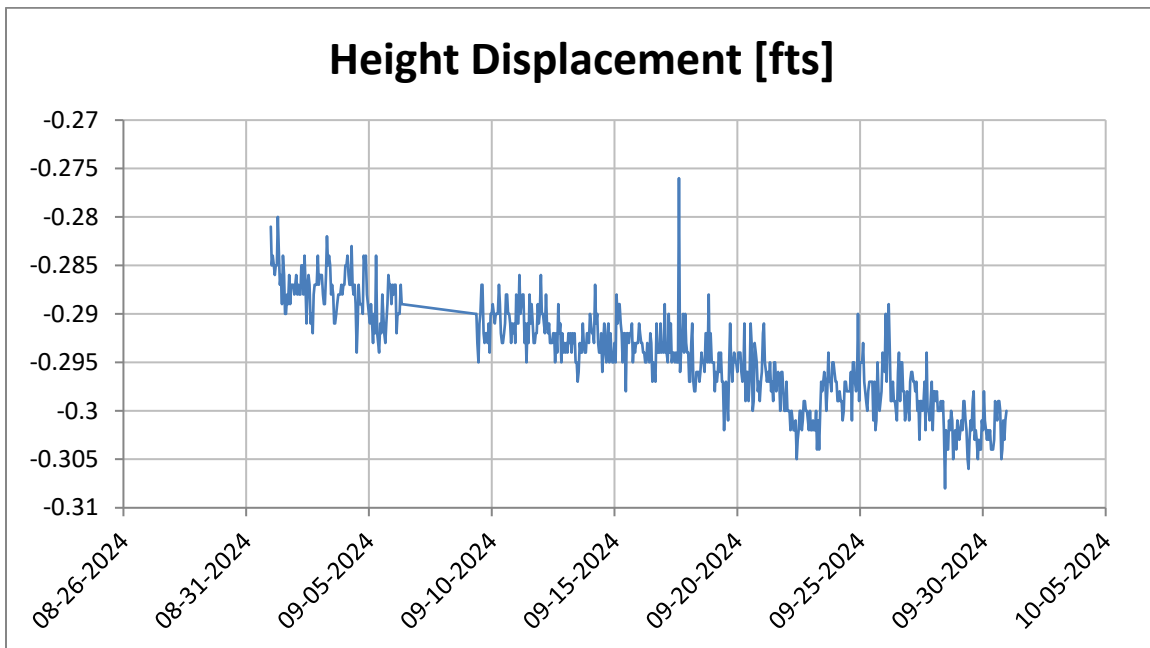
## Prism B7300-2

1. Survey accuracy is  $\pm 0.016$  feet.
2. Alert threshold is  $\pm 0.35$  feet.
3. Transverse displacement is in the horizontal direction. Positive direction means closer to the robotic total station.
4. Height displacement is in the vertical direction. Positive direction means higher in elevation.
5. Rain and fog caused erroneous data on September 17.

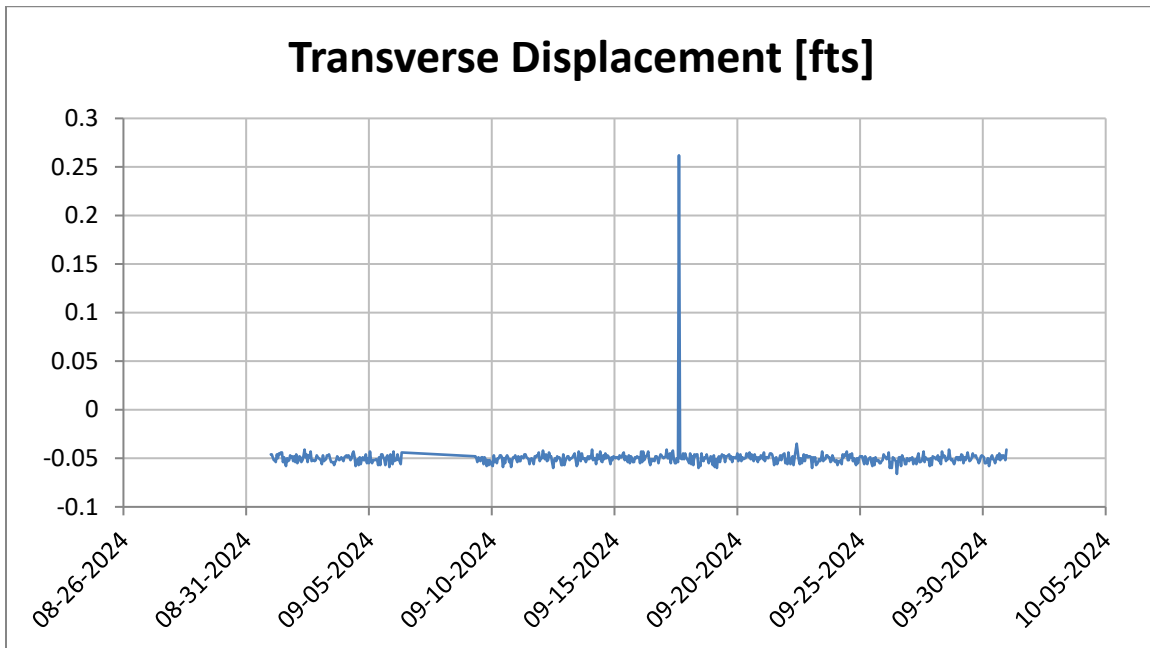
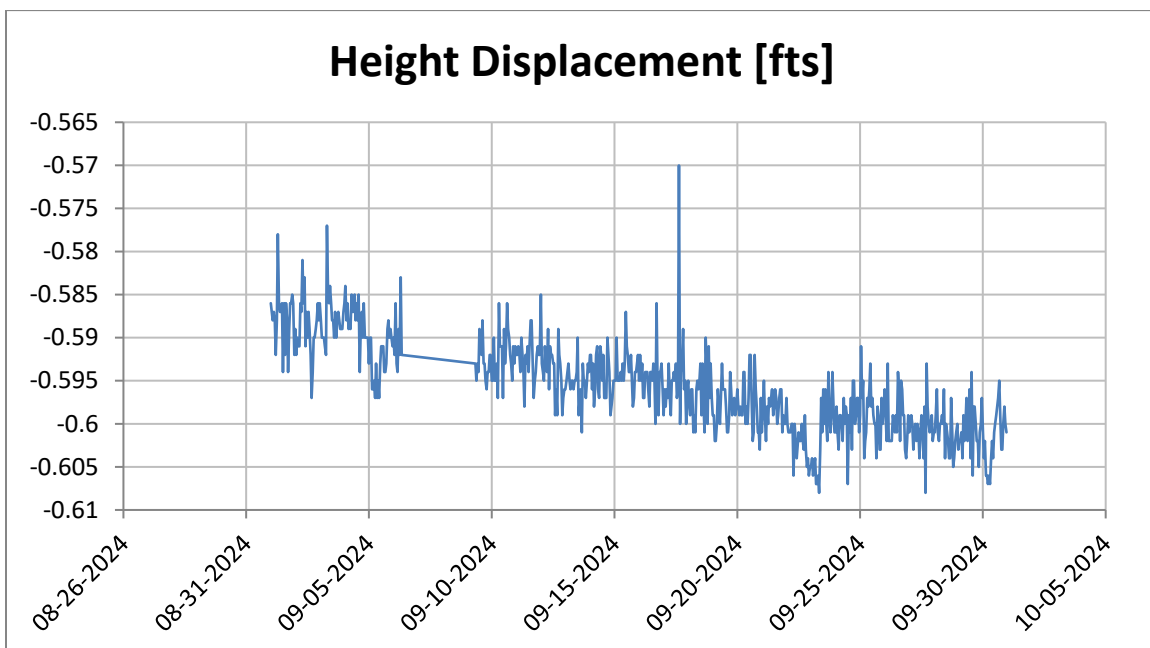
## Prism B7400-2

1. Survey accuracy is  $\pm 0.016$  feet.
2. Alert threshold is  $\pm 0.35$  feet.
3. Transverse displacement is in the horizontal direction. Positive direction means closer to the robotic total station.
4. Height displacement is in the vertical direction. Positive direction means higher in elevation.
5. Rain and fog caused erroneous data on September 17.

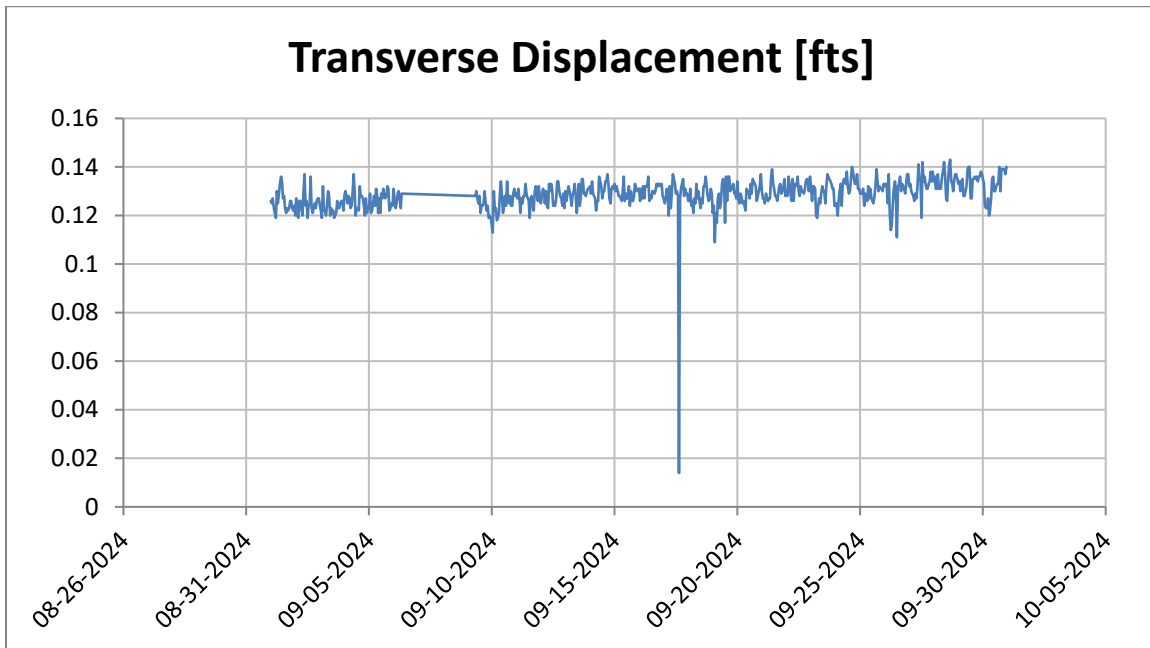
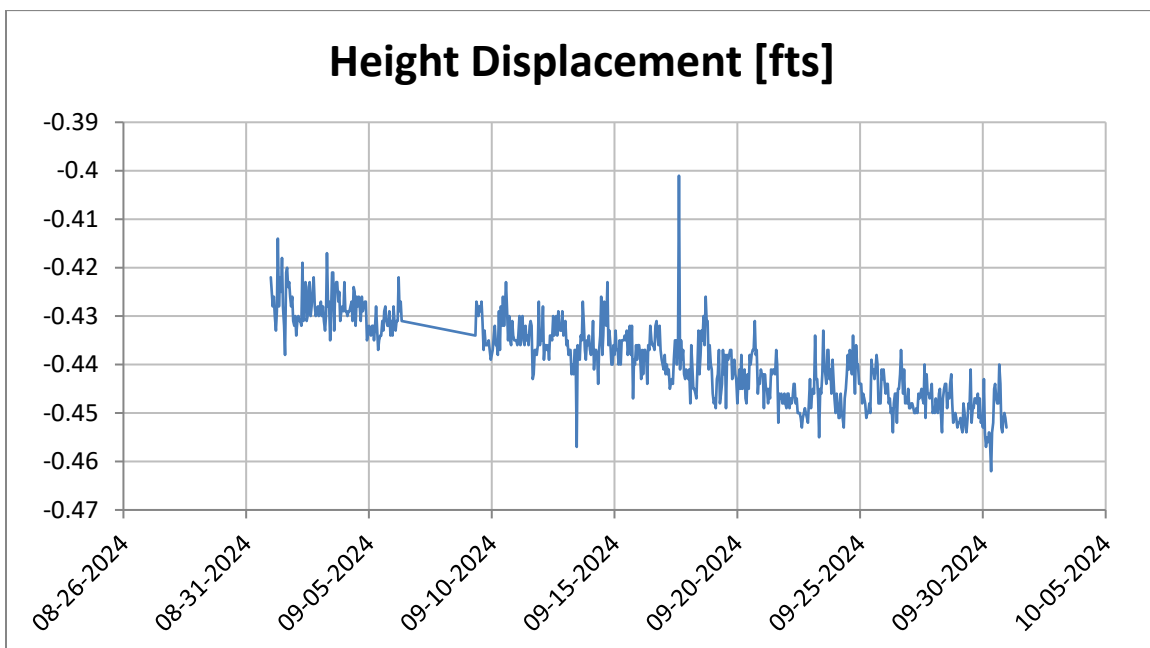
### Prism B7400-3

1. Survey accuracy is +/-0.016 feet.
2. Alert threshold is +/-0.35 feet.
3. Transverse displacement is in the horizontal direction. Positive direction means closer to the robotic total station.
4. Height displacement is in the vertical direction. Positive direction means higher in elevation.
5. Rain and fog caused erroneous data on September 17.

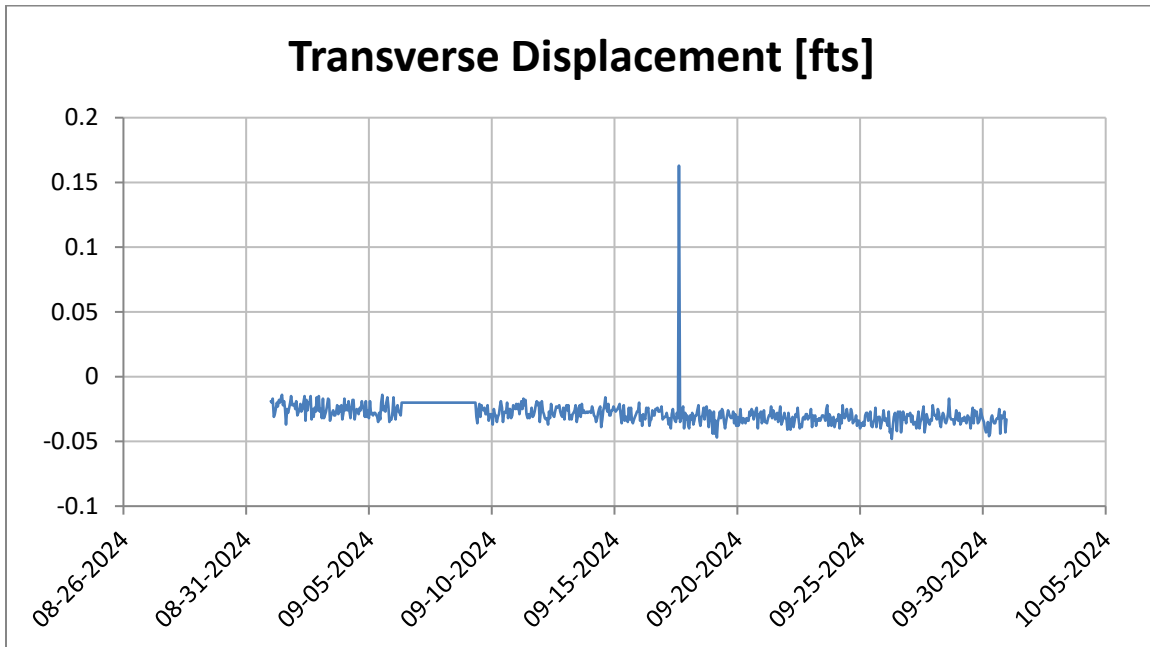
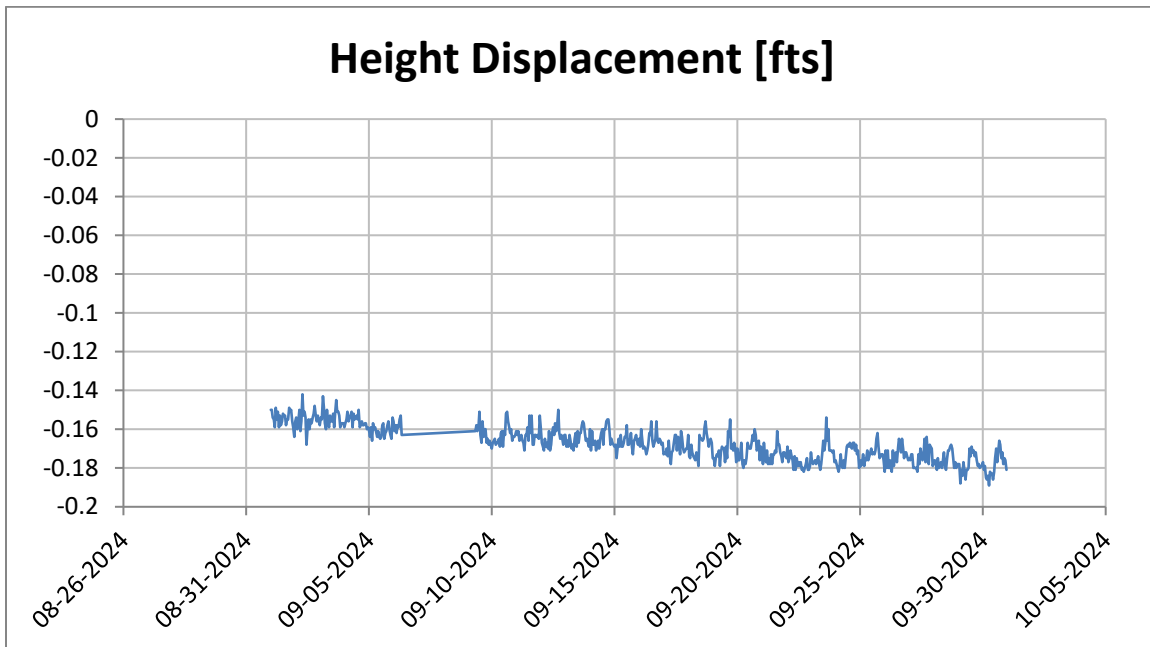
**B7500-1**

1. Survey accuracy is  $\pm 0.016$  feet.
2. Alert threshold is  $\pm 0.35$  feet.
3. Transverse displacement is in the horizontal direction. Positive direction means closer to the robotic total station.
4. Height displacement is in the vertical direction. Positive direction means higher in elevation.
5. Rain and fog caused erroneous data on September 17.

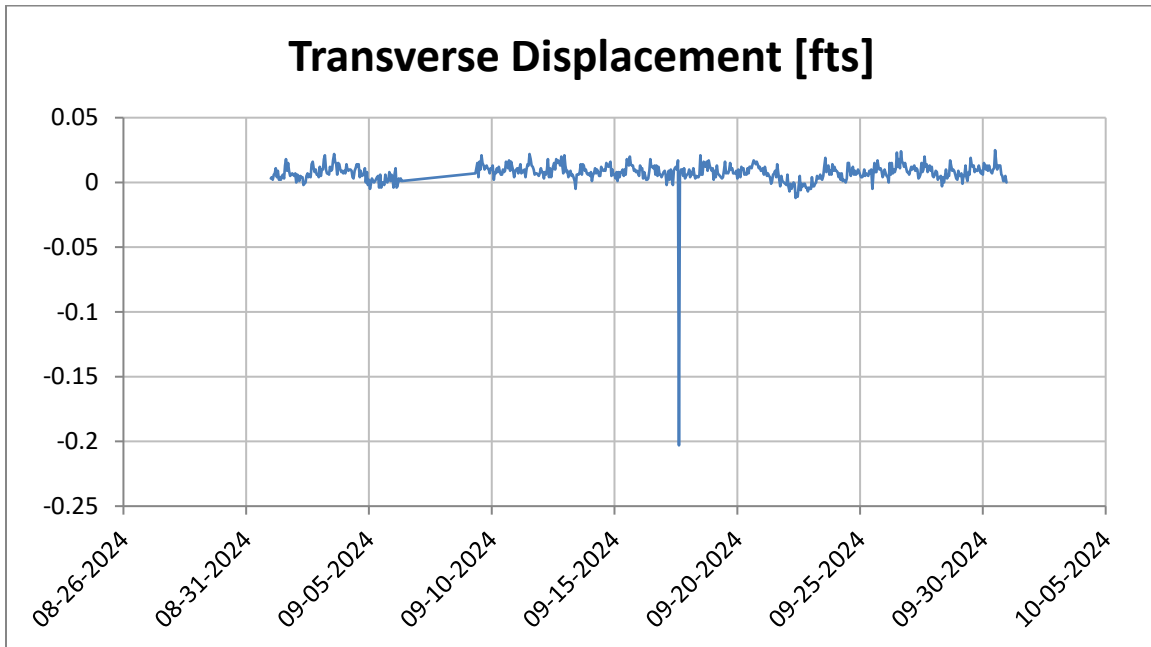
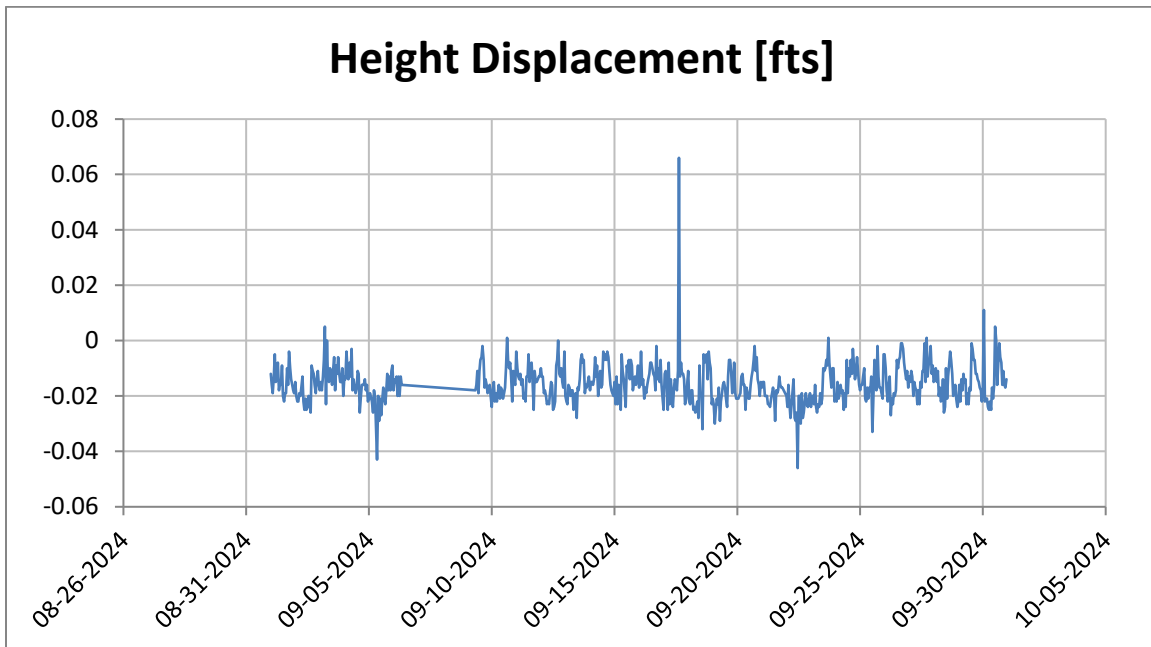
## Prism P5

| Date(s) | Alert | Cause/Actions taken | Resolved |
|---|---|---|---|
| 4-Sep | P5 not found | Single event. No work being performed at time of alert. | 4-Sep |

1. Survey accuracy is +/-0.016 feet.
2. Alert threshold is +/-0.35 feet.
3. Transverse displacement is in the horizontal direction. Positive direction means closer to the robotic total station.
4. Height displacement is in the vertical direction. Positive direction means higher in elevation.
5. Regression limit alert received on September 17.
6. Rain and fog caused erroneous data on September 17.

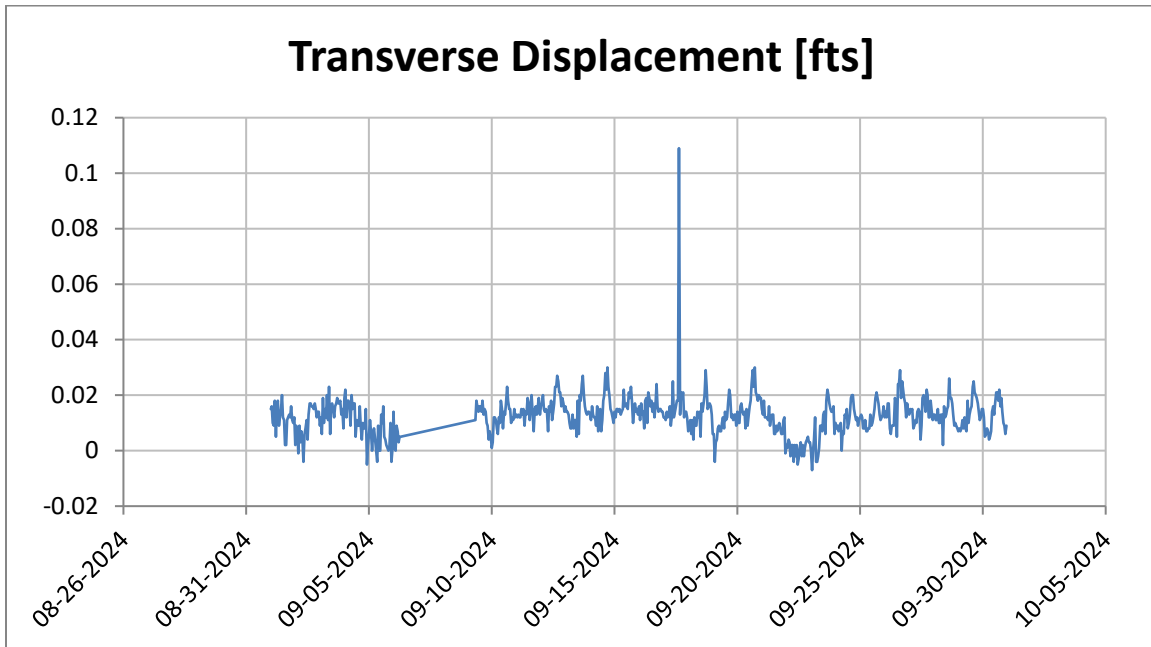
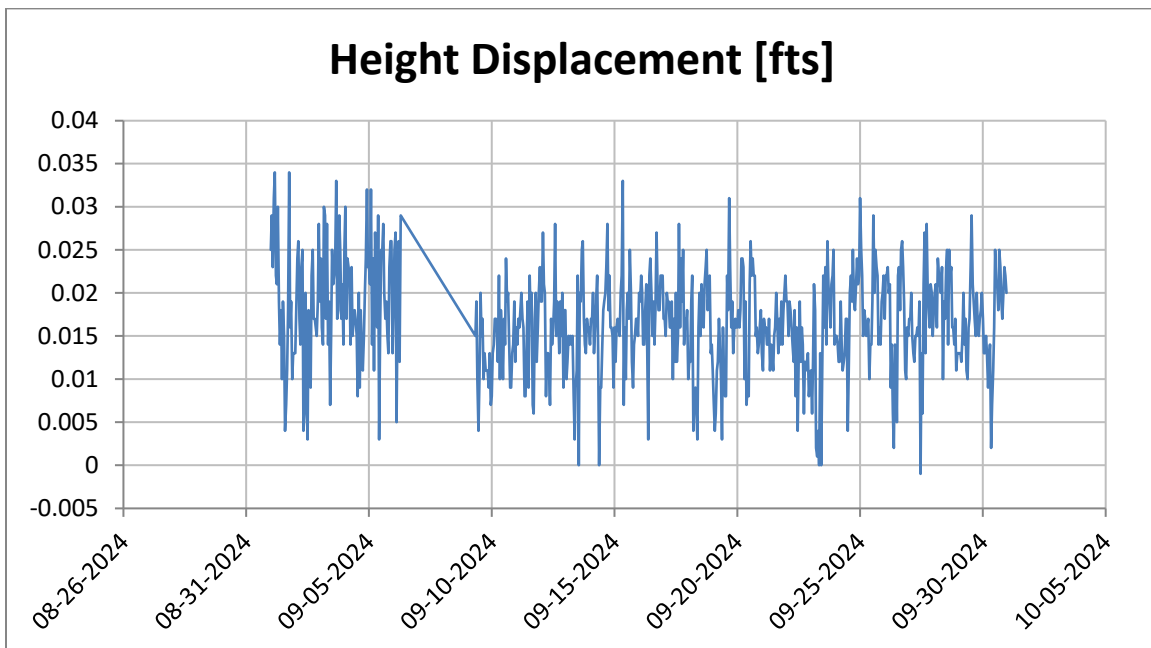
## Prism P25

| Date(s) | Alert | Cause/Actions taken | Resolved |
|---|---|---|---|
| 6-Sep | P25 not found | Single event. Mulching operations in area blocked prism. Operators watching out for each other. | 6-Sep |

1. Survey accuracy is  $\pm 0.016$  feet.
2. Alert threshold is  $\pm 0.35$  feet.
3. Transverse displacement is in the horizontal direction. Positive direction means closer to the robotic total station.
4. Height displacement is in the vertical direction. Positive direction means higher in elevation.
5. Regression limit alert received on September 17.
6. Rain and fog caused erroneous data on September 17.

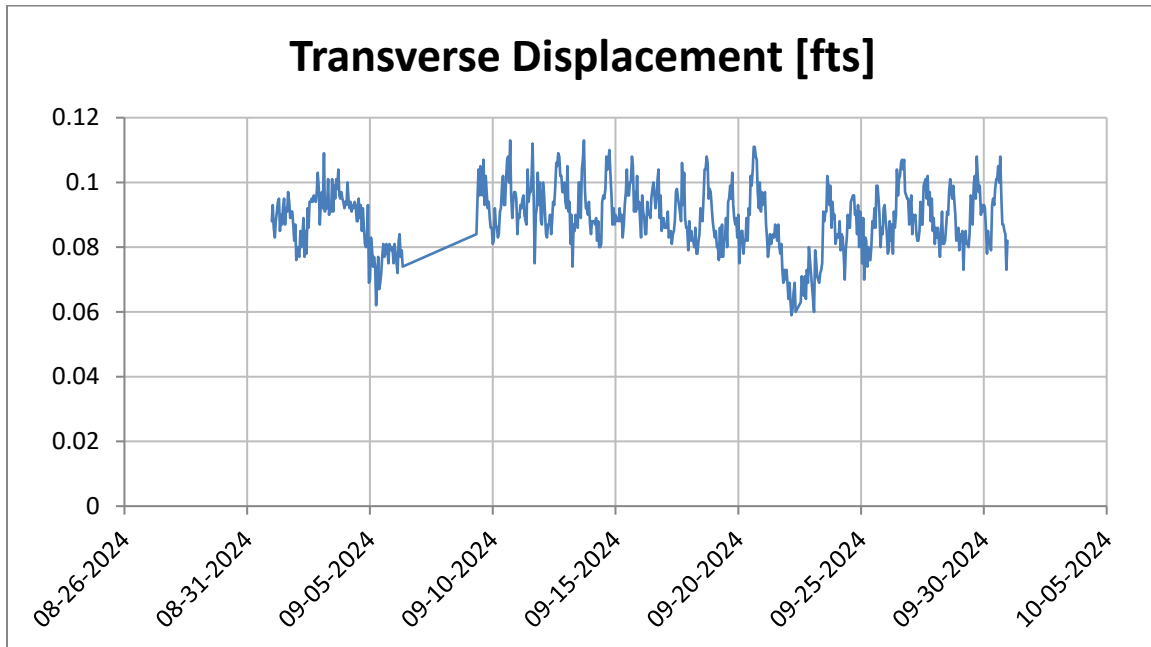
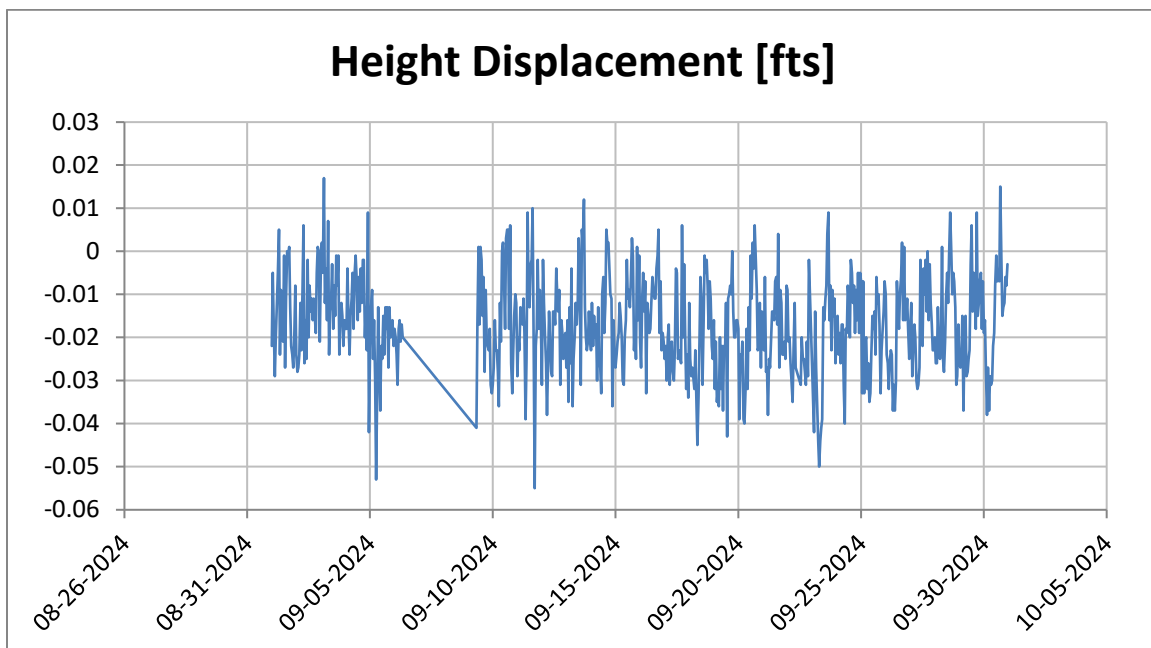
## Prism P33

| Date(s) | Alert | Cause/Actions taken | Resolved |
|---|---|---|---|
| 2-Sep | P33 not found | Single event. No work being performed at time of alert. | 2-Sep |
