**MINERALS PROGRAM INSPECTION REPORT**  
**PHONE: (303) 866-3567**

<b>MINE NAME:</b> Jolly Pit	<b>MINE/PROSPECTING ID#:</b> M-2012-010	<b>MINERAL:</b> Borrow material for construction	<b>COUNTY:</b> Las Animas
<b>INSPECTION TYPE:</b> Monitoring	<b>WEATHER:</b> Cloudy	<b>INSP. DATE:</b> November 5, 2024	<b>INSP. TIME:</b> 14:00
<b>OPERATOR:</b> Las Animas County	<b>OPERATOR REPRESENTATIVE:</b> Keith Woodring and Joe Avila	<b>TYPE OF OPERATION:</b> 112c - Construction Regular Operation	
<b>REASON FOR INSPECTION:</b> Normal I&E Program	<b>BOND CALCULATION TYPE:</b> None	<b>BOND AMOUNT:</b> \$0.00	
<b>DATE OF COMPLAINT:</b> NA	<b>POST INSP. CONTACTS:</b> None	<b>JOINT INSP. AGENCY:</b> None	
<b>INSPECTOR(S):</b> Amber M. Gibson	<b>INSPECTOR'S SIGNATURE:</b>

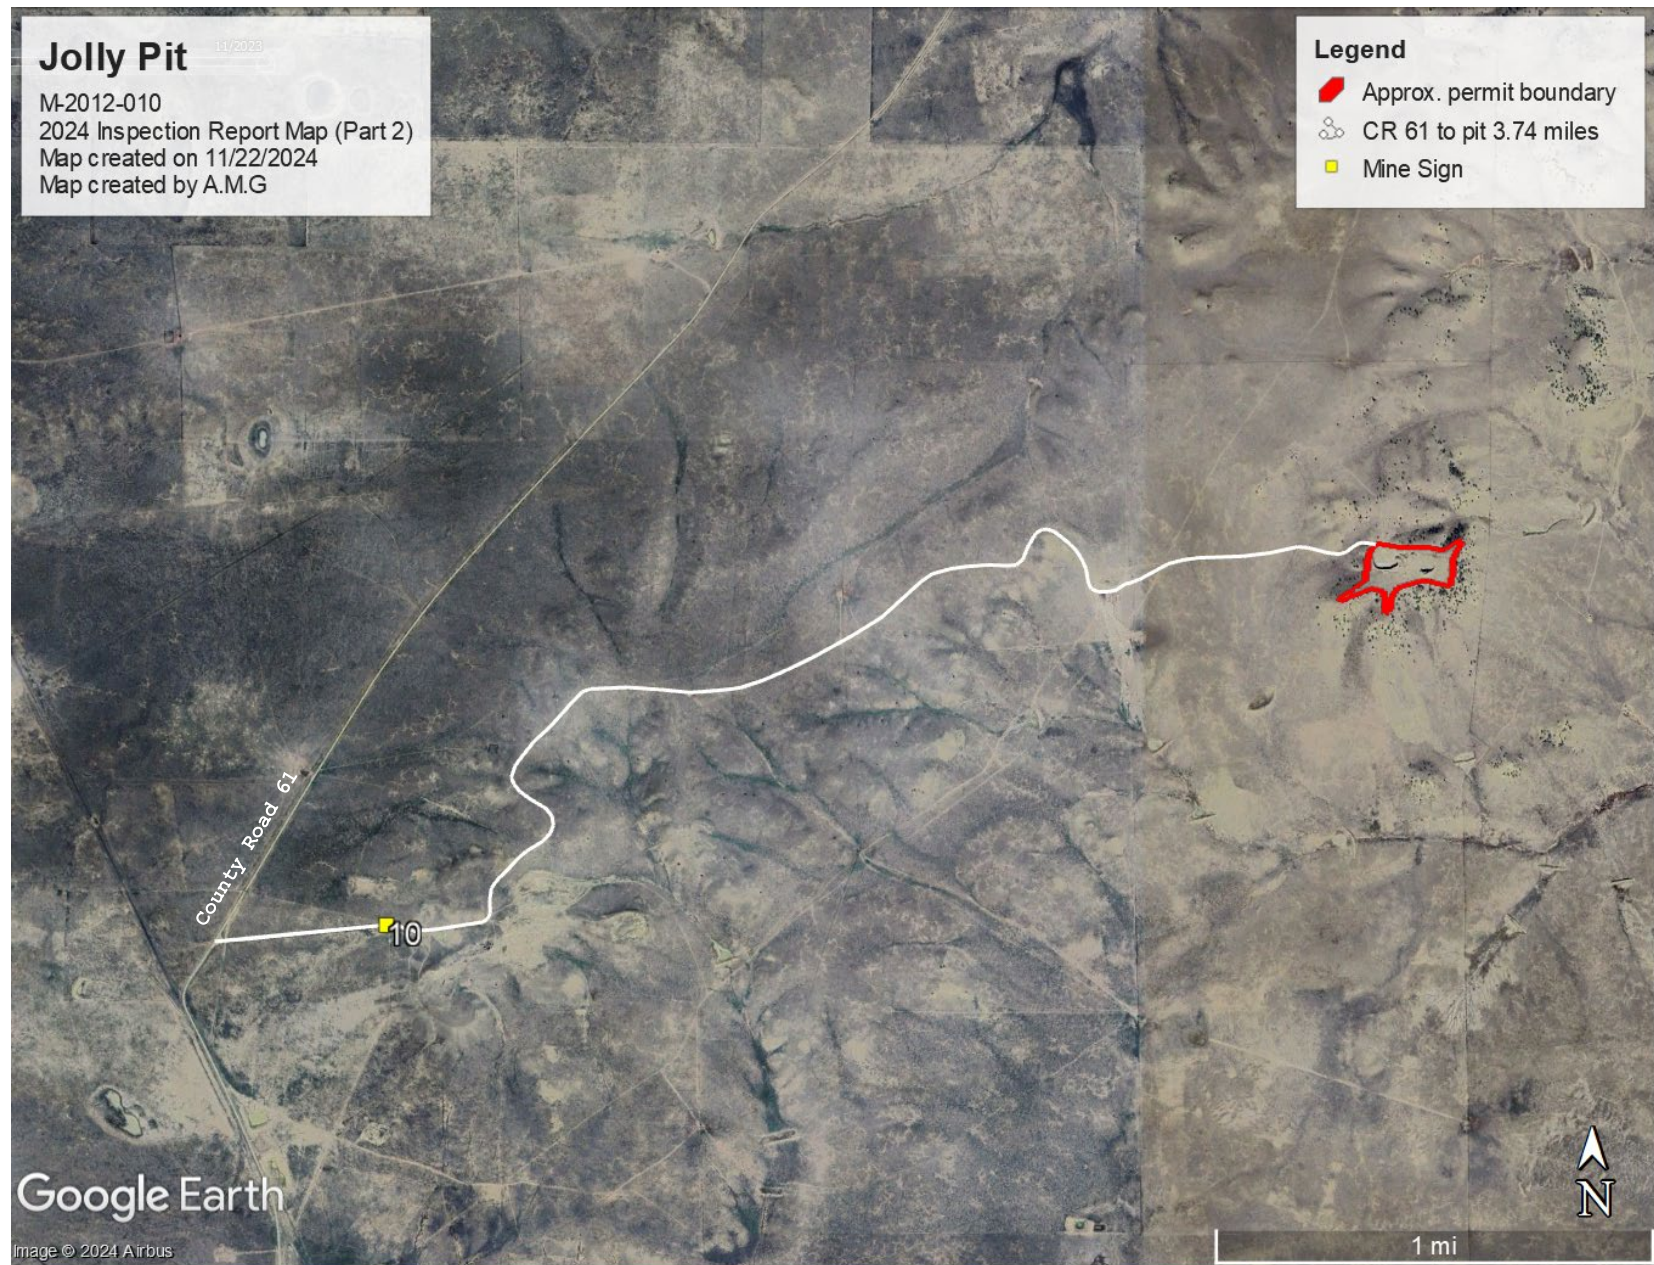
**Map 2:** Inspection report map showing the private access road located off of CR 61 that leads to the permit area, and the location of the permit sign along that road.

The mine sign was observed and appears to be in compliance with Rule 3.1.12(1). The mine sign is posted approximately 2.9 miles west of the entrance to the pit, near the start of the private road leading east from CR 61 (Photo 10; Map 2).
