Division of Reclamation,
Mining and Safety

MINERALS PROGRAM INSPECTION REPORT

MINE NAME: Meadow Hollow Quarry	MINE/PROSPECTING ID#: M-2009-006	MINERAL: Sandstone (silica, st quartzite)	COUNTY: Larimer
INSPECTION TYPE: Monitoring	WEATHER: Windy	INSP. DATE: October 24, 2024	INSP. TIME: 13:00
OPERATOR: Colorado Quarry I, LLC	OPERATOR REPRESENTATIVE: John Holiday	TYPE OF OPERATION: 110c - Construction Limited Impact

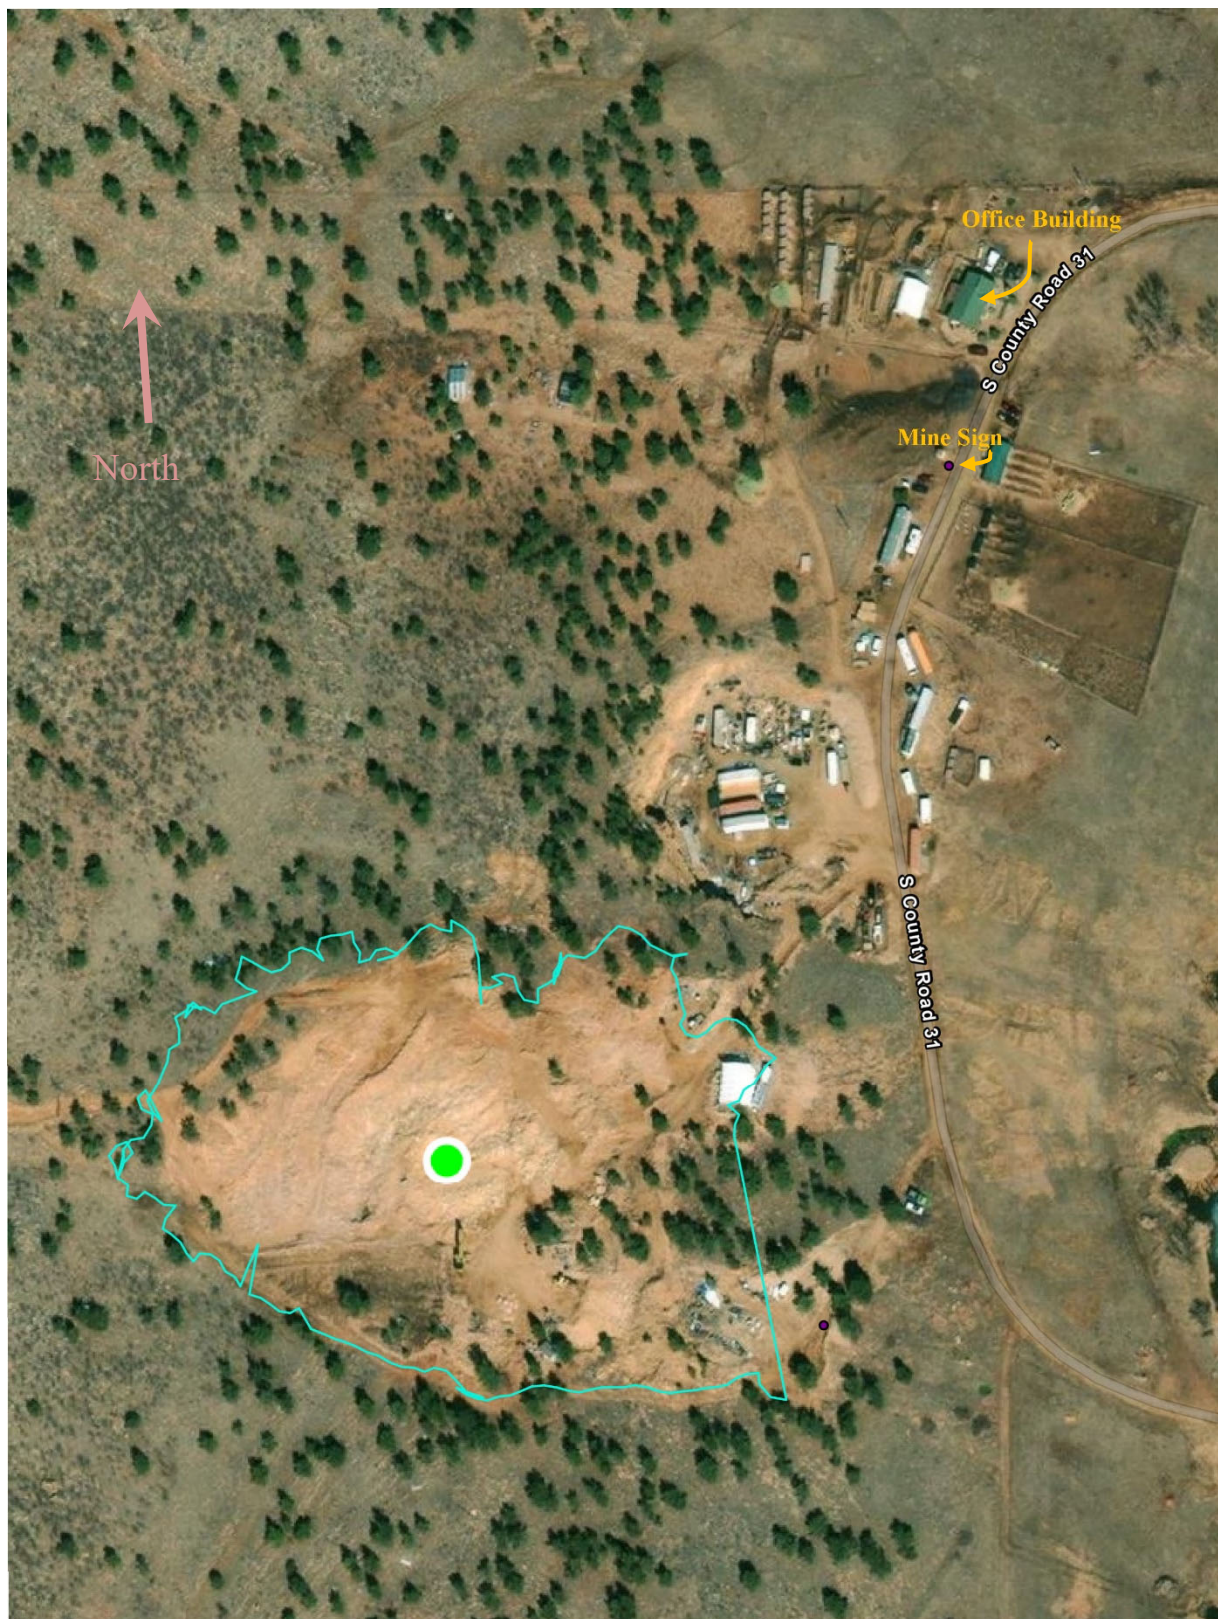
Map/Satellite image, the green polygon represents the approximate active mining area that was walked during the inspection. To the north, the office building and mine sign are identified.
