**MINERALS PROGRAM INSPECTION REPORT**  
**PHONE: (303) 866-3567**

| <b>MINE NAME:</b><br>Ted Franciscotti Pit #1 | <b>MINE/PROSPECTING ID#:</b><br>M-2007-006 | <b>MINERAL:</b><br>Sand and gravel | <b>COUNTY:</b><br>Huerfano |
| <b>INSPECTION TYPE:</b><br>Monitoring | <b>WEATHER:</b><br>Cloudy | <b>INSP. DATE:</b><br>December 17, 2024 | <b>INSP. TIME:</b><br>10:40 |
| <b>OPERATOR:</b><br>Fremont Paving & Redi-Mix, Inc. | <b>OPERATOR REPRESENTATIVE:</b><br>Jodi Schreiber | <b>TYPE OF OPERATION:</b><br>112c - Construction Regular Operation | |

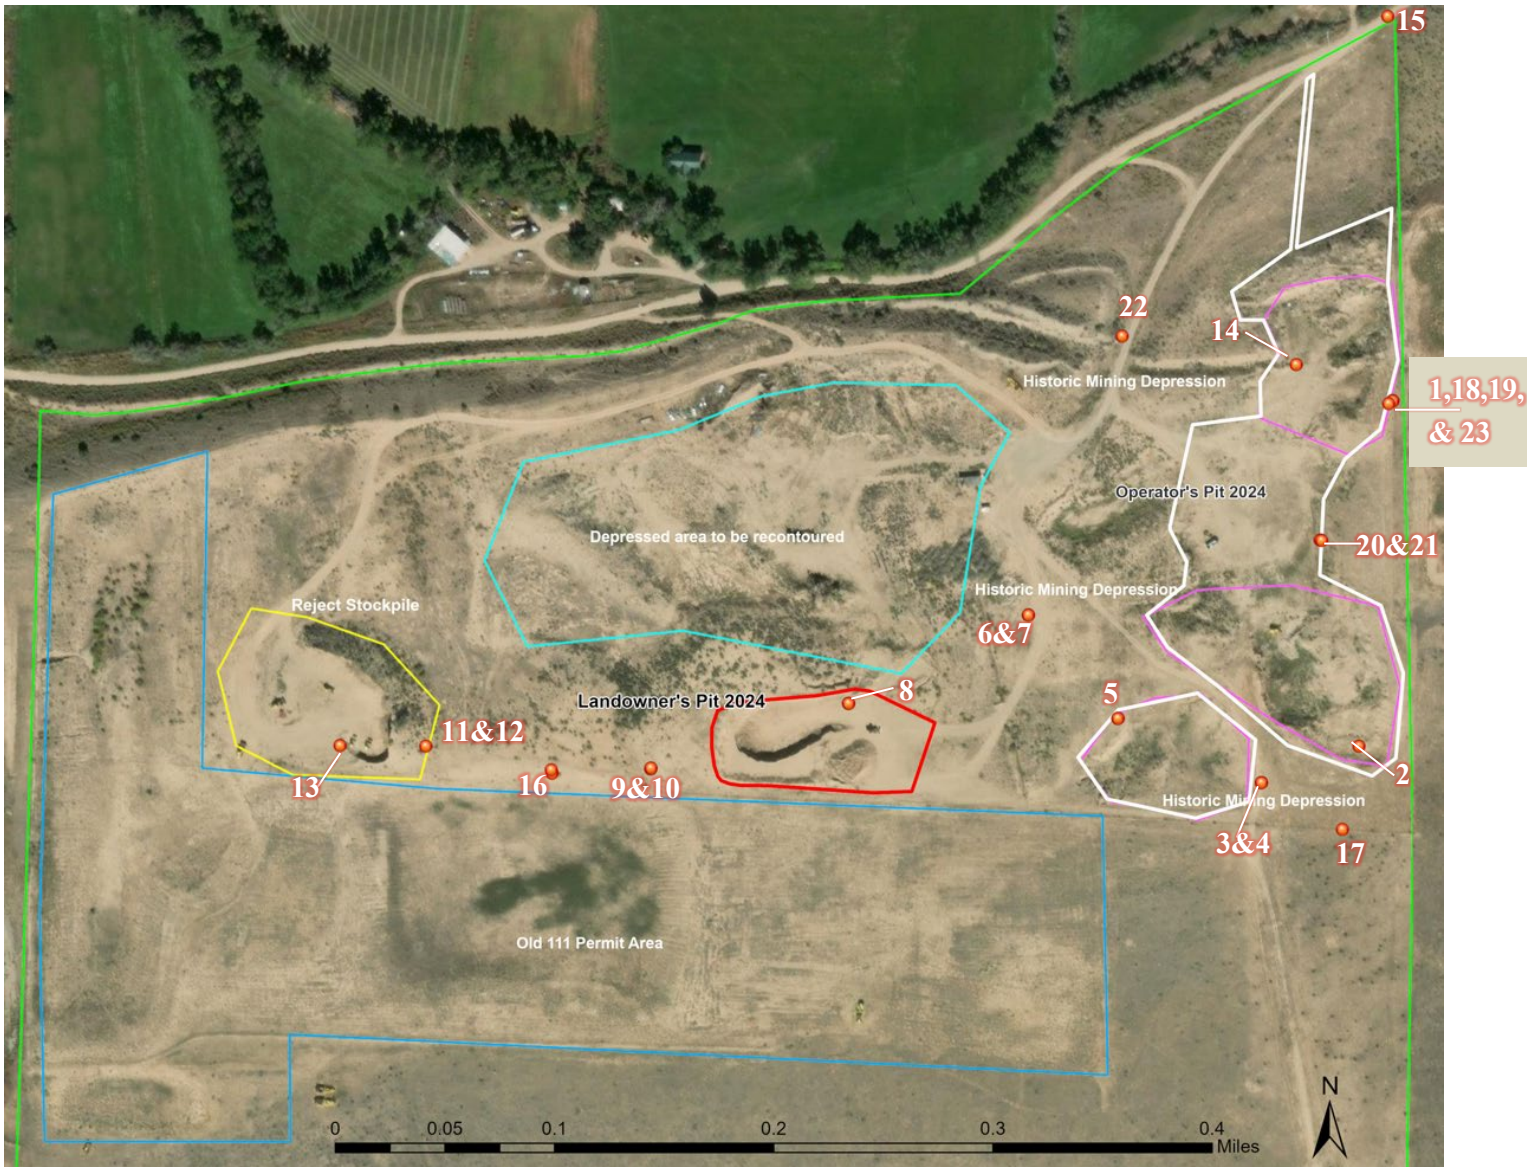
**Map 1:** Inspection overview map for the Division's inspection conducted for the Ted Franciscotti Pit #1 (permit no. M-2007-006) on December 17, 2024. The map was generated using ArcGIS Online. The aerial imagery is undated, but in comparison with available Google Earth imagery, it is more recent than September 2019. The contents in this photo focus on the Phase 1 area of the permitted boundary. All the polygons, besides the white and the red polygons, correspond with the Division's 2020 inspection report map. The green polygon indicates the approximate location of the permit boundary. The large white polygon indicates the area where the Operator is actively mining, and an estimation of the new road's orientation on the north side. The small white polygon to the southwest of the active mining area encompasses some pre-law disturbance that is currently approved to be backfilled, regraded, and revegetated per the reclamation plan. The red polygon indicates the area where the landowner has excavated material for use on their property on and around the site. The red dots indicate the locations where inspection photos were taken, and the numbers correspond to the inspection photo's numbers throughout this report.

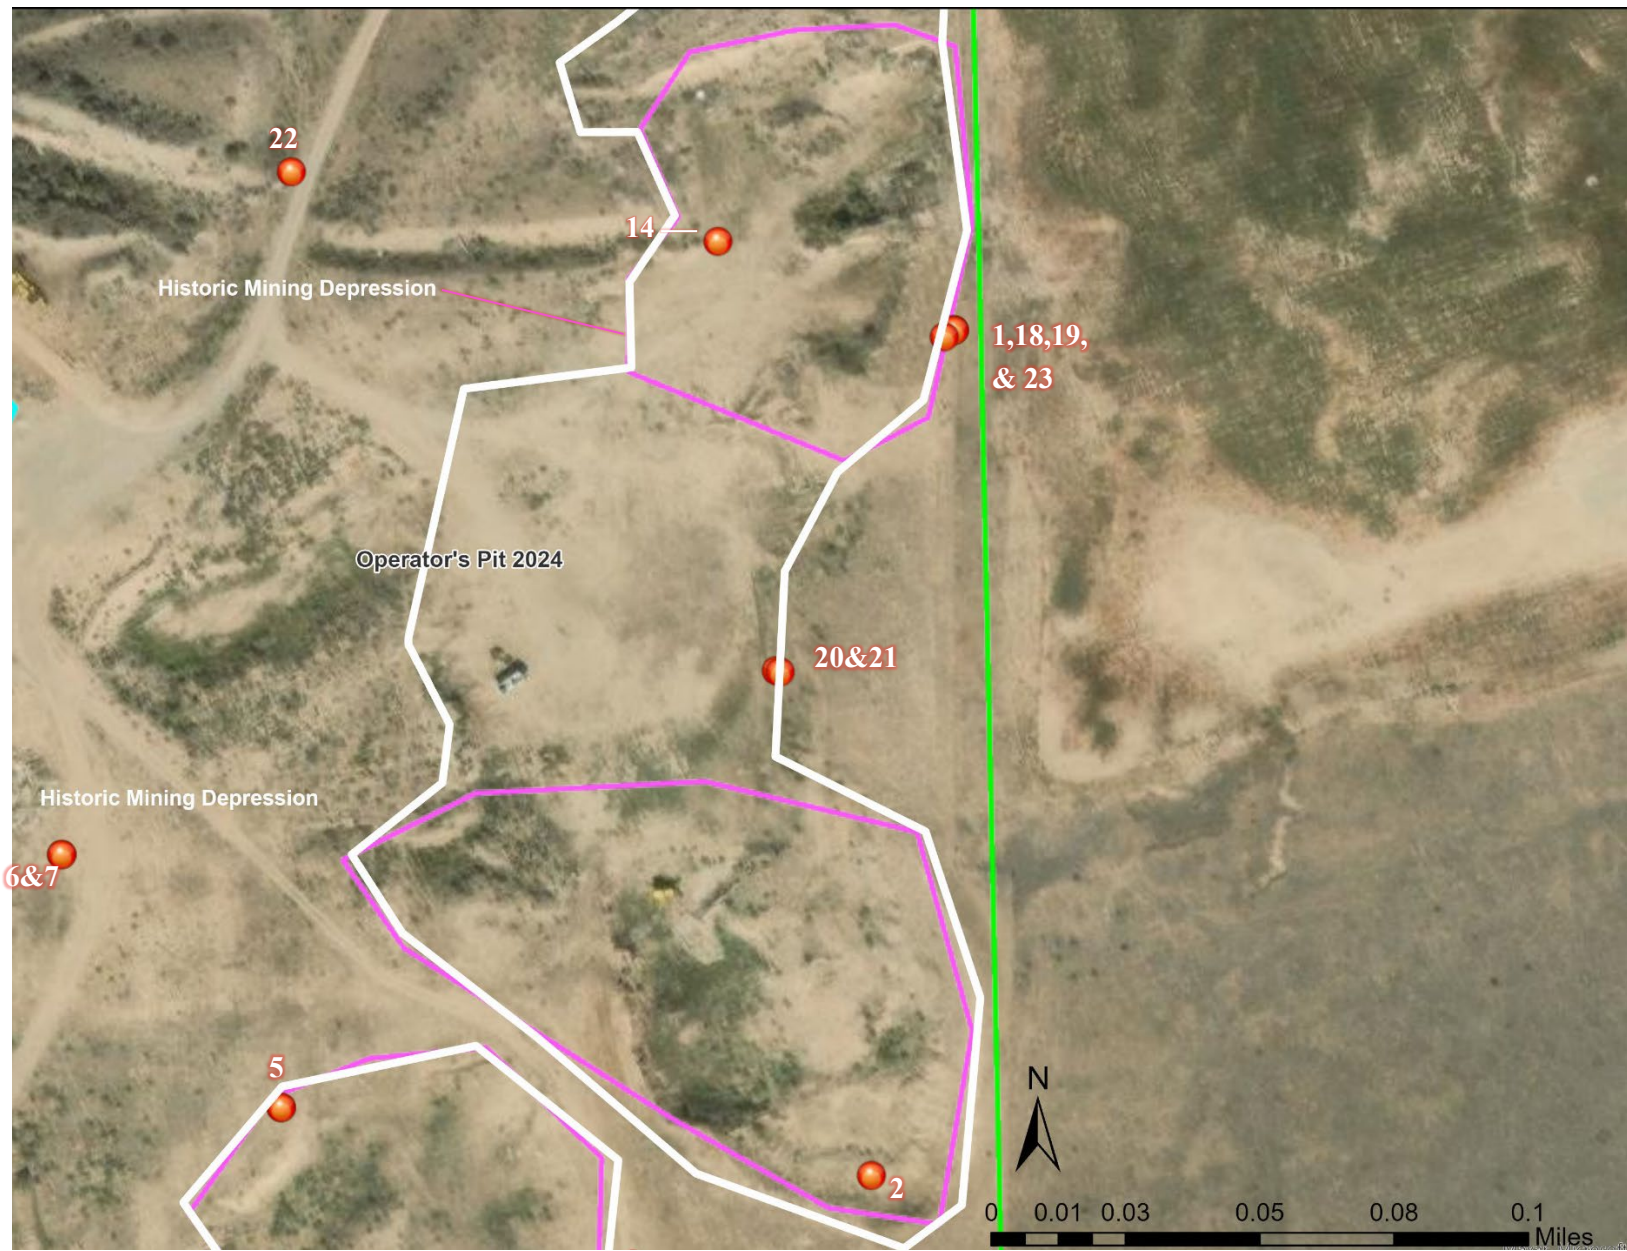
The mine was not active during the inspection but had been active recently. Mining at this site has remained within Phase 1 (Maps 1 & 2a). The current pit consists of excavated areas along the north and east banks, as well as some expansion to the south. Product stockpiles and overburden stockpiles (as mentioned in the section above) were observed throughout the mining area (Photo 1). The presence of a visual berm along the northeast corner of Phase 1 was observed and is located where the Permittee's Mining Plan Map indicates. A few Tamarisk trees were observed within the current active mining area (Photo 2). The establishment of both Tamarisk and Russian Olive trees within the historic mining areas (Photos 3-5) has been noted in previous inspection reports (Tamarisk was also observed in the historic area during the current inspection), and had prompted the need for a technical revision (TR1) to establish a weed management plan. Per the approved revision, the Operator shall employ weed control measures throughout the affected area – with the highest priority being the eradication of existing infestations. The presence of noxious weeds throughout the affected area has been **cited as a problem above**. The Operator shall provide photo evidence to the Division that the noxious weeds have been eradicated through methods approved in the weed management plan by the corrective action date.

**Map 2a:** Close up of the current operating area within Phase 1 at the Ted Franciscotti Pit #1.
