MINERALS PROGRAM INSPECTION REPORT
PHONE: (303) 866-3567

MINE NAME: Seeley Reservoir Stockpiles	MINE/PROSPECTING ID#: M-2023-043	MINERAL: Borrow material for construction	COUNTY: Weld
INSPECTION TYPE: Preoperation Inspection	WEATHER: Windy	INSP. DATE: January 9, 2025	INSP. TIME: 09:30
OPERATOR: Four C Sons, Inc.	OPERATOR REPRESENTATIVE: Scott Cockroft, Tim Naylor, Travis Koch	TYPE OF OPERATION: 112c - Construction Regular Operation	
REASON FOR INSPECTION: Pre-operation Inspection	BOND CALCULATION TYPE: None	BOND AMOUNT: \$0.00	
DATE OF COMPLAINT: NA	POST INSP. CONTACTS: None	JOINT INSP. AGENCY: None	
INSPECTOR(S): Amber Gibson Jared Ebert	INSPECTOR'S SIGNATURE:

An application for the Seeley Reservoir Stockpiles (M-2023-043) has been received by the Division of Reclamation, Mining and Safety (Division/DRMS) and was deemed complete on December 2, 2024. The site was inspected by Amber Gibson and Jared Ebert with the Division as part of a pre-operation inspection. The site was previously inspected by the Division on January 18, 2024 as a possible violation investigation inspection. Scott Cockroft, Tim Naylor, and Travis Koch (representing the Applicant), and Charles and Spencer Keirn

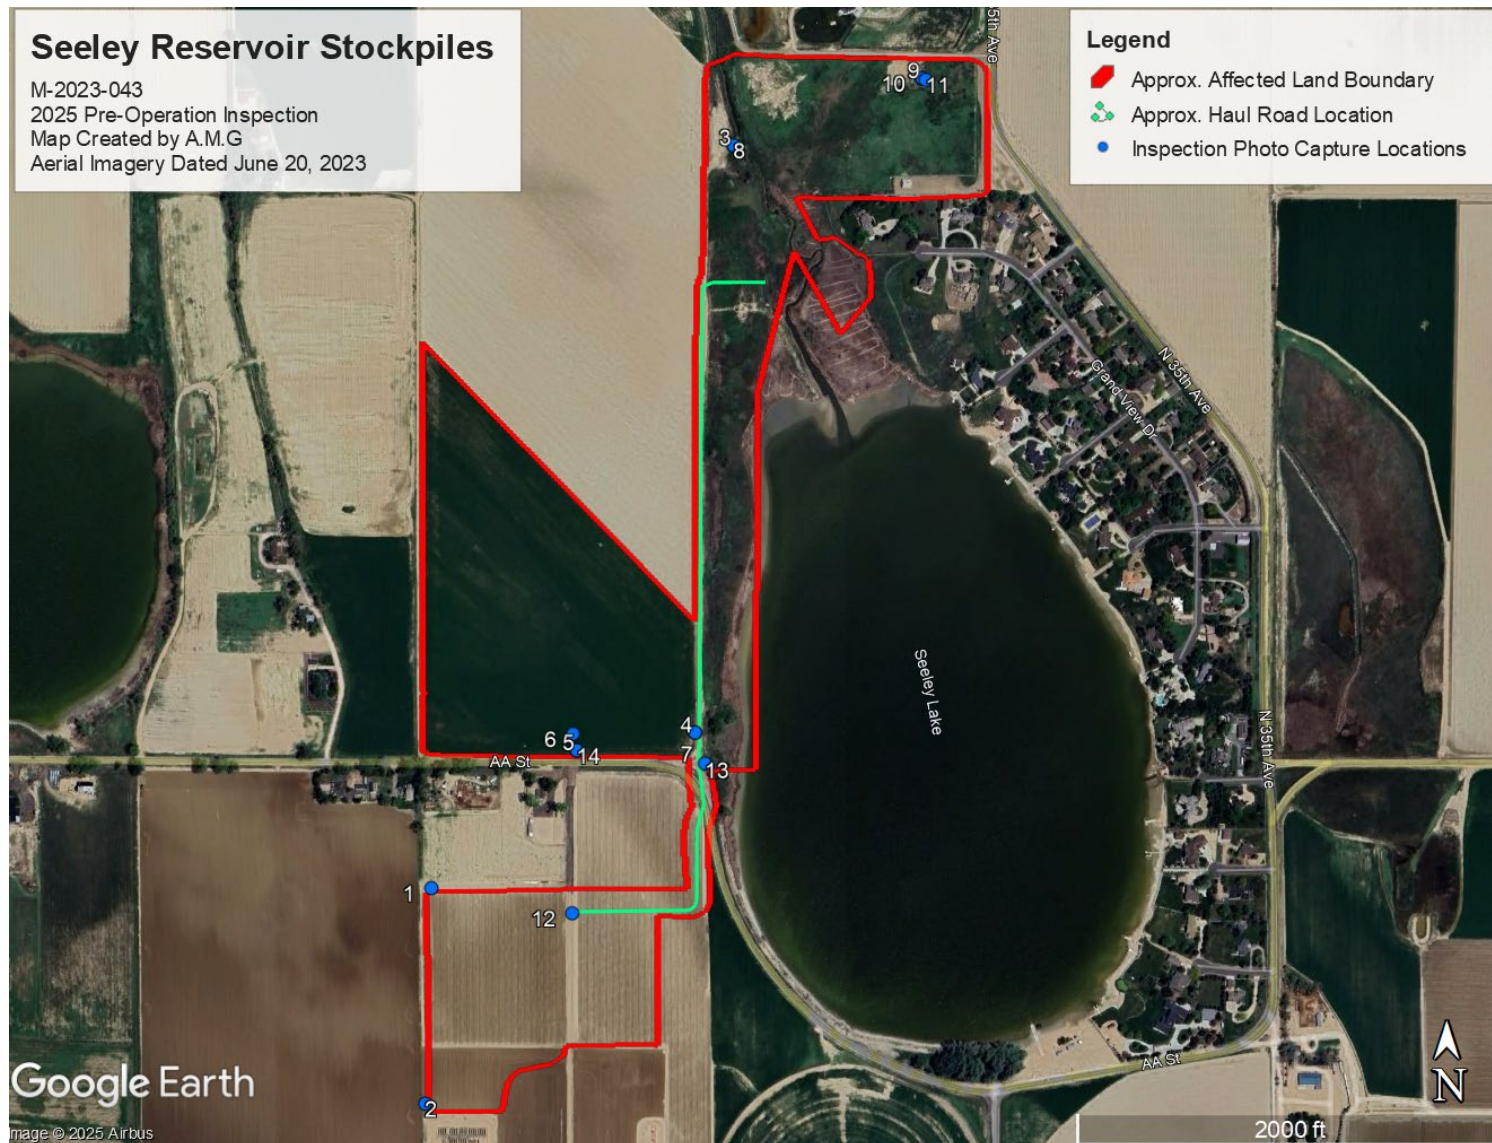
INSPECTION MAP

During the inspection, the landowners brought the inspectors and the Applicant to the location where they believed remaining materials needed to be reclaimed and included in the affected area of the permit boundary (Map 1; Figure 1; Photo 13). At the time of the inspection, the Applicant's stated that that material was on Ogilvy's property and was not included as part of the operation. However, following the inspection the Division discovered that this area is already included in the Applicant's affected area boundary (Figure 1). The reclamation of this portion of the permit will need to be further addressed and accounted for in the Applicant's adequacy responses.

Map 1: Map created using both ArcPro and Google Earth Pro based on the Applicant's affected land boundary depicted on their Mining and Reclamation Plan maps. The blue icons indicate the locations where inspection photos with corresponding numbers were taken. The aerial imagery pre-dates stockpiling from the dredging operation.

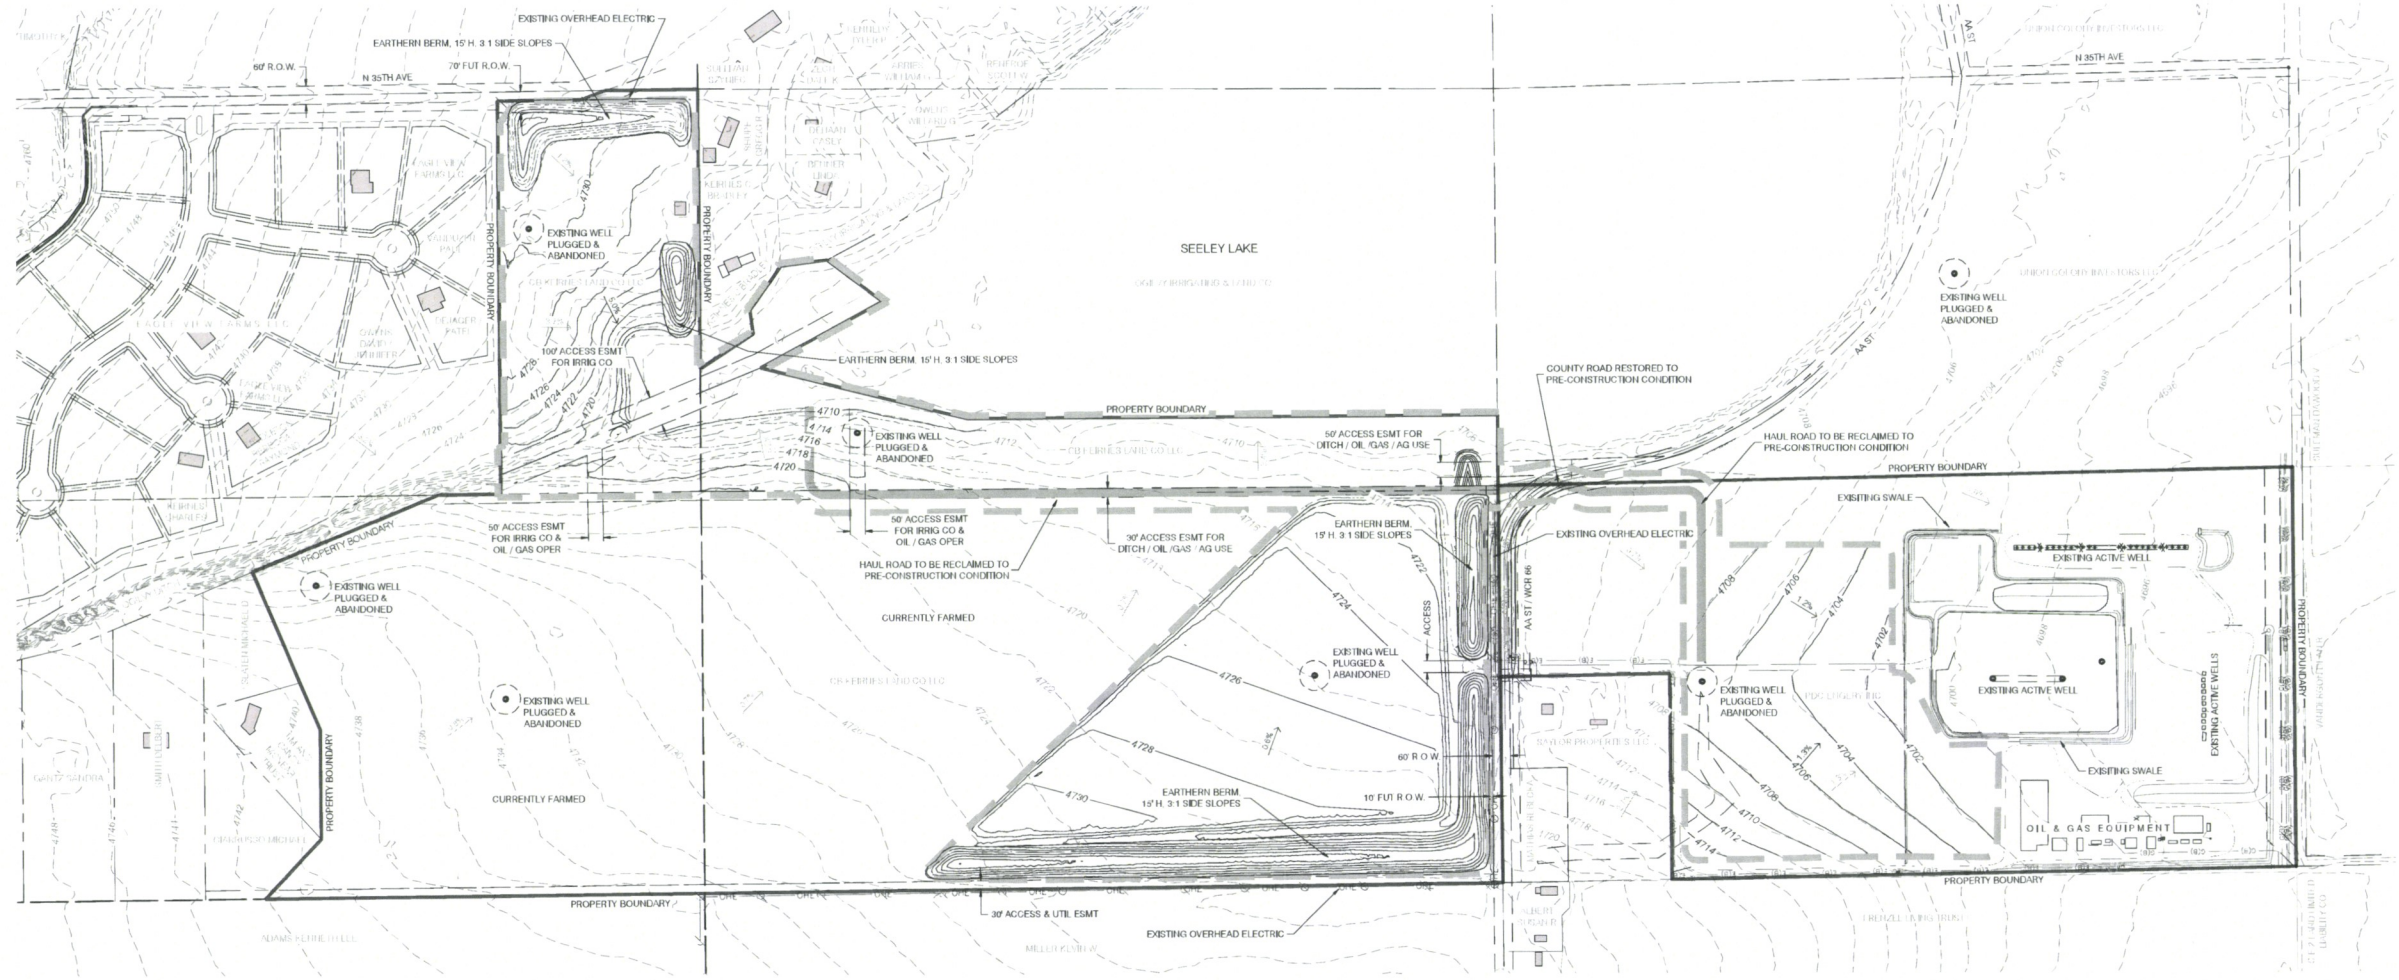
RECLAMATION PLAN OPTION 2

Figure 1: (Right) Excerpt from the Applicant's Reclamation Plan Map Option 2. The dashed lines indicate the Applicant's affected area boundary. (Left) Approximate location of the Applicant's affected area boundary (yellow dashed line), haul road (red line), property/parcel boundary included on the maps (purple line), overlain on aerial imagery that pre-dates the dredging operation in ArcOnline. The red dot indicates the location where inspection Photo #13 was taken. In comparison with the Applicant's maps, the location where excess material was stored on Ogilvy's land during the dredging project is included in the affected area boundary. The reclamation plan for this area will need to be addressed via the Applicant's response to the Division's adequacy review of the permit application.
