MINERALS PROGRAM INSPECTION REPORT
PHONE: (303) 866-3567

MINE NAME: Gunnison River Gravel Pits	MINE/PROSPECTING ID#: M-2009-048	MINERAL: Sand and gravel	COUNTY: Mesa
INSPECTION TYPE: Surety-Related Inspection	WEATHER: Clear	INSP. DATE: February 12, 2025	INSP. TIME: 14:30
OPERATOR: CW Construction, LLC	OPERATOR REPRESENTATIVE: Tim Loncarich	TYPE OF OPERATION: 112c - Construction Regular Operation	
REASON FOR INSPECTION: Surety Release Requested	BOND CALCULATION TYPE: Complete Bond	BOND AMOUNT: \$91,664.00	
DATE OF COMPLAINT: NA	POST INSP. CONTACTS: None	JOINT INSP. AGENCY: None	
INSPECTOR(S): Amy Yeldell	INSPECTOR'S SIGNATURE:

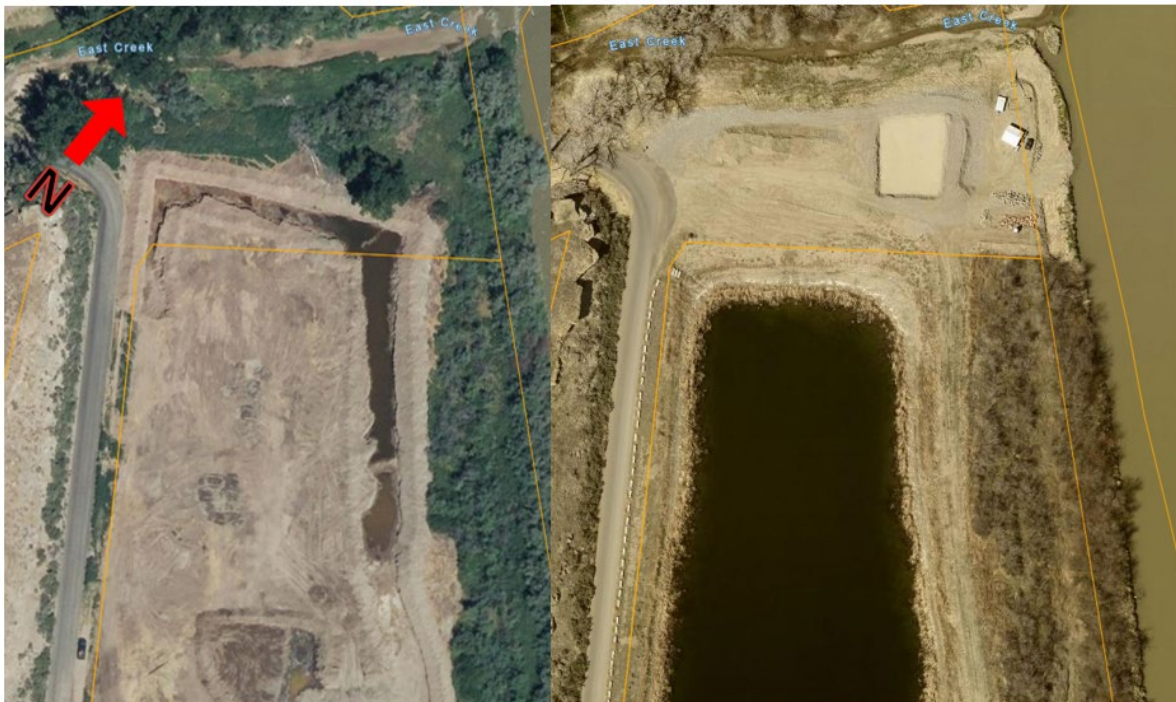
Photo 12: Stabilized pad within Pit 5 affected lands (TR-6)
