MINERALS PROGRAM INSPECTION REPORT
PHONE: (303) 866-3567

MINE NAME: Yocam Pit	MINE/PROSPECTING ID#: M-1999-060	MINERAL: Gravel	COUNTY: Las Animas
INSPECTION TYPE: Monitoring	WEATHER: Windy	INSP. DATE: February 12, 2025	INSP. TIME: 10:00
OPERATOR: Las Animas County	OPERATOR REPRESENTATIVE: Brian Heguy	TYPE OF OPERATION: 112c - Construction Regular Operation

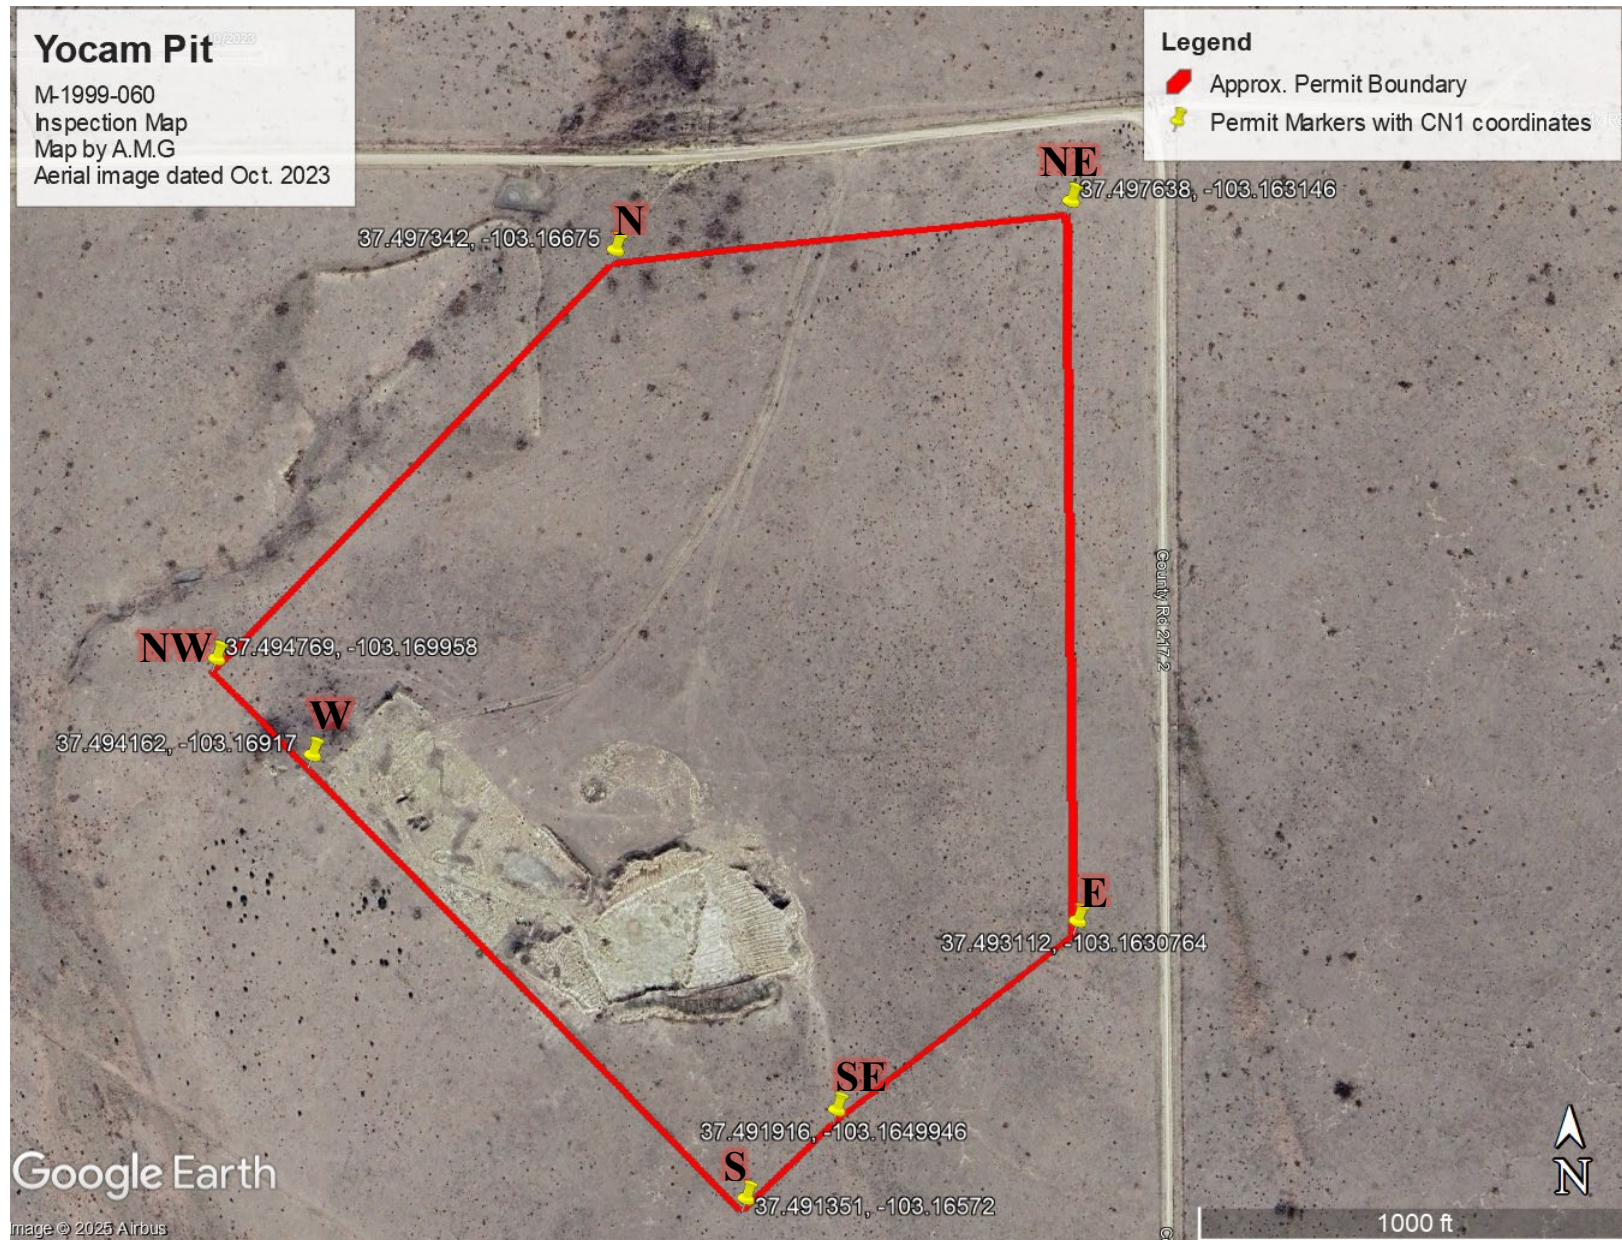
Map 1: Inspection Map generated in Google Earth Pro for the 2025 Inspection Report.

The Division found that the recent annual report maps were inadequate. The topsoil locations depicted on the 2018-2023 inspection report maps appear to be inaccurate when compared with aerial imagery and field observations (see the topsoil section below). **Please update the topsoil locations on the 2025 annual report submittal for the 2024 annual reporting period.**
