MINERALS PROGRAM INSPECTION REPORT

MINE NAME: Unwin Gravel Pit	MINE/PROSPECTING ID#: M-1998-011	MINERAL: Gravel	COUNTY: Las Animas
INSPECTION TYPE: Monitoring	WEATHER: Windy	INSP. DATE: February 12, 2025	INSP. TIME: 11:32
OPERATOR: Las Animas County	OPERATOR REPRESENTATIVE: Brian Heguy	TYPE OF OPERATION: 110c - Construction Limited Impact

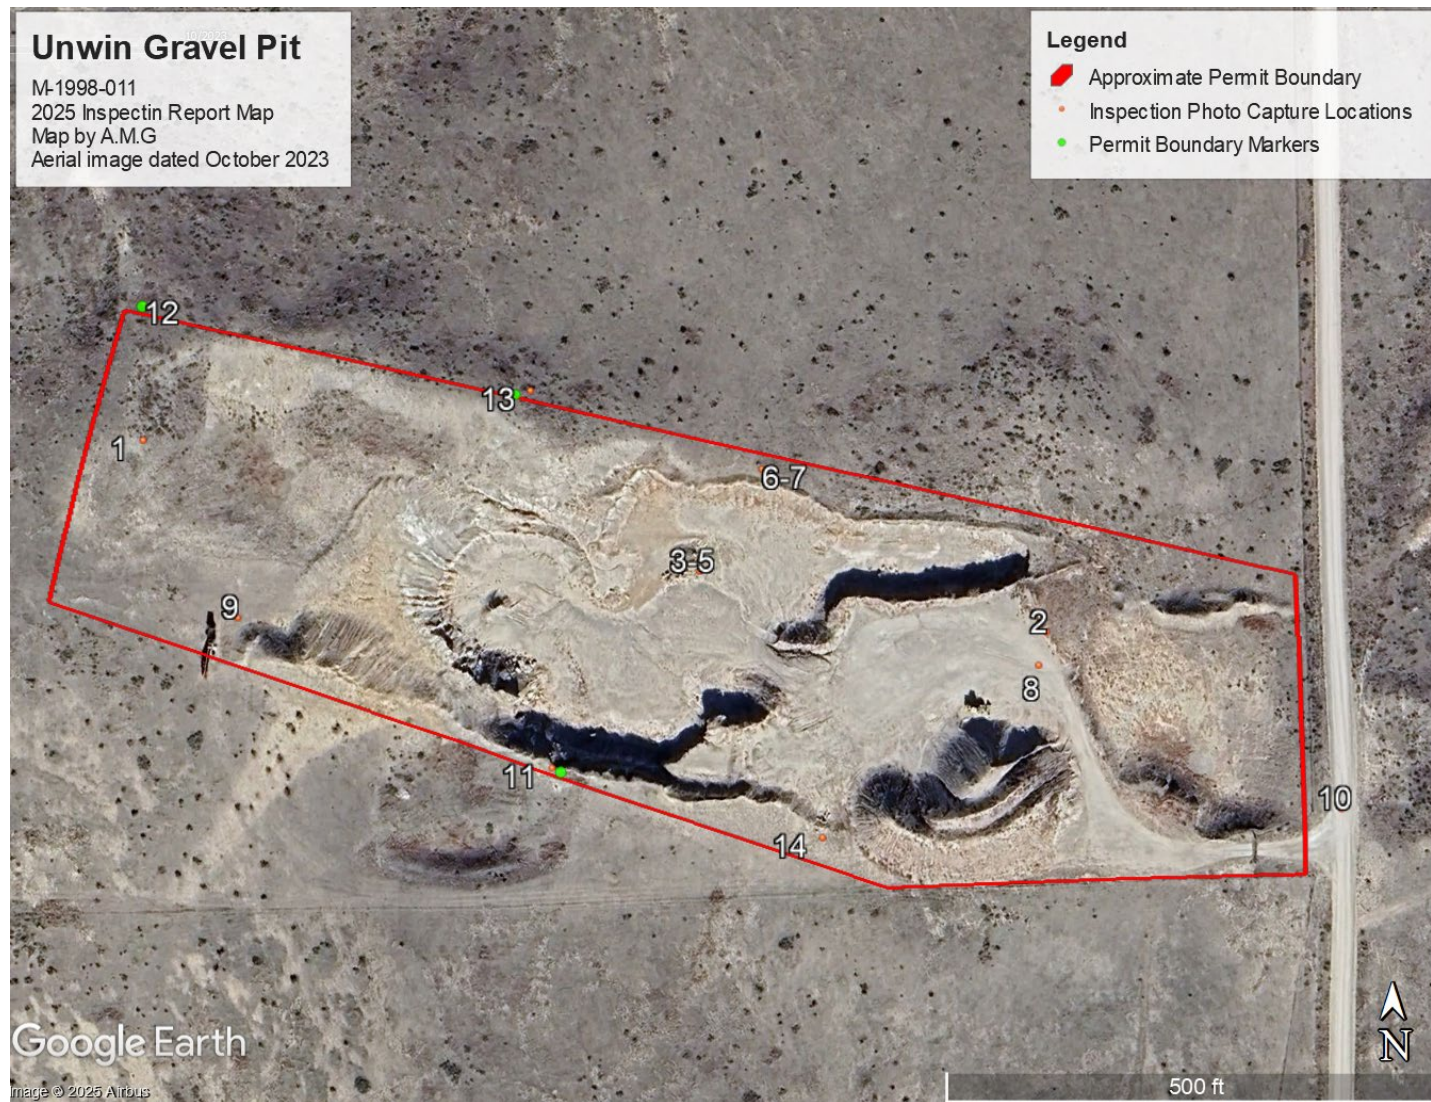
Map 1: Inspection report map generated in Google Earth Pro. The numbers correspond with the inspection photo captions below.
