### MINERALS PROGRAM INSPECTION REPORT

<b>MINE NAME:</b> Orphan View Gravel Pit	<b>MINE/PROSPECTING ID#:</b> M-2013-016	<b>MINERAL:</b> Borrow material for construction, gravel and sand	<b>COUNTY:</b> Huerfano
<b>INSPECTION TYPE:</b> Monitoring	<b>WEATHER:</b> Clear	<b>INSP. DATE:</b> February 13, 2025	<b>INSP. TIME:</b> 12:50
<b>OPERATOR:</b> Huerfano County	<b>OPERATOR REPRESENTATIVE:</b> Dustin Hribar	<b>TYPE OF OPERATION:</b> 112c - Construction Regular Operation

The Orphan View Gravel Pit was inspected by Amber Gibson with the Division of Reclamation, Mining and Safety (Division/DRMS). The inspection was completed as part of the Division's routine monitoring inspection program. The site was previously inspected by the Division on October 7, 2020 as part of an acreage release request. Dustin Hribar (representing the Operator - Huerfano County) accompanied me during the inspection. The weather was cool and the sky was clear.

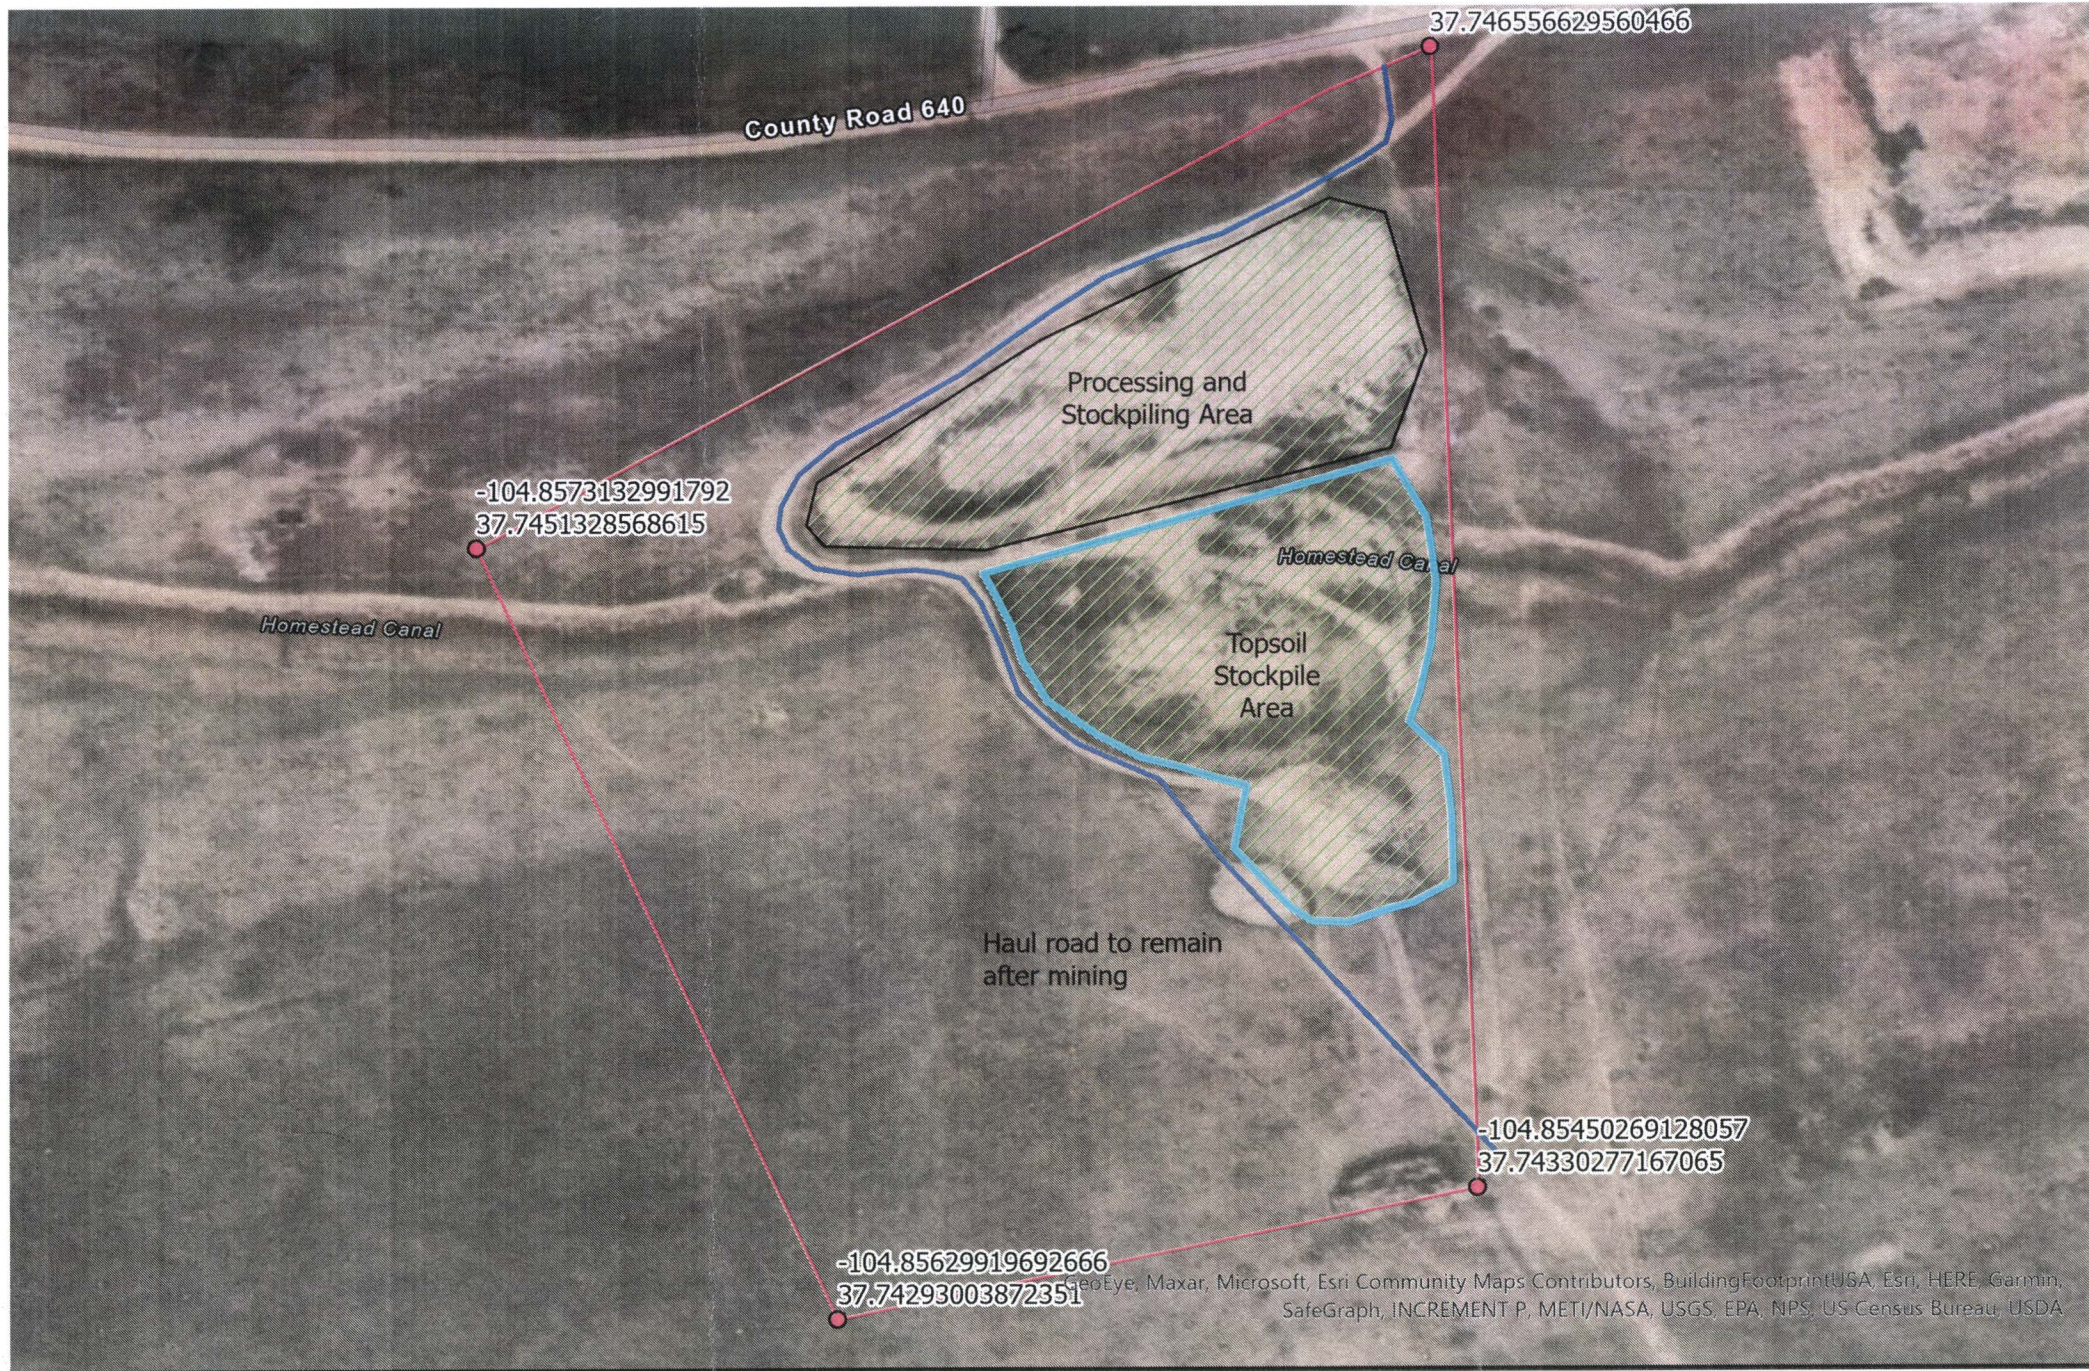
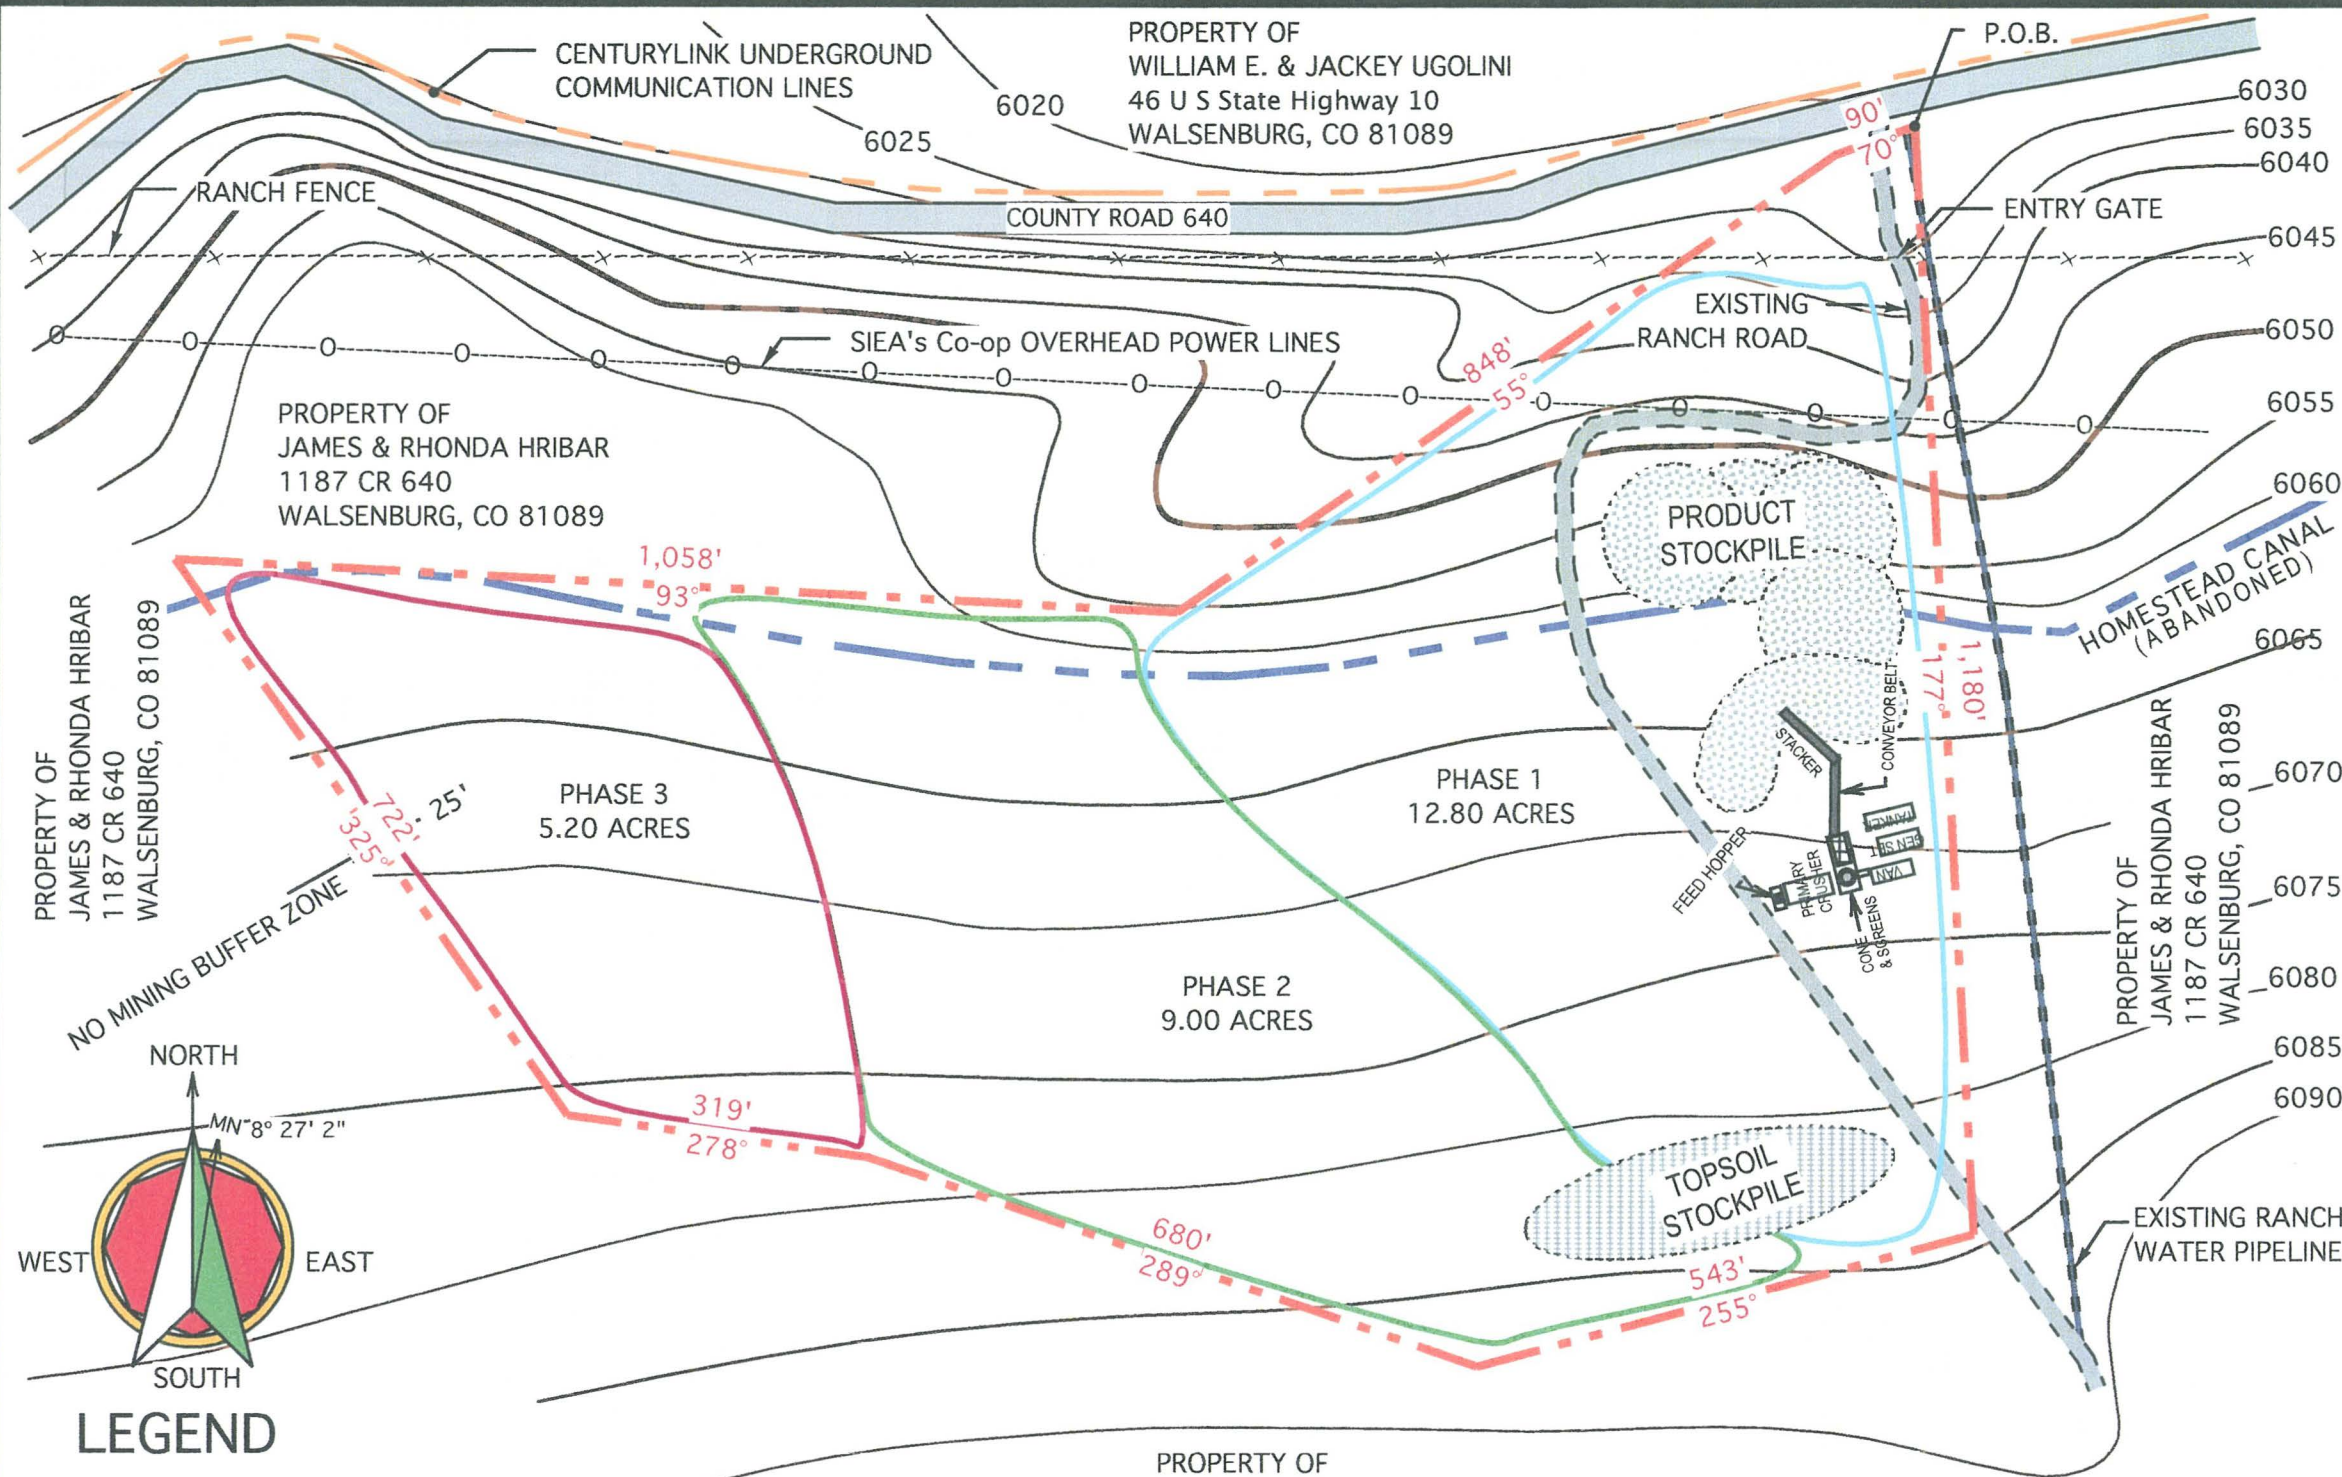
During the pre-inspection permit review, a few discrepancies were identified that occurred during the AR1/TR1 process. First, the shape of the phase boundaries were simplified on the acreage release description map submitted with TR1 (see Figure 1). Also, the phases were assumed to equal the acreages shown for each phase on the original mining plan map (Figure 1). However, the acreages shown on the original mining plan map correspond with the estimated acres to be mined, which does not equal the total acreage at the site.

**Figure 1:** (Top) Photo from the original mine plan map. The red solid line indicates the minable acreage in Phase 3, the green solid line indicates the minable acreage in Phase 2, and the light blue solid line indicates the mineable acreage in Phase 1. (Bottom) The acreage release reference map submitted with TR1, where the phase boundaries were unknowingly simplified/altered.
