MINERALS PROGRAM INSPECTION REPORT
PHONE: (303) 866-3567

MINE NAME: Irwin/Thomas Mine	MINE/PROSPECTING ID#: M-2016-054	MINERAL: Sand and gravel	COUNTY: Boulder
INSPECTION TYPE: Monitoring	WEATHER: Clear	INSP. DATE: March 12, 2025	INSP. TIME: 10:00
OPERATOR: Holcim - WCR, Inc.	OPERATOR REPRESENTATIVE: Wyatt Webster, Chris Zadel, Dominick Sobotka	TYPE OF OPERATION: 112c - Construction Regular Operation	
REASON FOR INSPECTION: Normal I&E Program	BOND CALCULATION TYPE: Partial Bond	BOND AMOUNT: \$8,260,499.00	
DATE OF COMPLAINT: NA	POST INSP. CONTACTS: None	JOINT INSP. AGENCY: None	
INSPECTOR(S): Patrick Lennberg	INSPECTOR'S SIGNATURE:

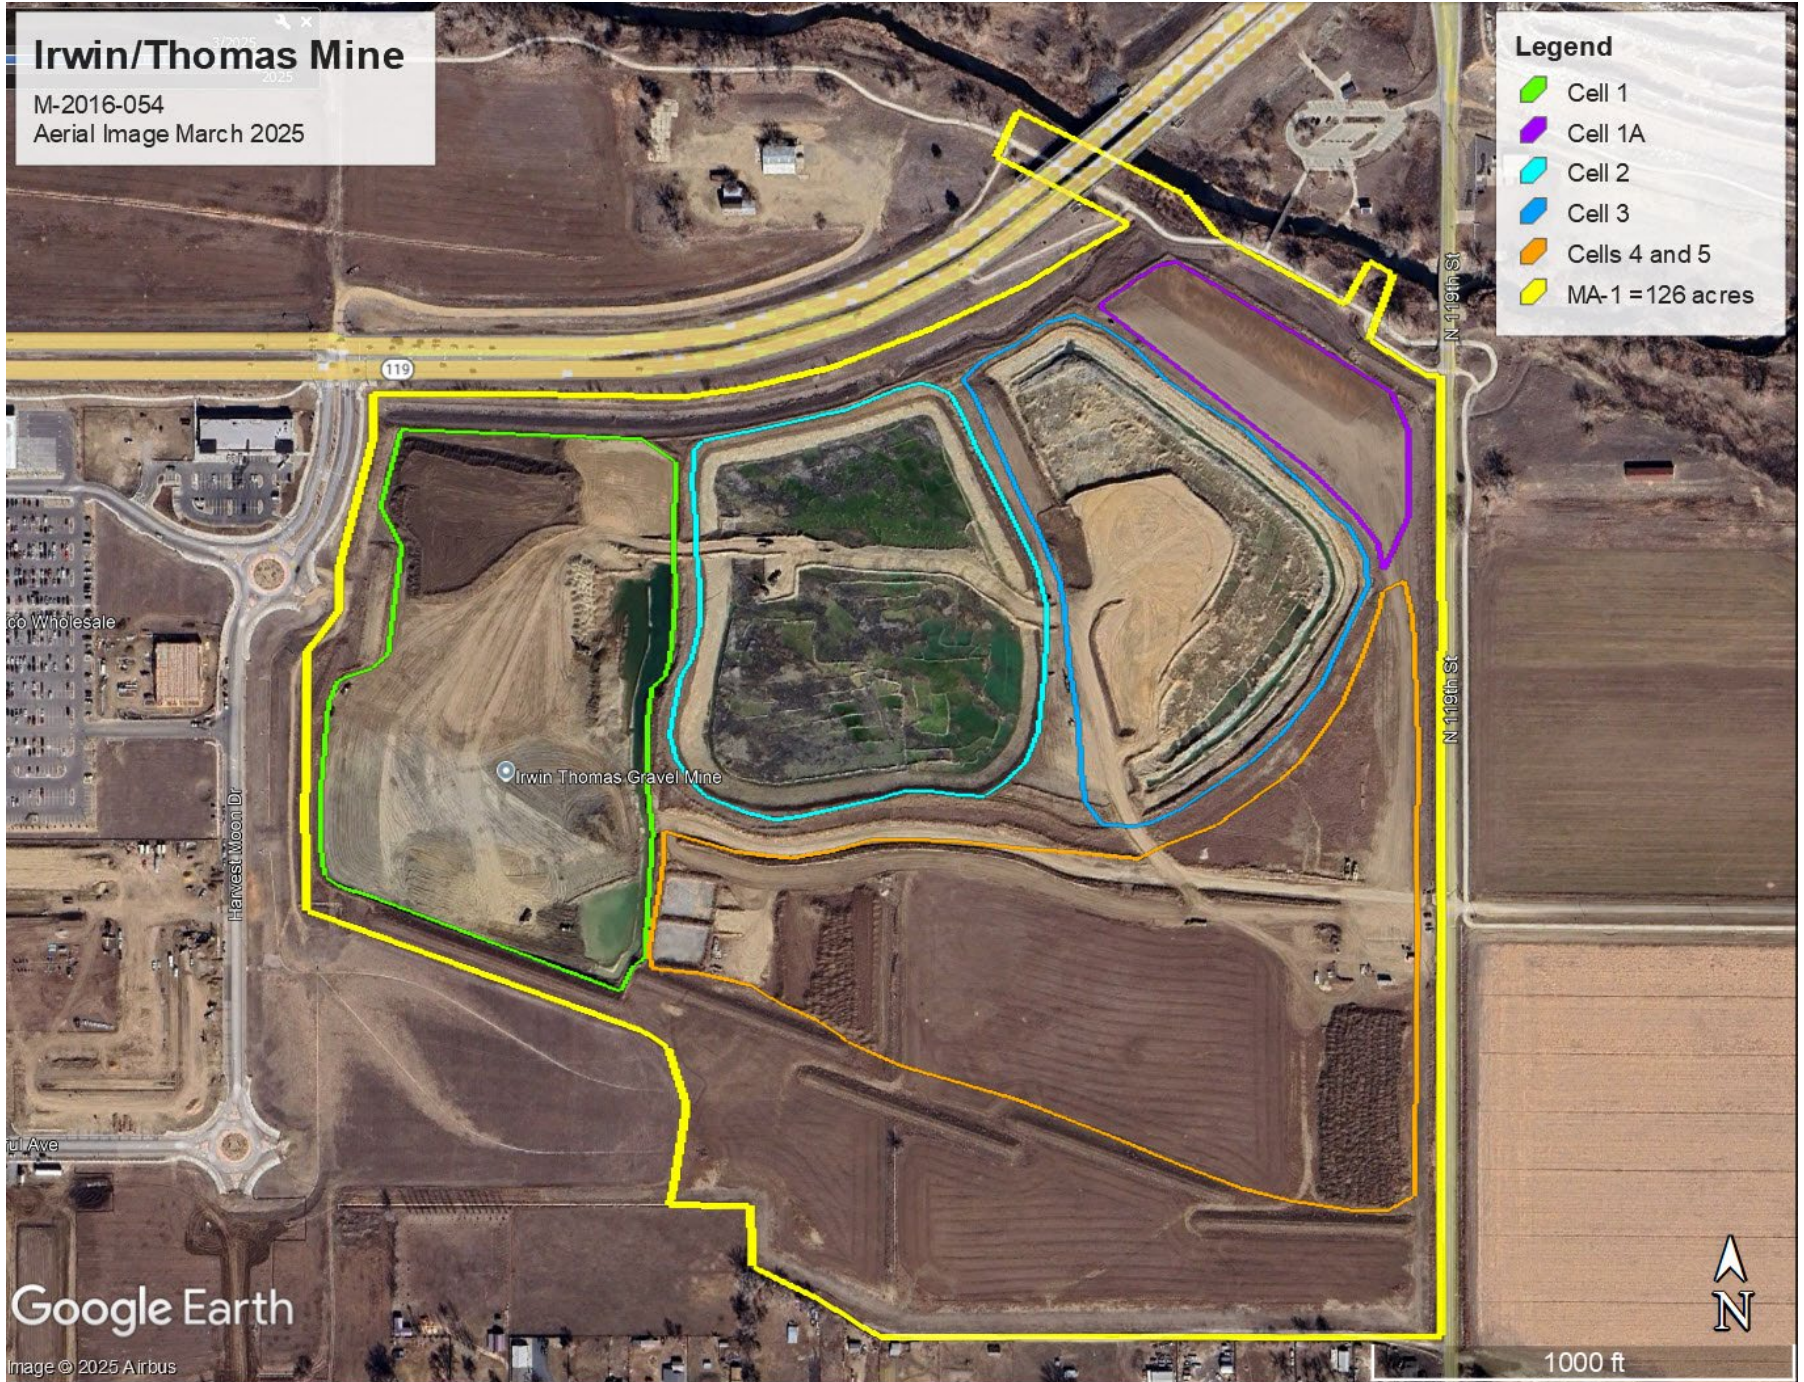
The outfall of the underdrain was observed just northeast of Cell 1A. At the time of inspection the underdrain had a plug in it to prevent discharge. The plug was in place because a concrete riser was needed to add to the manhole to promote gravity flow to an adjacent culvert that conveys water to St Vrain Creek. The Division stated that with runoff occurring soon that getting that manhole riser installed should be a priority to ensure groundwater does not mound unnecessarily.

Photo 12: Underdrain outfall location adjacent to the culvert that drains under bikepath to creek
