Fremont Gravel Pit M1984117

M-1984-117 Fremont Gravel Pit Post Inspection Map

FREMONT COUNTY PIT
M-1984-117
9.85 ACRES

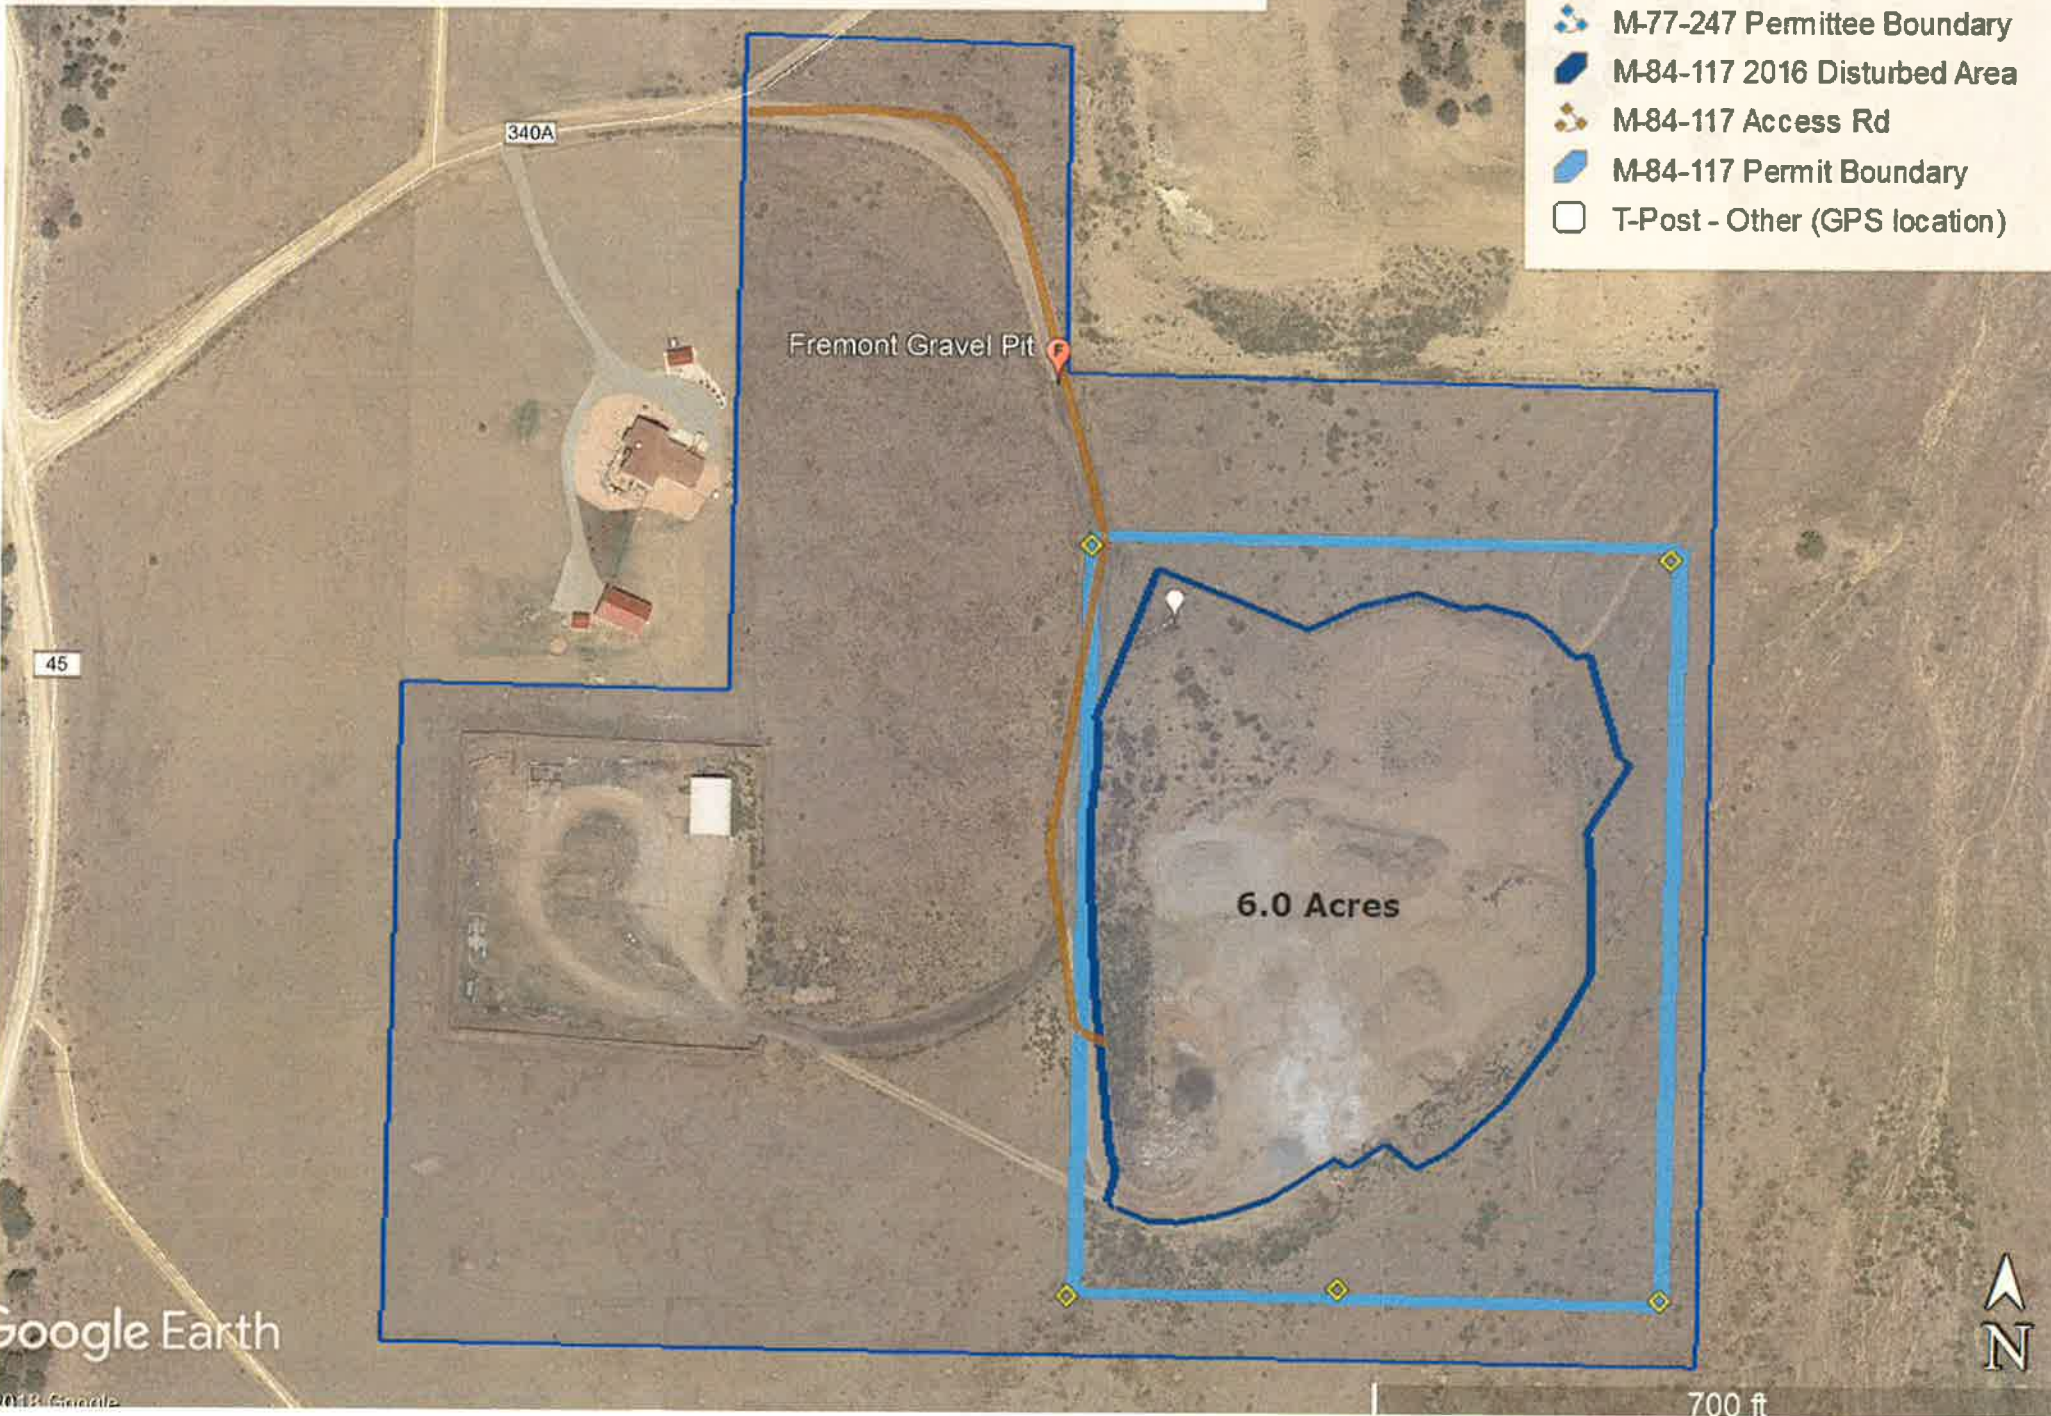
Figure #1: Map created from observations made during the inspection. The thicker purple line and the orange line represent the approximate permit boundary, the thinner light purple inspection polygon represents the extent of the affected area, the yellow star represents where the posted mine sign was located, the blue stars represent the locations of the five permit boundary markers, and the purple inspection points represent the locations of the various stockpiles of materials observed.
