**MINERALS PROGRAM INSPECTION REPORT**  
**PHONE: (303) 866-3567**

<b>MINE NAME:</b> Lascar Pit	<b>MINE/PROSPECTING ID#:</b> M-2025-004	<b>MINERAL:</b> Sand and gravel	<b>COUNTY:</b> Huerfano
<b>INSPECTION TYPE:</b> Pre-operation Inspection	<b>WEATHER:</b> Cloudy	<b>INSP. DATE:</b> March 28, 2025	<b>INSP. TIME:</b> 09:30
<b>OPERATOR:</b> Siete, Inc.	<b>OPERATOR REPRESENTATIVE:</b> Jodi Schrieber and Mike Loya	<b>TYPE OF OPERATION:</b> 112c - Construction Regular Operation

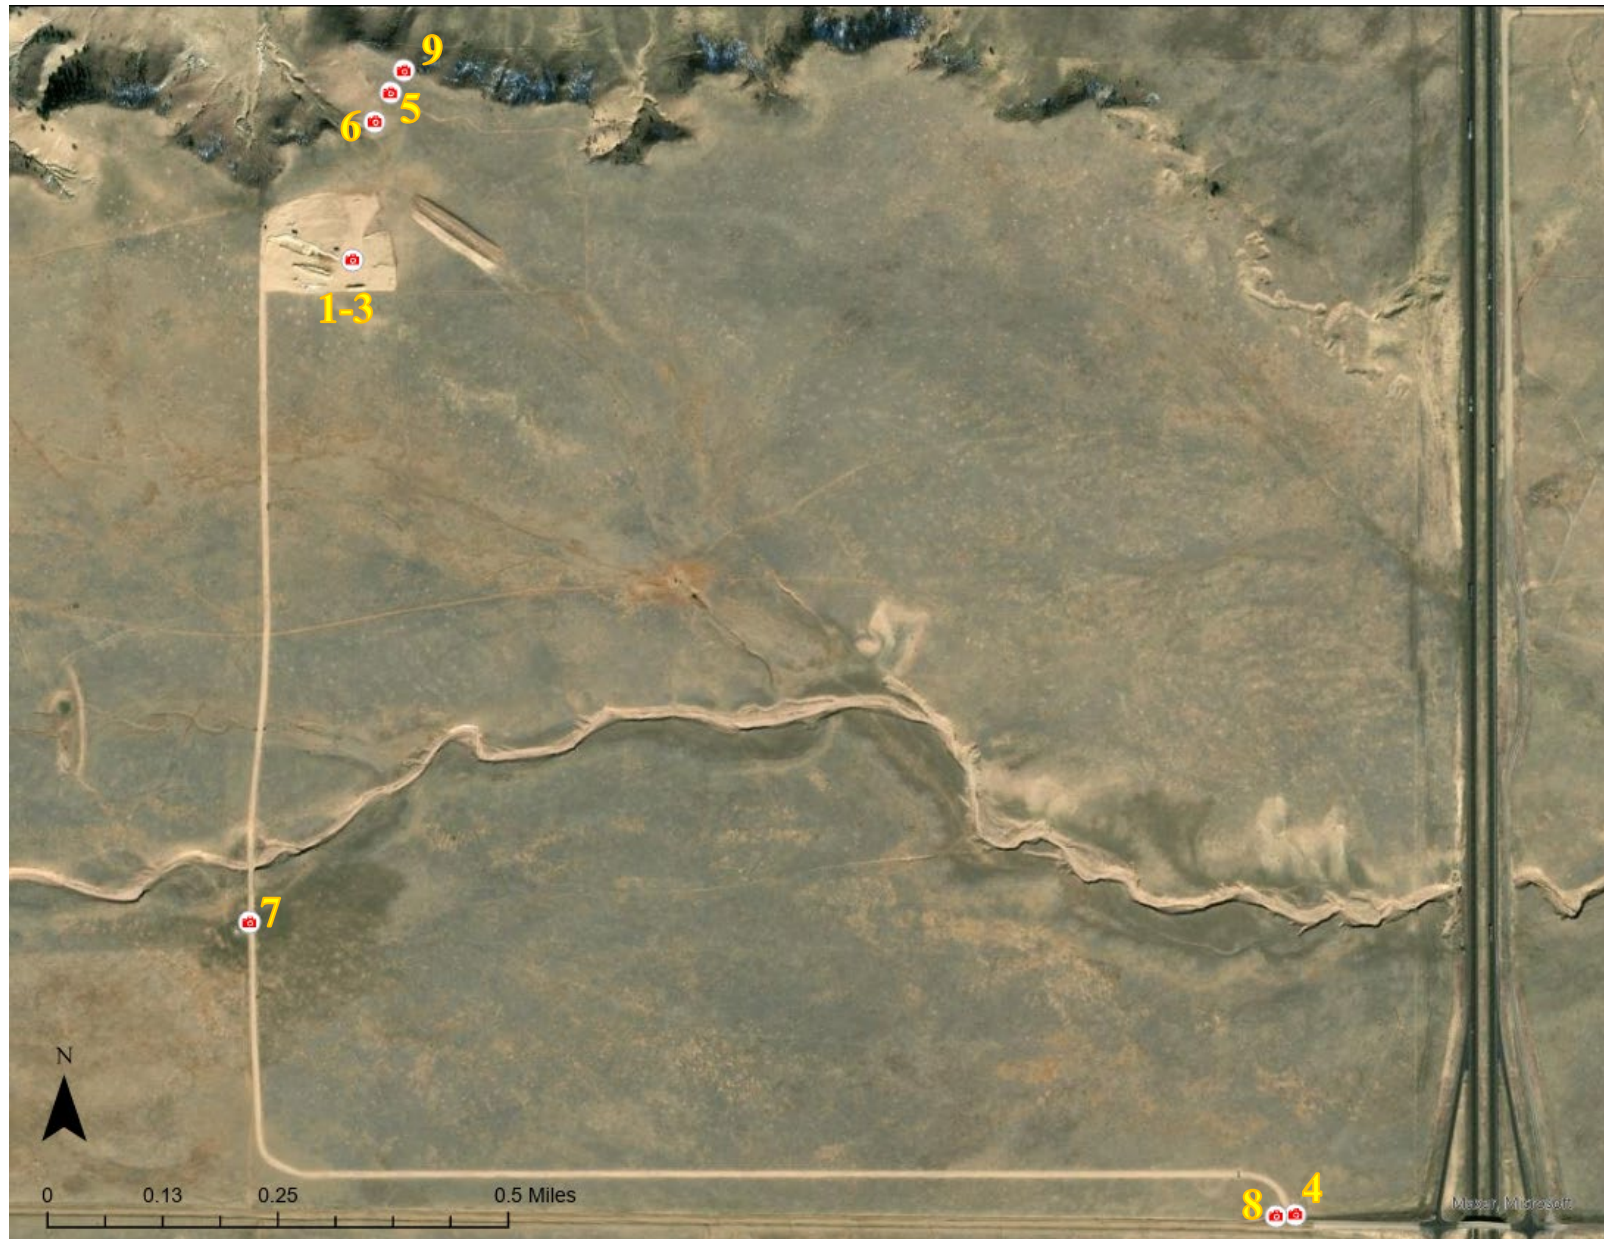
**Map 1:** Inspection Map for the Division's 2025 Pre-Op Inspection conducted as part of the 112c application review process. The camera icons indicate where the inspection photos were taken and the numbers correspond with the inspection photos above.
