## Spring 2024 Subsidence and Geologic Field Observations Report

# Spring 2024 Subsidence and Geologic Field Observations

## Southern Panels and Sunset Trail Mining Areas

September 2024

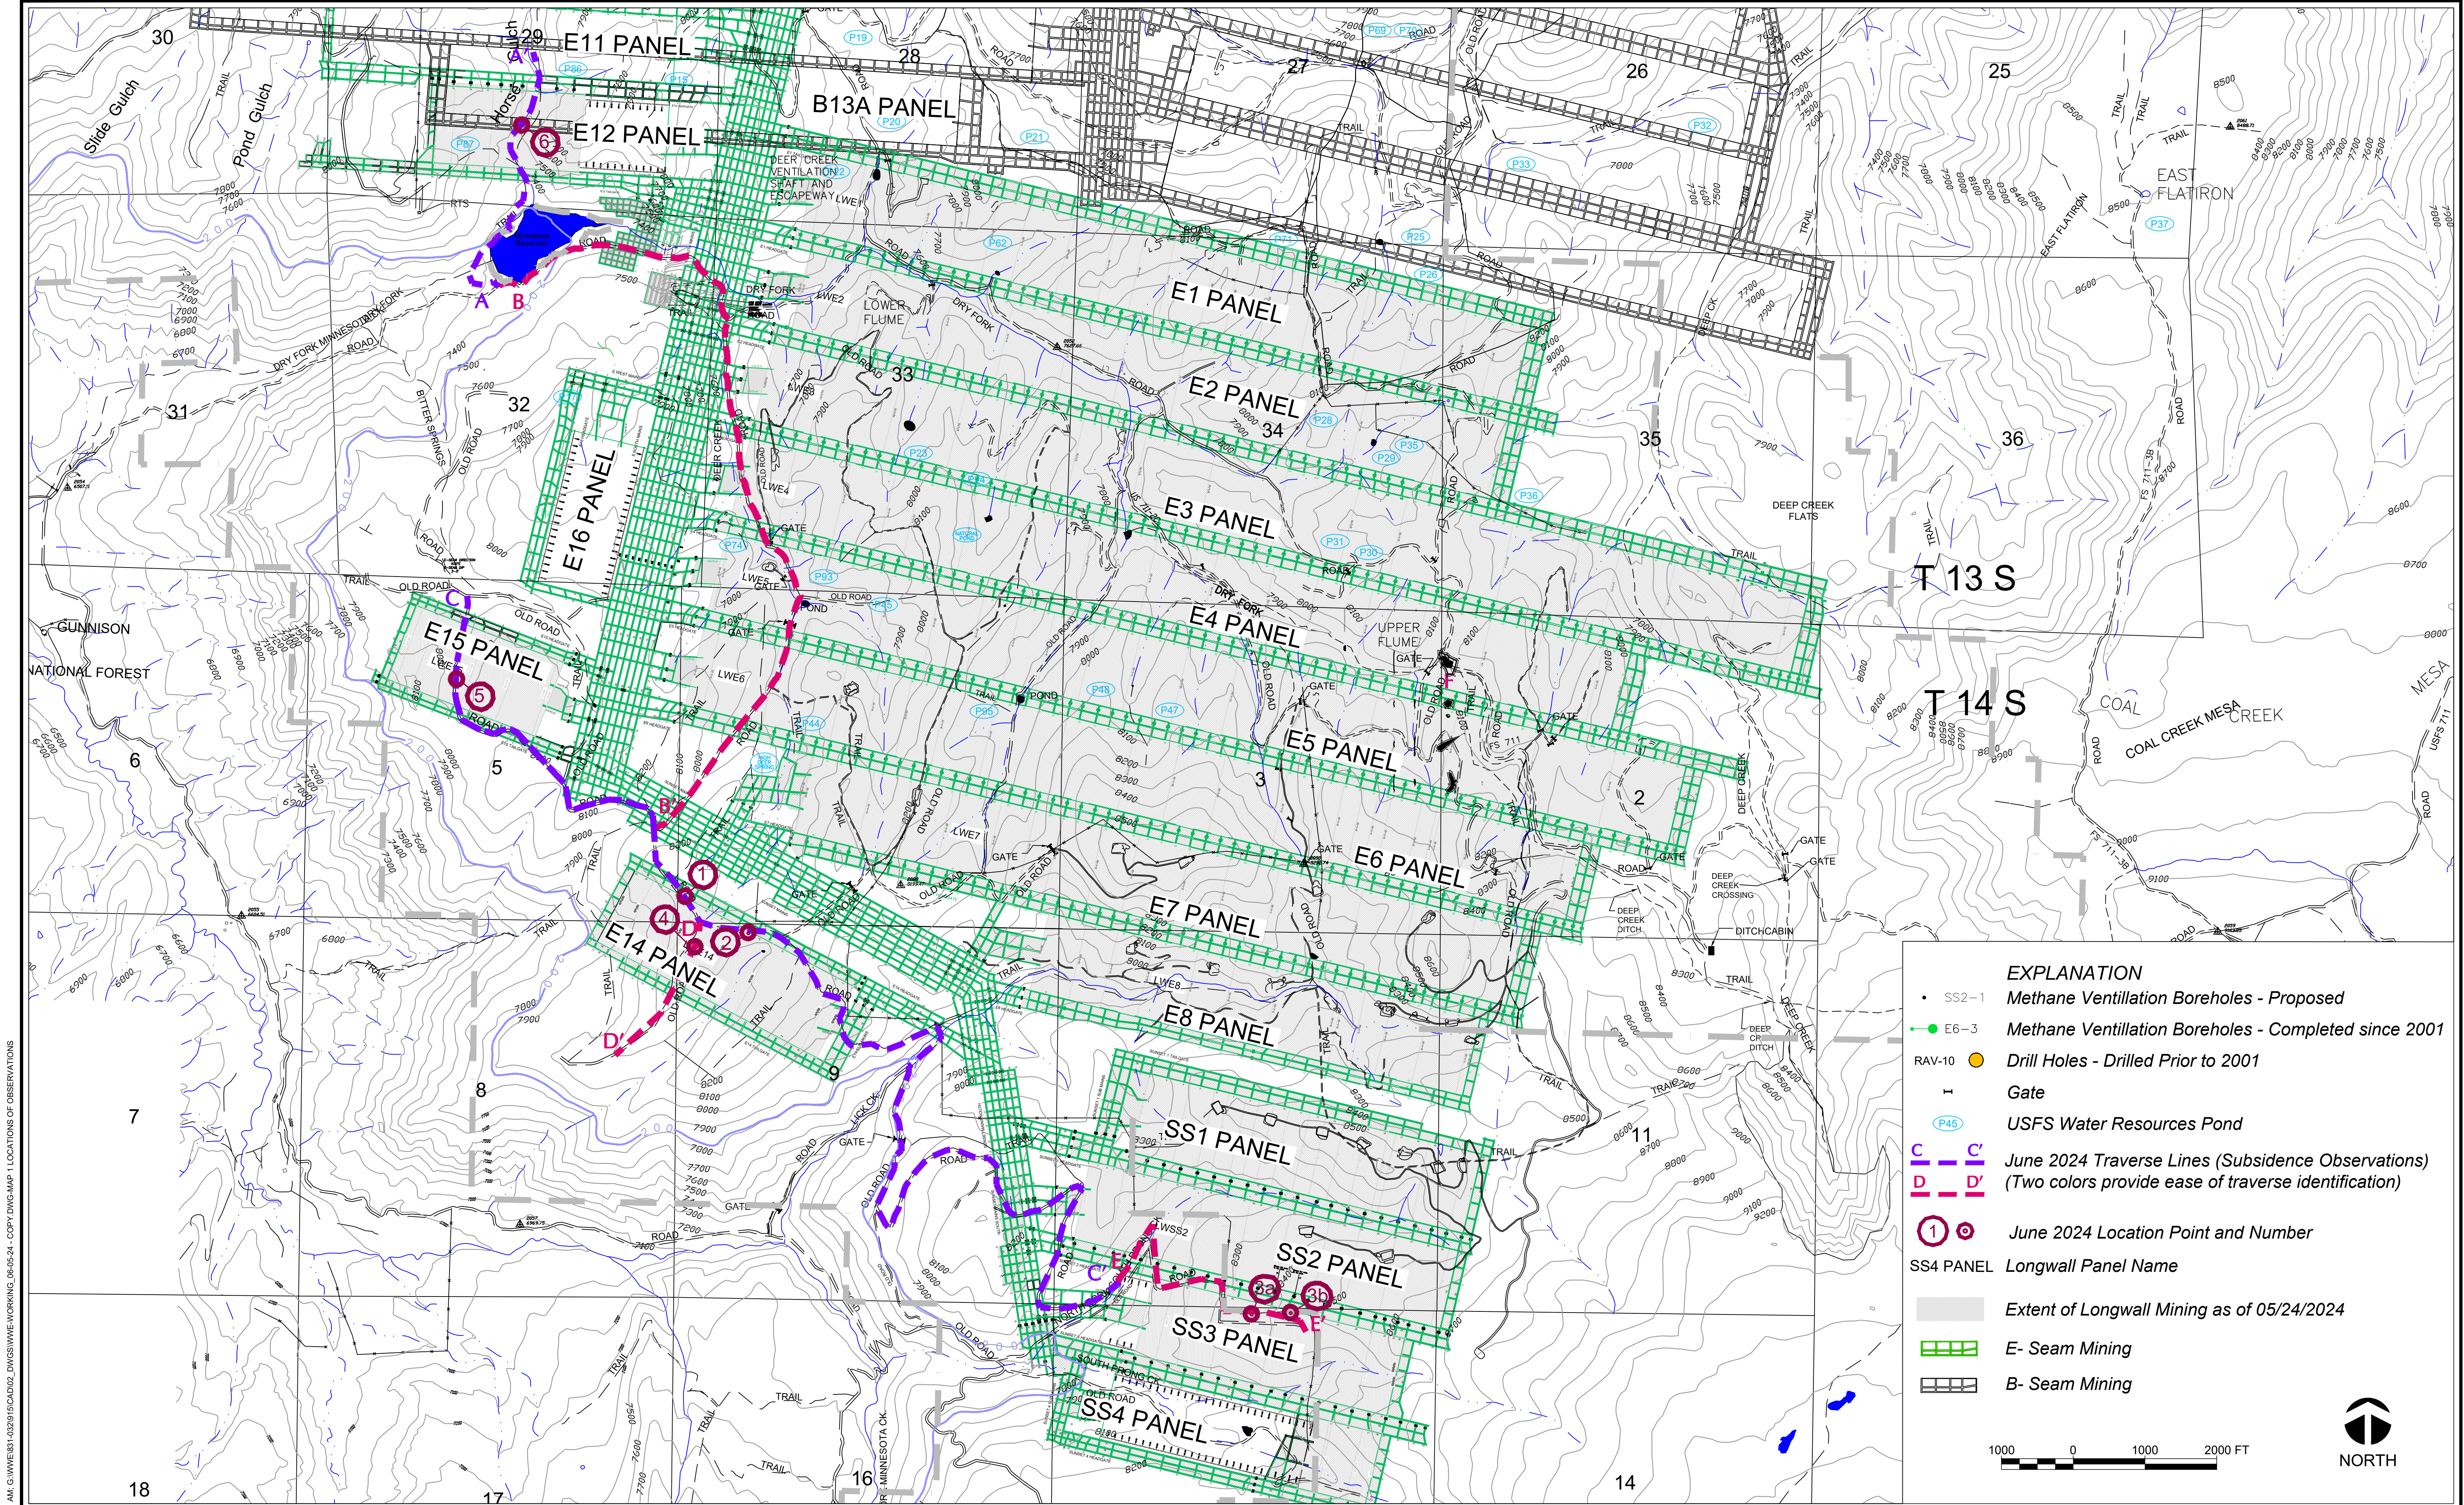
MAP  
1

Plot Date/Time: 09/27/2024, 11:12:21 AM, C:\WWE\831-032915\CAD\02, DWG\WWE\WORKING, 06-05-24, COPY DWG-MAP, 1 LOCATIONS OF OBSERVATIONS

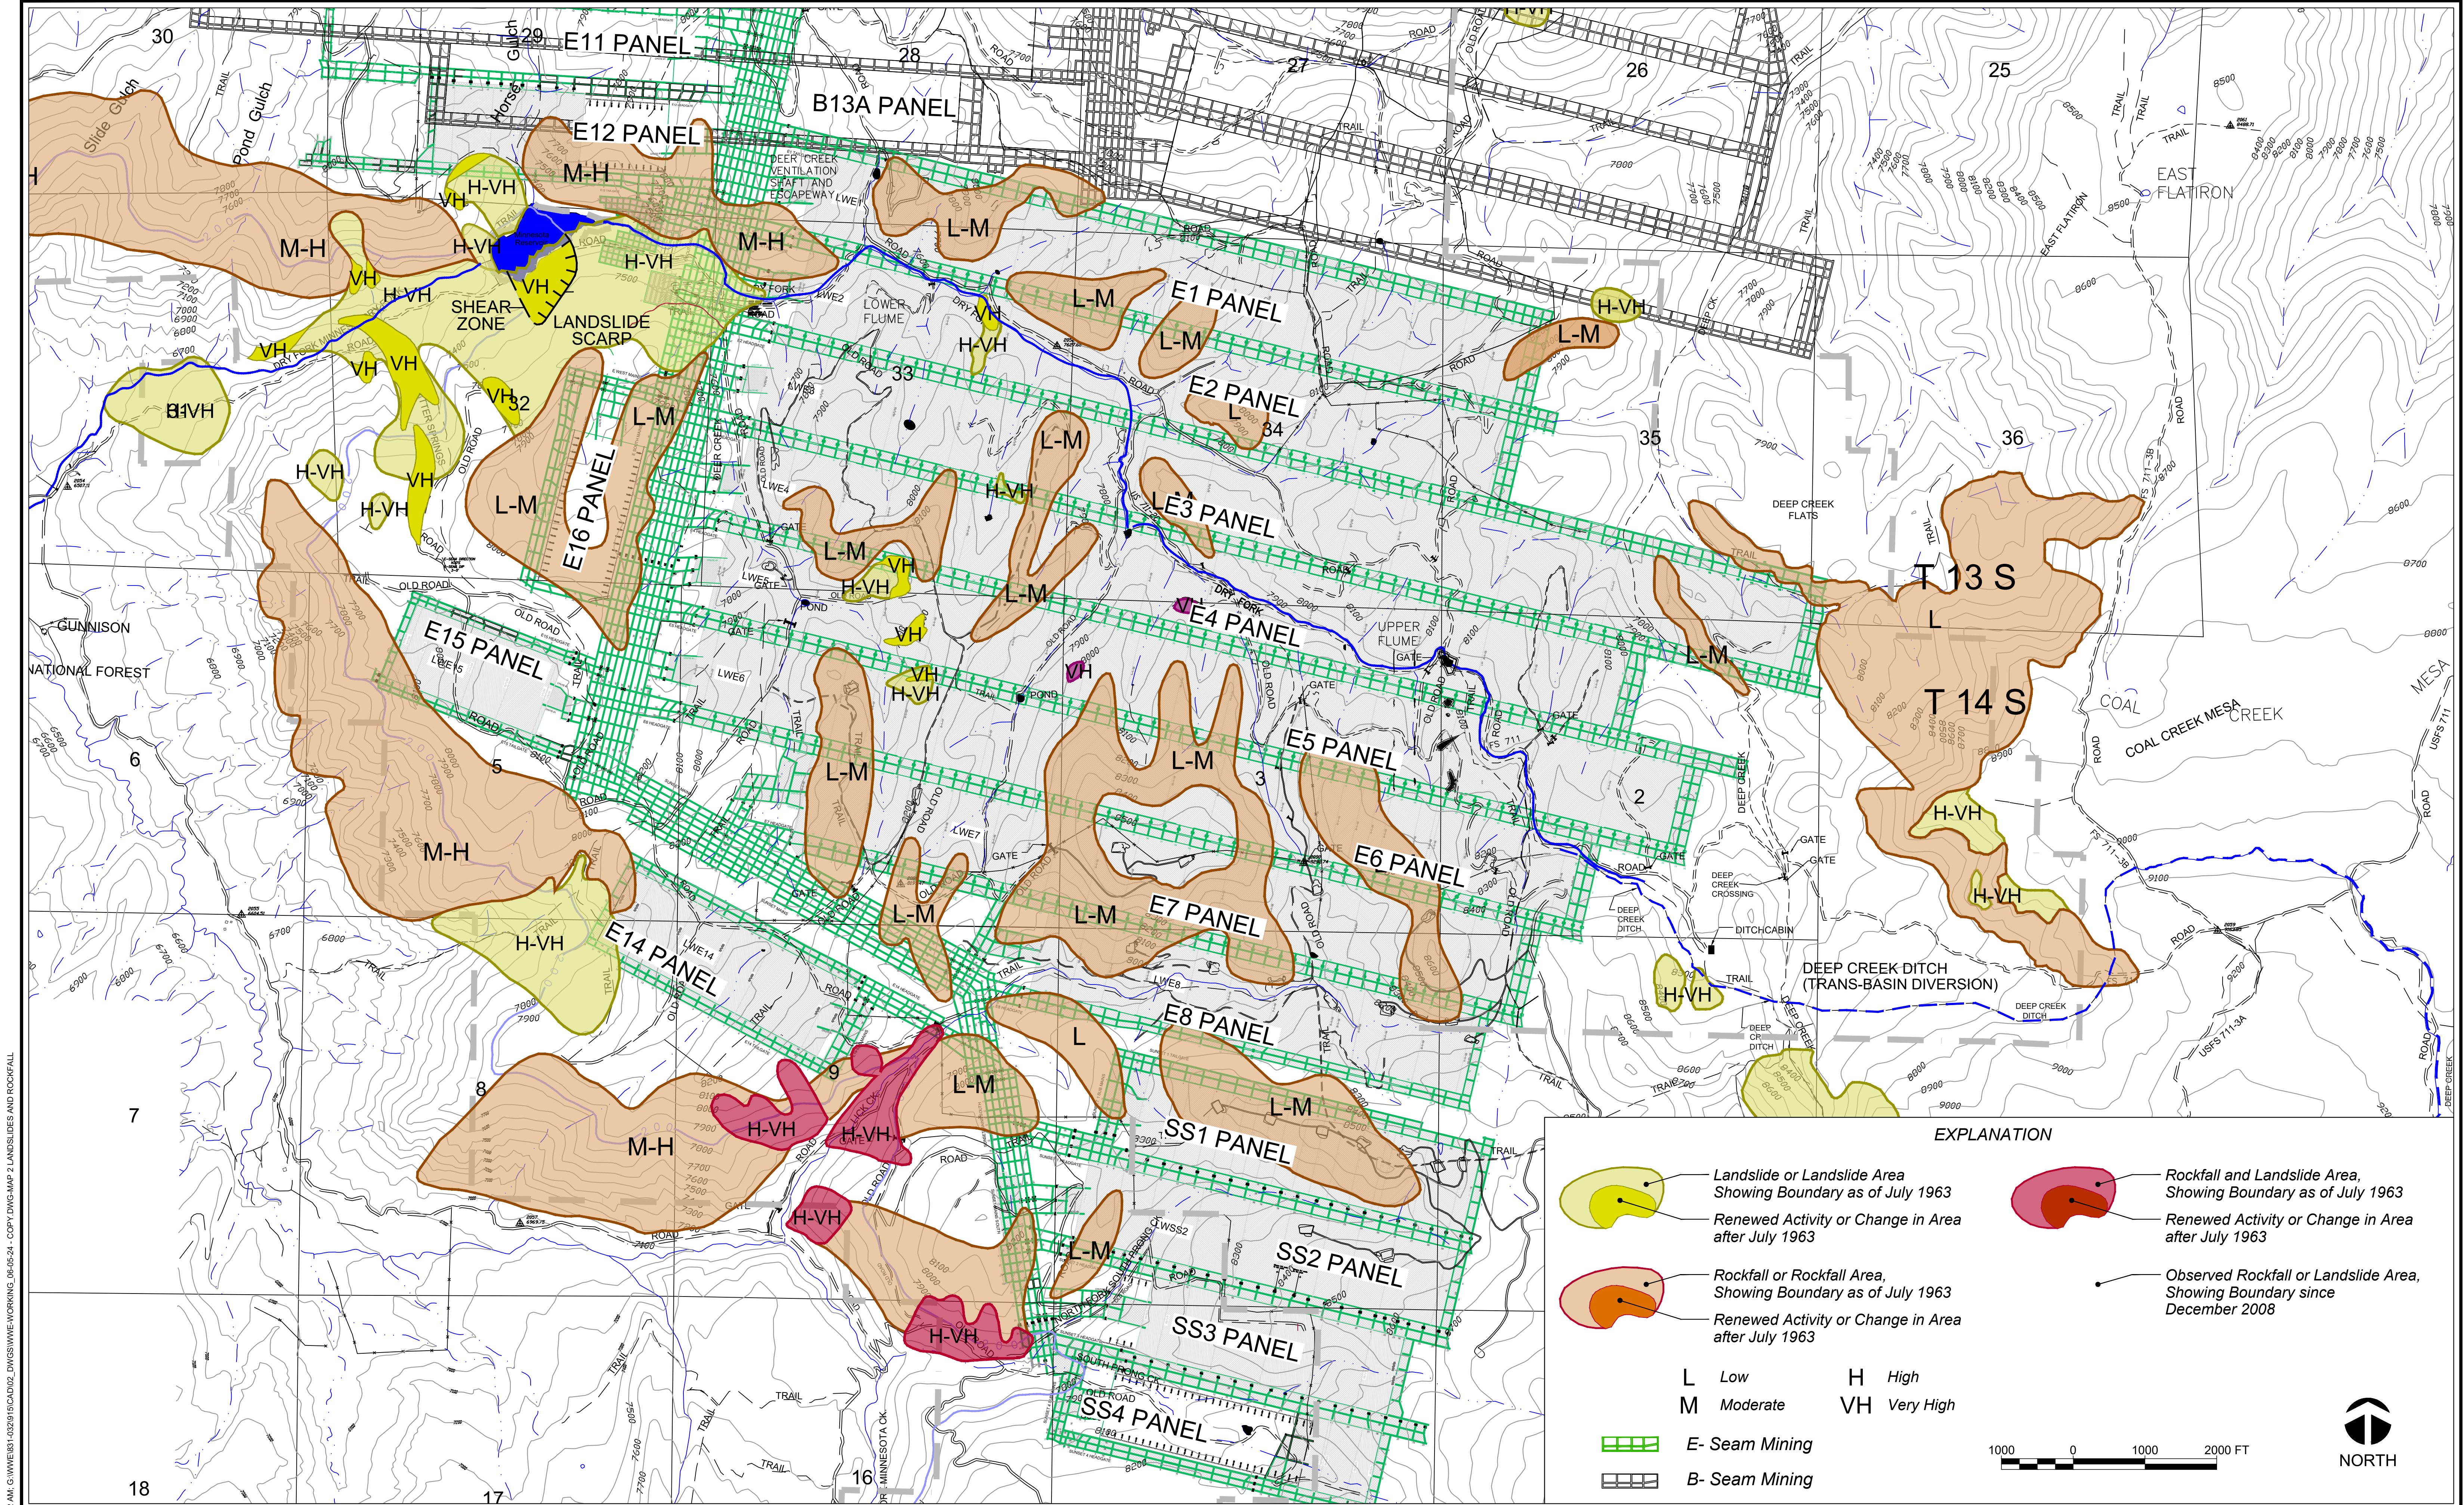
MOUNTAIN COAL COMPANY WEST ELK MINE  
LANDSLIDES AND ROCKFALLS - JUNE 2024
