## Inspection Report, Mesa DeMaya Pit

<b>MINE NAME:</b> Mesa DeMaya Pit	<b>MINE/PROSPECTING ID#:</b> M-2014-019	<b>MINERAL:</b> Sand and gravel	<b>COUNTY:</b> Las Animas
<b>INSPECTION TYPE:</b> Monitoring	<b>WEATHER:</b> Clear	<b>INSP. DATE:</b> March 26, 2025	<b>INSP. TIME:</b> 12:33
<b>OPERATOR:</b> Las Animas County	<b>OPERATOR REPRESENTATIVE:</b> Keith Woodring and Brian Heguy	<b>TYPE OF OPERATION:</b> 110c - Construction Limited Impact	
<b>REASON FOR INSPECTION:</b> Normal I&E Program	<b>BOND CALCULATION TYPE:</b> None	<b>BOND AMOUNT:</b> \$0.00	
<b>DATE OF COMPLAINT:</b> NA	<b>POST INSP. CONTACTS:</b> None	<b>JOINT INSP. AGENCY:</b> None	
<b>INSPECTOR(S):</b> Amber M. Gibson	<b>INSPECTOR'S SIGNATURE:</b>

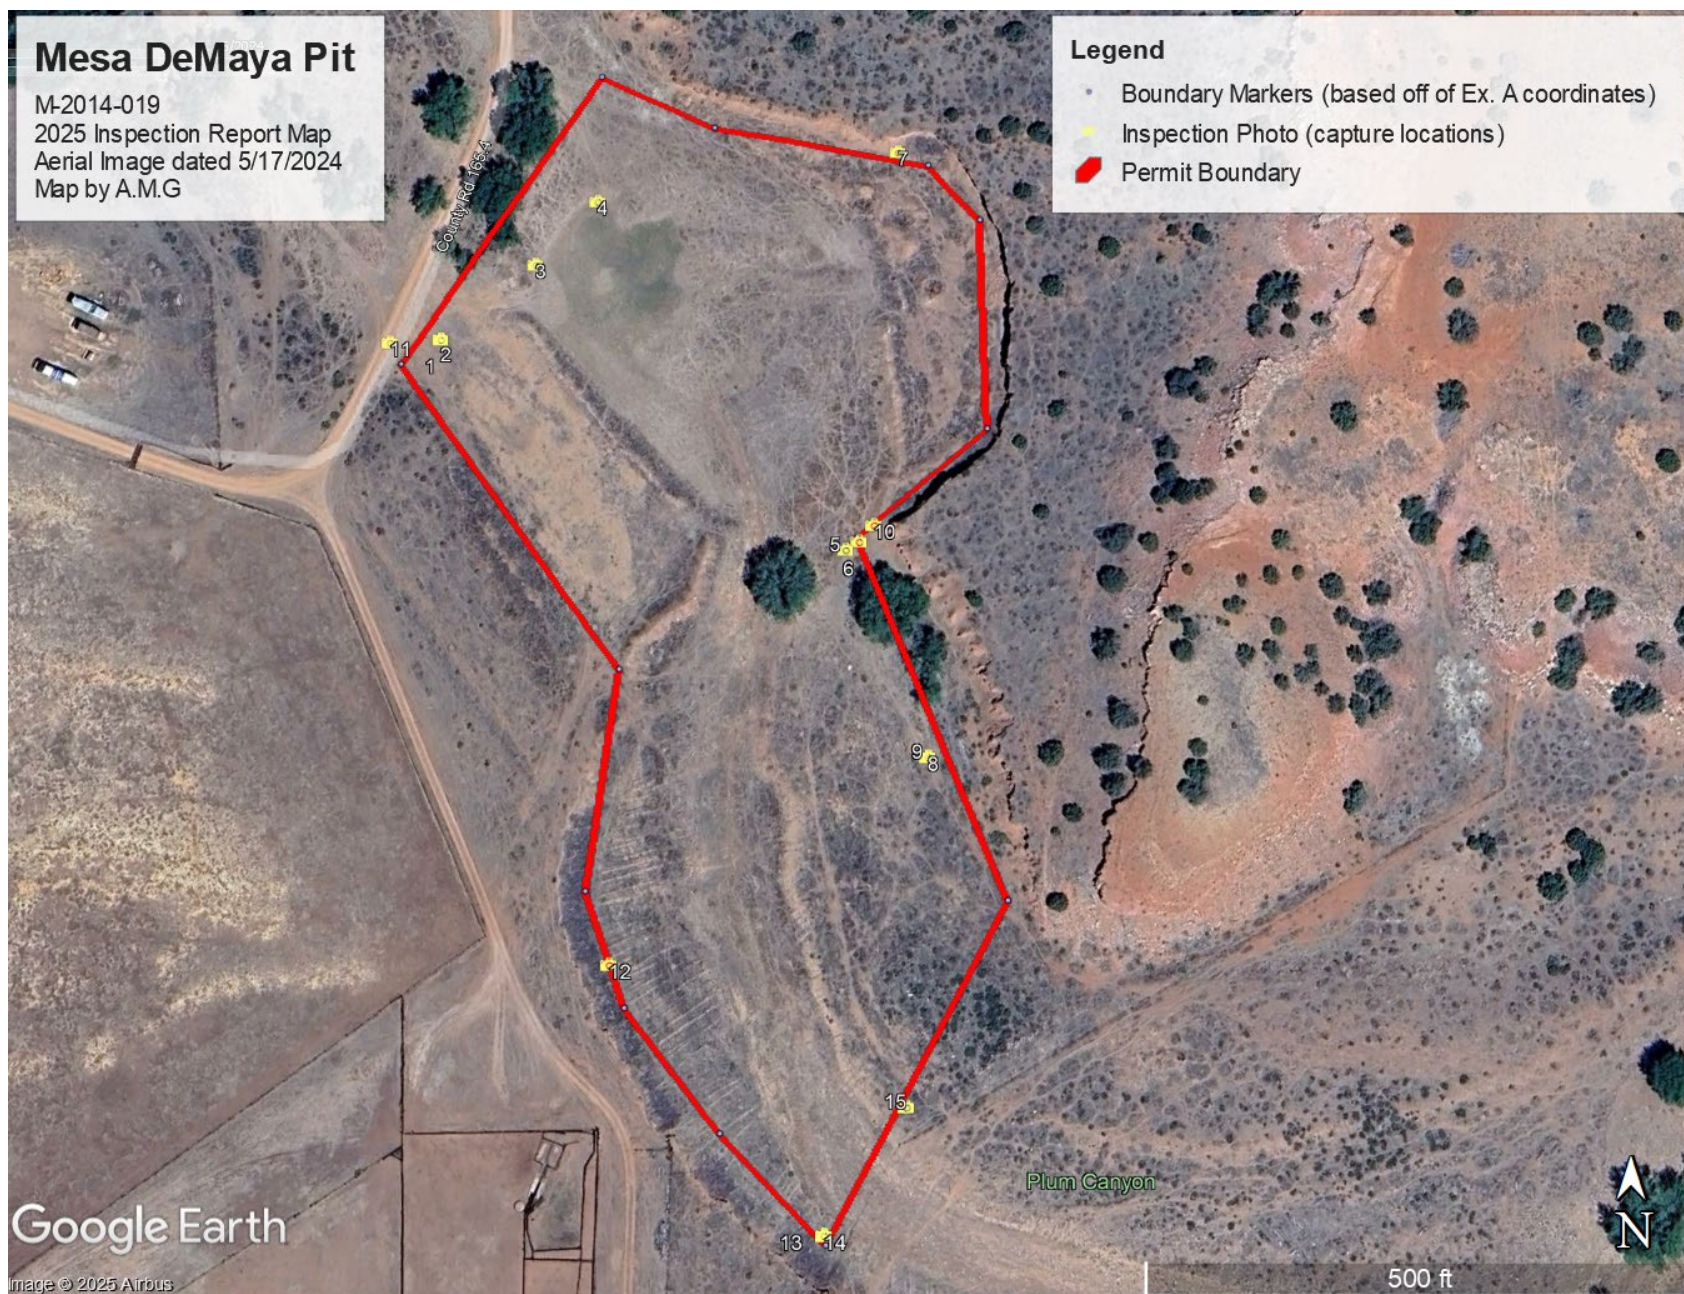
**Map 1:** 2025 Inspection Map created in Google Earth Pro. The numbers next to the camera icons correspond to the inspection photos.

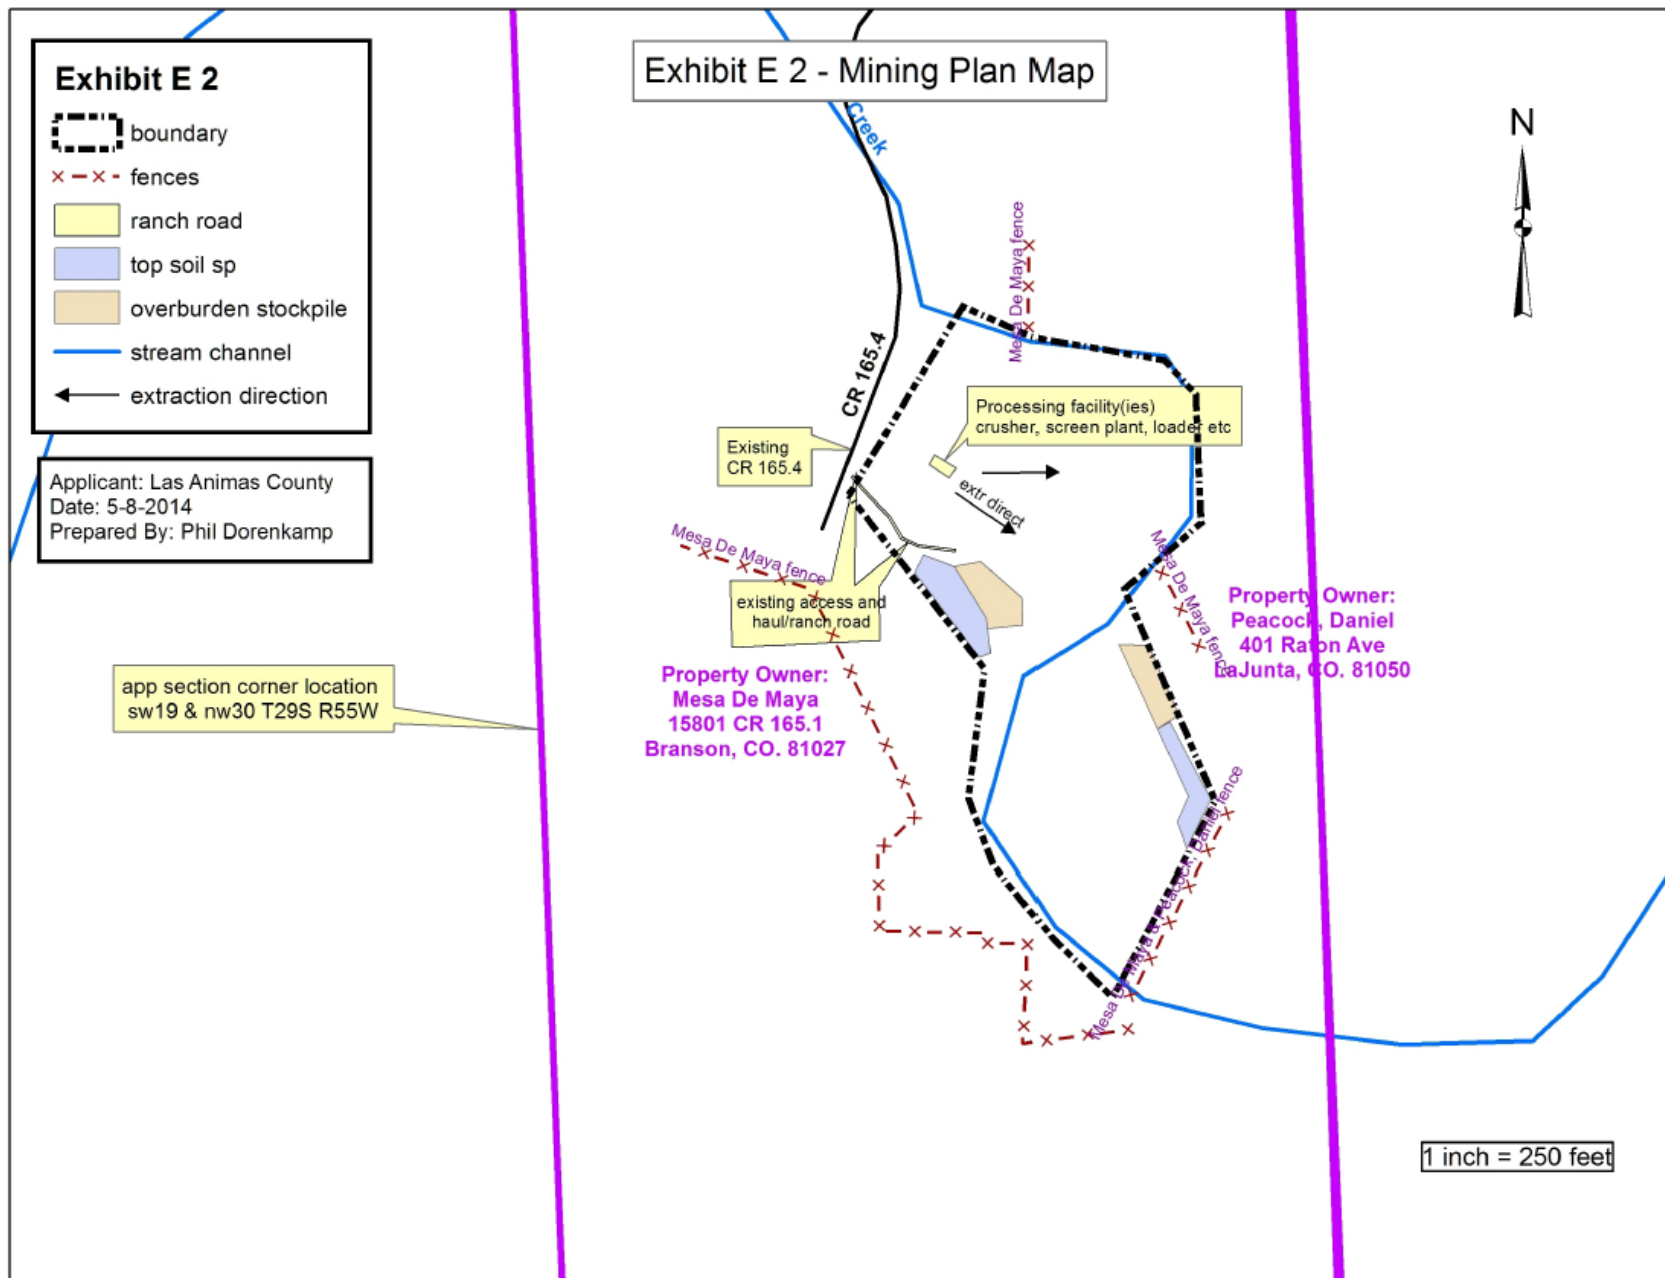
**Map 2:** The approved Mining Plan Map for the Mesa DeMaya Pit.
