MINERALS PROGRAM INSPECTION REPORT
PHONE: (303) 866-3567

MINE NAME: Topaz Mine	MINE/PROSPECTING ID#: M-1980-055-HR	MINERAL: Uranium and vanadium	COUNTY: San Miguel
INSPECTION TYPE: Multi Person Inspection	WEATHER: Clear	INSP. DATE: February 27, 2025	INSP. TIME: 10:23
OPERATOR: Pinon Ridge Mining LLC	OPERATOR REPRESENTATIVE: Bruce Smith	TYPE OF OPERATION: 112d-3 - Designated Mining Operation	
REASON FOR INSPECTION: Normal I&E Program	BOND CALCULATION TYPE:	BOND AMOUNT: \$162,630.00	
DATE OF COMPLAINT: NA	POST INSP. CONTACTS: None	JOINT INSP. AGENCY: None	
INSPECTOR(S): Lucas West	INSPECTOR'S SIGNATURE:

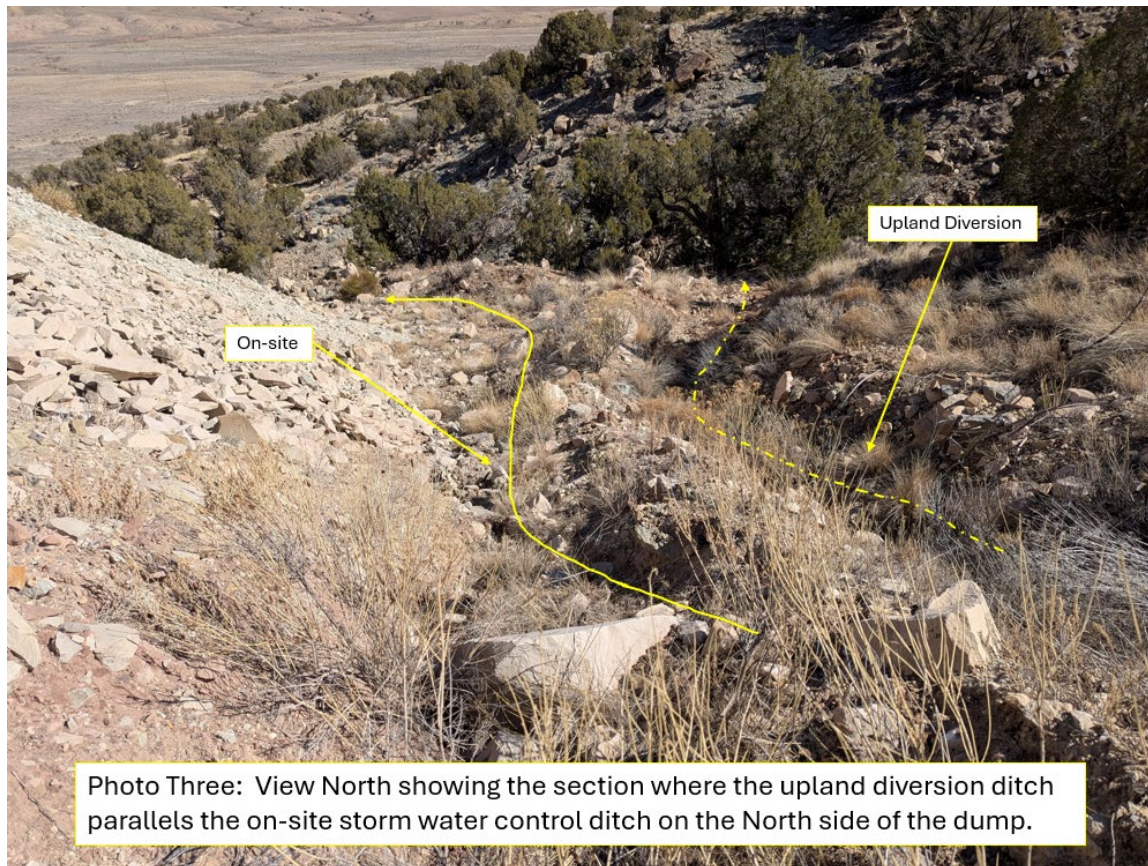
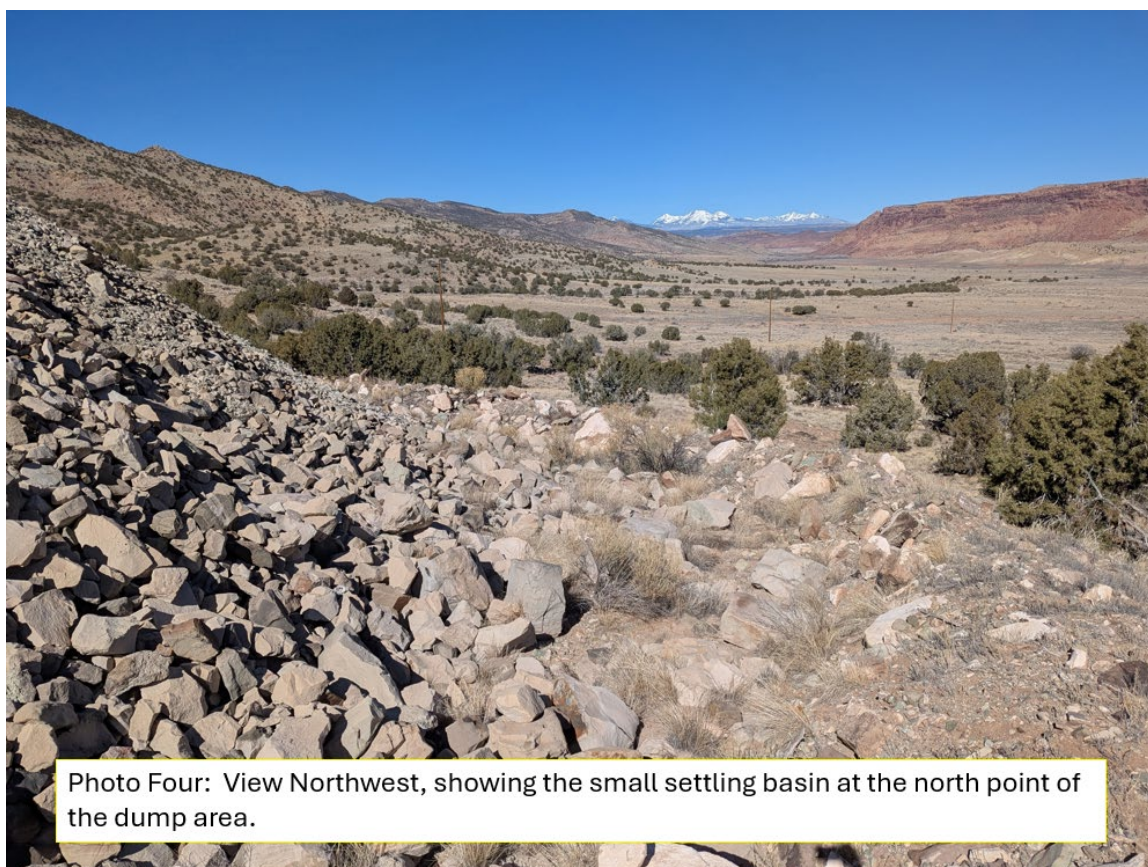
The upland diversion ditches that divert any potential run on water around the site to prevent it from becoming impacted stormwater were not observed during this inspection. On site discussions with Bruce Smith of Western Water and Land revealed that a comprehensive stormwater inspection had been conducted the day before the inspection and that all systems were in good working order. Along the south end of the site, however one of the upland diversion ditches parallels the ditch that collects stormwater from the slope of the waste rock dump. The upland diversion ditch was observed to be clear, free from obstruction and able to function as designed. An example of this upland diversion can be seen in Photo Three. The toe berm that collects storm water from the waste rock dump was also observed to be in good condition. There is one section around the northeast corner of the toe of the dump that will require improvement soon, but is still functional. The ditch follows the toe and leads to a small catchment basin shown in Photo Four. The stormwater controls on the North and West side of the dump were also free from obstruction and appeared to be able to function as designed. One section of the control systems were identified by the Operator to need attention, around the Northwest section of the dump. Different mitigation efforts were discussed and agreed that re-establishing the ditch for continuous flow would be the best option. The area requiring work can be seen in Photo Five.
