MINERALS PROGRAM INSPECTION REPORT PHONE: (303) 866-3567

MINE NAME:	MINE/PROSPECTING ID#:	MINERAL:	COUNTY:
Olathe Pit	M-1984-108	Sand and gravel	Montrose
INSPECTION TYPE:	WEATHER:	INSP. DATE:	INSP. TIME:
Monitoring	Clear	April 2, 2025	14:00
OPERATOR:	OPERATOR REPRESENTATIVE:	TYPE OF OPERATION:	
Western Gravel, Inc.		110c - Construction Limited Impact

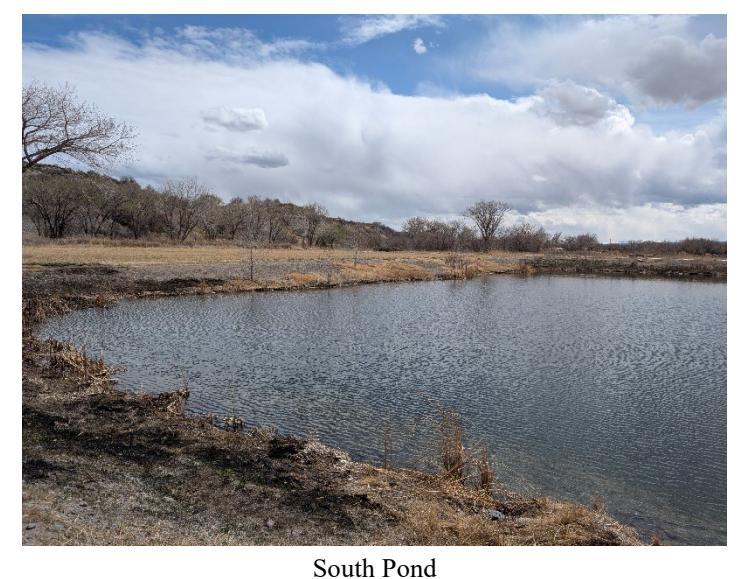
PROBLEM/POSSIBLE VIOLATION: Problem: The site has been in final reclamation for greater than 5 years. The area around the south pond has not been adequately revegetated to meet the requirements of Rule 3.1.10. This is a possible violation of Rule 3.1.3 for failure to complete reclamation within 5 years.

CORRECTIVE ACTION DUE DATE: 6/02/25
